**Preliminary Investigation into Historic Flood Marks
in the
“Smith” House
Hamilton, Washington**

Conducted November 29, 2006

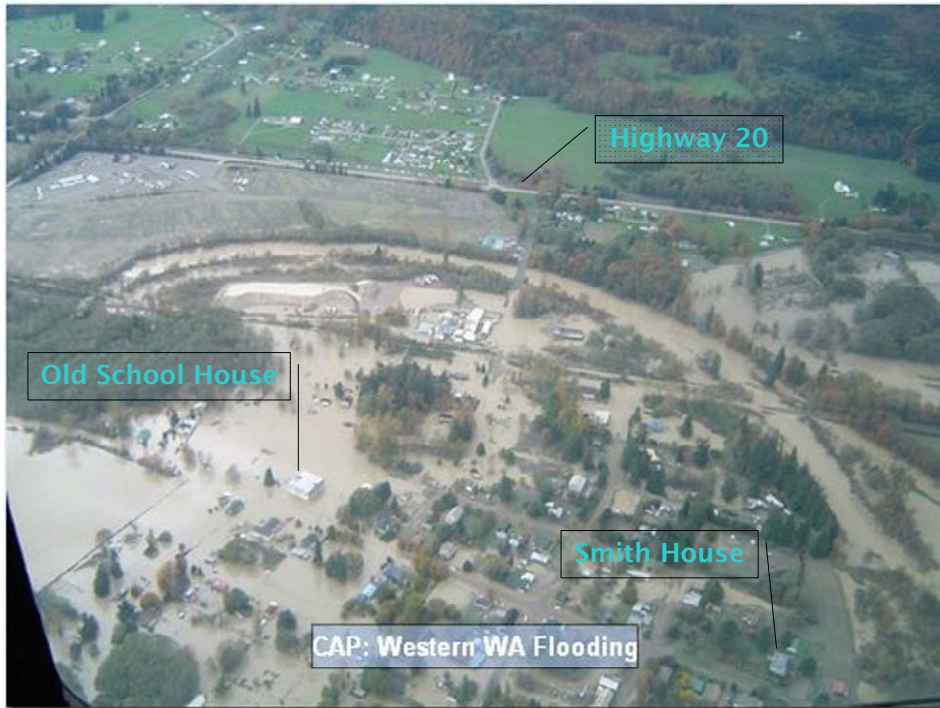
Graphic 2: 2003 flood aerial photo of Hamilton by Washington Military Department

From the aerial photograph above, taken by the Washington Military Department, Emergency Management Division as flood waters were receding during the 2003 flood event, it can be seen that the Smith House is located on somewhat higher ground than other houses and structures in Hamilton.

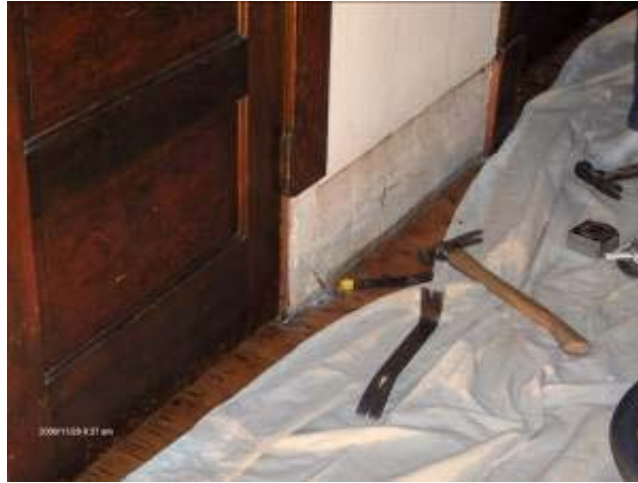
Graphic 4: Photo taken before the first cut with floorboard removed.

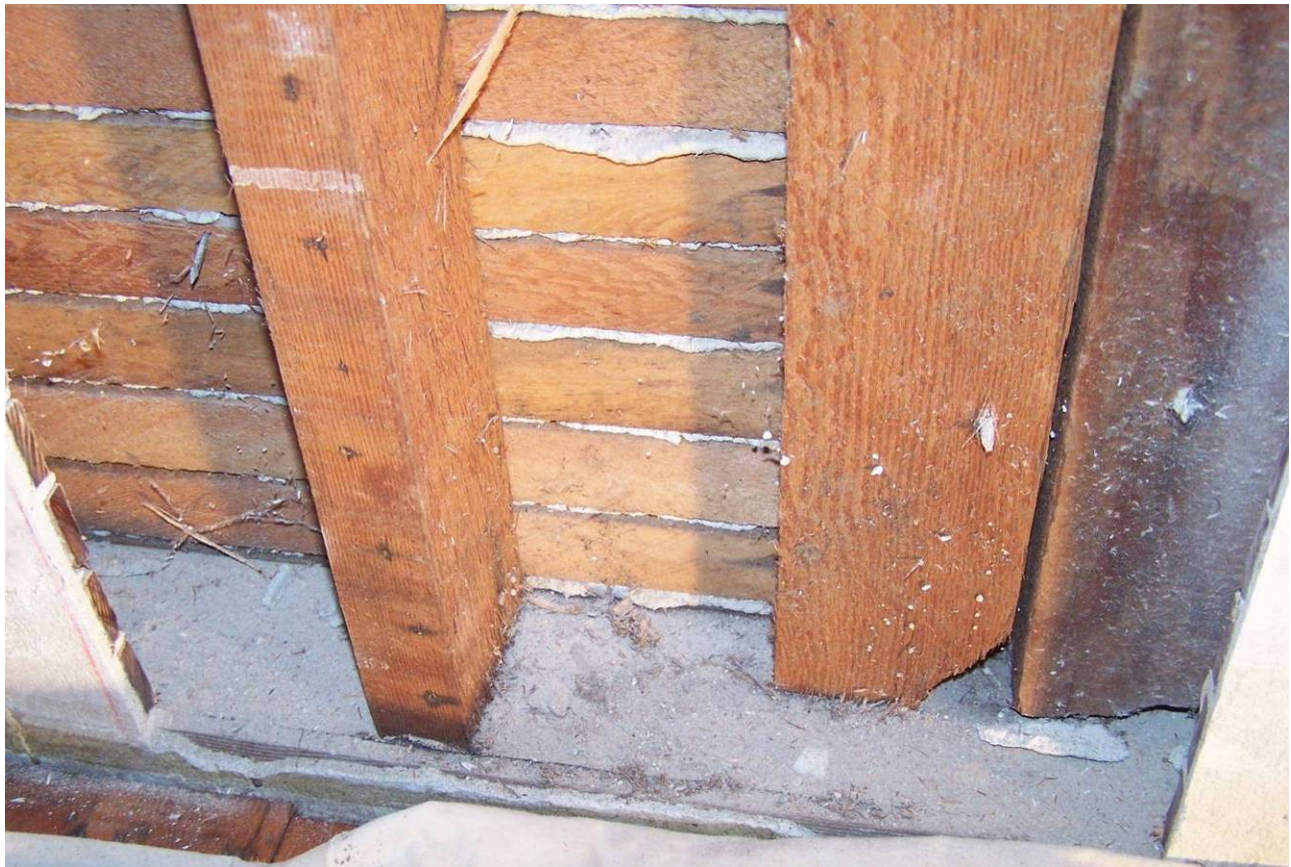
Graphic 7: Interior wall cavity of initial cut showing condition of lath and plaster.

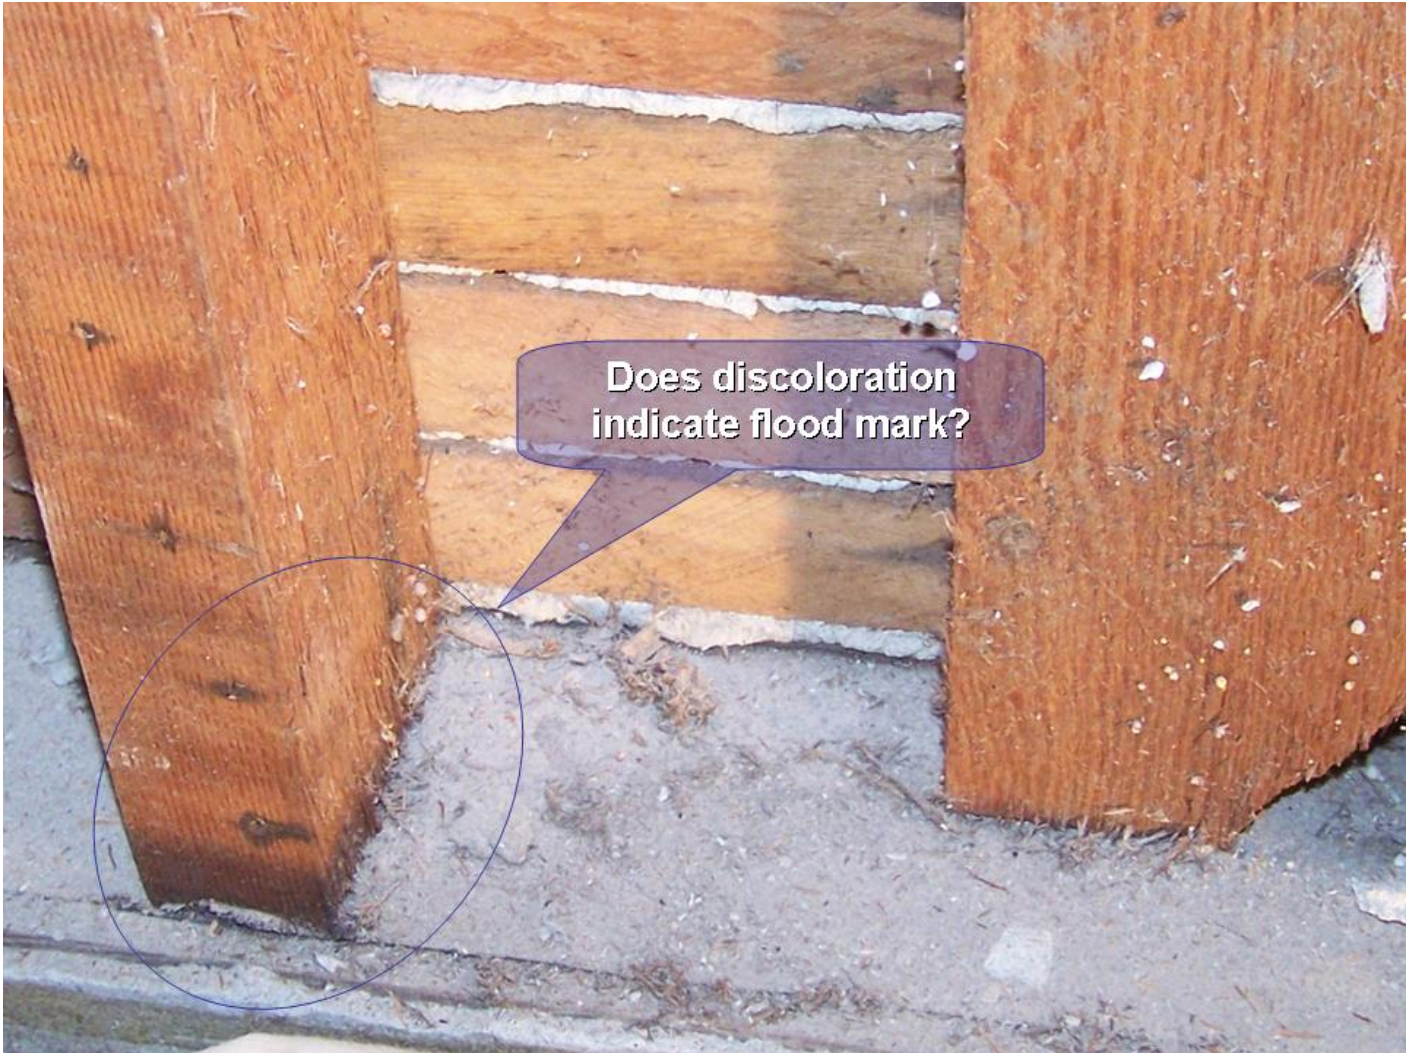
Graphic 8: Close-up of base wall plate.

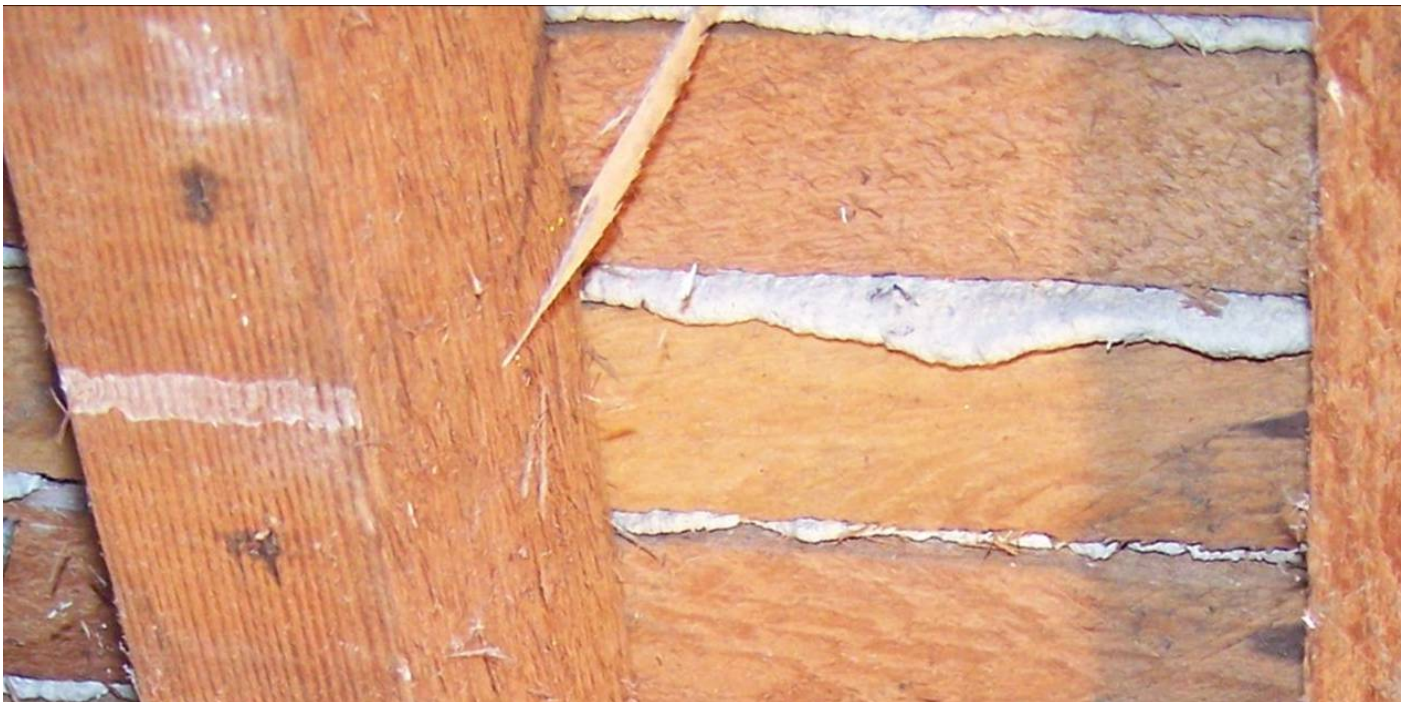
Graphic 9: Close-up of initial wall cutout. No bleaching or discoloration of the original lath was observed.

Close inspection of the cutout wall sections revealed no apparent flood marks or discoloration of the interior lath and plaster above the bottom piece of horizontal lath. There were indications that water might have extended above the floor boards of the house. This would be consistent with anecdotal reports that flooding did occur in 1995, extended slightly above the floor boards, and that the floor was refinished after that flood. The current property owners reported that the flood of 2003 did not rise above the floor boards as the flood of 1995 did. It is plausible this was the case even though the peak flow of the 2003 flood (166,000 cfs) was greater than the peak discharge of the 1995 flood (160,000 cfs) because the peak duration of the 1995 flood event was longer.

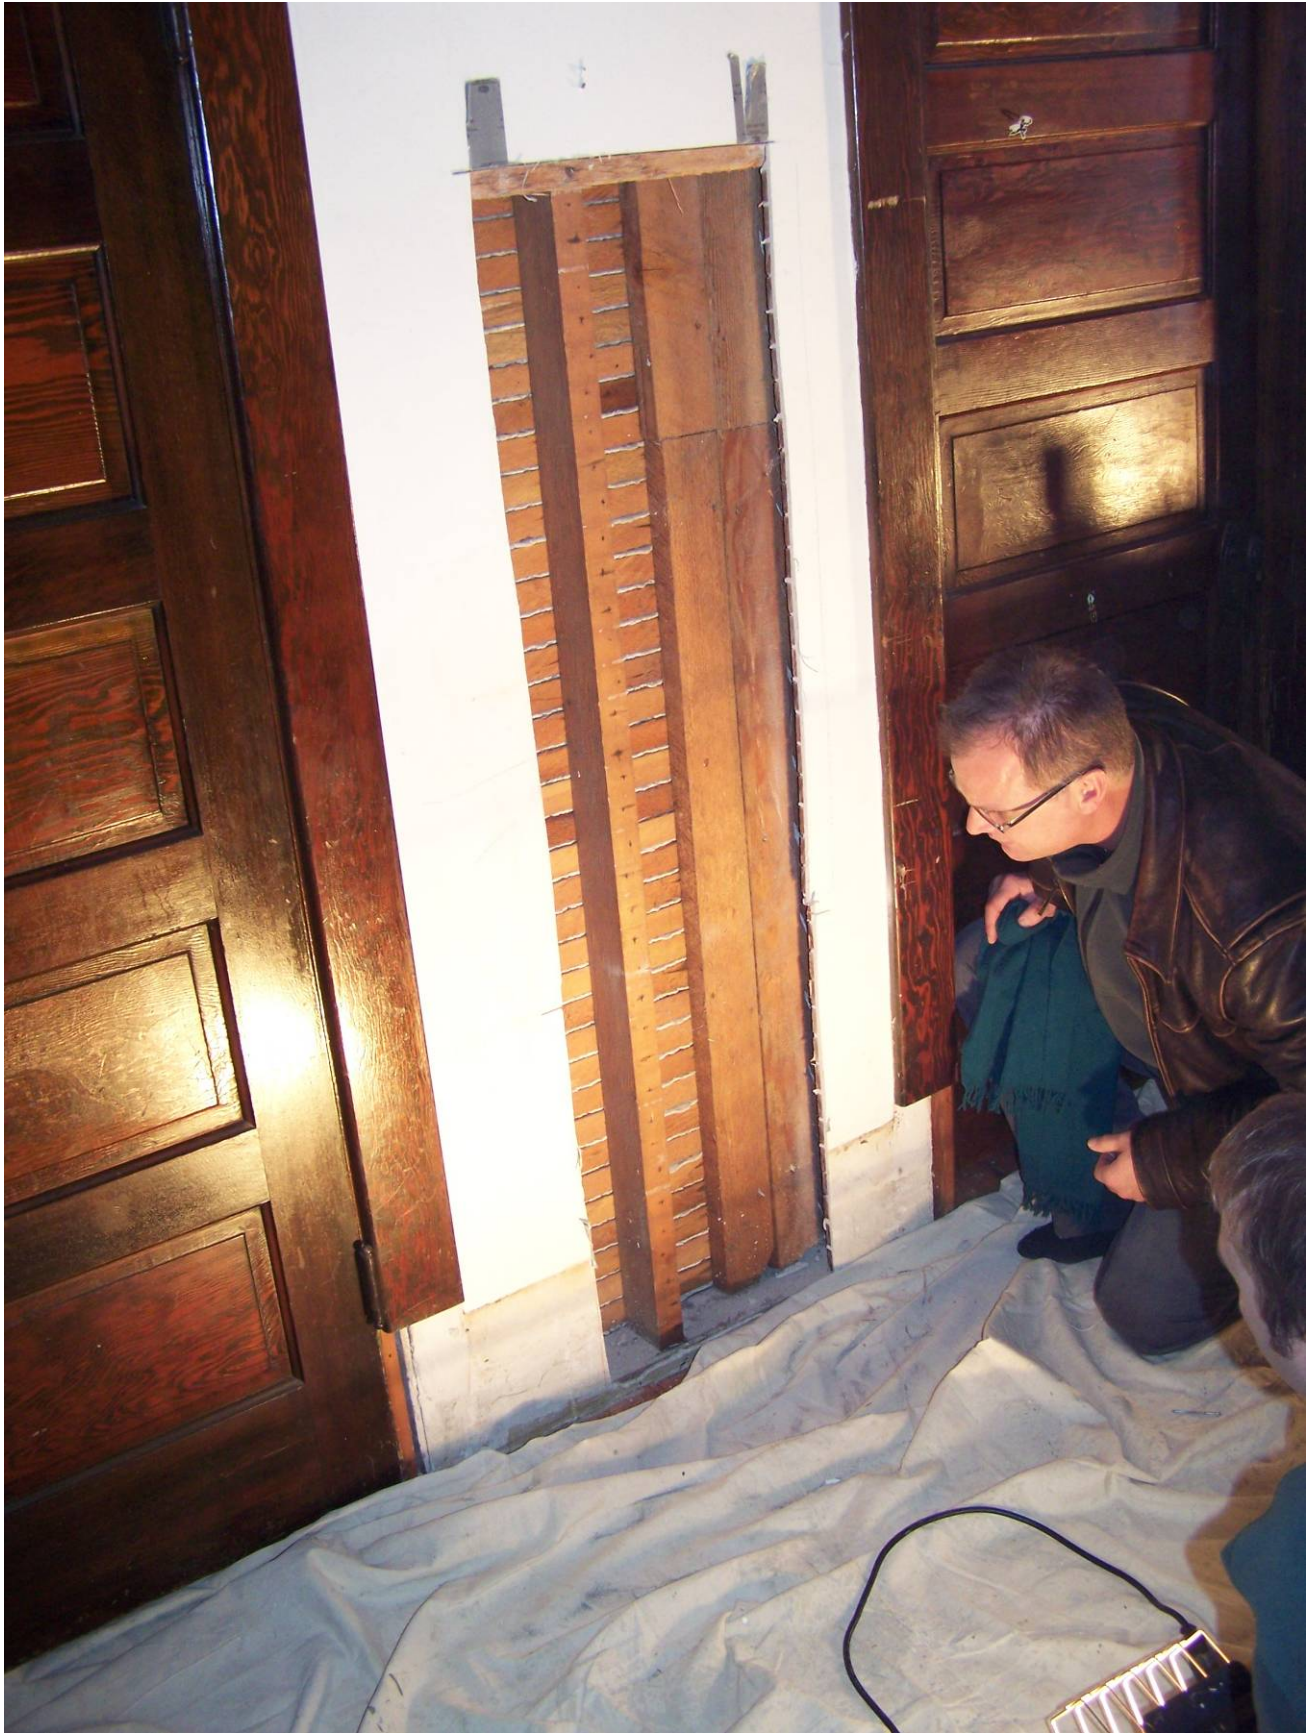
Graphic 10: The first cut was extended to a total of 5'3" in height to observe the interior above the original cut to preclude the possibility that a flood mark existed above the level of the initial cutout.

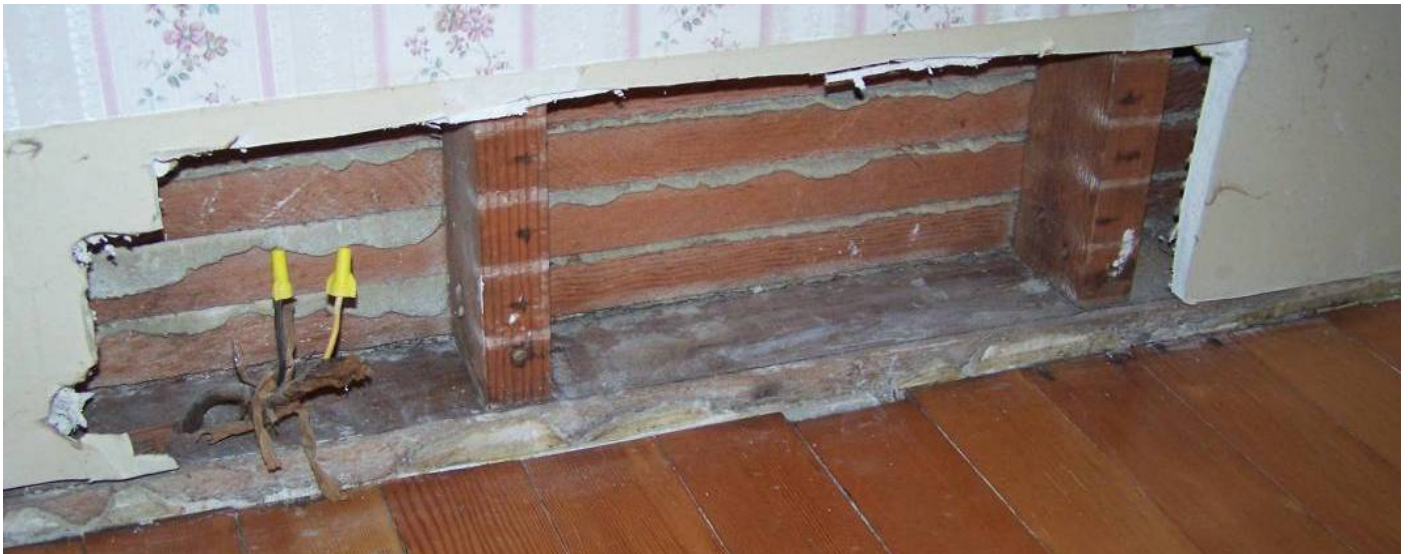
Graphic 11: 2nd cut between the dining room and kitchen, from the dining room side. Lath/plaster had been replaced with gypsum wall board on the dining room side.

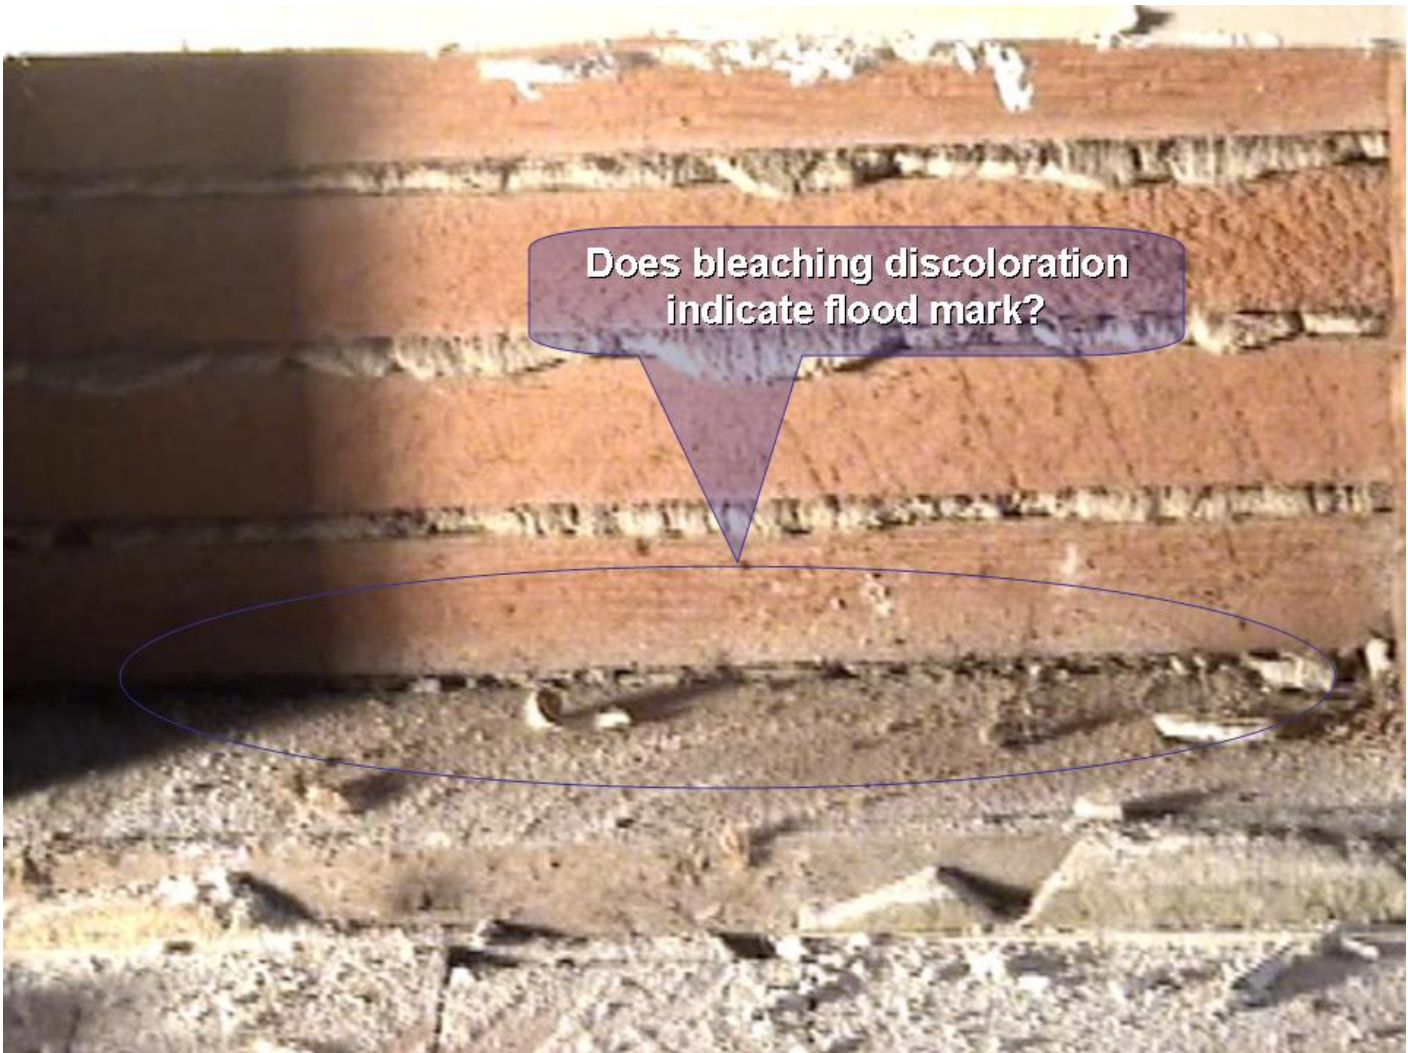
Graphic 12: Close-up of 2nd cut from video documentation

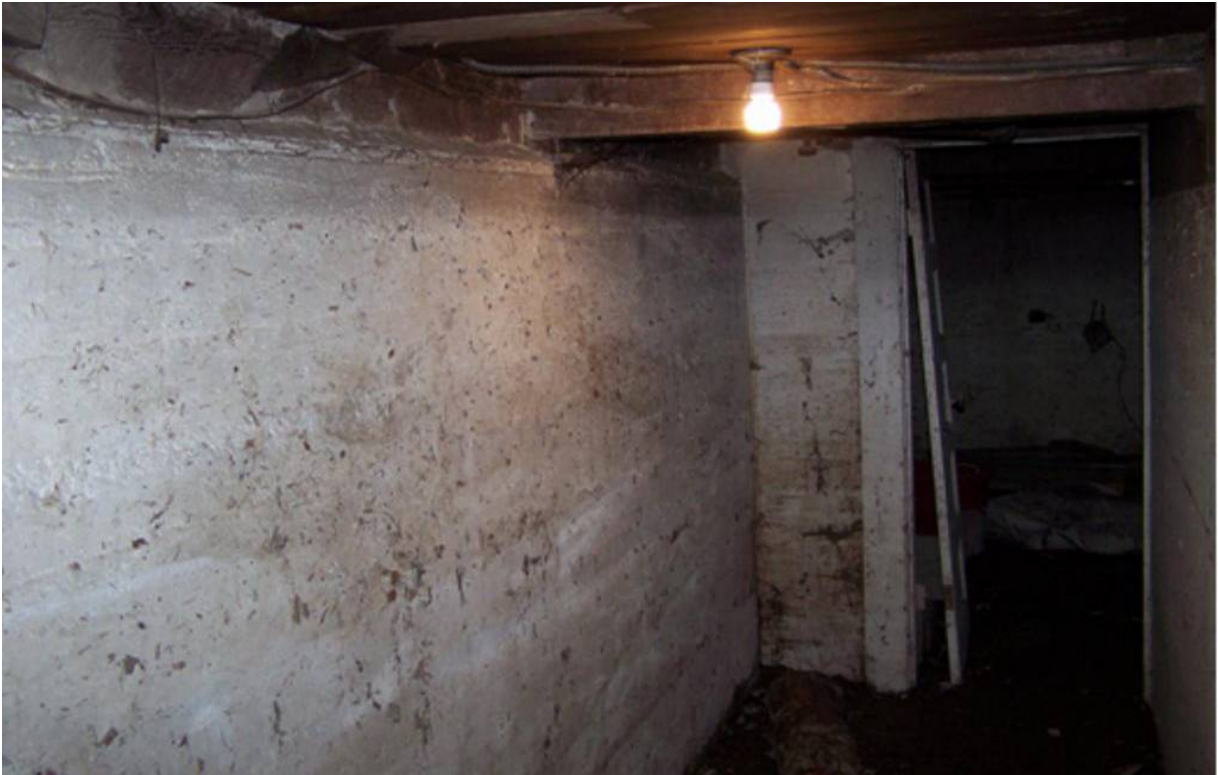
Graphic 13: The original foundation included a basement under approximately a third of the house. Good access enabled easy visual verification that the substructure framing of the house had not been modified or elevated.

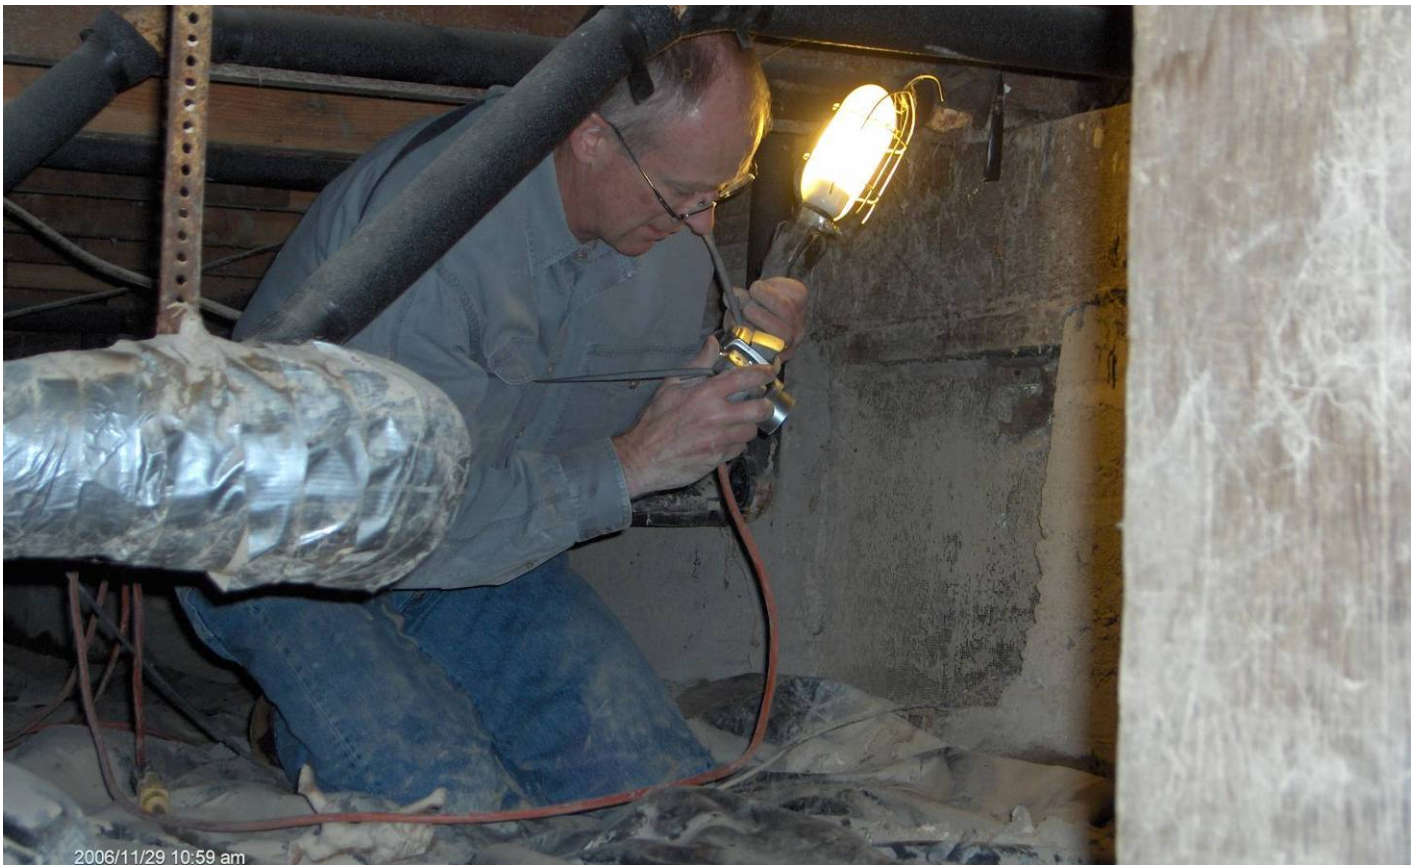
Graphic 14: The original foundation was unaltered. Crawl space observation indicated the house was not elevated.

The current property owners also reported that additional repairs were necessary to the house in the crawl space substructure following the flood of 1995. This was verified by inspection of the interior crawl space. It was noted that, since the substructure of the house needed repair after the 1995 flood event when water rose to just above the finished floor, it seems likely that had the water level been several inches higher, the house would have been moved completely off of its foundation.
