17 August 2007

Re: City of Hamilton
Historic Flood Investigation
WJE No. 2006.5898

Subject: Debris Studies

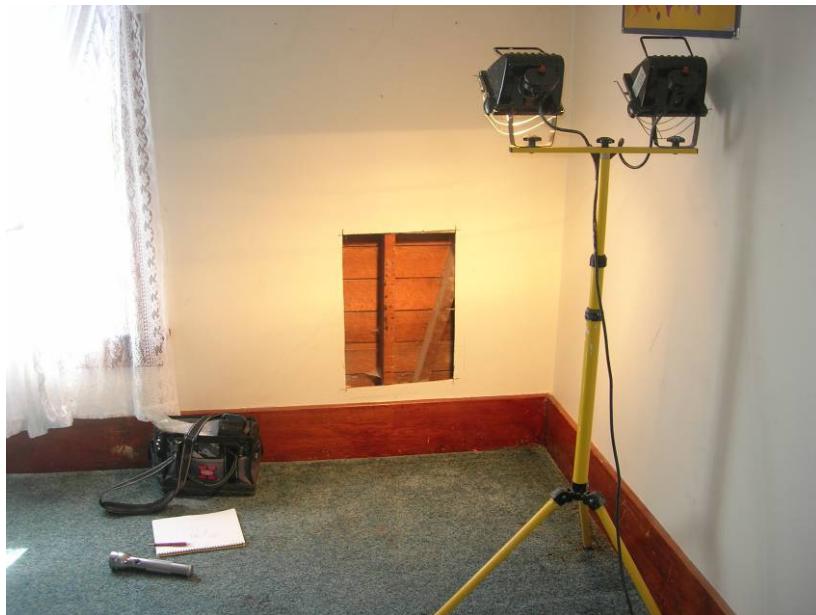
Opening No. 1 was located in the upper floor, north bedroom. The opening was made in the interior surface of the north, exterior wall. The wall finish was the original wood lath-and-plaster. No apparent flood lines or debris were observed within the wall cavity. The lath nails exhibited minor rust staining on the 2x4 wall studs.

Figure 1. Smith House, Opening No. 1. Upstairs bedroom, north exterior wall.

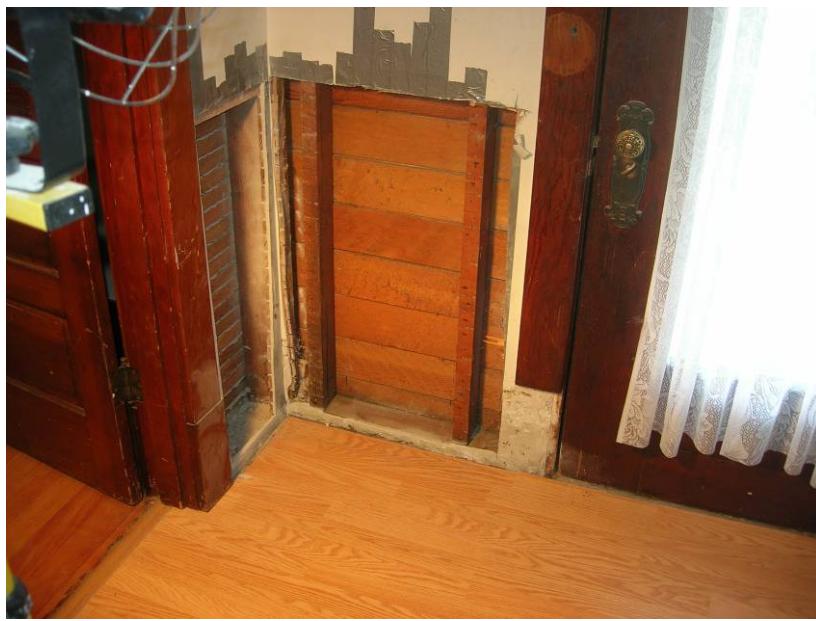
Figure 2. Smith House, Opening No. 2. Interior opening of east exterior wall adjacent to front door.

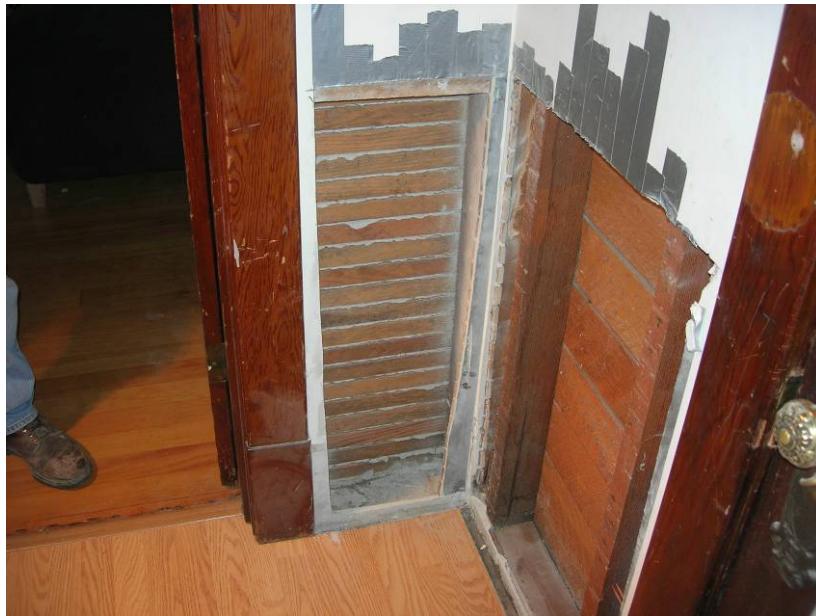
At the Smith House, WJE did not observe any evidence to indicate that flood water elevations ever exceeded the finish floor elevation of the house. The debris samples removed from Opening 3 were similar in constituency to the debris found within the crawlspace, but there was no visual evidence to indicate the material was deposited by flooding. In addition, none of the same materials were found in Opening 2, which was immediately adjacent to Opening 3 in an exterior wall. The debris in Opening 3 is likely from soils deposited in the wall at the time of construction and from fragments of the plaster deposited in the space while cutting the opening.

Figure 3. Smith House, Opening No. 3. Opening at south side of interior wall adjacent to Opening No. 2.

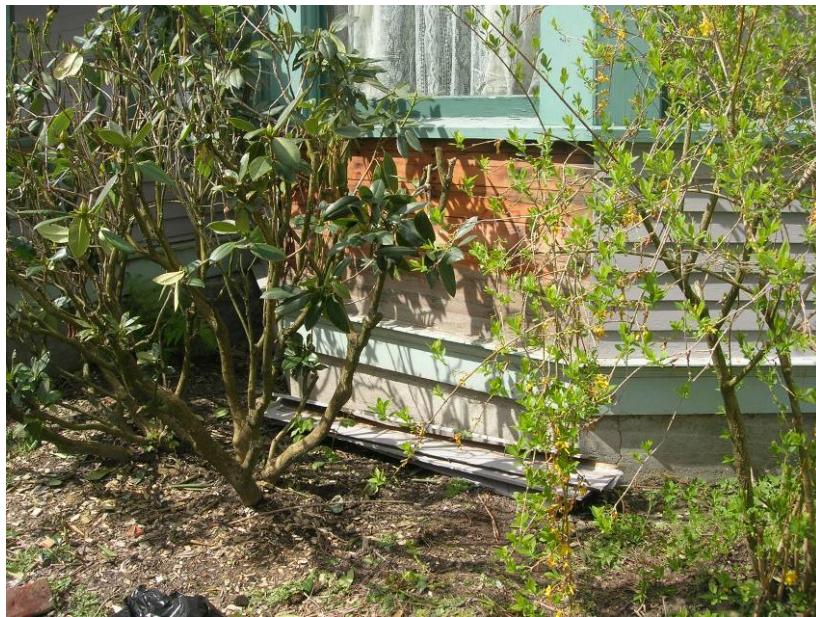
Opening No. 4 was an exterior opening located on the north wall, just below the dining room bay window. At this location, the wood lap siding was removed to reveal the wood wall sheathing. Seven courses of lap siding, approximately 2-1/2 feet in height, were removed below the window.

Figure 4. Smith House, Opening No. 4. North exterior wall behind siding.

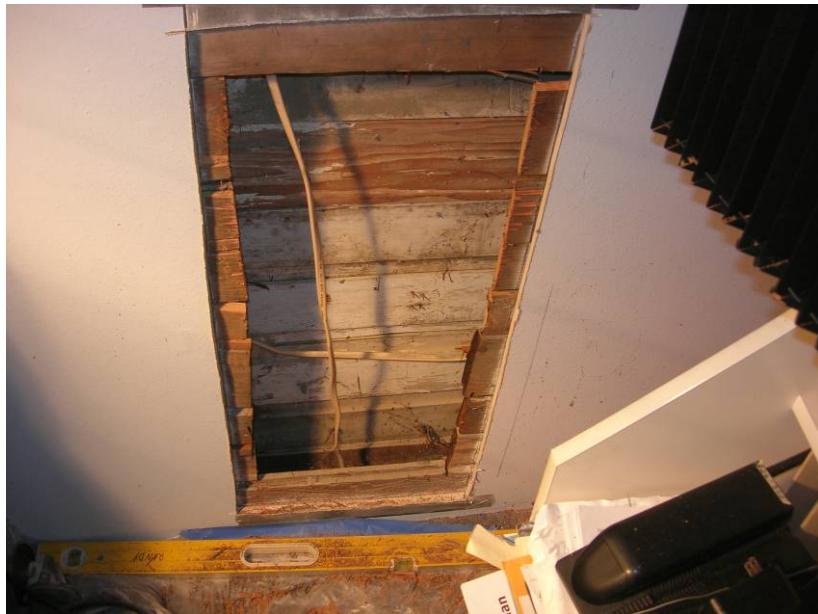
The Slipper House, reportedly built around the same era as the Smith House, has reportedly been relocated and elevated from its original location. One opening, Opening No. 5, was made within the Slipper House. The opening was located at the base of the interior, west wall of the office. The office side of the wall was sheathed with 1x shiplap sheathing with gypsum wallboard interior finish. The back side of the wall was sheathed with wood shiplap siding boards. The boards had paint on them and were shaped like siding boards. Some of the boards were installed upside down indicating that the backside of the wall was sheathed with re-used materials.

Figure 5. Slipper House, Opening No. 5. Opening at interior office wall.

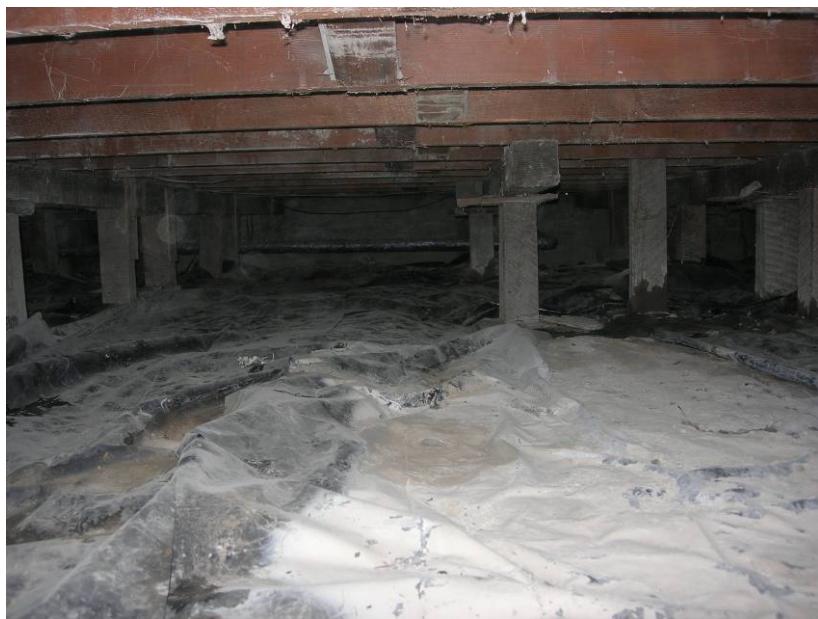
There is a black plastic vapor retarder on top of the ground surface throughout the crawlspace. The vapor retarder was generally overlain by a layer of fine silt (Figure 6). At the northwest corner of the crawlspace, a layer of silt was observed on the top surface of a floor beam located 2 feet 8 inches above the ground surface.

The silt debris found within the crawlspace on top of the vapor retarder is believed to have been primarily deposited by flooding. There was generally a thick layer of the silt observed throughout the crawlspace on top of the vapor retarder and on top of floor beams elevated approximately 2 feet 8 inches above the level of the crawlspace floor.

Figure 6. Smith House crawlspace.

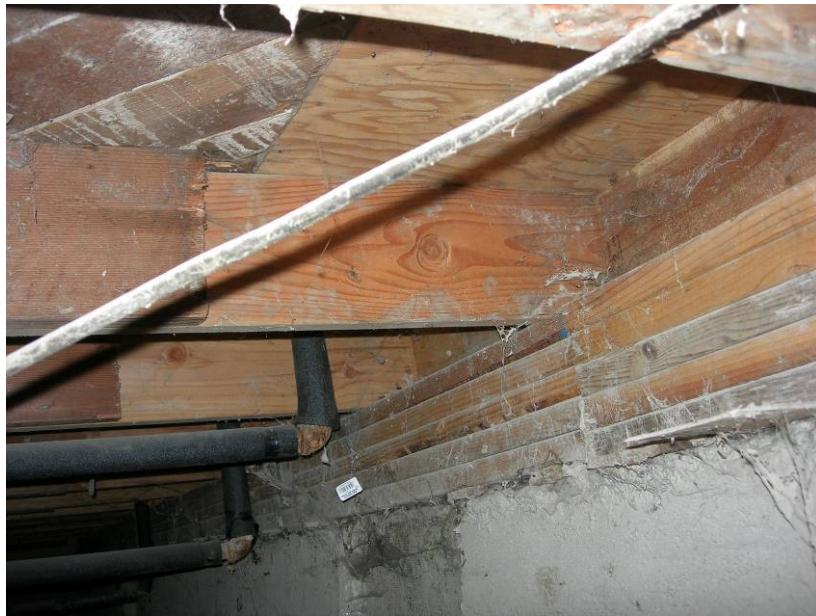
Extensive framing repairs were observed along the south wall at the east end of the house. Reportedly, the repairs were initiated to address damage resulting from a flood that occurred in 1995. The south end of the 2x8 floor joists were cut along most of the length of the south wall. The joists were extended with sistered 2x8 joists, which were supported on stacked 2x plates on top of the foundation wall (Figure 7). The 6x6 beam located approximately 6-1/2 feet inward from the south wall reportedly rolled as a result of the flood. The beam was realigned and supported by side gussets. The subflooring in this area was replaced by plywood.

It is our understanding that the repairs at the southeast corner of the house were performed as a result of damage from the 1995 flood. Based on the repairs that were performed, it appears that buoyancy effects from the 1995 flood caused the wood floor framing to lift off of the south foundation wall leaving the south end of the floor joists unsupported and one 6x6 floor beam rotated. Because there were no positive connections found between the wood framing and the concrete foundations, it is not surprising that the flood waters were able to float a portion of the house. While in the crawlspace, we did not observe any evidence of similar historic repairs to indicate that the house had been subjected to buoyancy effects during earlier area floods.

Figure 7. Repairs at south end of Smith House foundation.

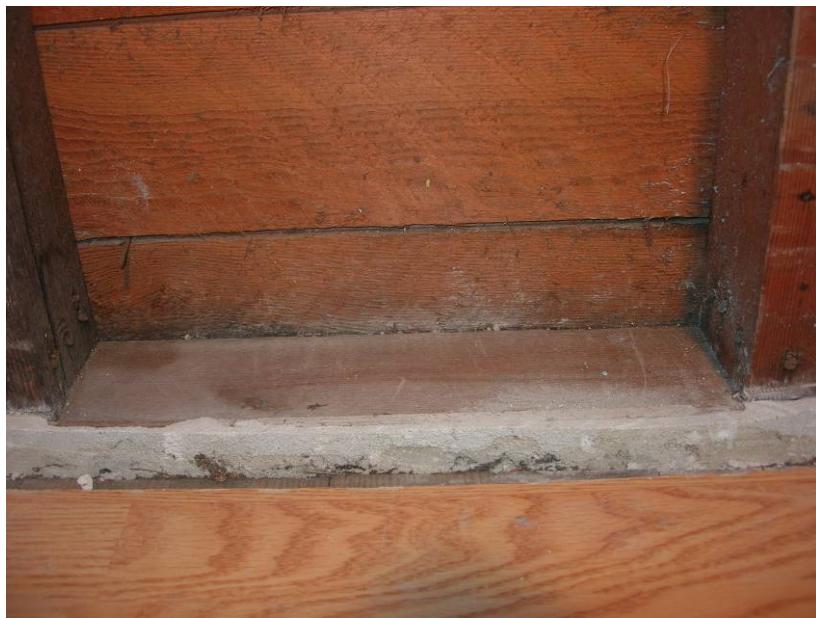
Opening Nos. 2 and 3 were located on the main floor level. Opening No. 2 was made in the interior surface of the east, exterior wall adjacent to the front door (Figure 8). Opening No. 3 was made in the south surface of the interior wall adjacent to the east exterior wall. Both openings were located at the base of the wall. No apparent flood debris or flood lines were observed within the wall cavities. Framing nails visible in the wall cavities were corroded. The lath nails exhibited minor rust staining on the 2x4 wall studs.

No visual indication of flooding was found within the interior wall cavities of the Smith House. The microscopical studies of the debris from Opening 2 consisted mainly of gypsum, which was likely the dust deposited from cutting the opening through the plaster wall finish. The debris from Opening 3 was found to contain many of the same components as were observed in the deposits found within the crawlspace, i.e. angular volcanic rock fragments (basalt, brown volcanic glass, colorless volcanic glass) and mineral grains (quartz, chert, feldspar, hornblende, biotite mica, pyroxene, hematite, and opaque grains), but did not appear to have been deposited due to flood waters.

Figure 8. Close-up view of Opening No. 2. No water lines present.

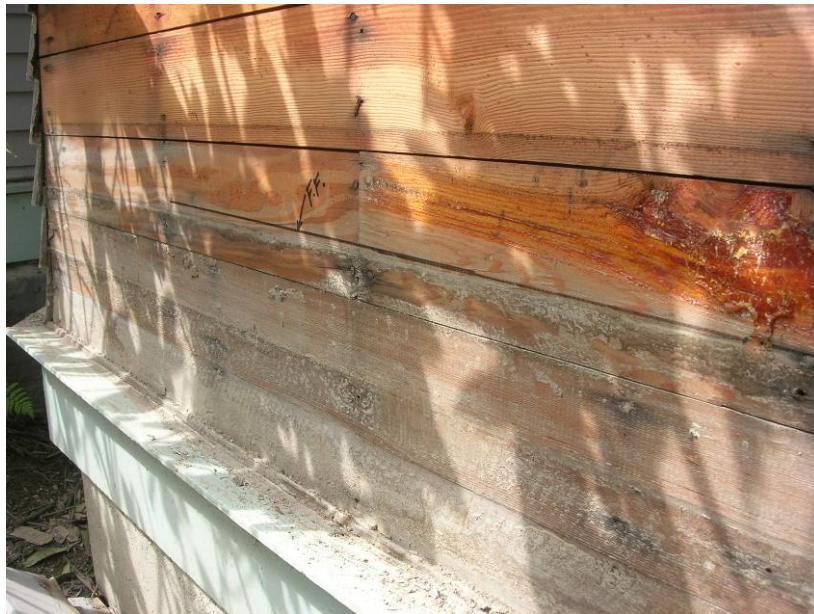
There was a discoloration line located on the 1x shiplap sheathing boards approximately 2 feet below the window. The line appeared to be a flood line and corresponded with the approximate elevation of the interior finish floor (Figure 9). Lesser discolorations, light staining, of the wood sheathing were observed above this line. If the line is a flood line, as it appears to be, the fainter discolorations above this line are likely due to wicking of water behind the siding.

The water line observed behind the north, exterior wall opening behind the lap siding, was approximately equal in elevation to the finish floor elevation. No silt debris was observed above the water line at this location. Both silt samples removed from behind the siding contained many of the same constituents as the silt samples found on top of the vapor retarder within the crawlspace. It is likely that the silt debris found behind the lap siding at this location was deposited by flood water.

The highest water mark and/or indication of flood silt deposits found at the Smith House were at Opening 4, behind the wood lap siding on the north side of the house. The elevation of the flood markings and silt deposits at this location were approximately equal in elevation to the finish floor elevation. We are unable to determine from the debris samples when the approximate date of this highest flood level occurred; however, based on the damage and repairs that occurred as a result of the 1995 flood, it appears that this flood may have been close to, if not the highest elevation of flood water that the house ever experienced.

Figure 9. Smith House, Opening No. 4. Water line at approximately same elevation as finish floor line behind lap siding.

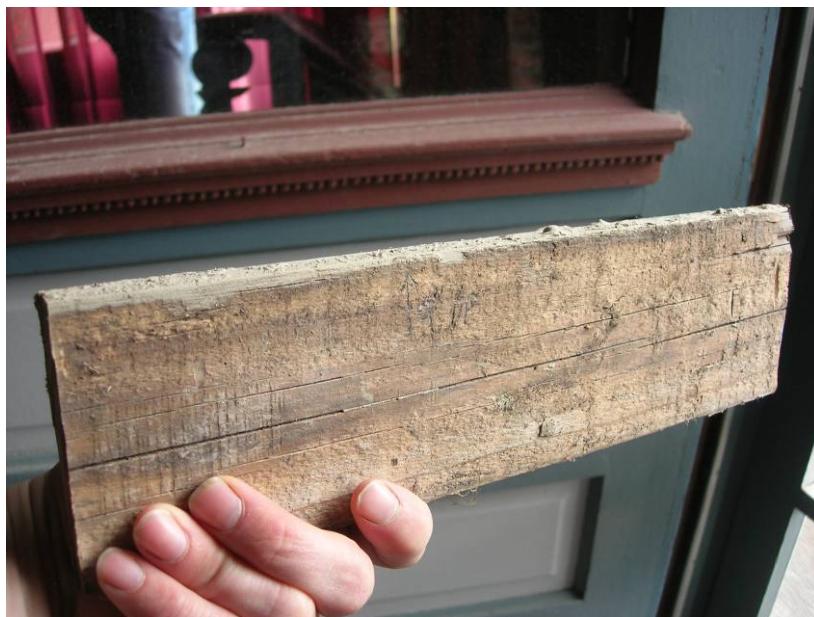
Grey colored deposits were observed on the top edge of the 1x shiplap sheathing boards on the office side of the wall (Figure 10). The deposits were primarily located on the top of the boards near the base of the wall. The bottom three boards removed from the opening and provided to the lab for microscopical examination.

The grey colored deposits found within the wall at the Slipper House appear to be mortar, not flood silt.

The deposit sample removed from inside the wall of the Slipper House appeared to be a mortar material, not flood silt. As a result, the limited sampling of the Slipper House was inconclusive regarding determination of past flood levels within the house and determination of flood silt materials that can be transferred into an interior wall cavity during a flood event.

Figure 10. Grey deposits on top of sheathing boards at Slipper House interior wall opening.
