June 26, 1978

RE: Skagit River Levee and Channel Improvements
Dike District #3

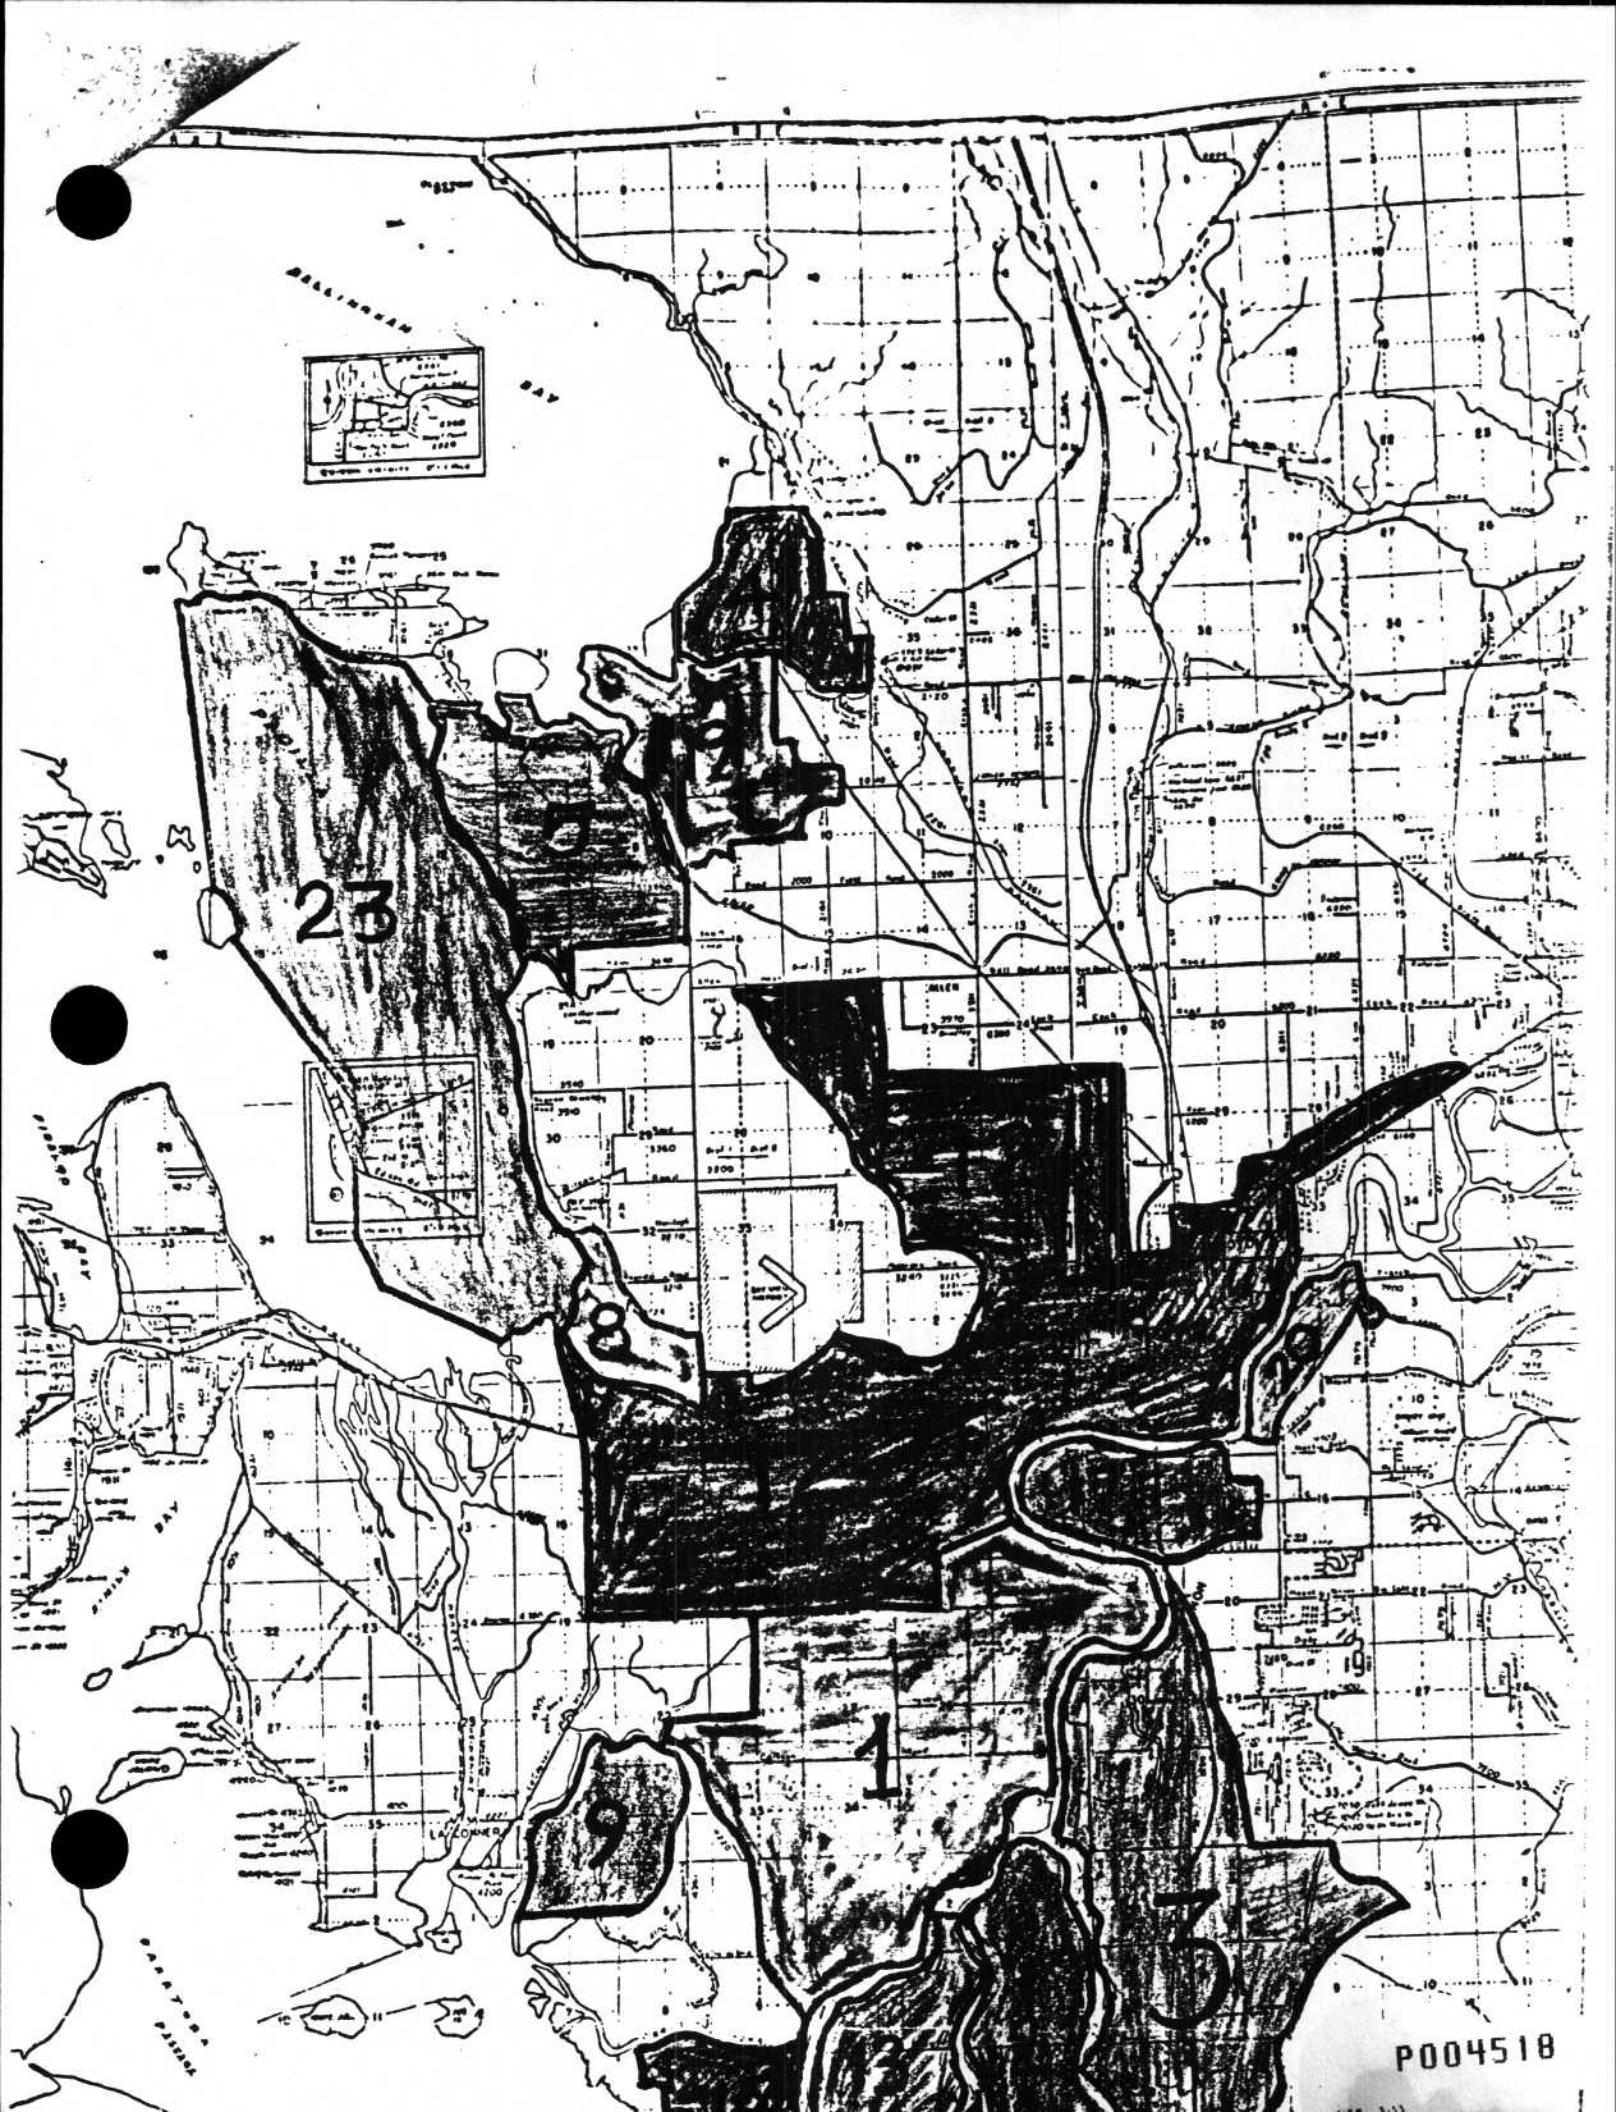
Major structures on our dikes include flood gates at Fishers Slough mentioned earlier in this letter, (1), drainage district pumps north of Conway bridge, (2), and outlet gates for Britt Slough, (3). Of these structures, only #1 is the primary responsibility of Dike District #3.

Another area of concern is 1000' south of the Hickox Road (5 on the map). In this area the river cuts dangerously close to the base of the dike and we are continually rip-rapping this area to maintain sufficient shoulder along the river side of the dike.
