RE-EVALUATION OF THE MAGNITUDE OF HISTORIC FLOODS ON THE SKAGIT RIVER NEAR CONCRETE FINAL REPORT

OCTOBER 2008

nhc northwest
hydraulic
consultants

30 October 2008
nhc project # 21637

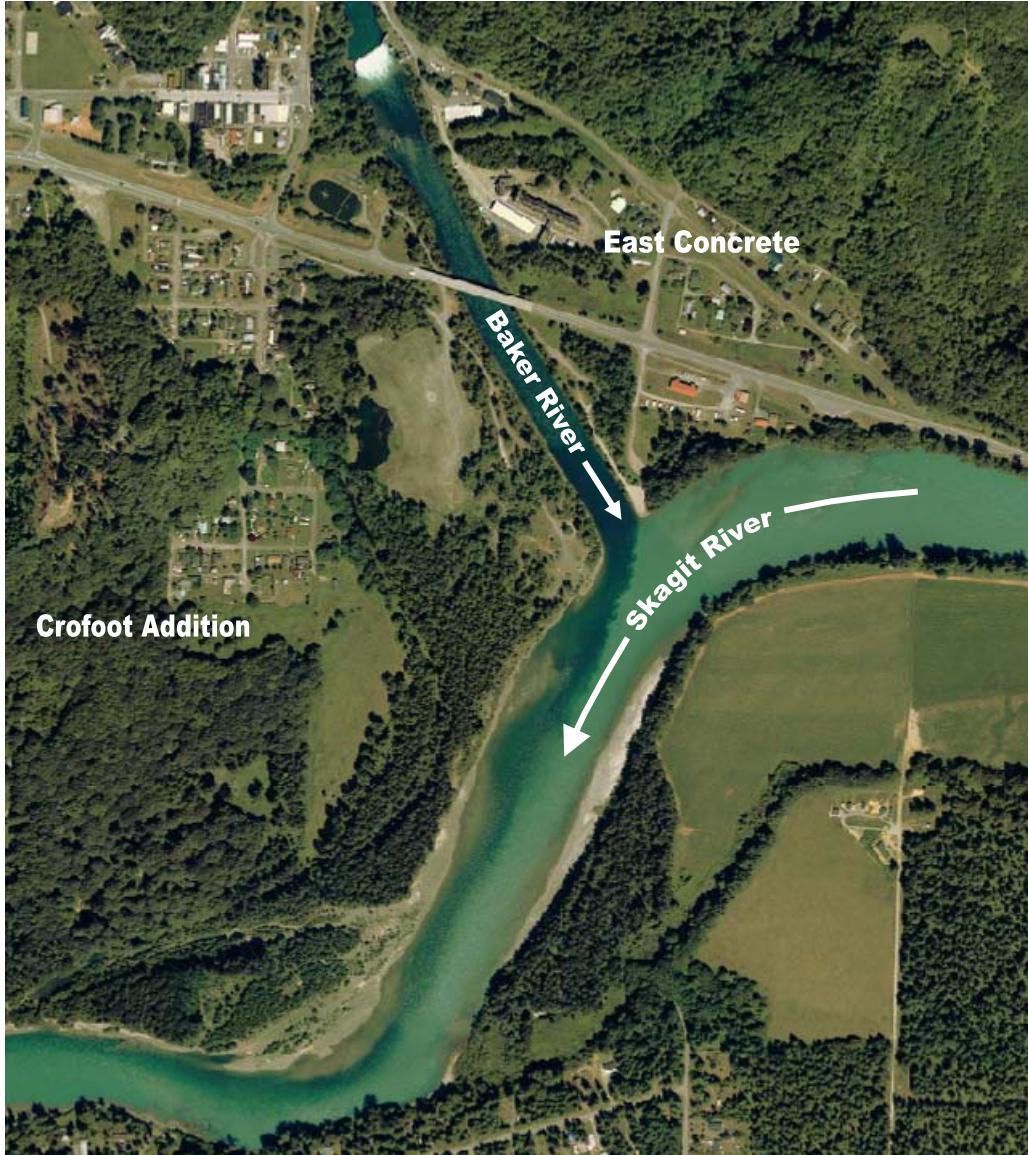
Figure 1. Crofoot Addition of Concrete, WA (2001).

The Crofoot Addition is that area of Concrete in the Skagit and Baker River floodplains south of the present alignment of SR-20 and immediately west of the confluence of the Baker and Skagit (see Figure 1). East Concrete is in the floodplain immediately east of the Baker River.

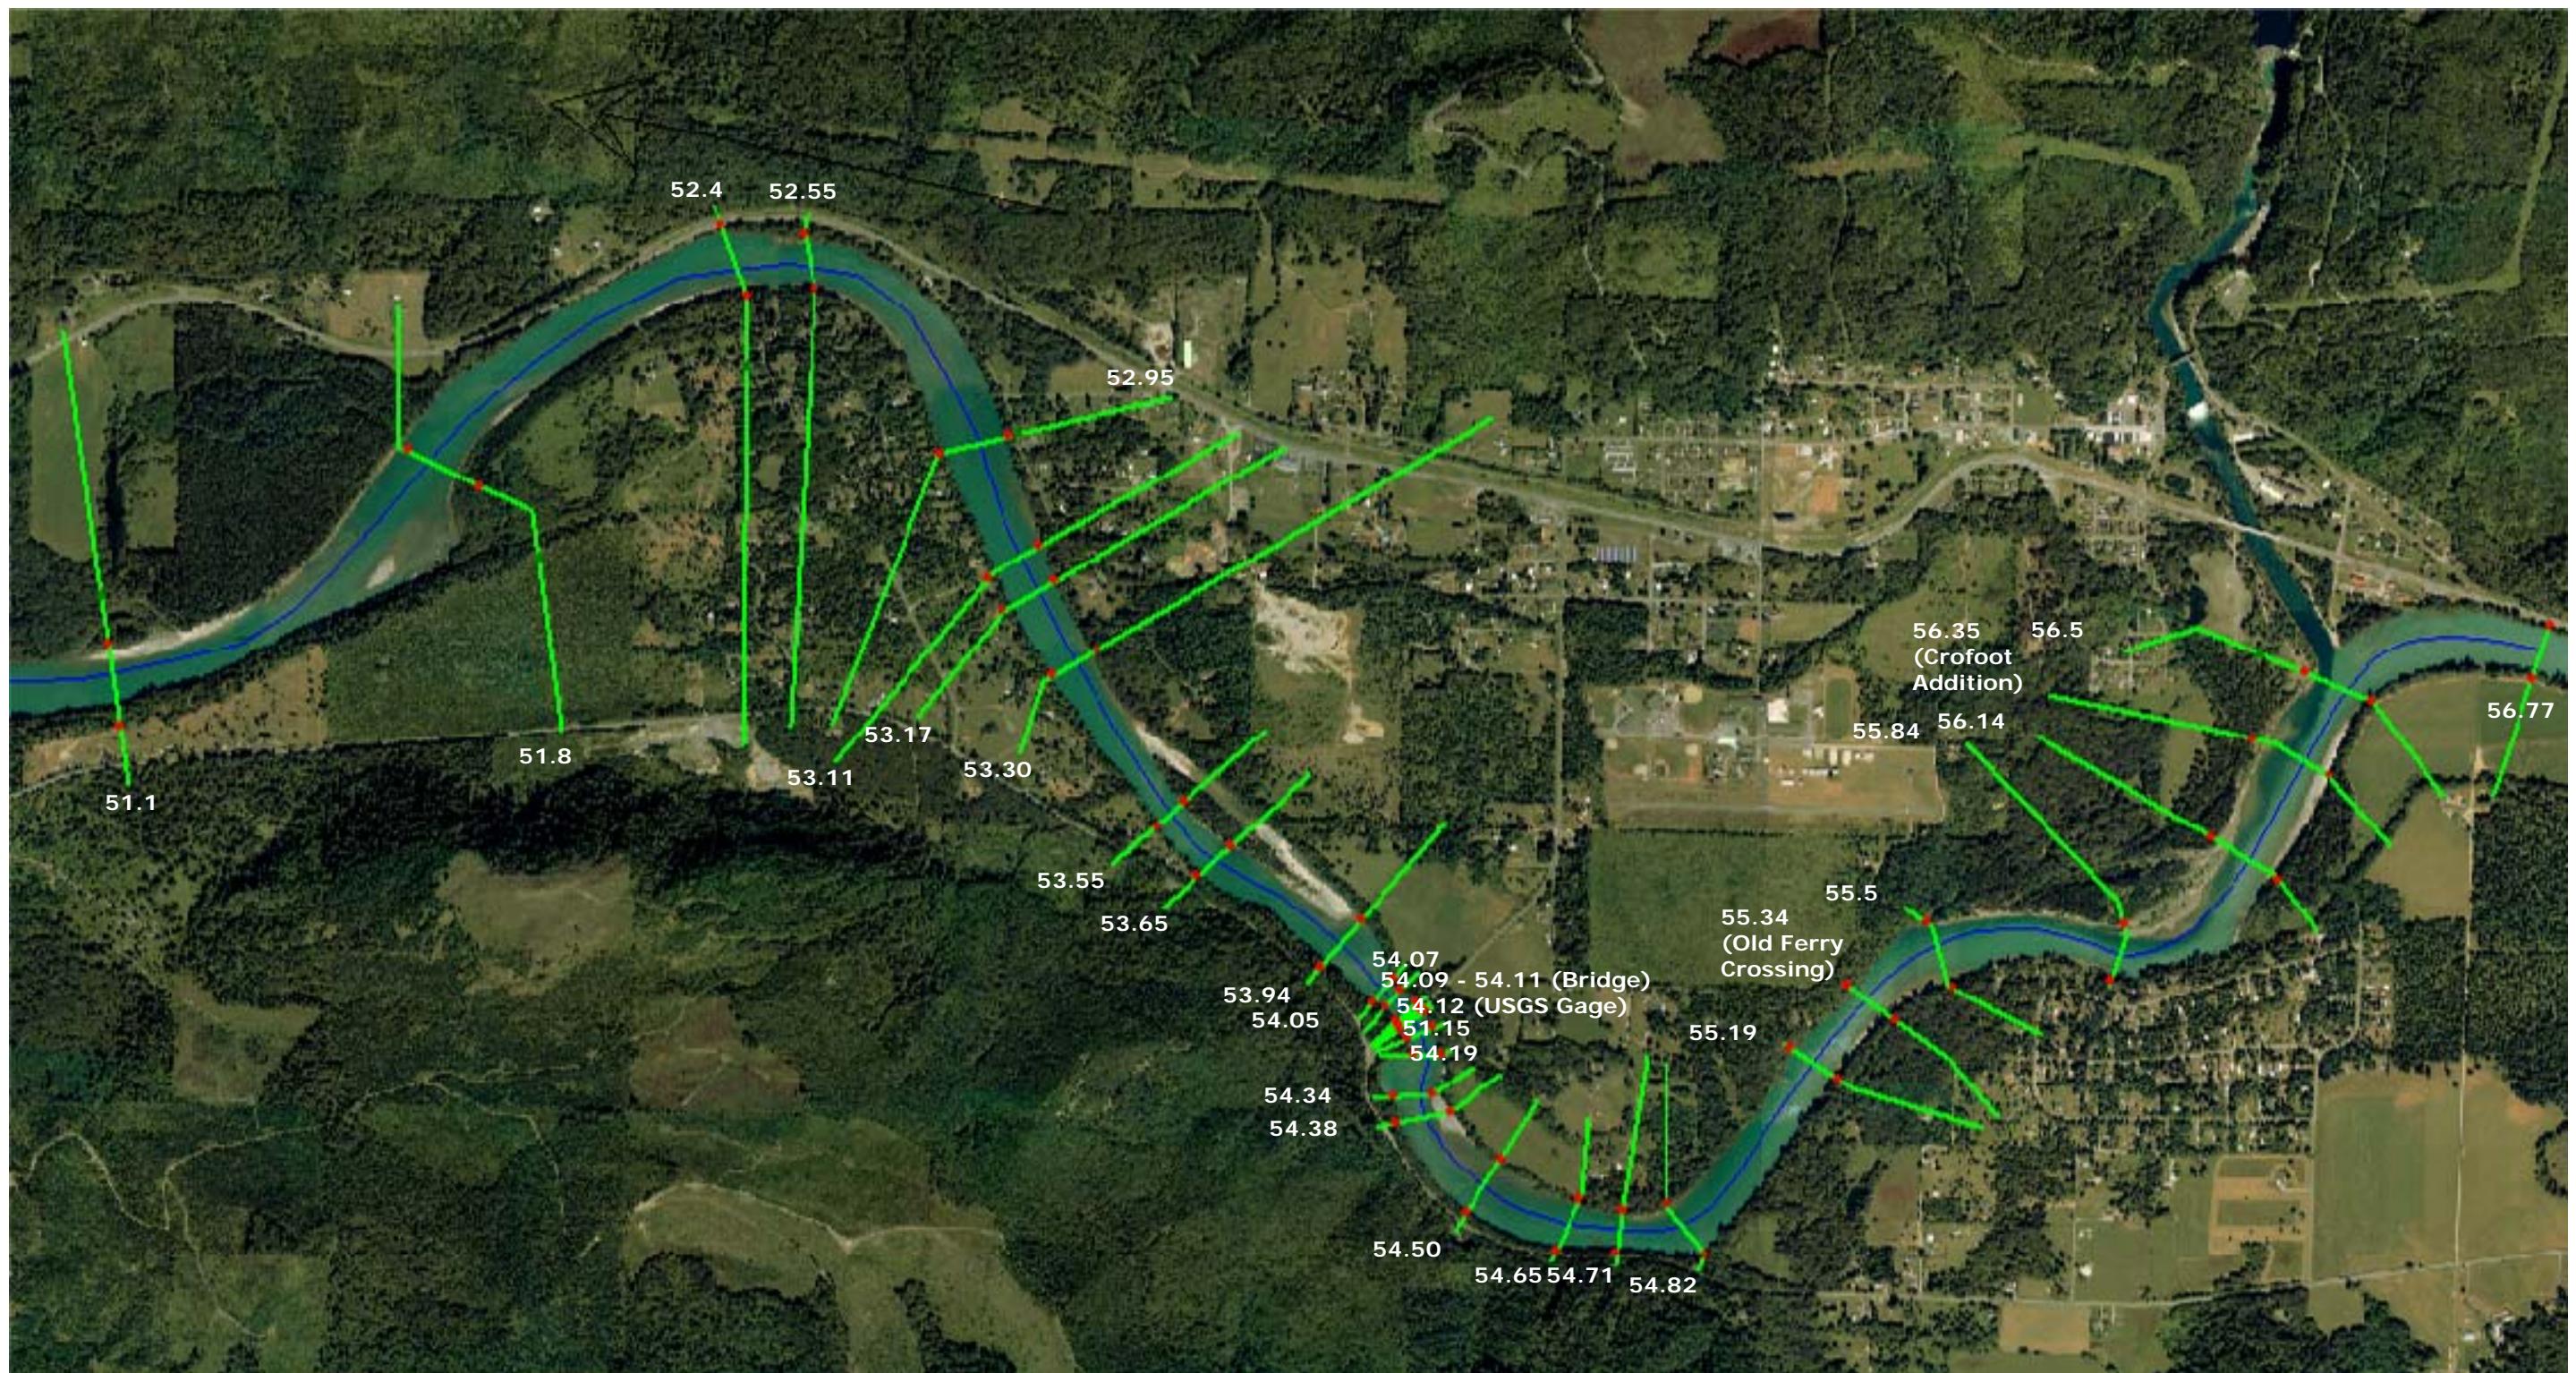
Figure 2. Schematic Plot of Study Reach with Cross-Sections and other Locations of Interest.

A 1-D steady-state HEC-RAS model was developed covering the reach of the Skagit from RM 51.1 (about 3 miles below The Dalles) to RM 56.77 (just above the confluence with the Baker River). The model relied on the following cross-section data:

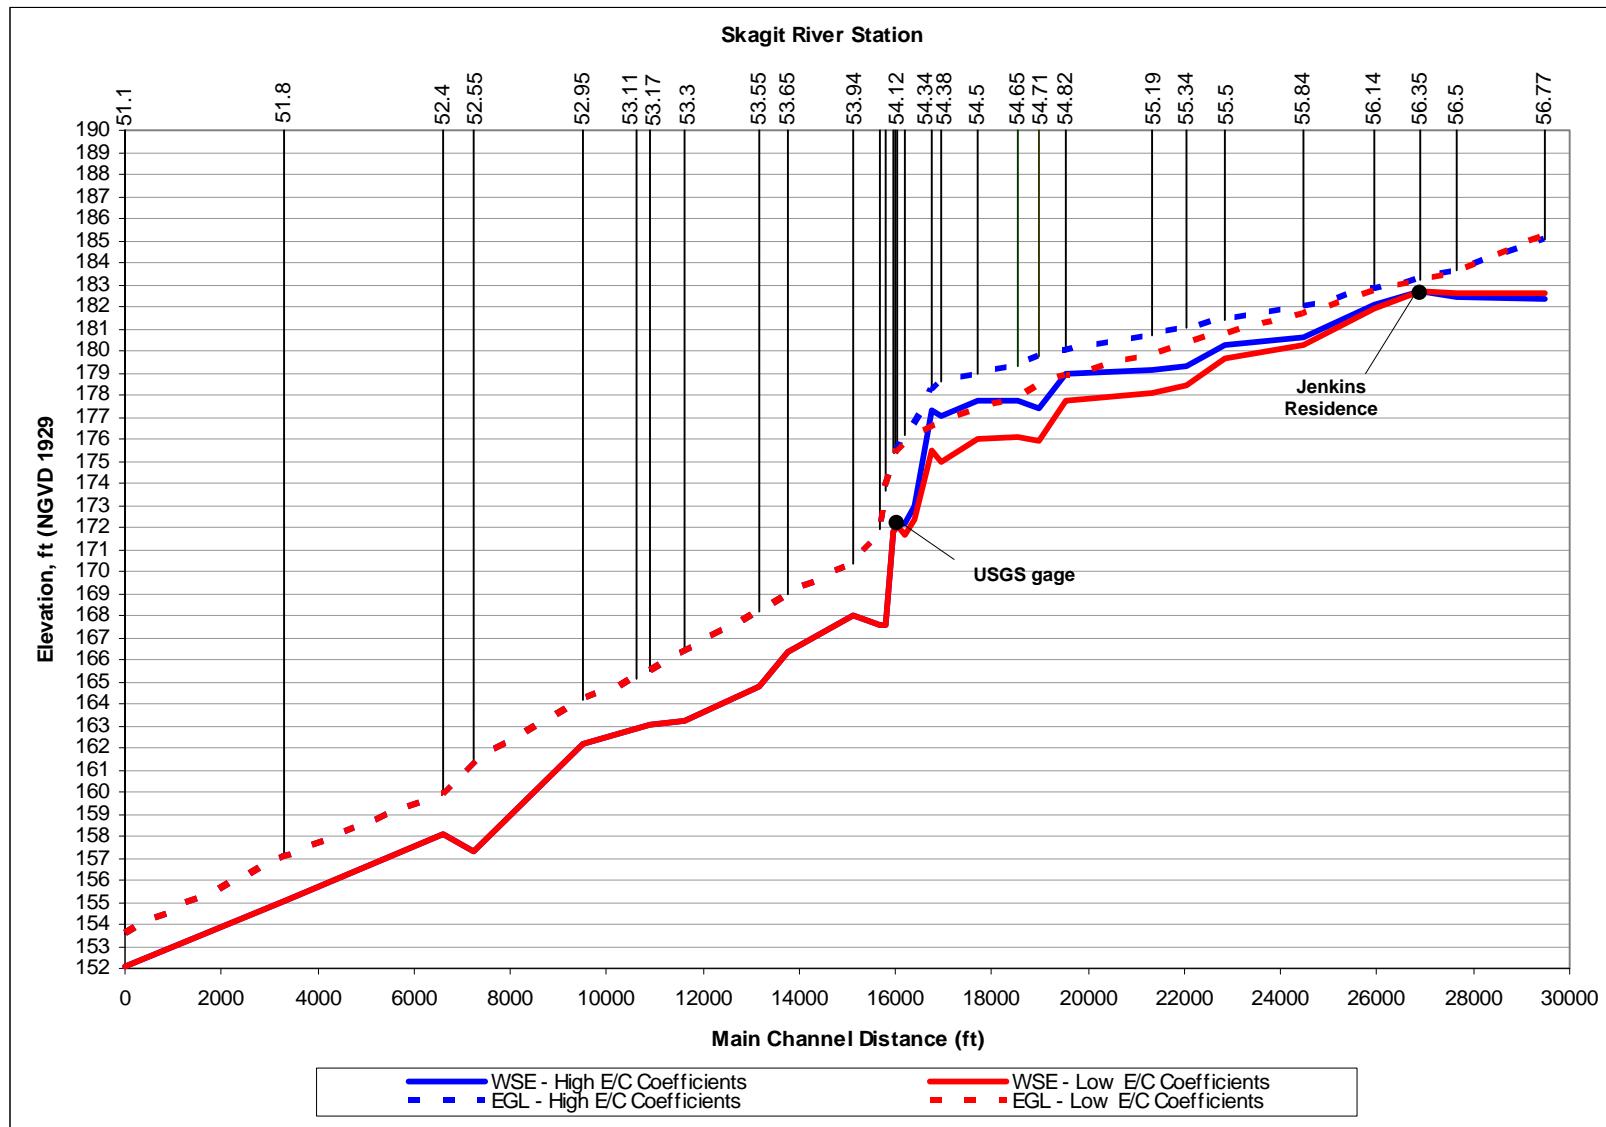
Figure 3. Water Surface and Energy Grade Line Profiles for Study Reach (October 2003 Calibration - 166,000 cfs).

HEC-RAS model parameters for the two alternative current condition models are provided in Table 2. The calibrated water surface profiles from the two models for the October 2003 flood are shown in Figure 3, and the modeled stage-discharge relationship at RM 54.12 is compared with the published stage-discharge Rating 6 in Figure 4. Note that in Figure 3, the legend High EC and Low EC refer to the high and low expansion/contraction coefficient models respectively.

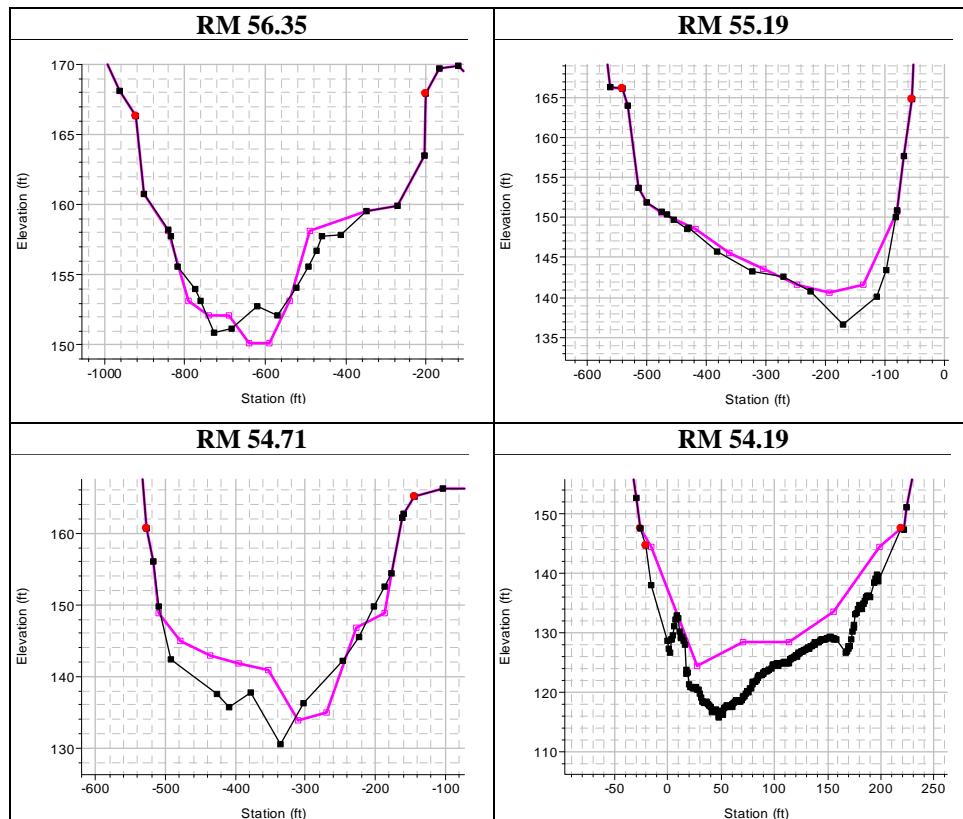
Figure 5. Comparison of Cross-Section Geometry Between 1911 (pink) and 2003 (black).

Selected in-channel cross-sections from the 1911 survey are compared with cross-sections from the current condition HEC-RAS model in Figure 5, and the thalweg profile from 1911 is compared against that from the current condition HEC-RAS model in Figure 6. The comparison shows relatively small differences in channel geometry between 1911 and the present. The channel in the current condition model is on average about 4 feet deeper than in 1911 over much of the reach between The Dalles and the confluence with the Baker River. Below The Dalles to RM 53.1, differences are not as consistent. In general, the current condition channel below The Dalles is somewhat deeper than the 1911 channel, except between RM 53.3 and RM 53.94 where the 1911 channel is locally deeper.

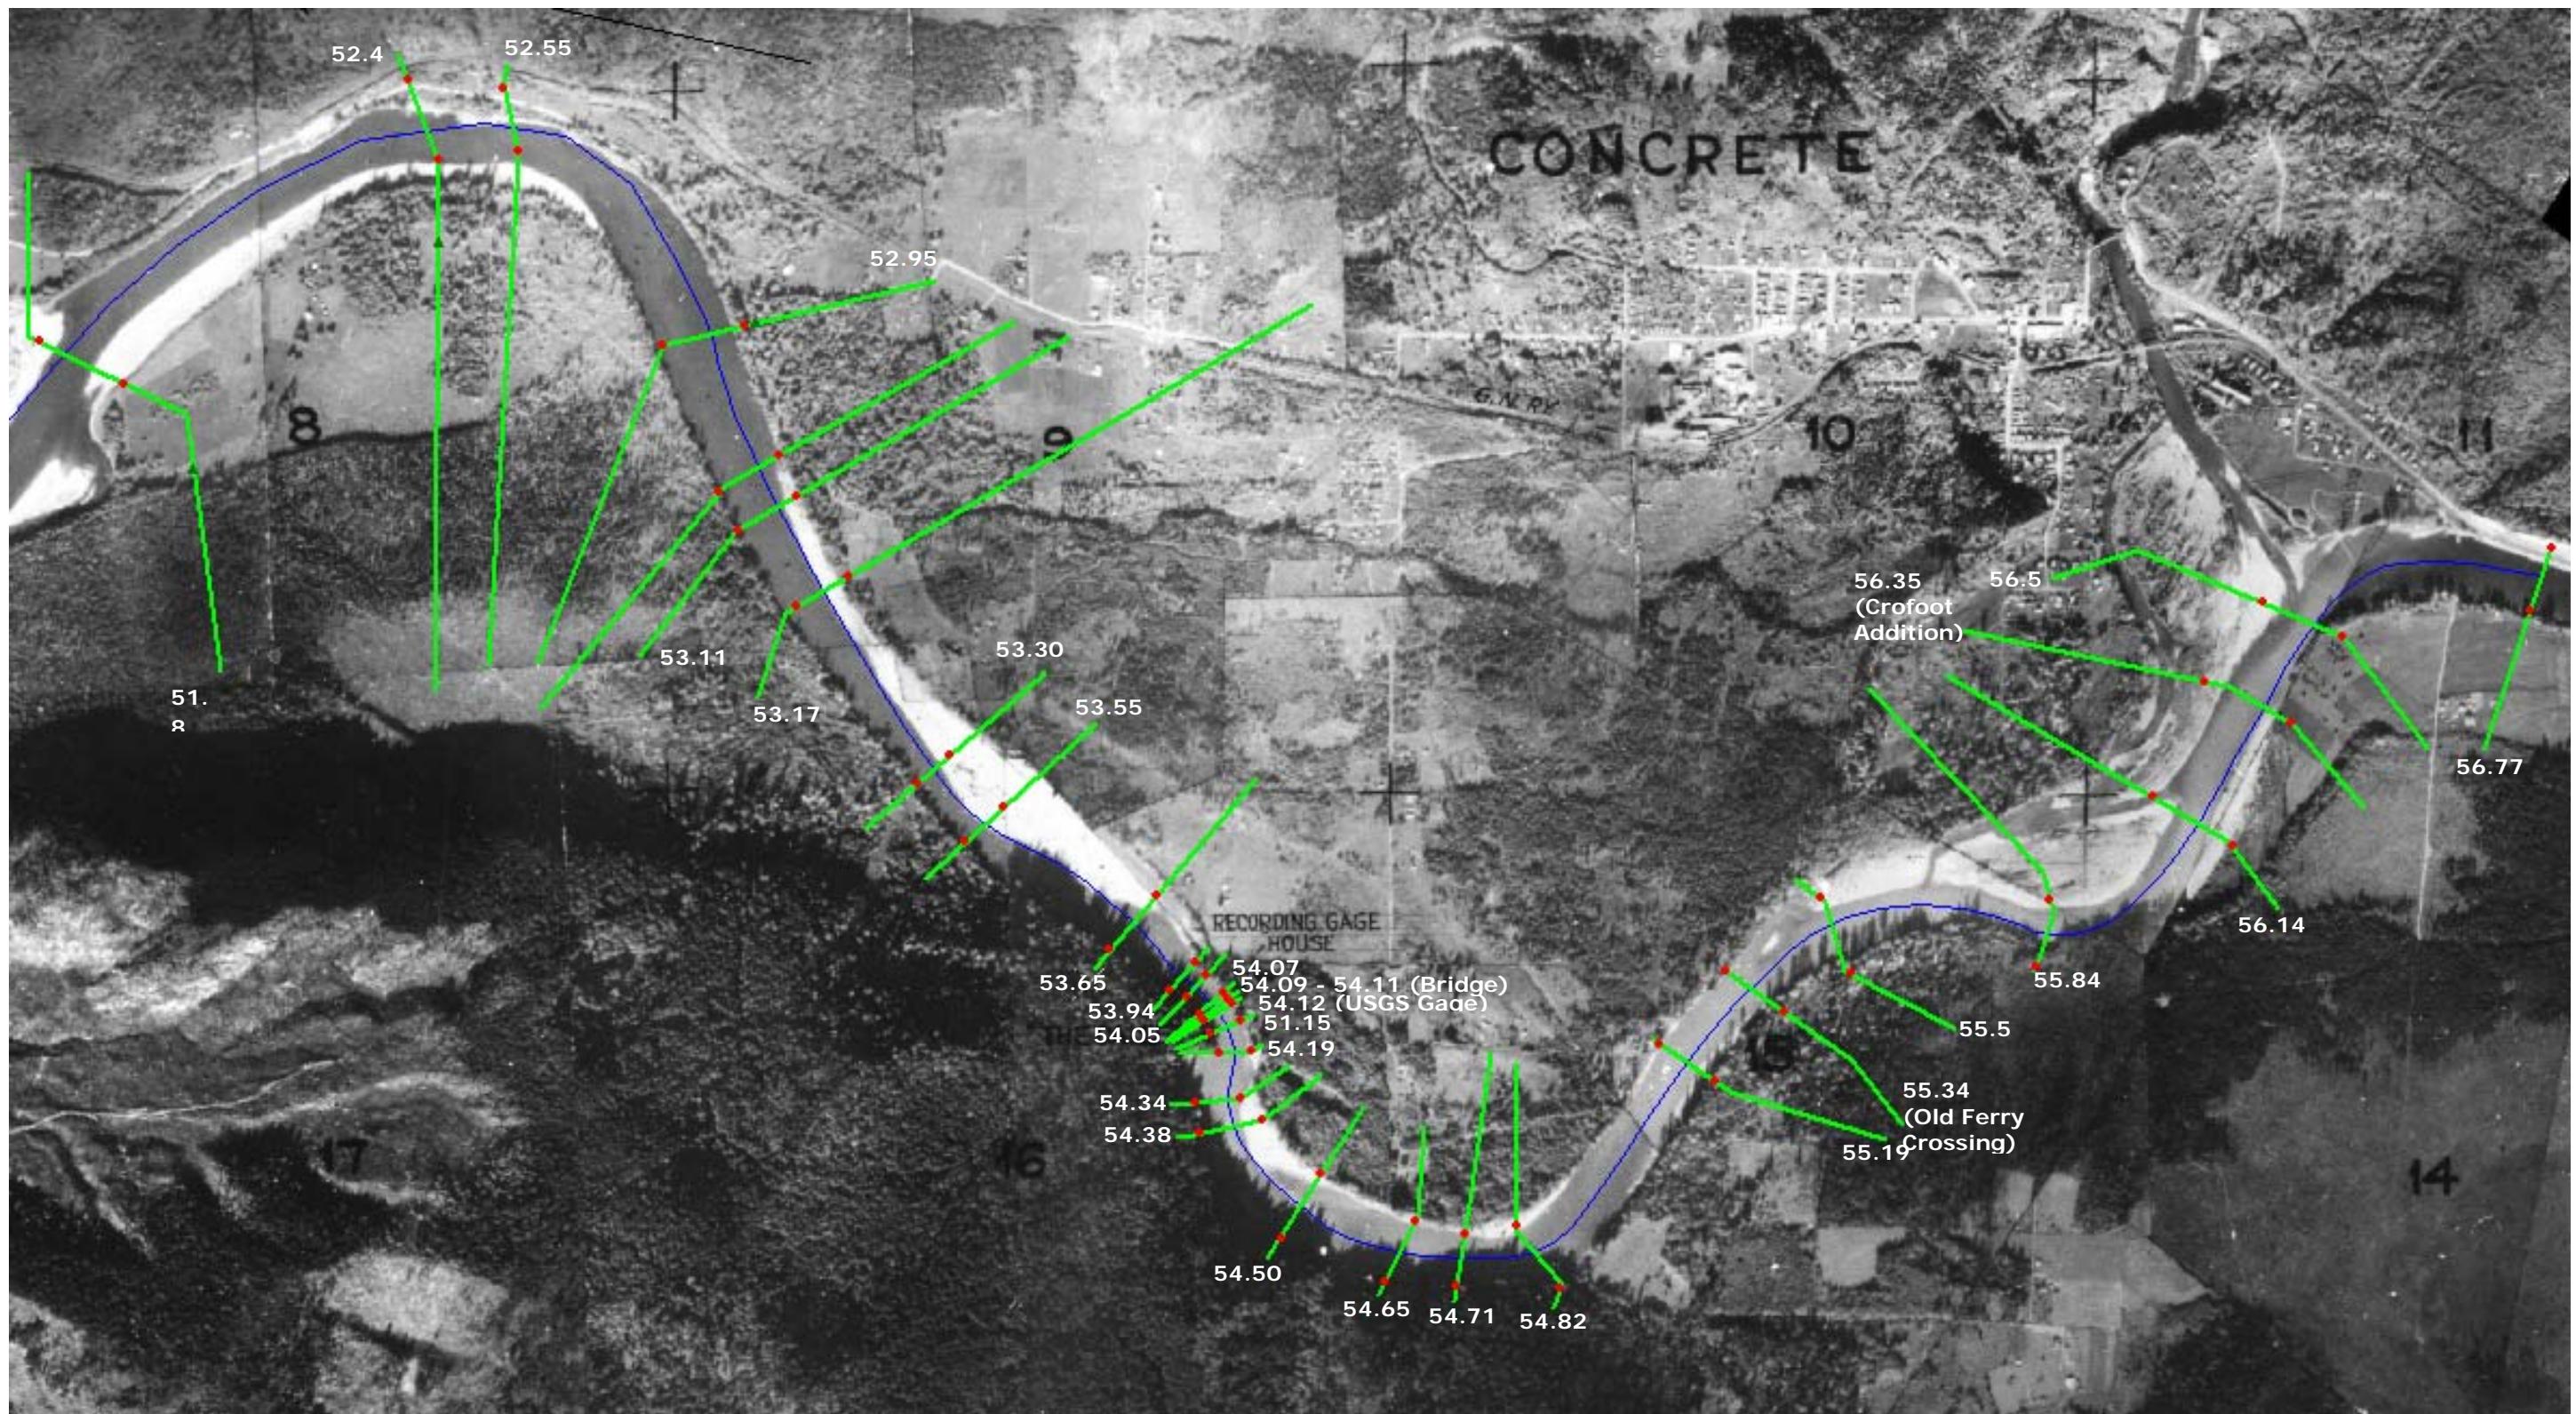
Figure 7. 1937 Aerial Photo with Cross-Sections and other Locations of Interest.

Changes in overbank conditions from 1921 to present were inferred from comparison of 2001 aerial photographs against the 1937 aerial mosaic and annotations on the 1911 Corps survey map. The only potentially significant change from 1921 to date is on the right bank from about RM 55.5 upstream to the confluence with the Baker River where gravel bars shown as more or less devoid of vegetation in the 1937 aerial are now well vegetated. The 1937 photograph covering this area is provided in Figure 7. The gravel bar just below The Dalles at about RM 53.65 is similarly bare in 1937 but is now well-vegetated. It is assumed that overbank conditions in 1921 were similar to those in 1937.

Comparison of bank lines from the 1937 and 2001 aerials shows the reach of the river from below The Dalles to the Baker River confluence to be reasonably stable with no indication of any significant change in bank lines.

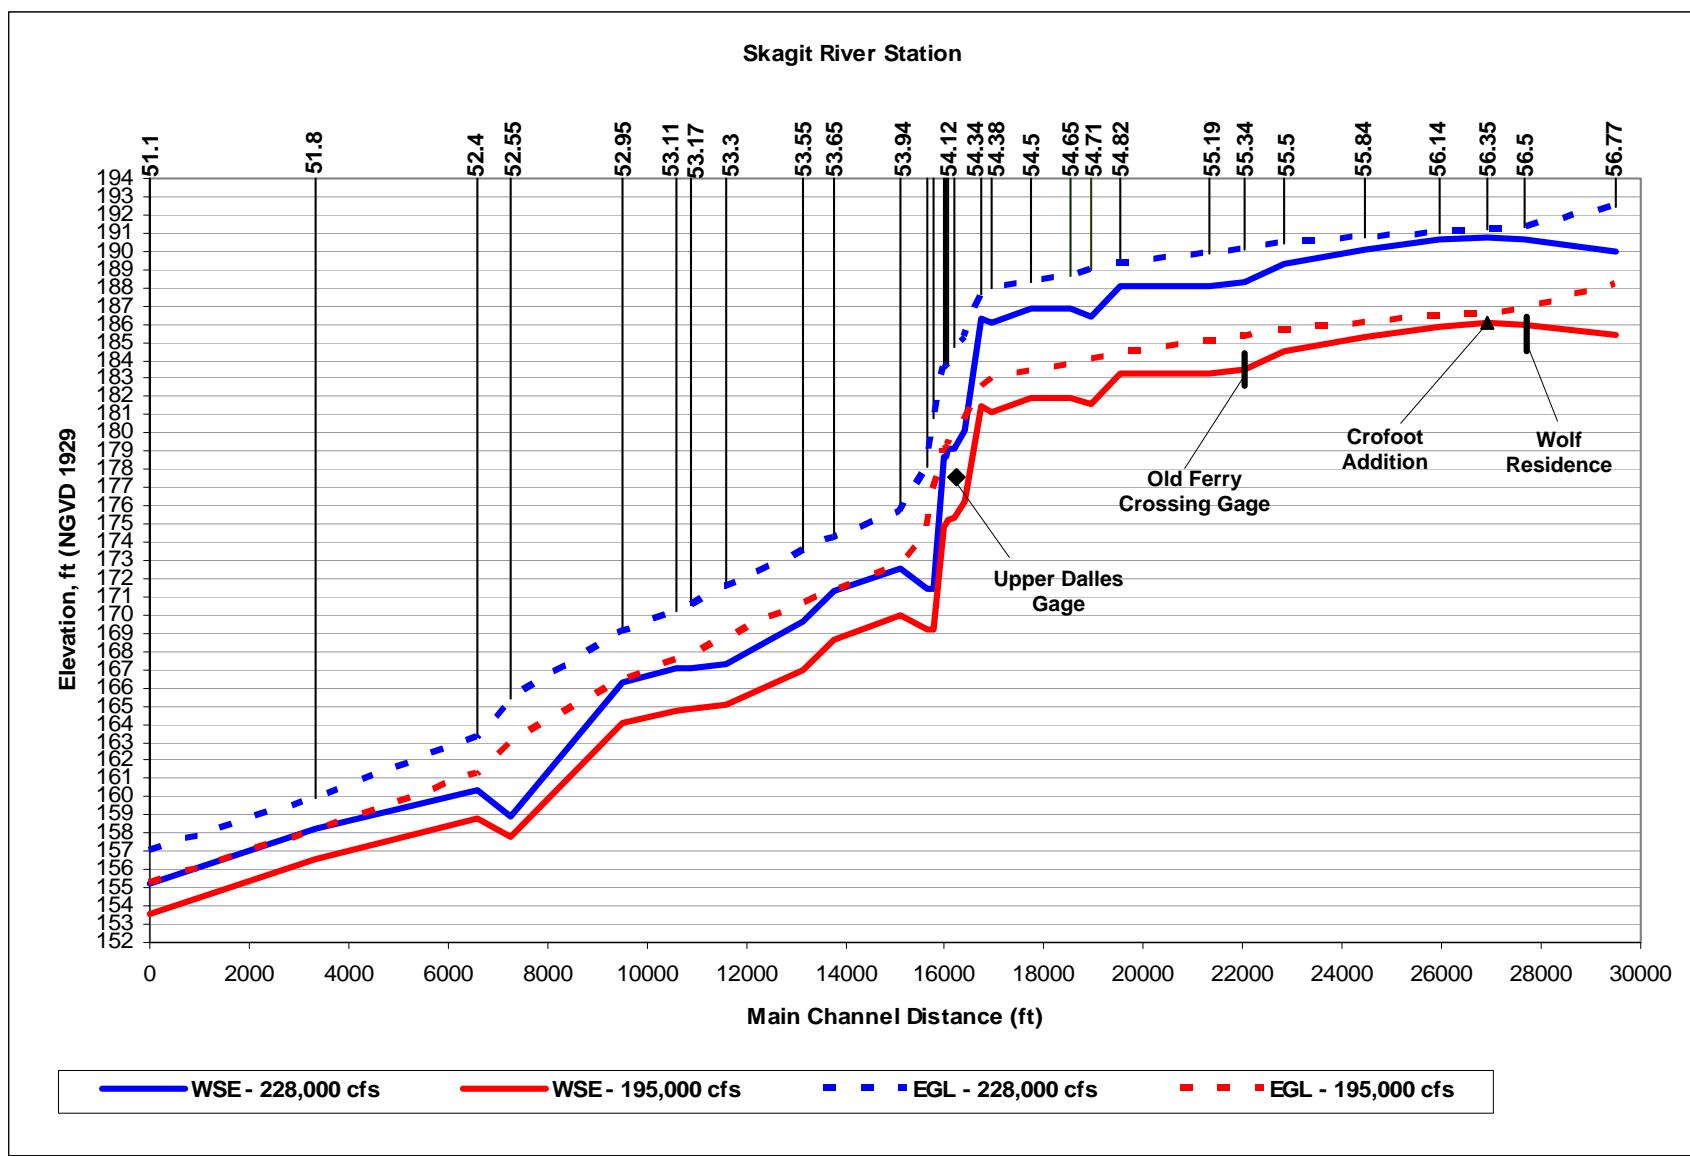
Figure 8. 1921 Model Flood Profiles – High Expansion/Contraction Coefficient

Also shown on Figures 8 and 9 are the 1921 high water data between The Dalles and Concrete as summarized in Table 1 above:

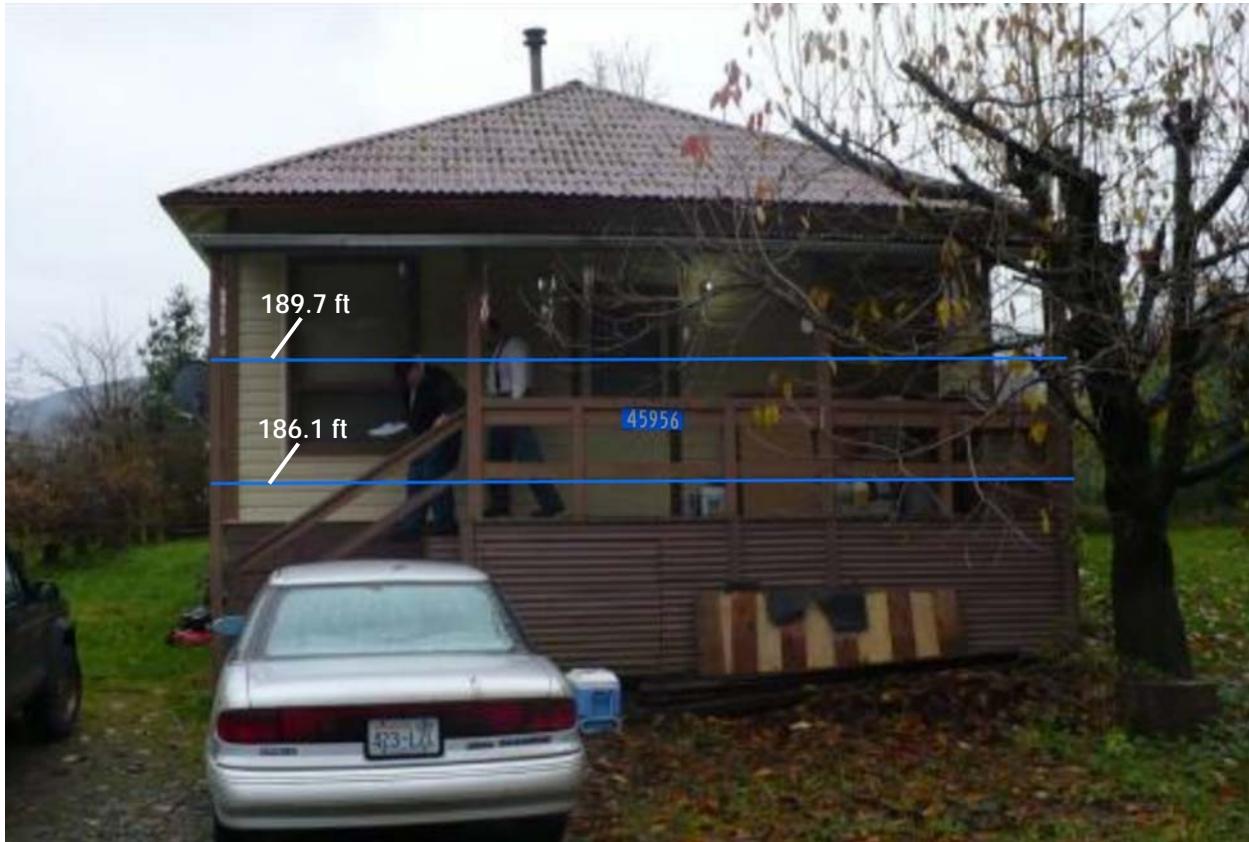
Figure 10. 45956 Albert Street.

the currently published value of 228,000 cfs. A somewhat conservative¹⁰ HEC-RAS model relying on current channel geometry produces simulated water surface elevations in the Crofoot Addition ranging from 189.7 to 190.8 ft at a discharge of 228,000 cfs for the combinations of model parameters bracketing their probable actual values (see Table 3). Based on the Concrete Herald report, the maximum water level in the Crofoot Addition during the 1921 flood was at most 186.1 ft. These water levels are shown in Figure 10 superimposed on a photograph of the lowest existing house in the Crofoot Addition dating from 1921 (45956 Albert Street).

The lowest existing residence dating from 1921 that has been identified in the Crofoot Addition is 45956 Albert Street, with a finished floor elevation of 184.93 feet NGVD 1929⁴. It is possible that other lower residences existed in 1921 that have since been demolished, or otherwise modified, but we have no way of either identifying such residences or of determining their elevations. Assuming the maximum reported depth of water of 14 inches was above the finished floor level at 45956 Albert Street, gives a maximum December 1921 water surface elevation in the Crofoot Addition of at most 186.1 ft. The only house dating from 1921 in East Concrete for which we have a finished floor elevation is 46335 Forest Place at 186.61 ft. Visually, this house appears to be one of the lowest, if not the lowest, house dating from 1921 in East Concrete. From the FIS (Federal Emergency Management Agency, 1989), the head loss between Crofoot and East Concrete is roughly 0.5 feet at a discharge of 226,000 cfs (the currently published 1921 peak discharge is 228,000 cfs), which would put the water level at 46335 Forest Place essentially at the finished floor level. This seems inconsistent with the statement in the Concrete Herald article that the “*waters also crept up around some of the dwellings in East Concrete*”, so the estimated 1921 peak water level of 186.1 ft. in the Crofoot Addition is probably high. Nevertheless, we have taken the estimate of 186.1 ft NGVD 1929 as the best estimate of high water level in the Crofoot Addition in the December 1921 flood and the basis for estimating the December 1921 peak discharge in Section 3.0 of this report.

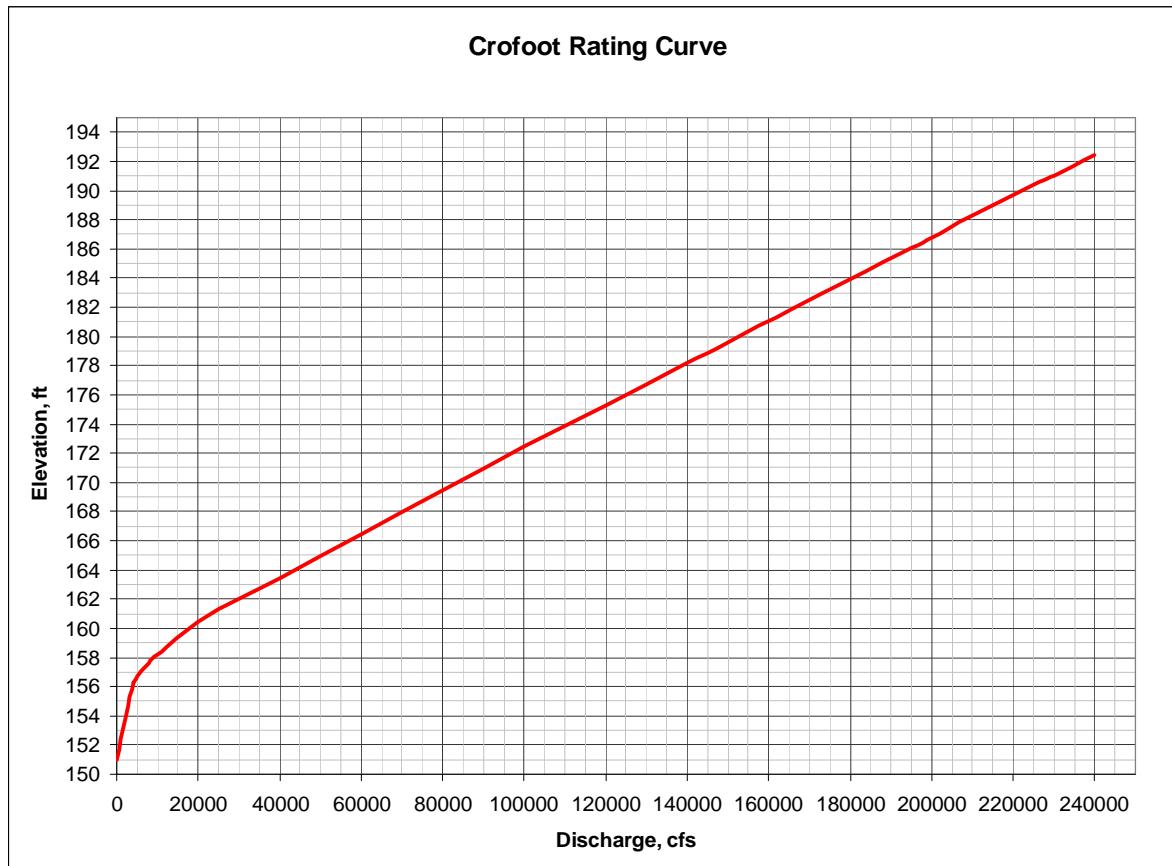
Figure 11. 1921 Rating Curve at Crofoot.

A stage/discharge rating at Crofoot produced using the final 1921 model is shown in Figure 11, and water surface profiles from the final 1921 model for discharges of 195,000 cfs and 228,000 cfs are provided in Figure 12. We recommend that a revised peak discharge of 195,000 cfs be adopted for the December 1921 flood.

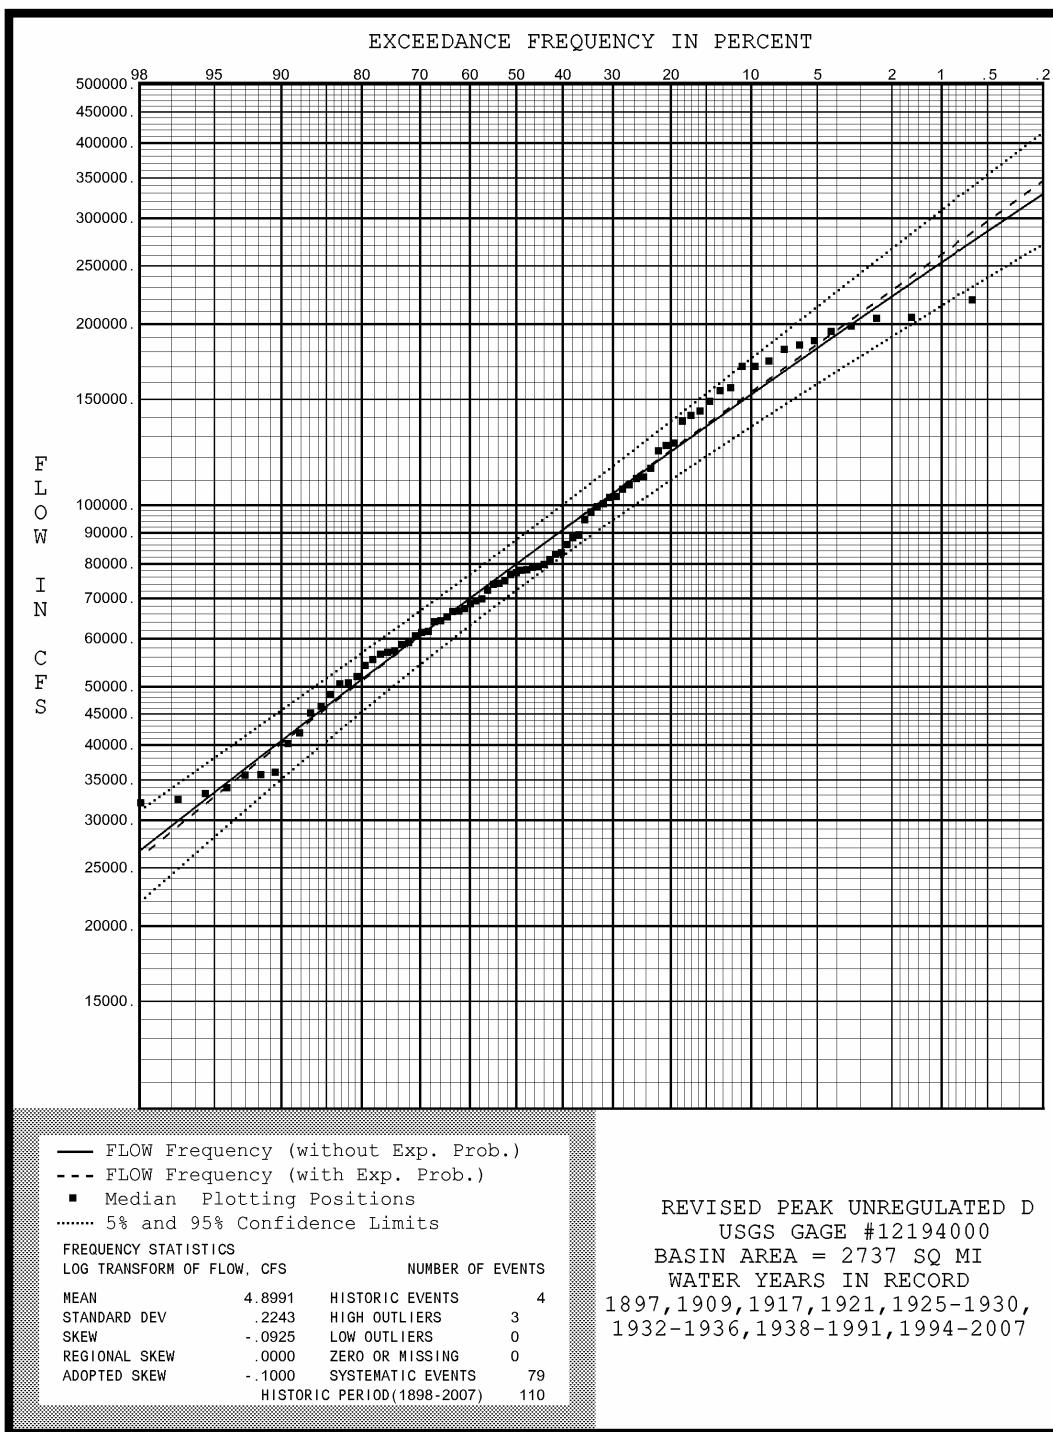
Figure 13. Frequency Analysis , Revised Unregulated Peak Discharge, Skagit River near Concrete.

Despite the relatively poor fit of the LP3 distribution, recognizing the uncertainty in the data, we recommend adoption of peak, one-day and three-day LP3 100-year quantiles from runs 2, 5 and 8 of Table 9.
