# **Technical Report - Supporting Data and Analysis for Skagit River RFIS Appeal**

March 2011

**Skagit County, Washington**

Pacific International Engineering, PLLC

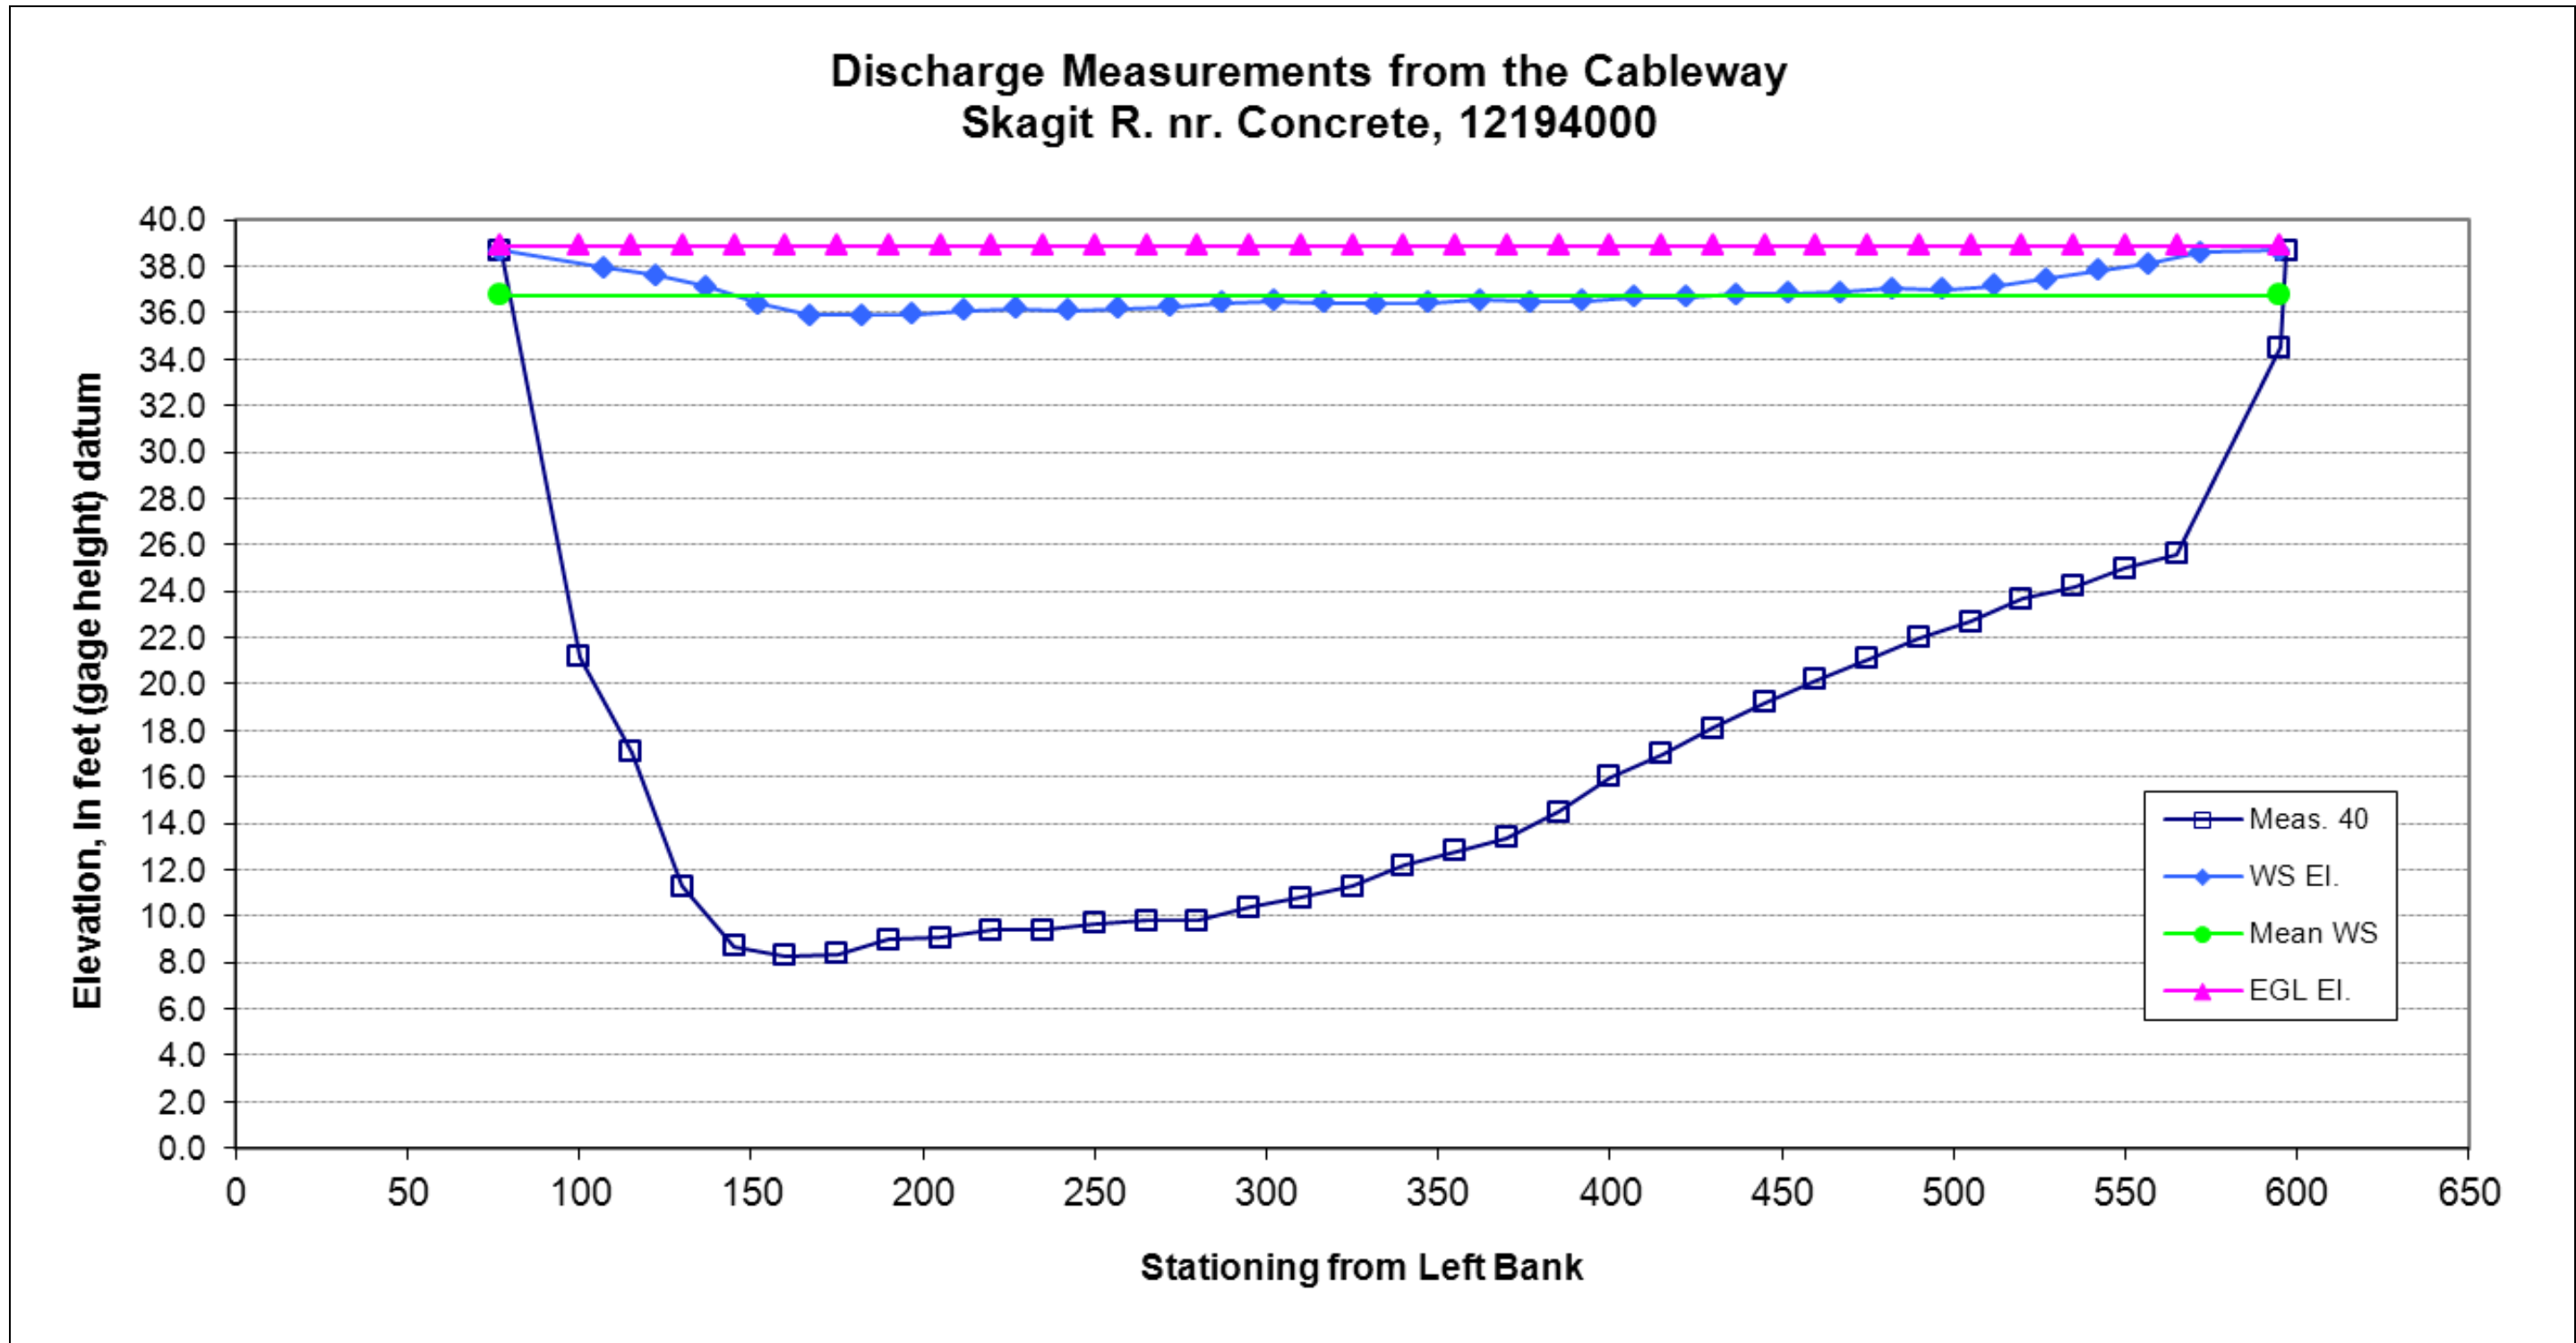
Figure 4. Discharge Measurement 40 from Cableway at Skagit River near Concrete  
 (Note: original source of data and water depth plots provided by USGS, in Microsoft Excel - Concrete\_cableway\_meas#475.xls)

The water is moving slower near the banks, where the water surface (WS) elevations are closer to the energy grade line (EGL) elevation, which equals the sum of the WS elevation and the velocity head. Figure 4 is a plot of Measurement 40 showing variation of the measured water depth and computed WS elevation based on the EGL elevation, subtracting the velocity head computed from the measured velocity across the cableway section. The plot also shows that the computed mean WS elevation across the cableway section is 2.1 ft (the computed velocity head) lower than the EGL elevation for Measurement 40.

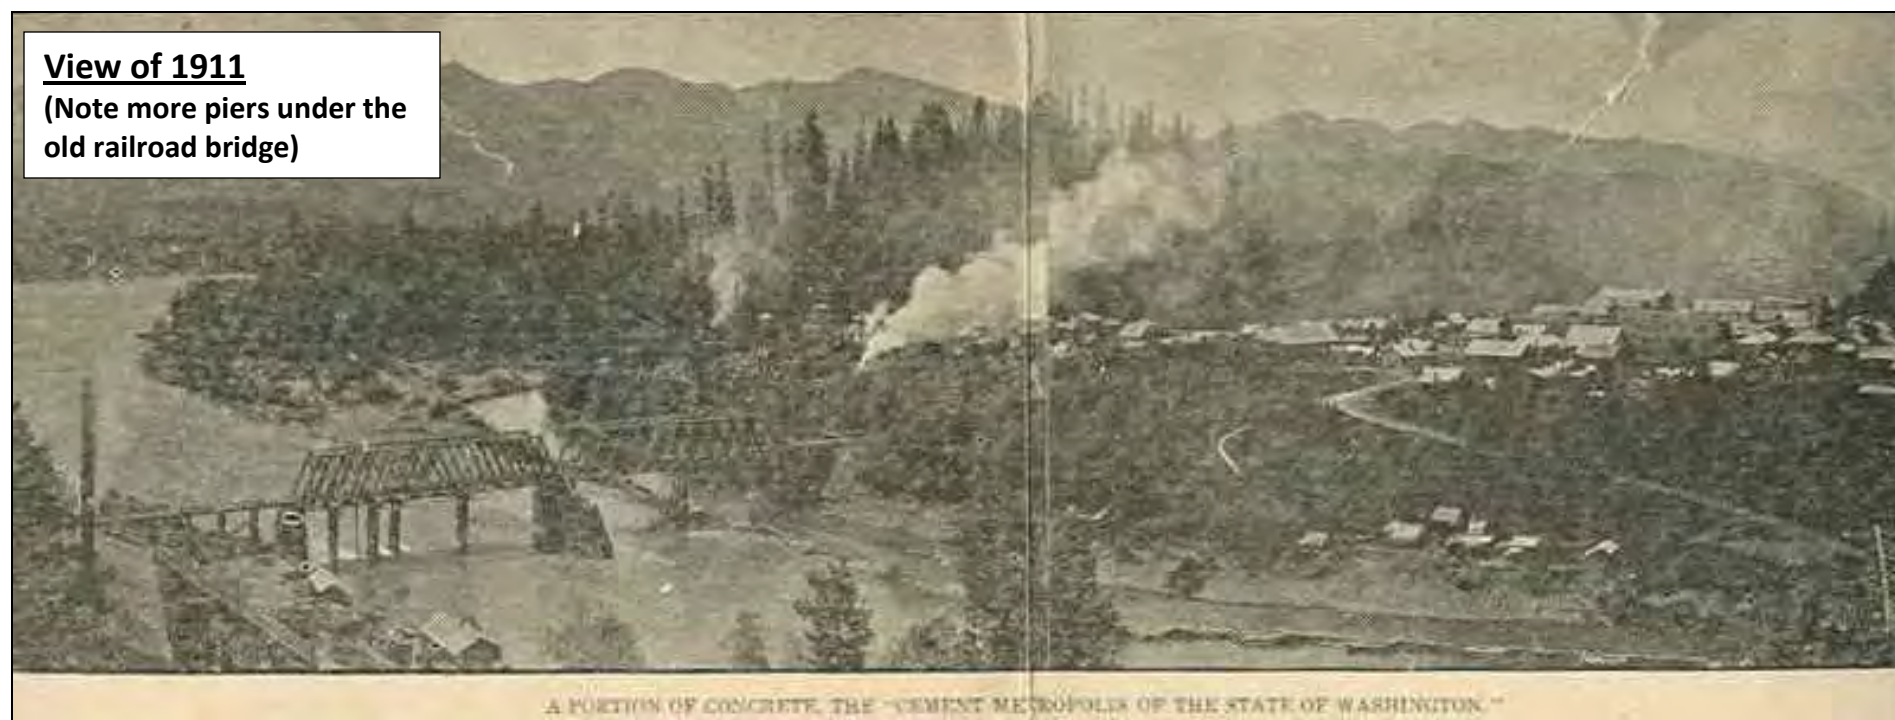
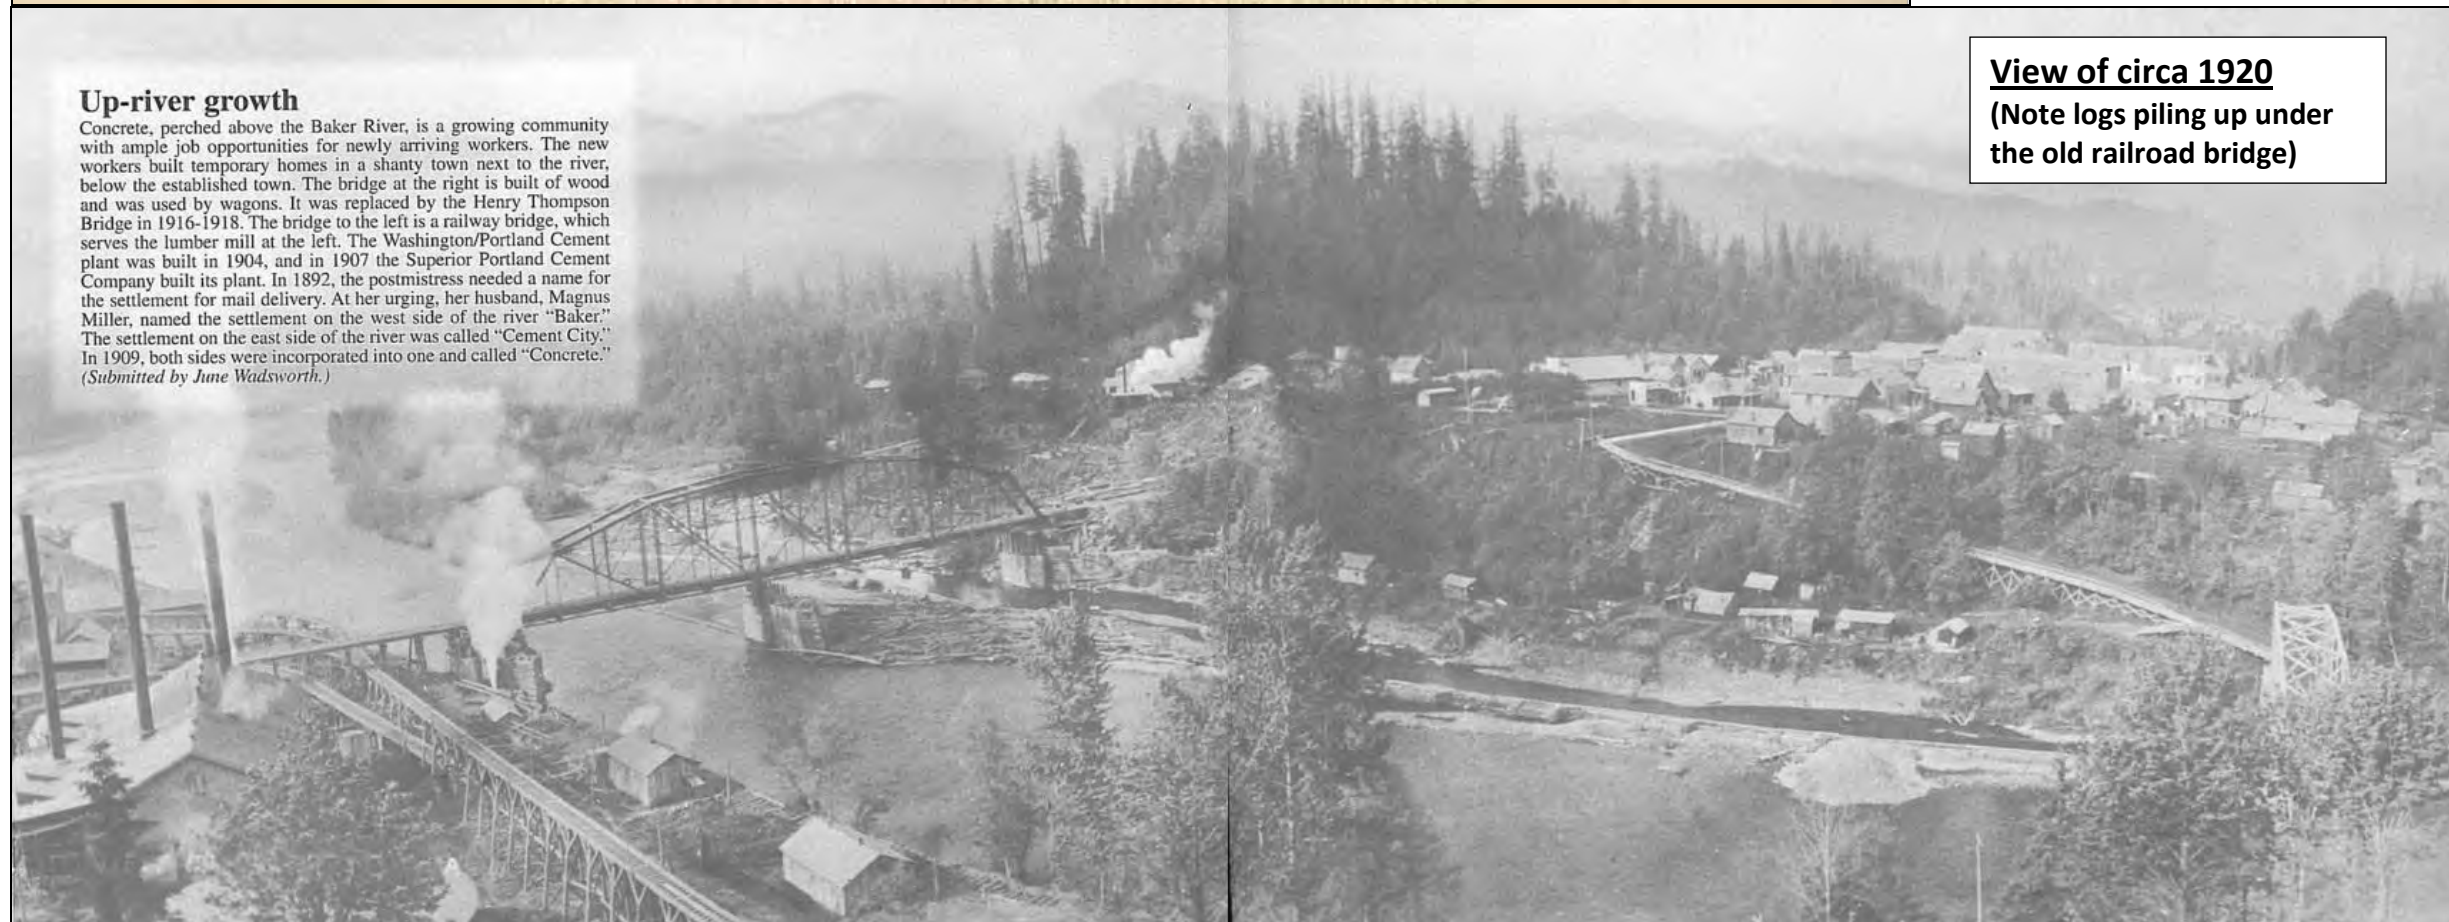
Figure 6. Panoramic views of Concrete in 1911 and circa 1920 (looking the Baker River downstream towards the Skagit River confluence)

Figure 5 is a 1937 aerial photo on which the old Wolfe residence, McDaniels residence, Washington Cement Plant (note an old railroad bridge crossing the Baker River downstream of the plant), upper Dalles, lower Dalles and current USGS gage site at the Dalles are annotated. Figure 6 shows the panoramic view of Concrete in the 1911 and circa 1920. The cement plant is on the left of the view and on the east bank of the Baker River upstream of the old railroad bridge (no longer existing). Likely the machine shop building and the old hotel were also located upstream of the old railroad bridge on the east bank of the Baker River.

The old cement plant and the Wolfe and McDaniels residences were all located in the Skagit River backwater area. However, due to constriction and debris jamming at the railroad bridge during floods, the flood stages at the cement plant site (likely including the hotel footing and the machine shop building) upstream of the old railroad bridge could have been higher due to the Baker River flow than due to the Skagit River backwater in the 1897 to 1921 time period.

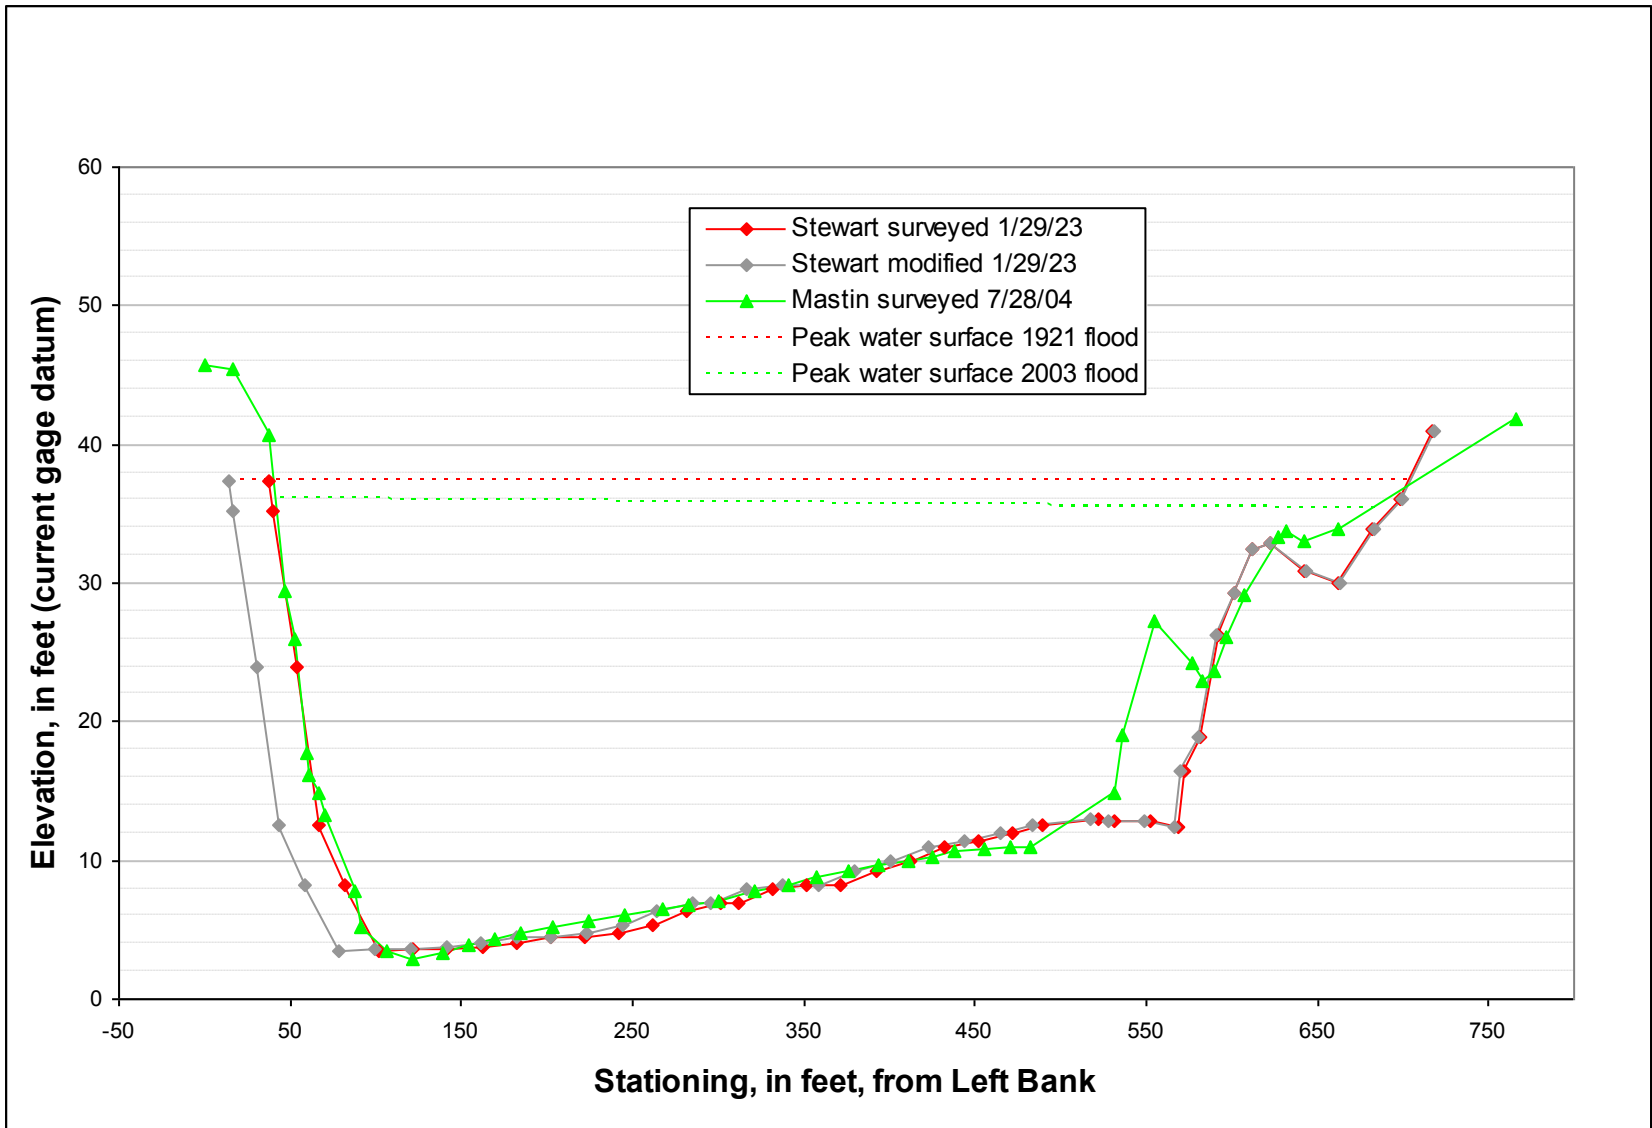
Figure 8. Slope Section XS3 – Skagit River near Concrete, WA

Figure 8 shows plots of Stewart’s originally surveyed and later-modified lower slope section. In 2004, the USGS (Mastin and his field crew) surveyed this section. The USGS 2004-surveyed lower slope section is also shown in the figure for a comparison. This comparison indicates that Stewart’s originally surveyed section appears accurate, matching the channel width and bottom elevations with the 2004-surveyed section better than his modified section. This comparison assumes that the 1923 and 2004 surveys are approximately at the same location, and that the change in cross section from 1923 to 2004 at this location is not significant.

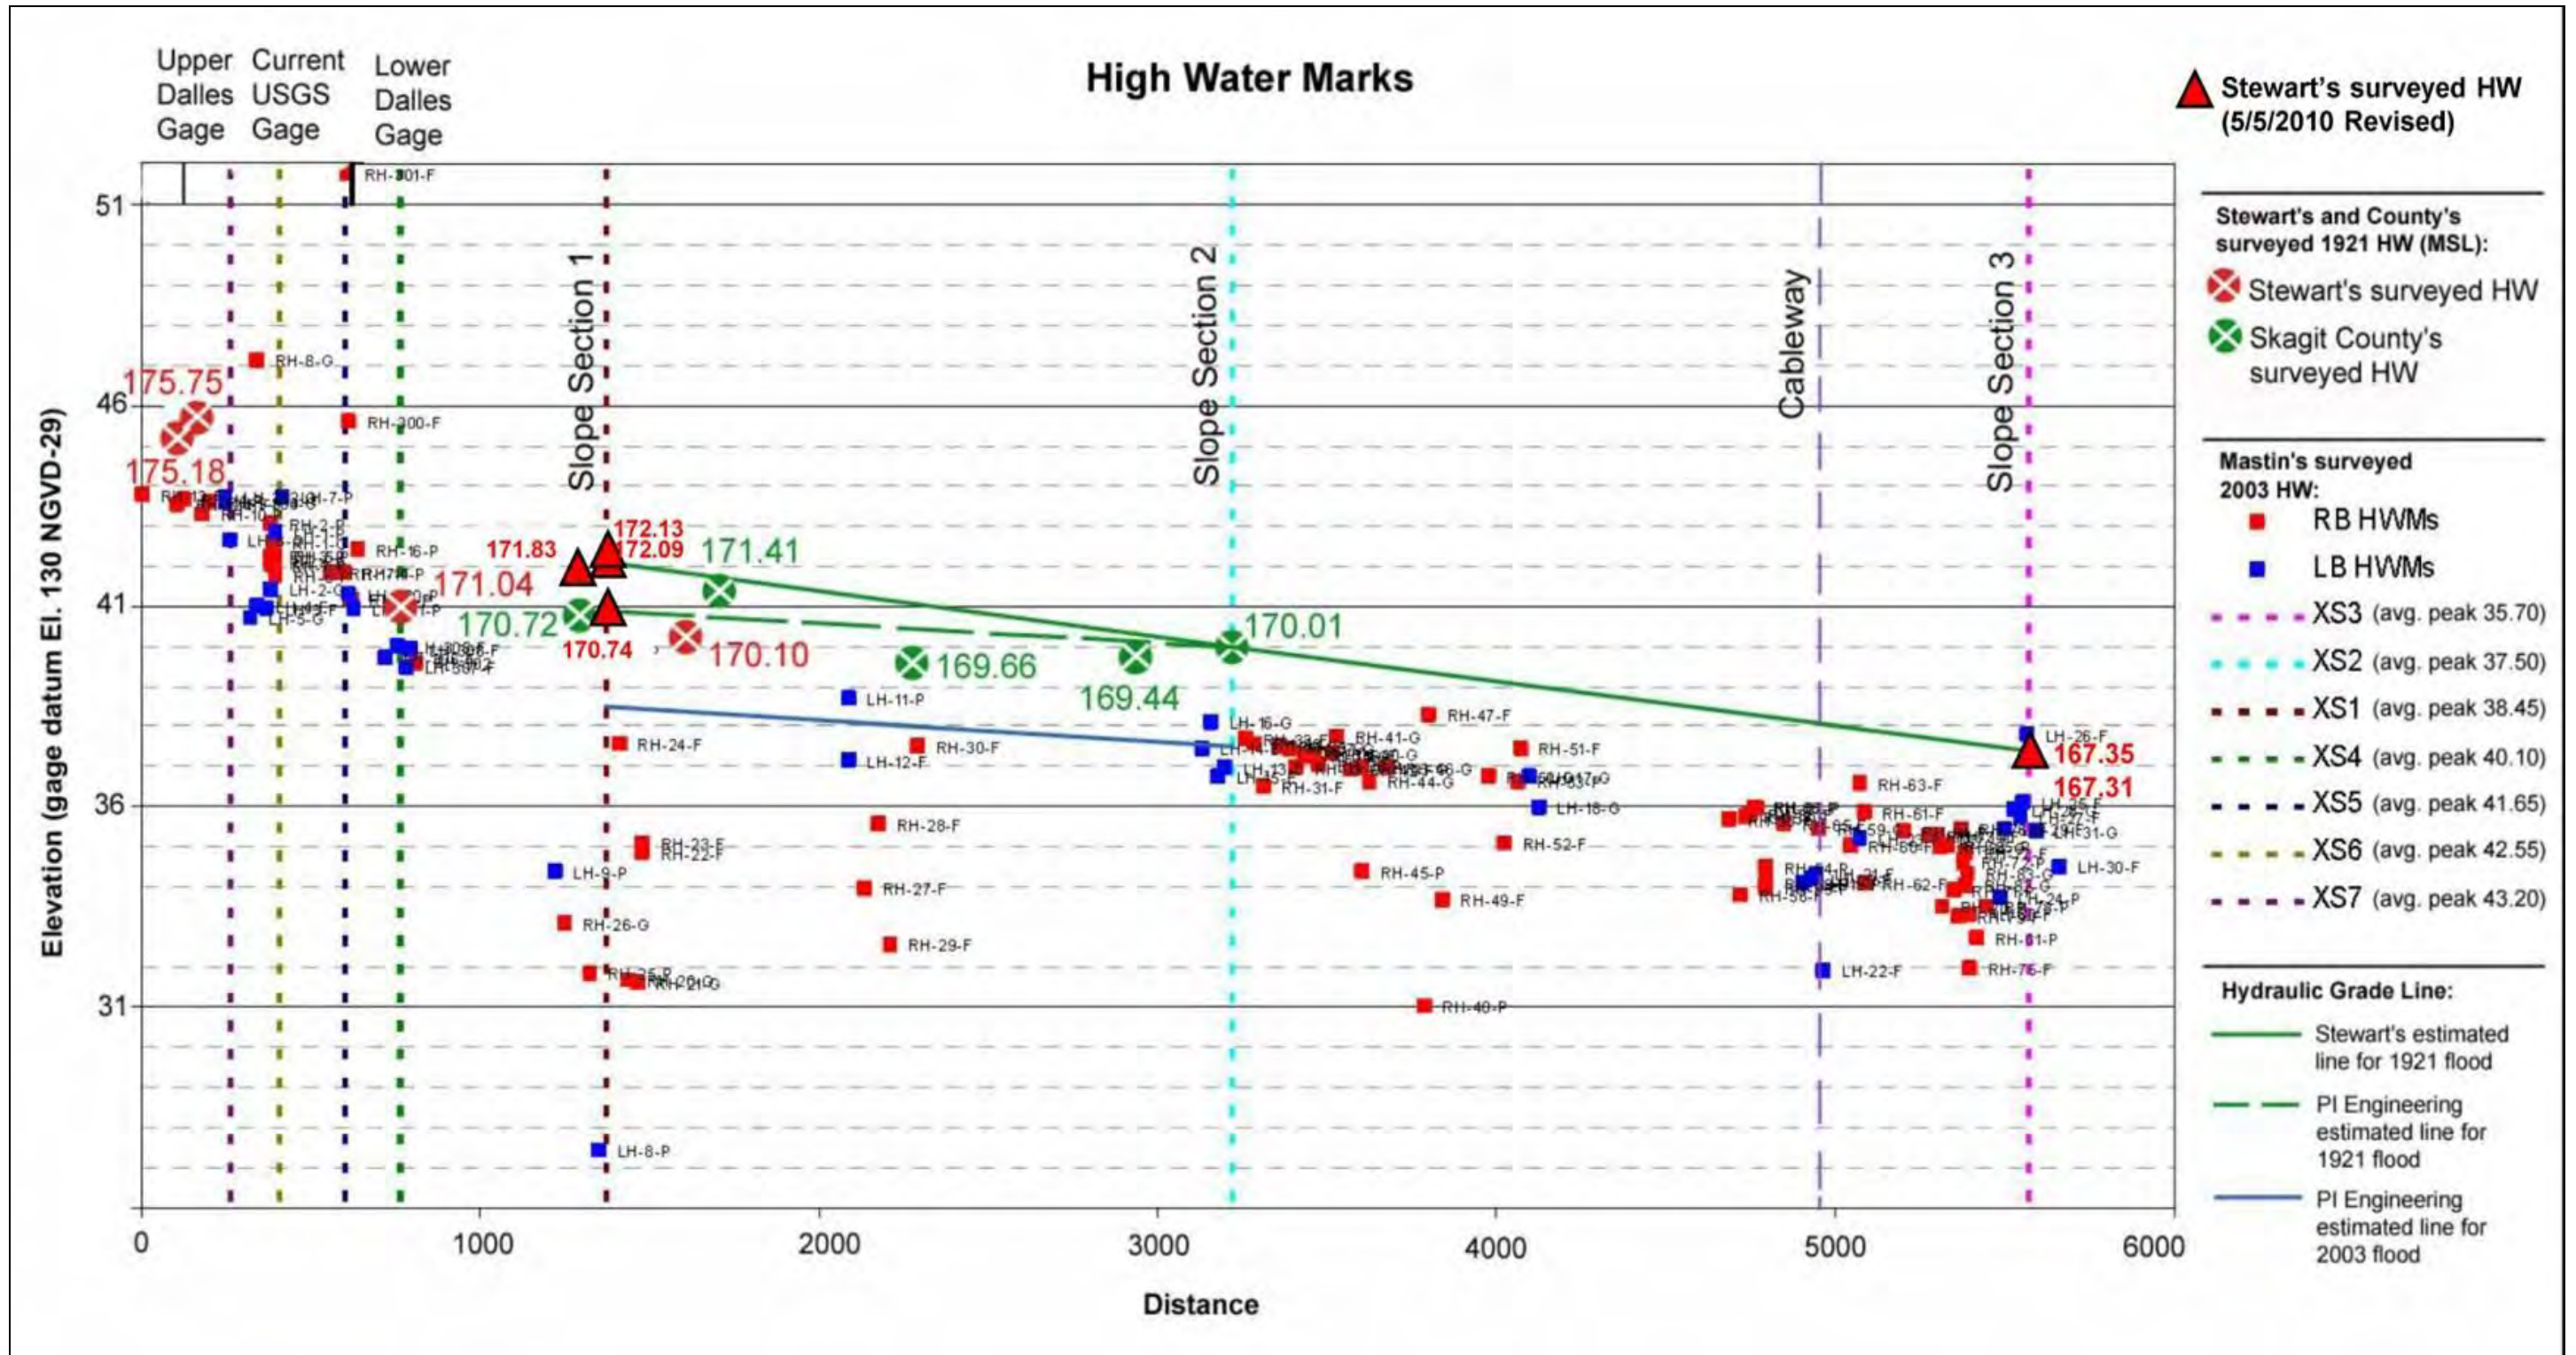
Figure 9. 1921 and 2003 flood high water marks surveyed by Stewart (in 1922-23) and USGS (in summer 2004)

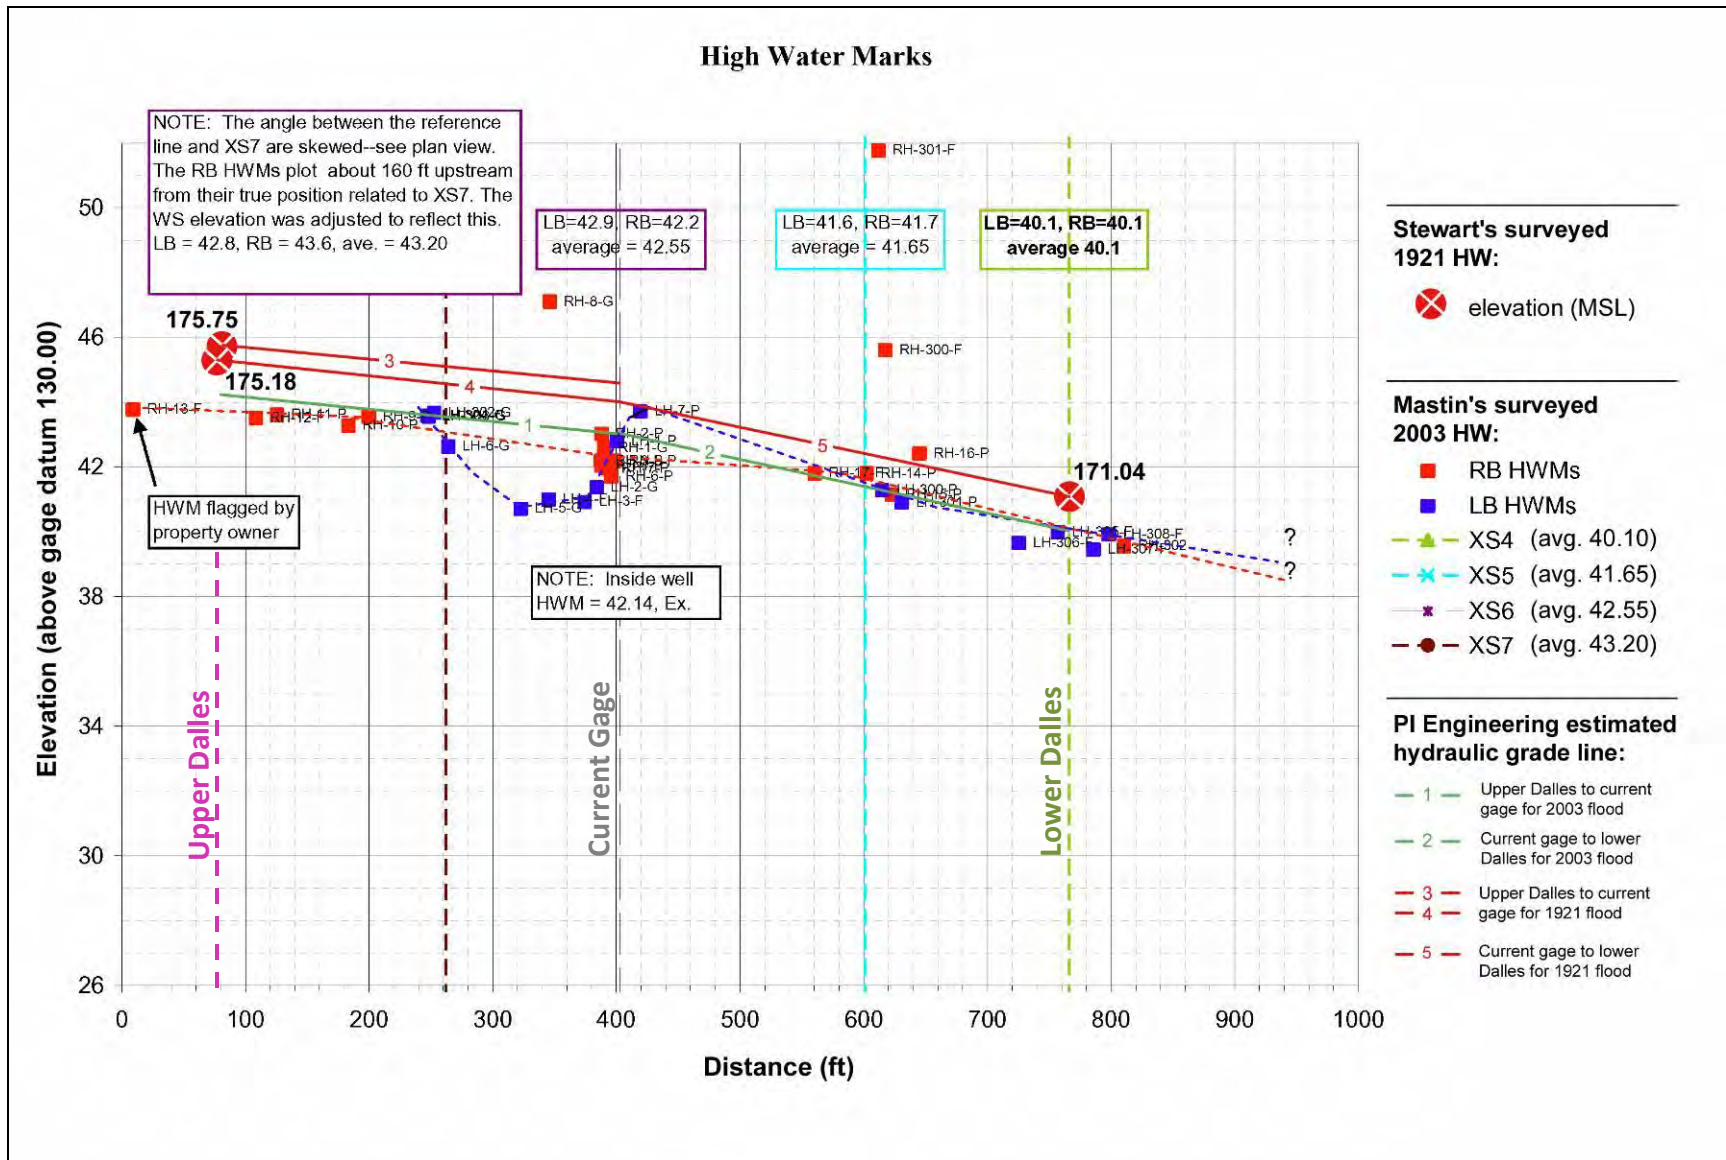
Figure 10. 1921 and 2003 HWMs in the Dalles gorge (original source of data: USGS-provided spreadsheet – Concrete\_03\_SAM.xls)

Three Stewart-surveyed 1921 HWMs (expressed in MSL) are shown in Figure 10 (an enlarged plot of Figure 9 showing only HWMs in the Dalles gorge), including 175.18 and 175.75 at his upper Dalles gage and 171.04 at his lower Dalles gage. Stewart noted that the upper Dalles is 695 ft above the lower end of the Dalles (Stewart's survey notes, p. 62). Figure 10 shows that the current gage (XS6) is located approximately 365 ft above the lower Dalles (XS4). This leads to an estimated distance of 330 ft between Stewart's upper Dalles gage and the current gage (which is more than "about 200 feet above present gage" stated incorrectly by the USGS-published Water Supply Paper 612 (USGS 1925, p. 62)).

To transfer Stewart's HWMs from the upper and lower Dalles to the current gage site, we first estimate two hydraulic grade lines between the upper Dalles and the current gage, and between the current gage and the lower Dalles, using the USGS-surveyed 2003 HWMs. These two hydraulic grade lines are plotted in Figure 10 (green lines 1 and 2). The 1921 flood hydraulic grade lines are expected to be closely parallel to the estimated 2003 flood hydraulic lines, as the channel geometry through the Dalles did not substantially change at high flood stages over the last 80 years, and the difference between the USGS-published 2003 flood peak discharge (166,000 cfs) and PI Engineering-estimated 1921 flood peak discharge (169,700 cfs, discussed later in Section 2.3.3) is not substantial. As shown in Figure 10, parallel lines (red lines 3, 4 and 5) are drawn to connect each of the three Stewart-surveyed 1921 HWMs to the current gage site. The estimated 1921 HWMs at the current gage site are thus determined by the elevation points where the hydraulic grade lines intersect the XS6 vertical line.

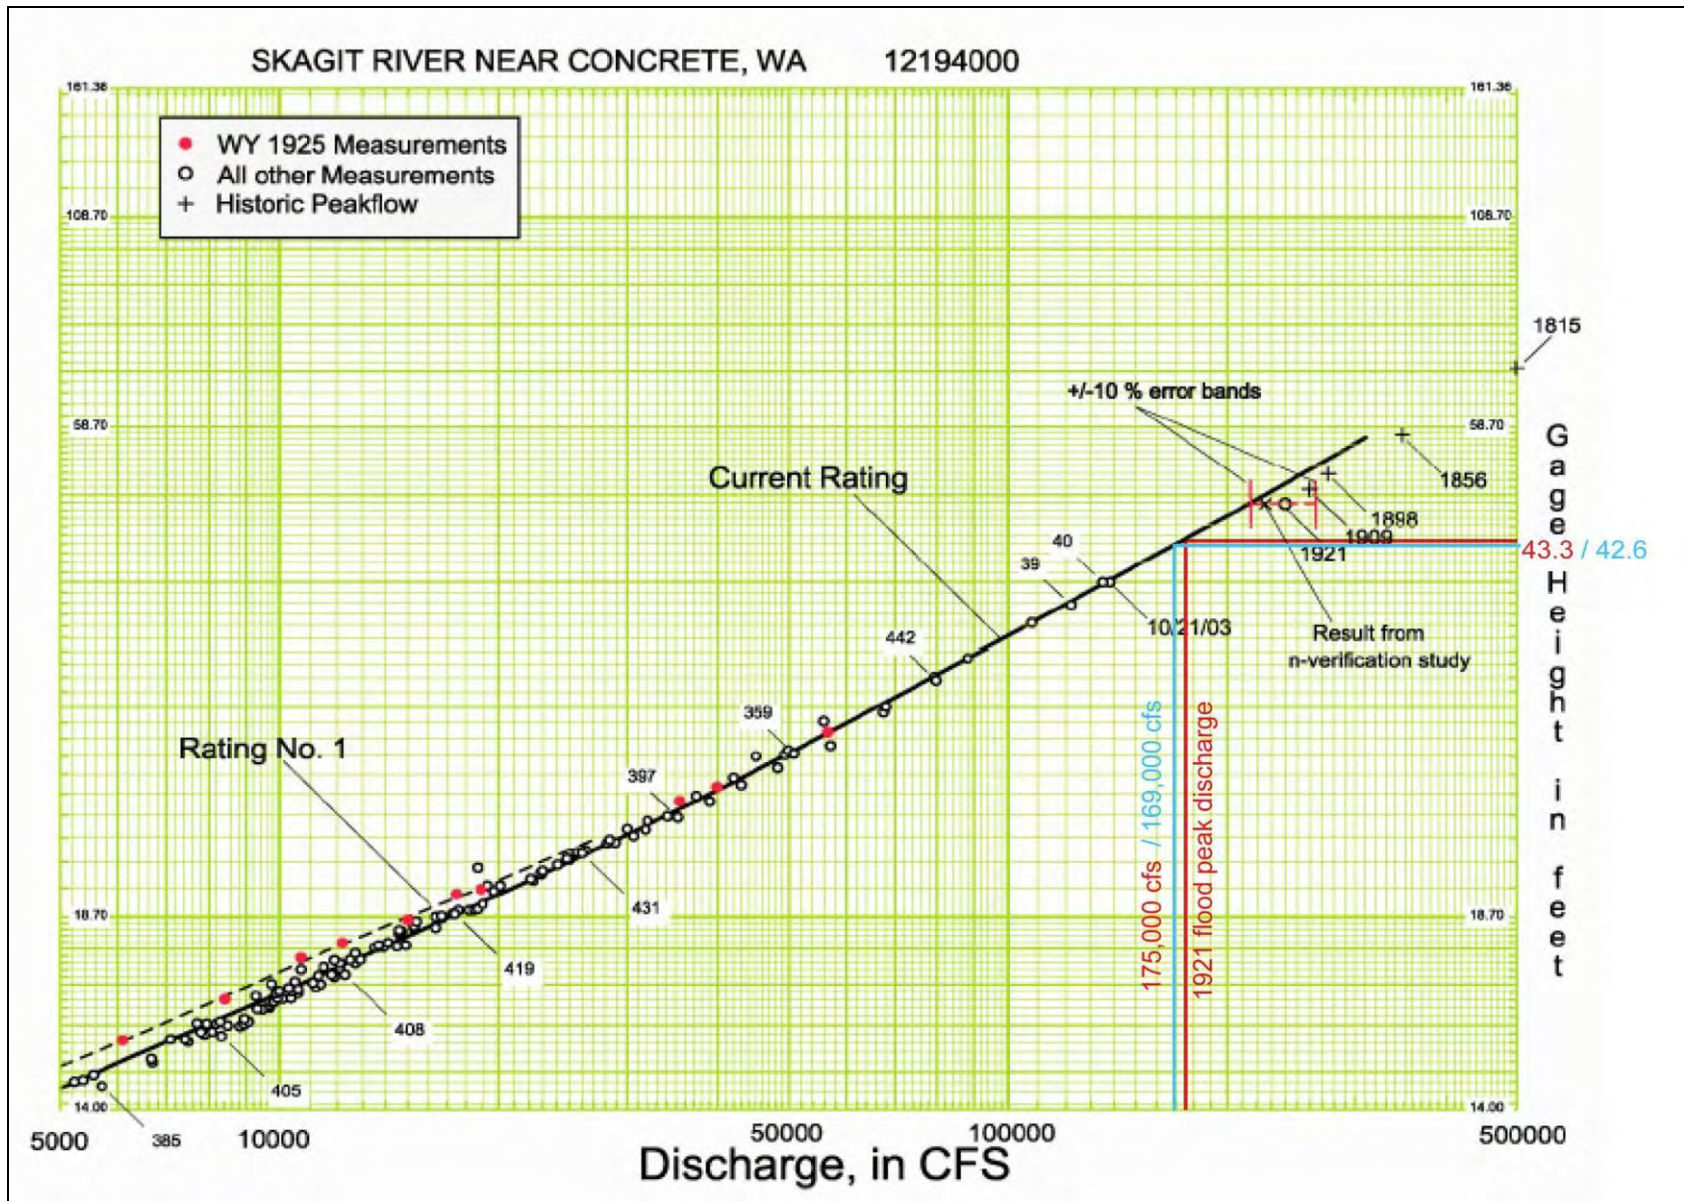
Figure 11. Stage-discharge Rating Curve for the Skagit River near Concrete (provided by USGS, May 2004)

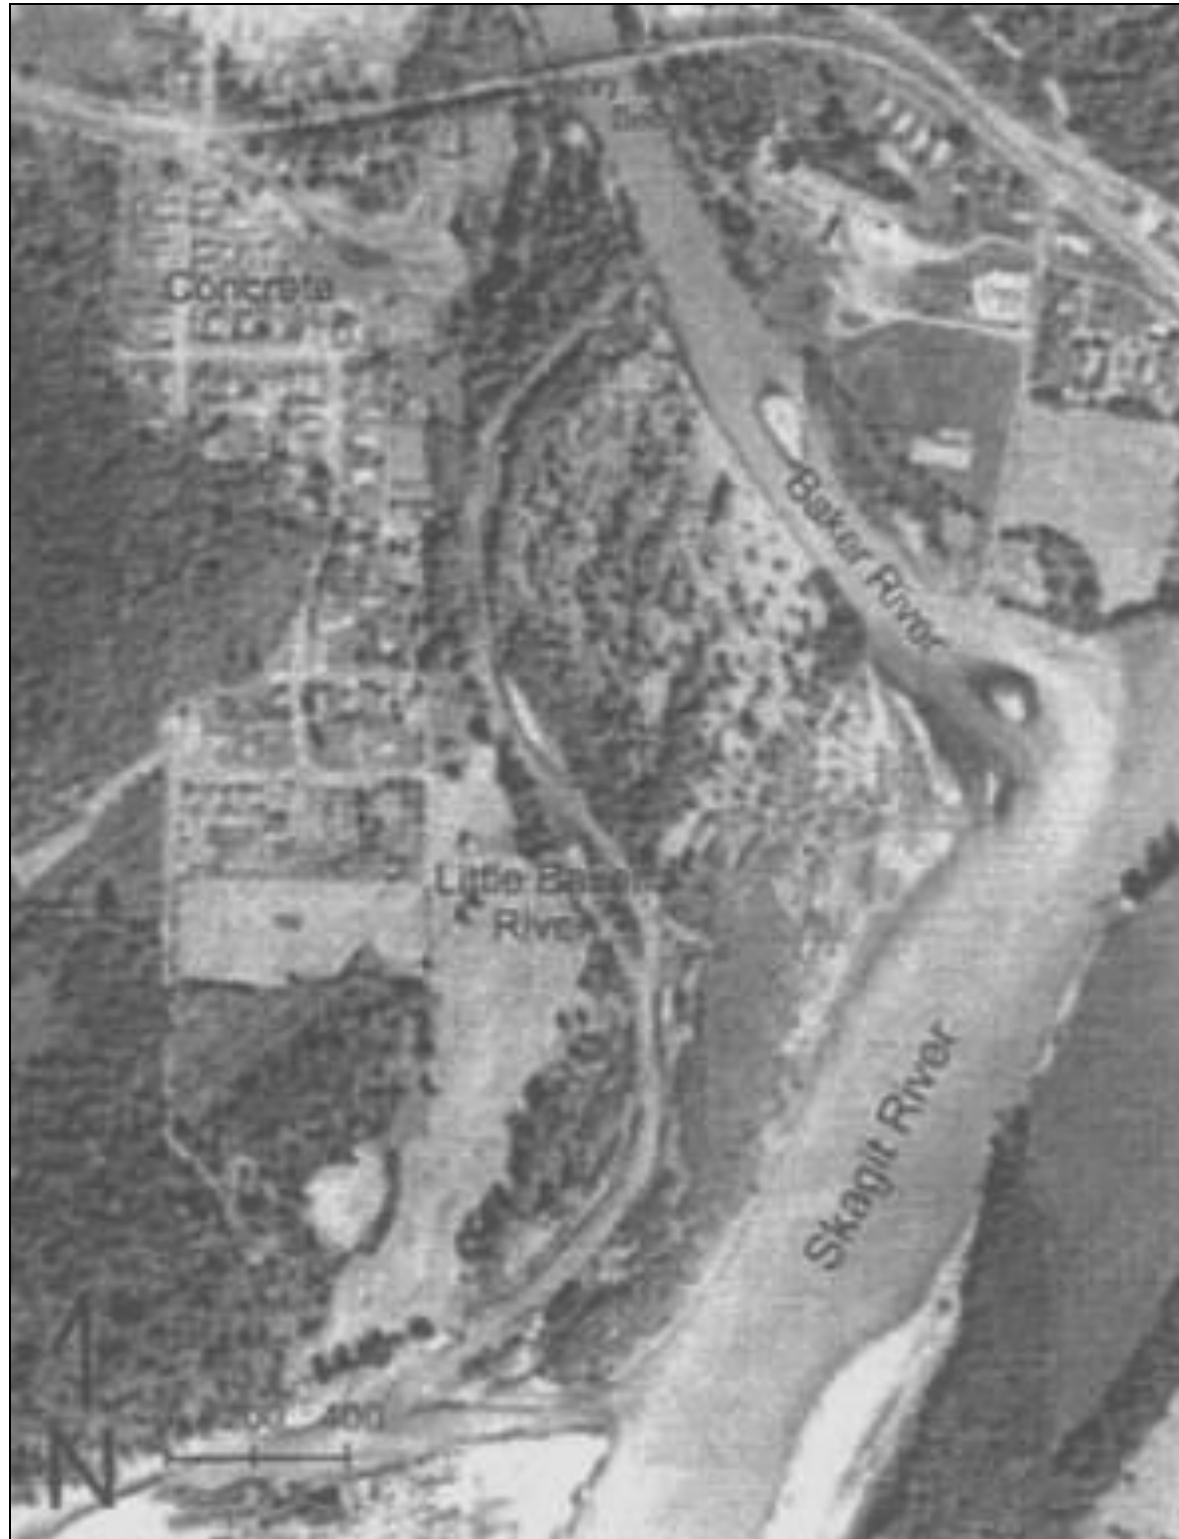
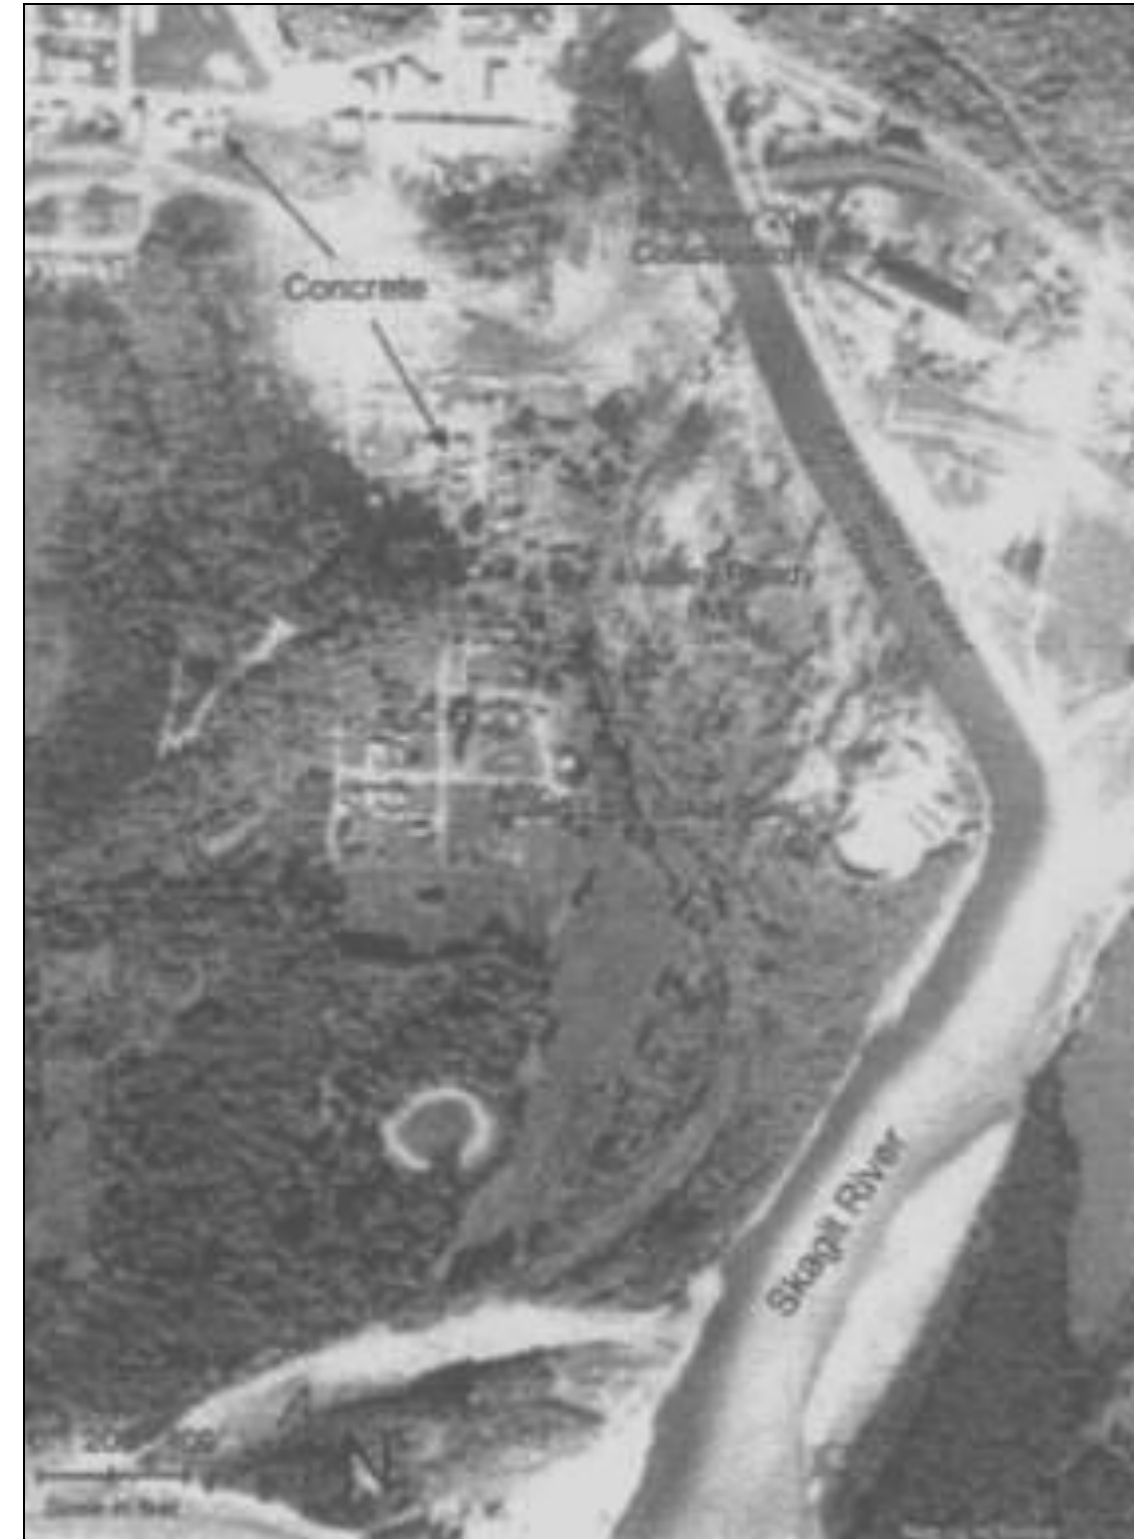
Historical view of the Baker River and Little Baker side channel circa 1956, prior to dredging of the Baker River.

Baker River after dredging, circa 1967, showing the dried-up Little Baker former side channel.

**Figure 13. Aerial views of the Baker River and Little Baker side channel prior to and after dredging of the Baker River (source of data: Little Baker River Side Channel Project, Skagit Fisheries Enhancement Group, Mount Vernon, WA)**

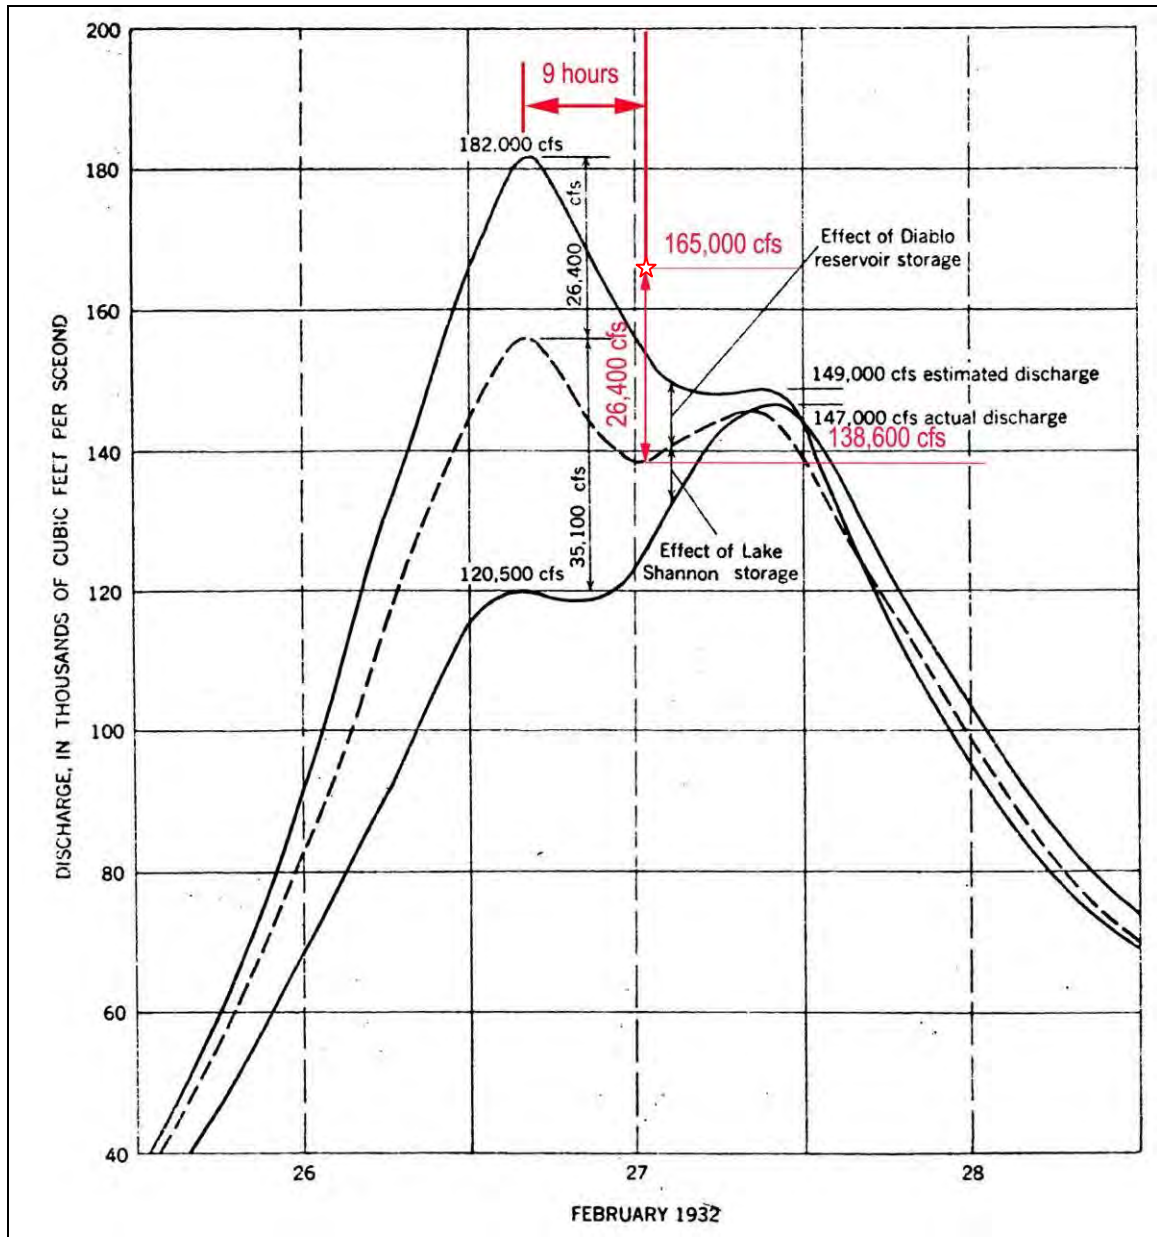
**Figure 17. USGS published estimate of 1932 unregulated flood peak discharge at Concrete (source of data: Figure 4 – Hydrographs showing effect of dams on flood peak, USGS 1961)**
