# **Technical Report - Supporting Data and Analysis for Skagit River RFIS Appeal**

March 2011

**Skagit County, Washington**

Pacific International Engineering, PLLC

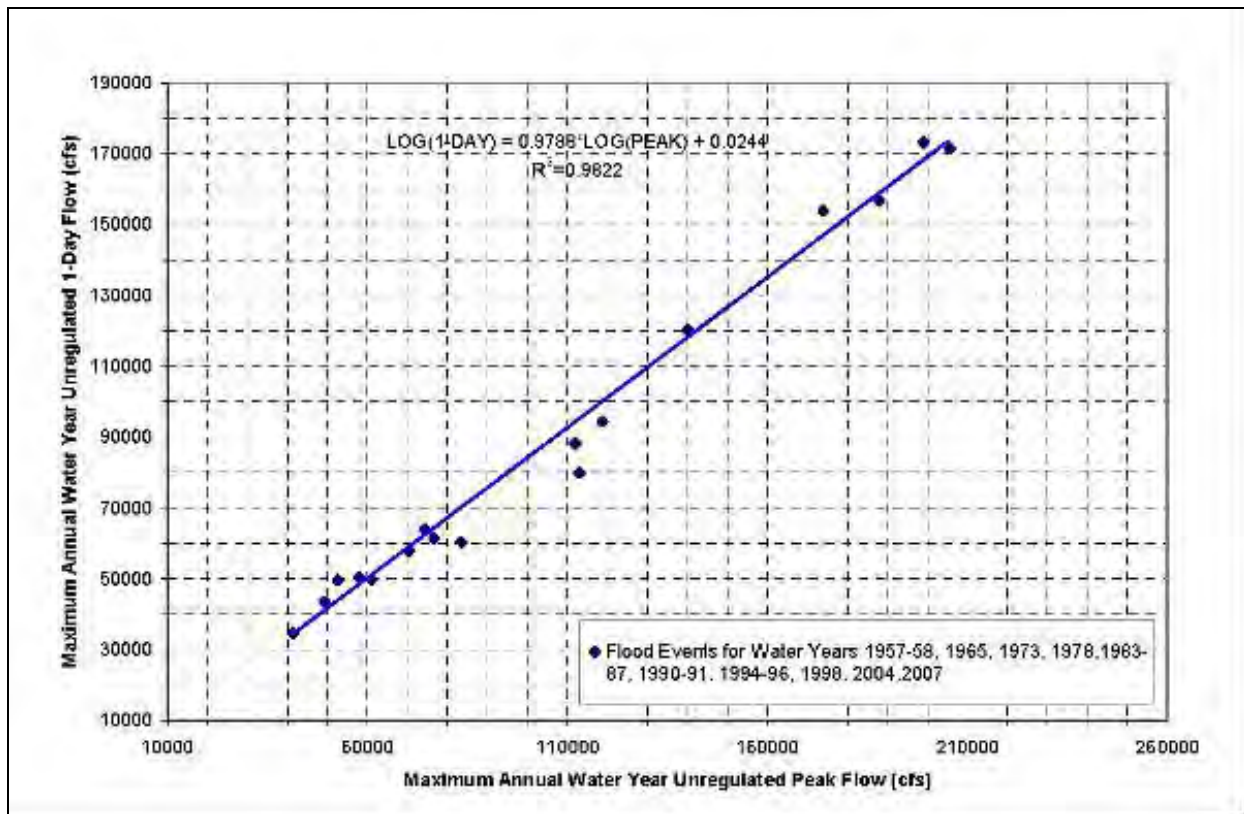
Figure 18. Regression curve of peak to one-day flow for the flood events unregulated by the USACE

The four historical floods estimated by Stewart and the USGS, as well as by PI Engineering, have only the unregulated peak discharges estimated. To estimate the corresponding unregulated one-day discharges for these four events, a regression of selected flood events developed by the USACE was applied. Figure 18 below shows the USACE' unregulated floods and the regression curve.

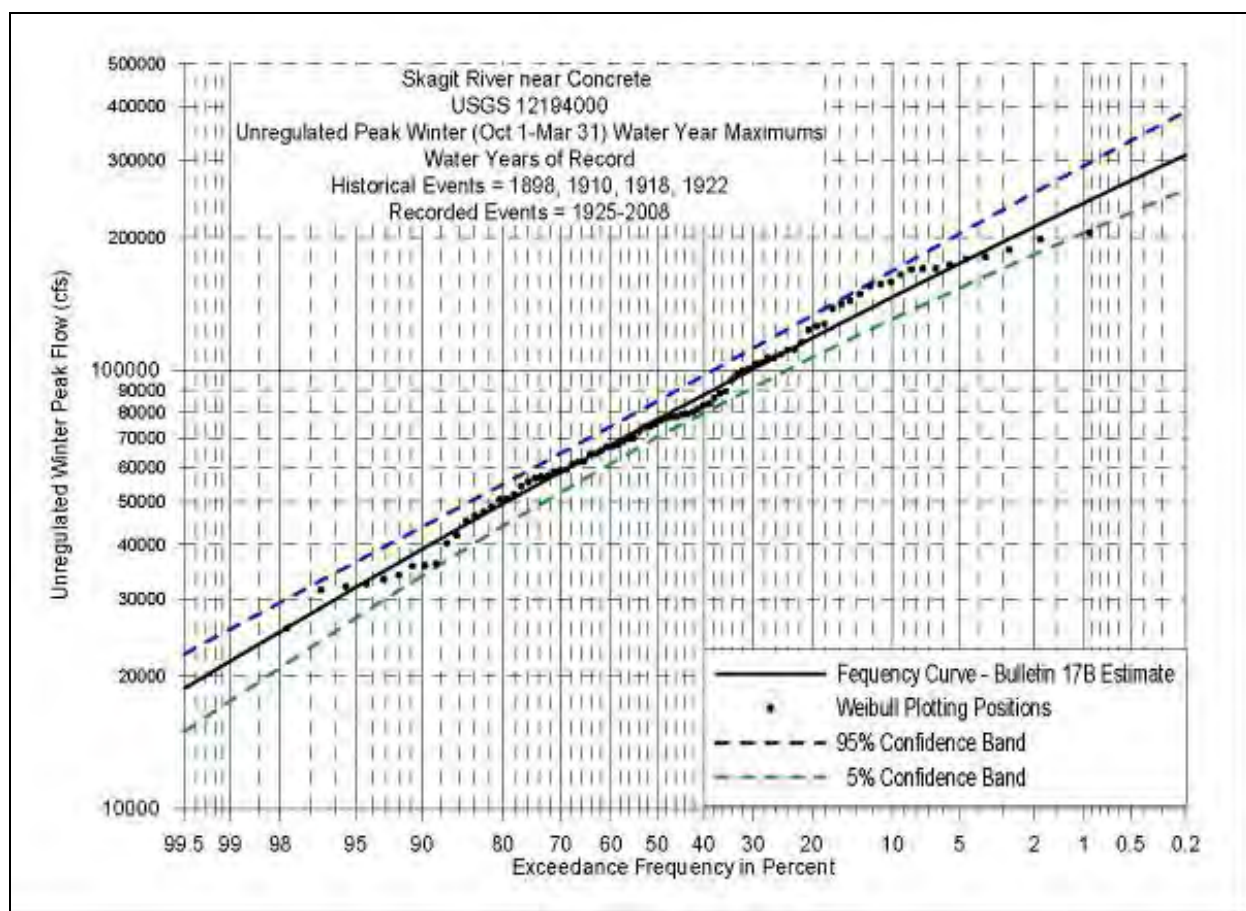
**Figure 19. The unregulated peak flow frequency curve for the Skagit River near Concrete, and the confidence band together with all data used in the frequency analysis at Concrete**

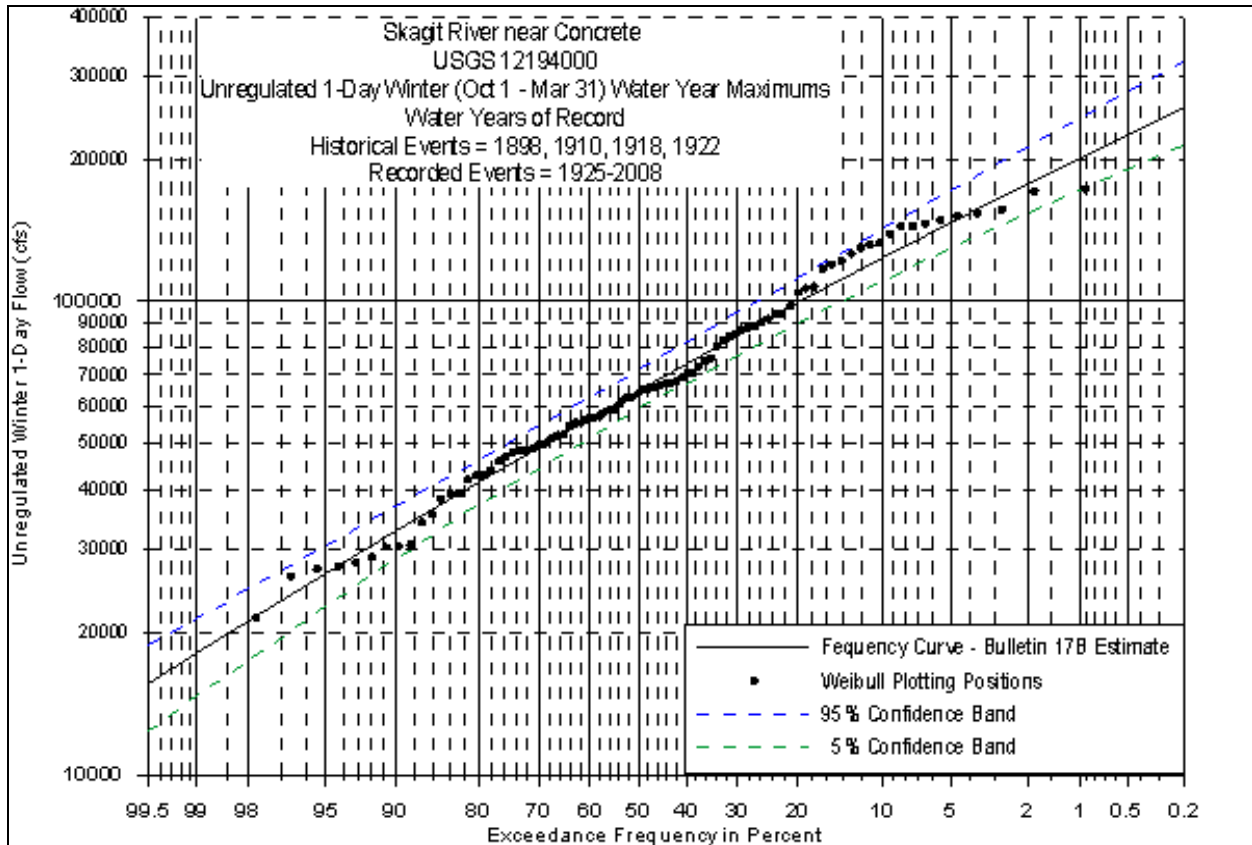
**Figure 20. The unregulated one-day flow frequency curve and the confidence band together with all data used in the frequency analysis at Concrete**

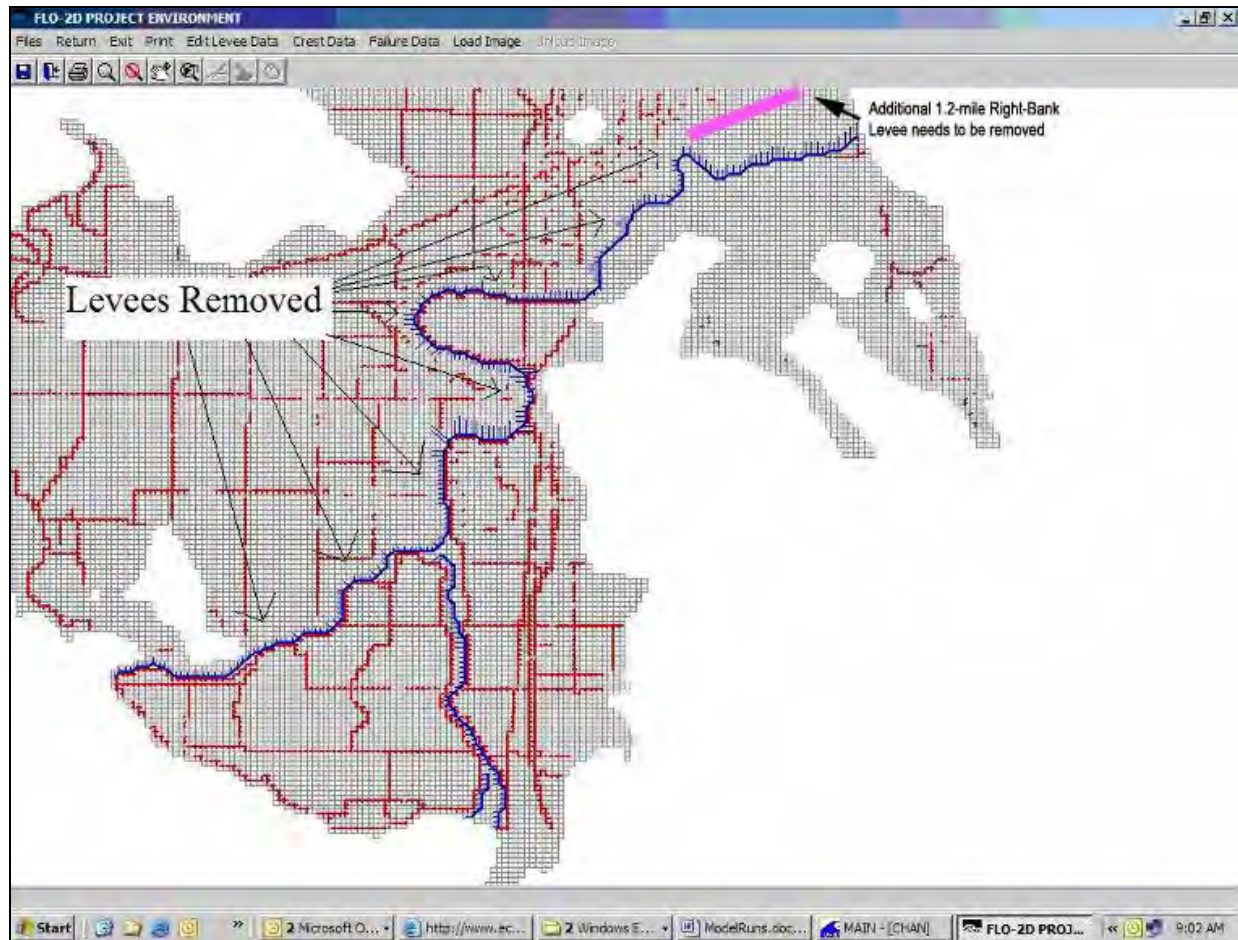
**Figure 22. Right Bank Levees on Mainstem and North Fork Skagit River Removed While All Other Levees Remain Intact** (original source: Figure 9, COE 2009)

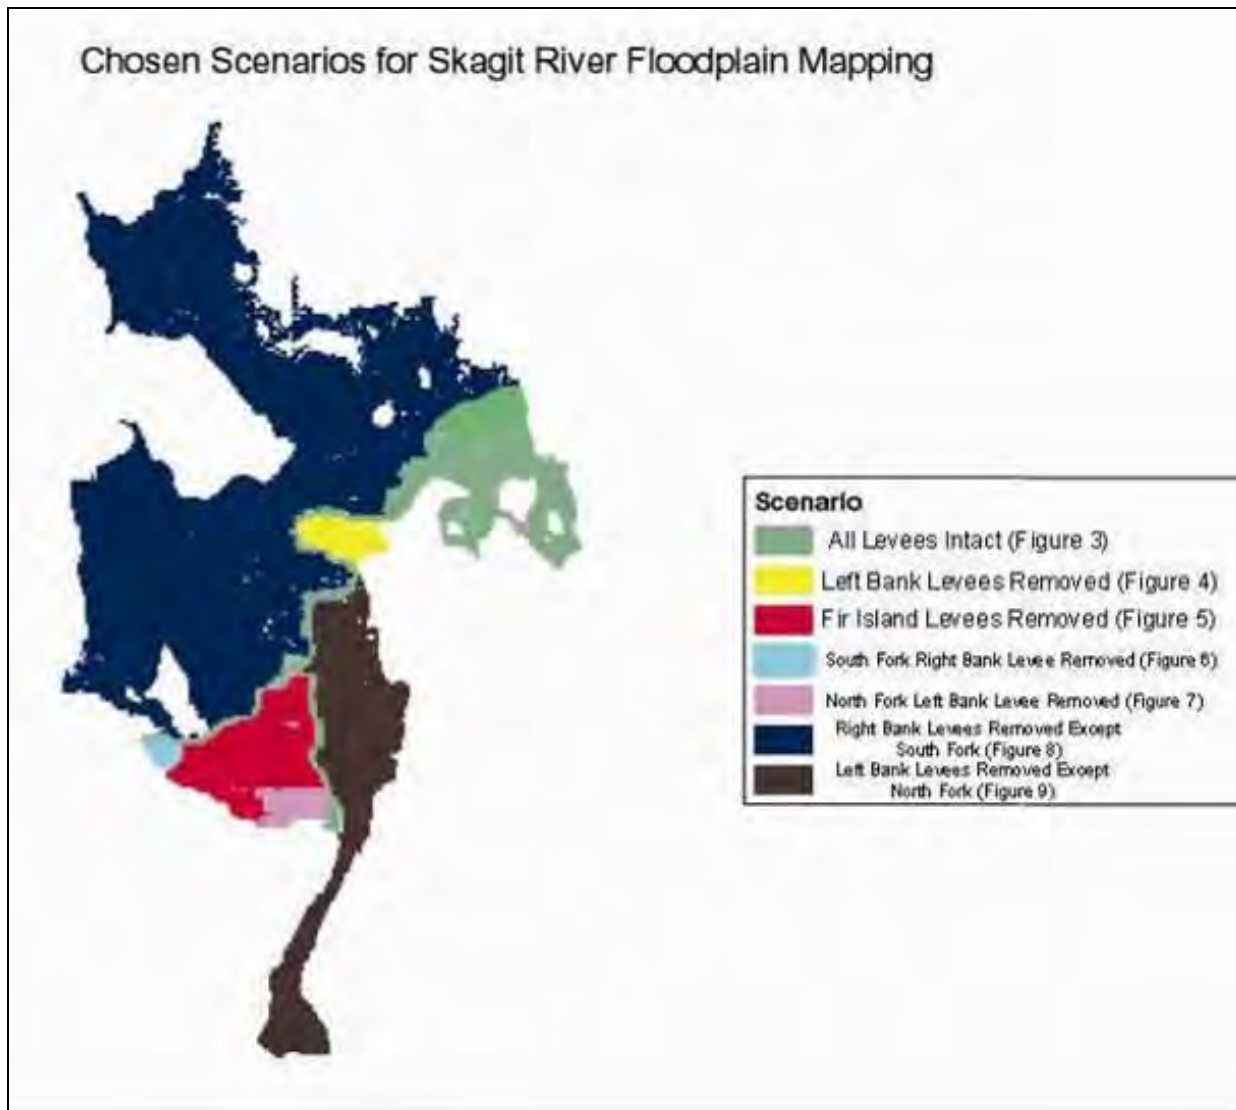
**Figure 23. Depiction of the Floodplain Scenario Location of Implementation (original source: Figure 11, COE 2009)**

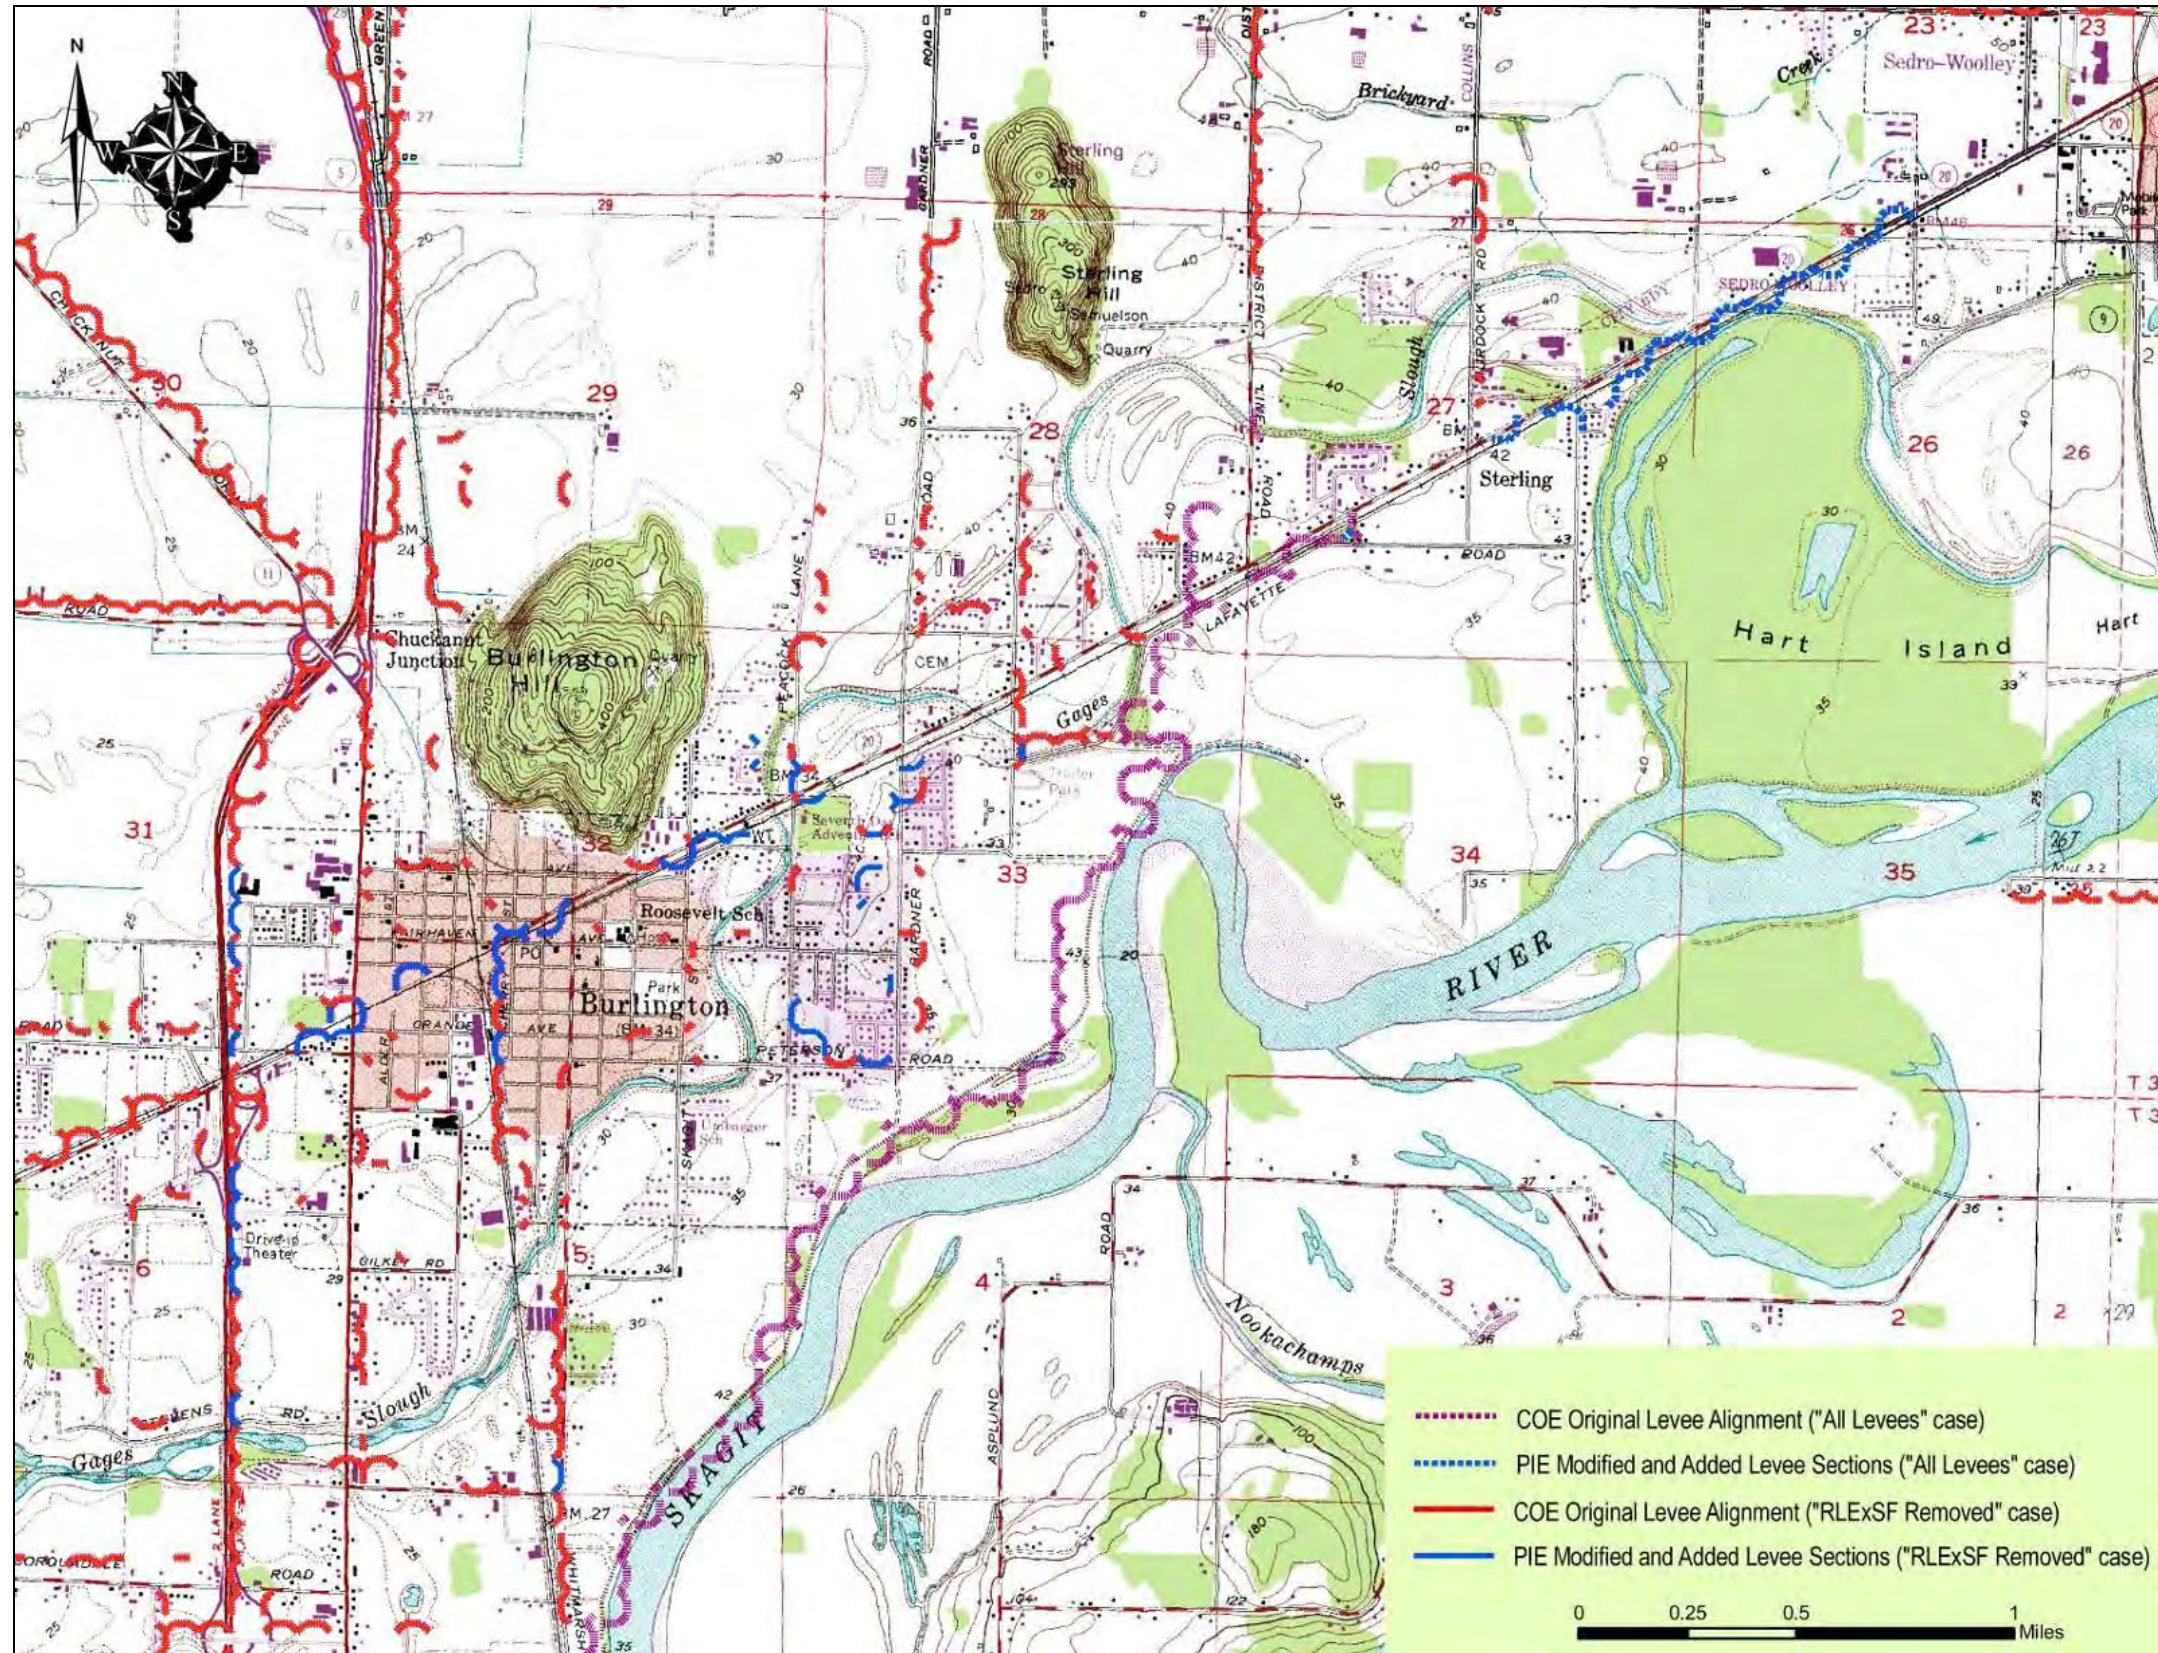
Figure 24. Comparison of COE Original and PIE Revised FLO-2D Model Levee Alignments

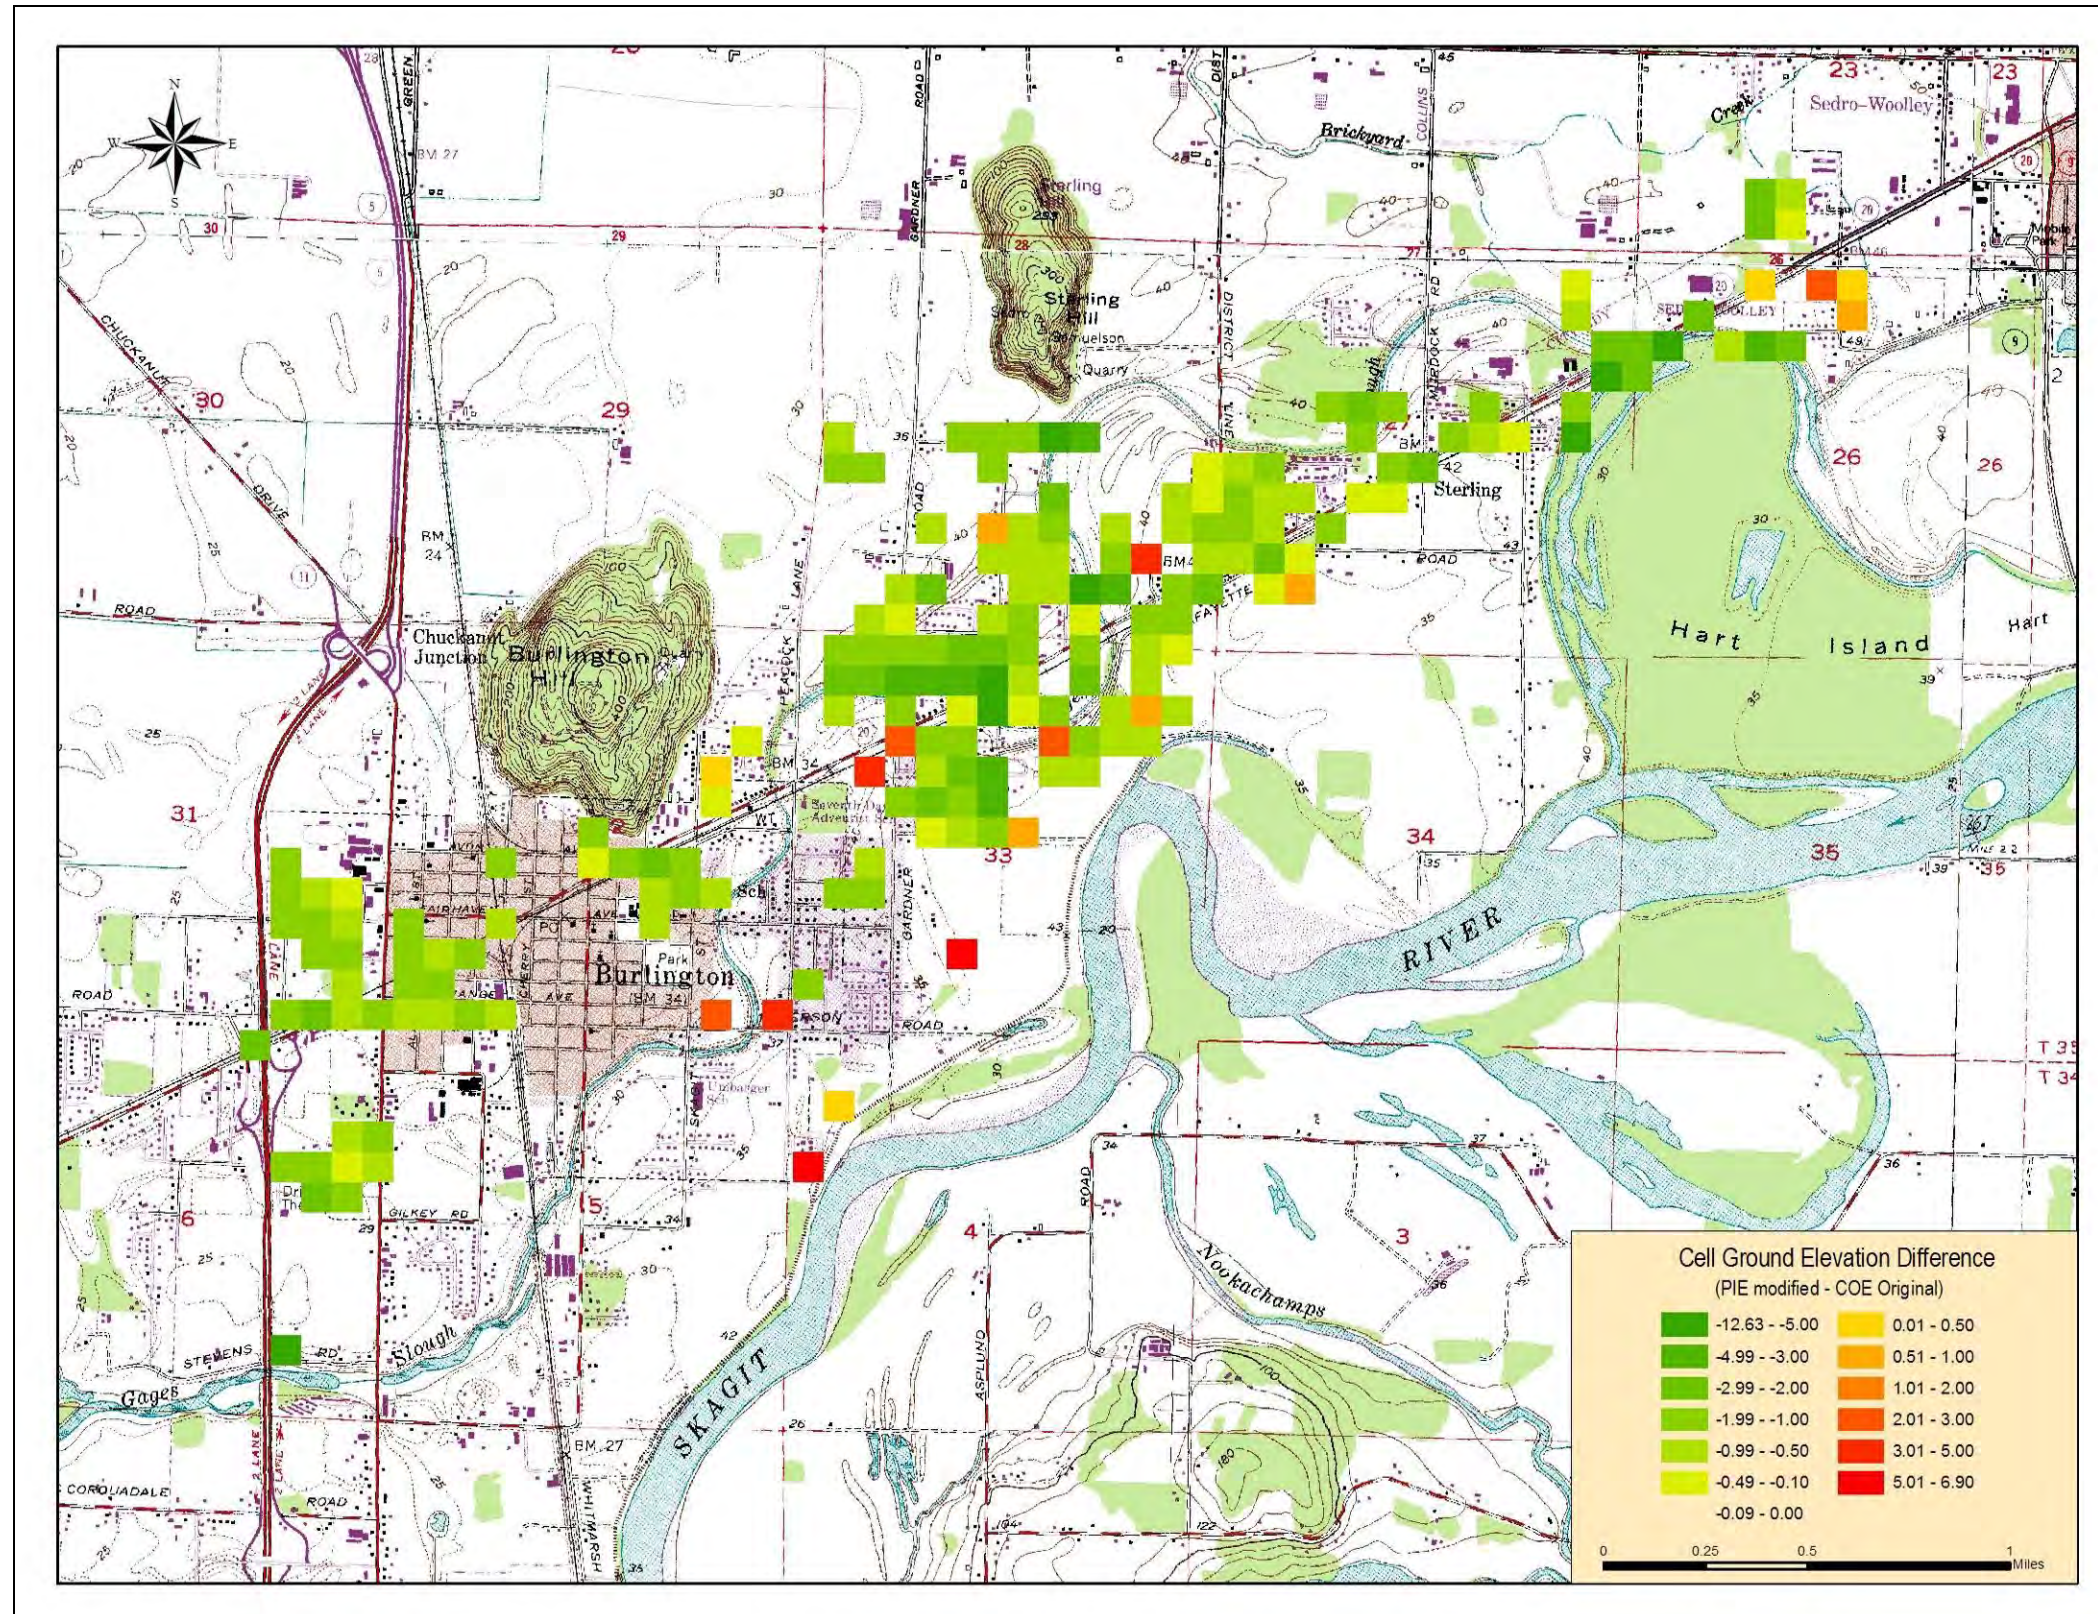
Figure 25. Cell Ground Elevation Difference between PIE Revised and COE Original FLO-2D Model

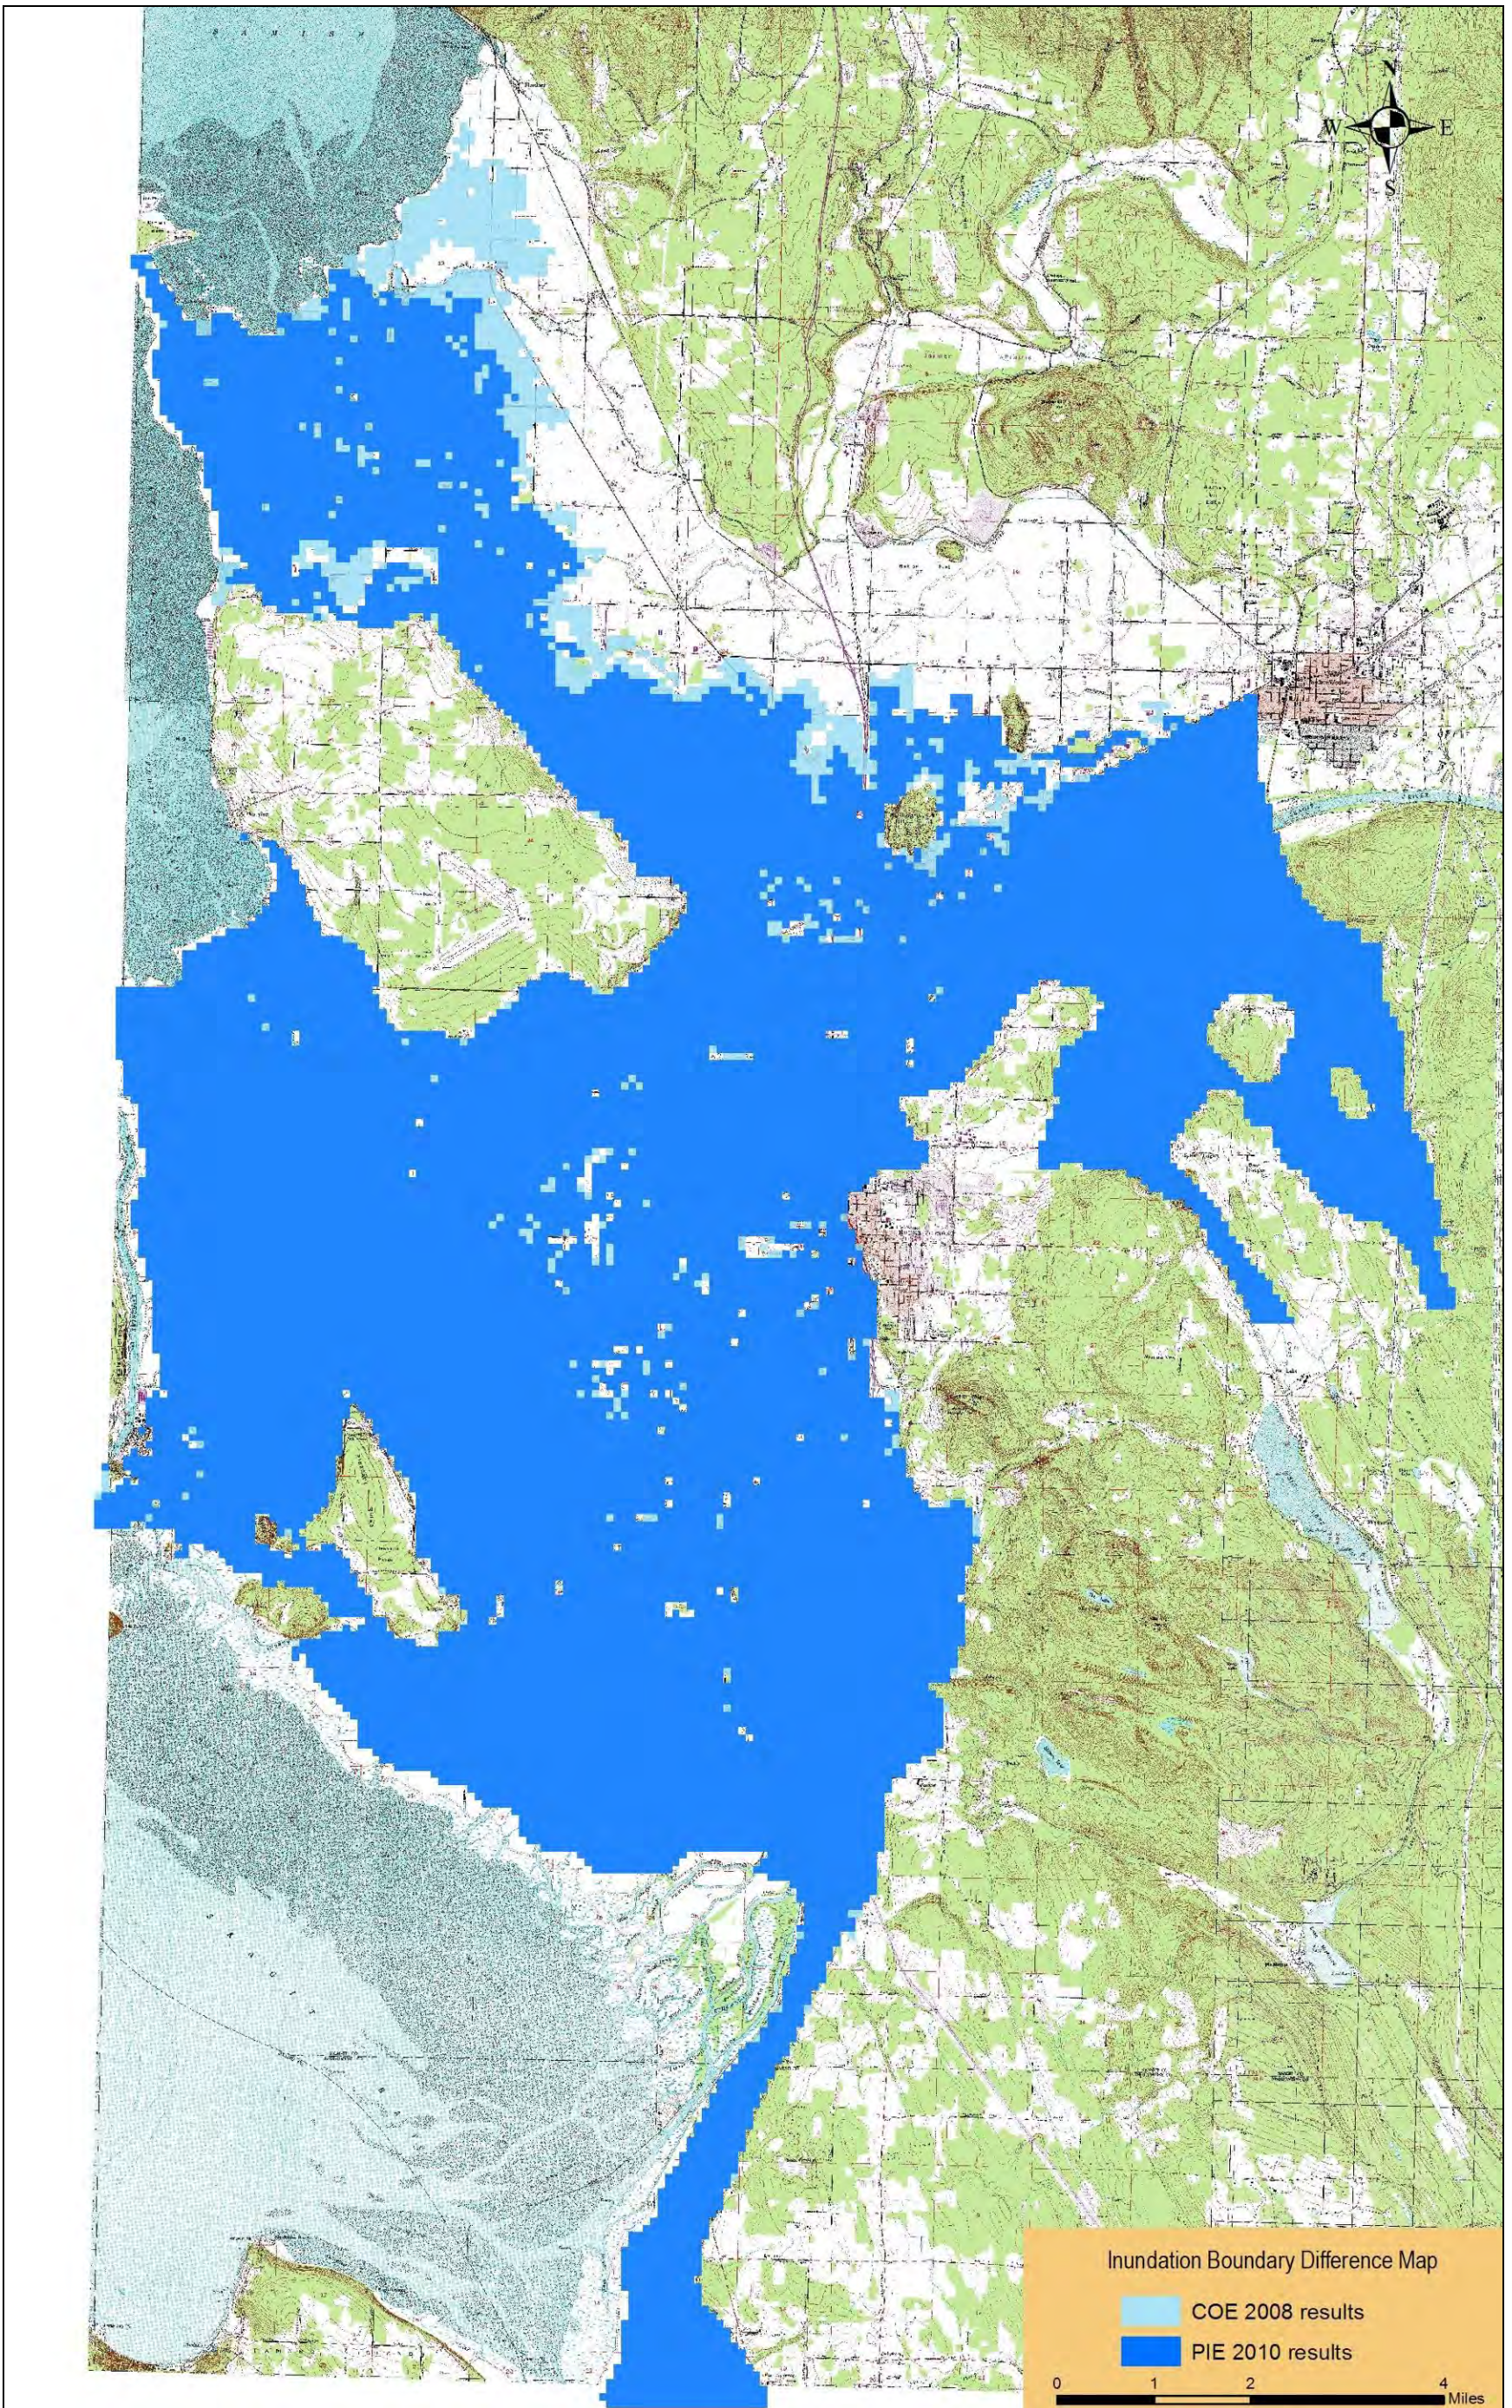
Figure 28. Base flood boundary difference map

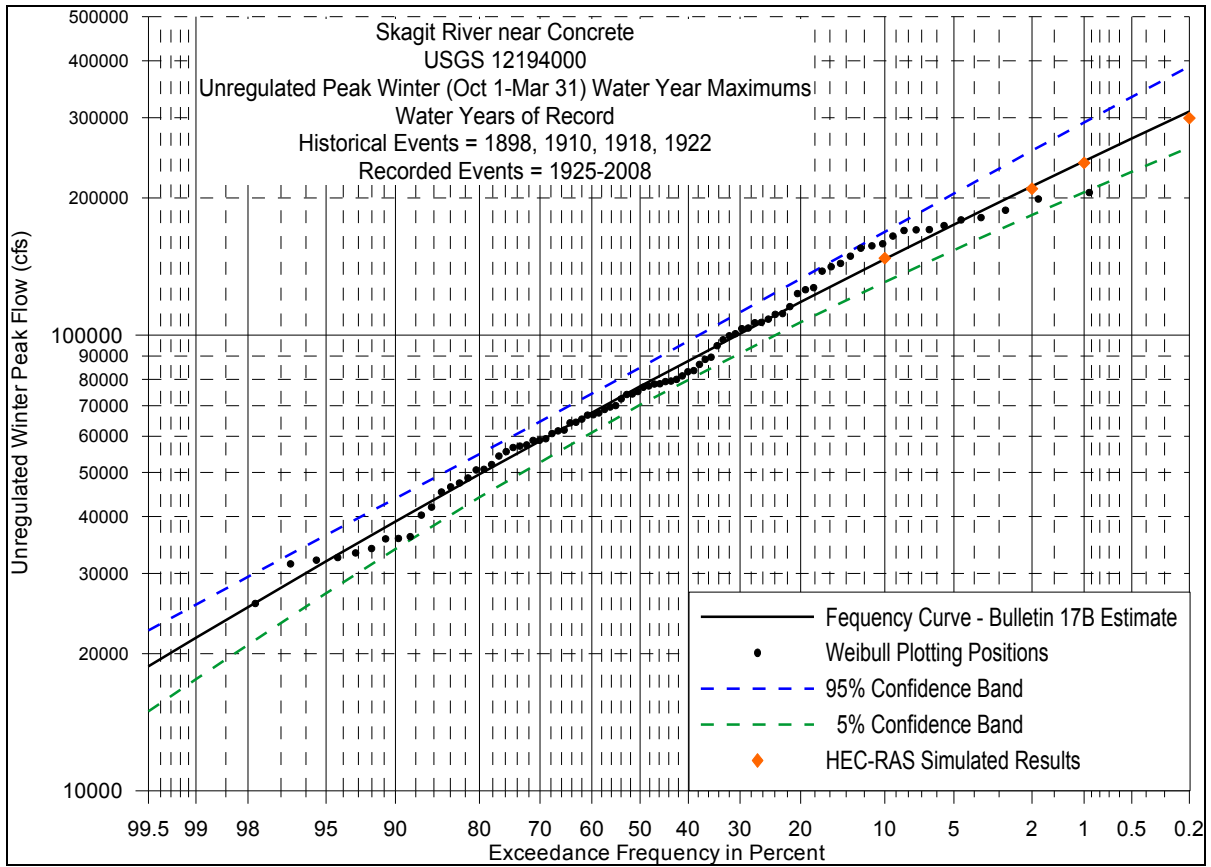
**Figure A-2. Flood frequency curve for unregulated peak discharges at Concrete, compared with the HEC-RAS simulated peak flows at Concrete for the 10-, 50-, 100-, and 500-year synthetic events**

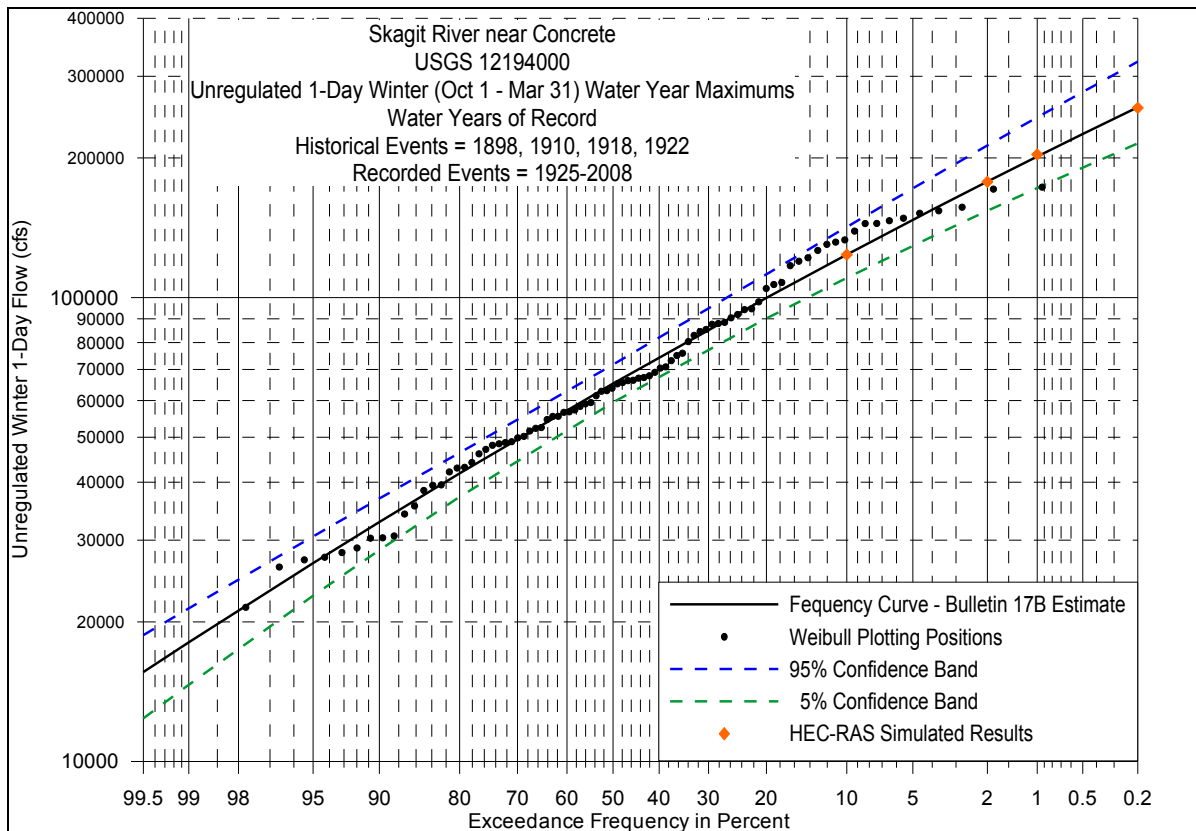
**Figure A-3. Flood frequency curve for unregulated one-day discharges at Concrete, compared with the HEC-RAS simulated one-day flows at Concrete for the 10-, 50-, 100-, and 500-year synthetic events**

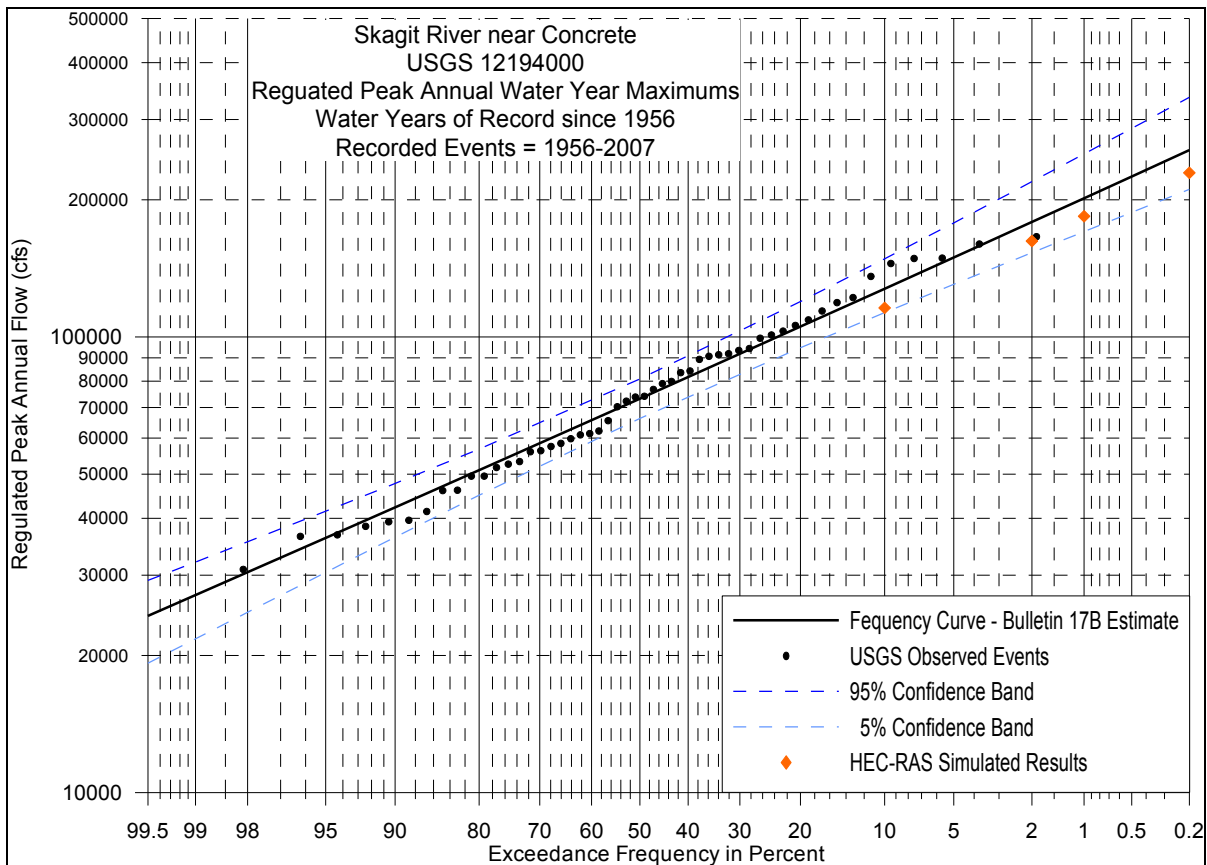
**Figure A-4. Flood frequency curve for regulated peak discharges observed by USGS at Concrete, compared with the HEC-RAS simulated regulated peak flows at Concrete for the 10-, 50-, 100-, and 500-year synthetic events**
