United States Department of the Interior

USGS Washington Water Science Center

Subject: USGS responses to issues raised by the Technical Memorandum, "Review and reevaluation of Skagit River 1921 flood peak discharge."

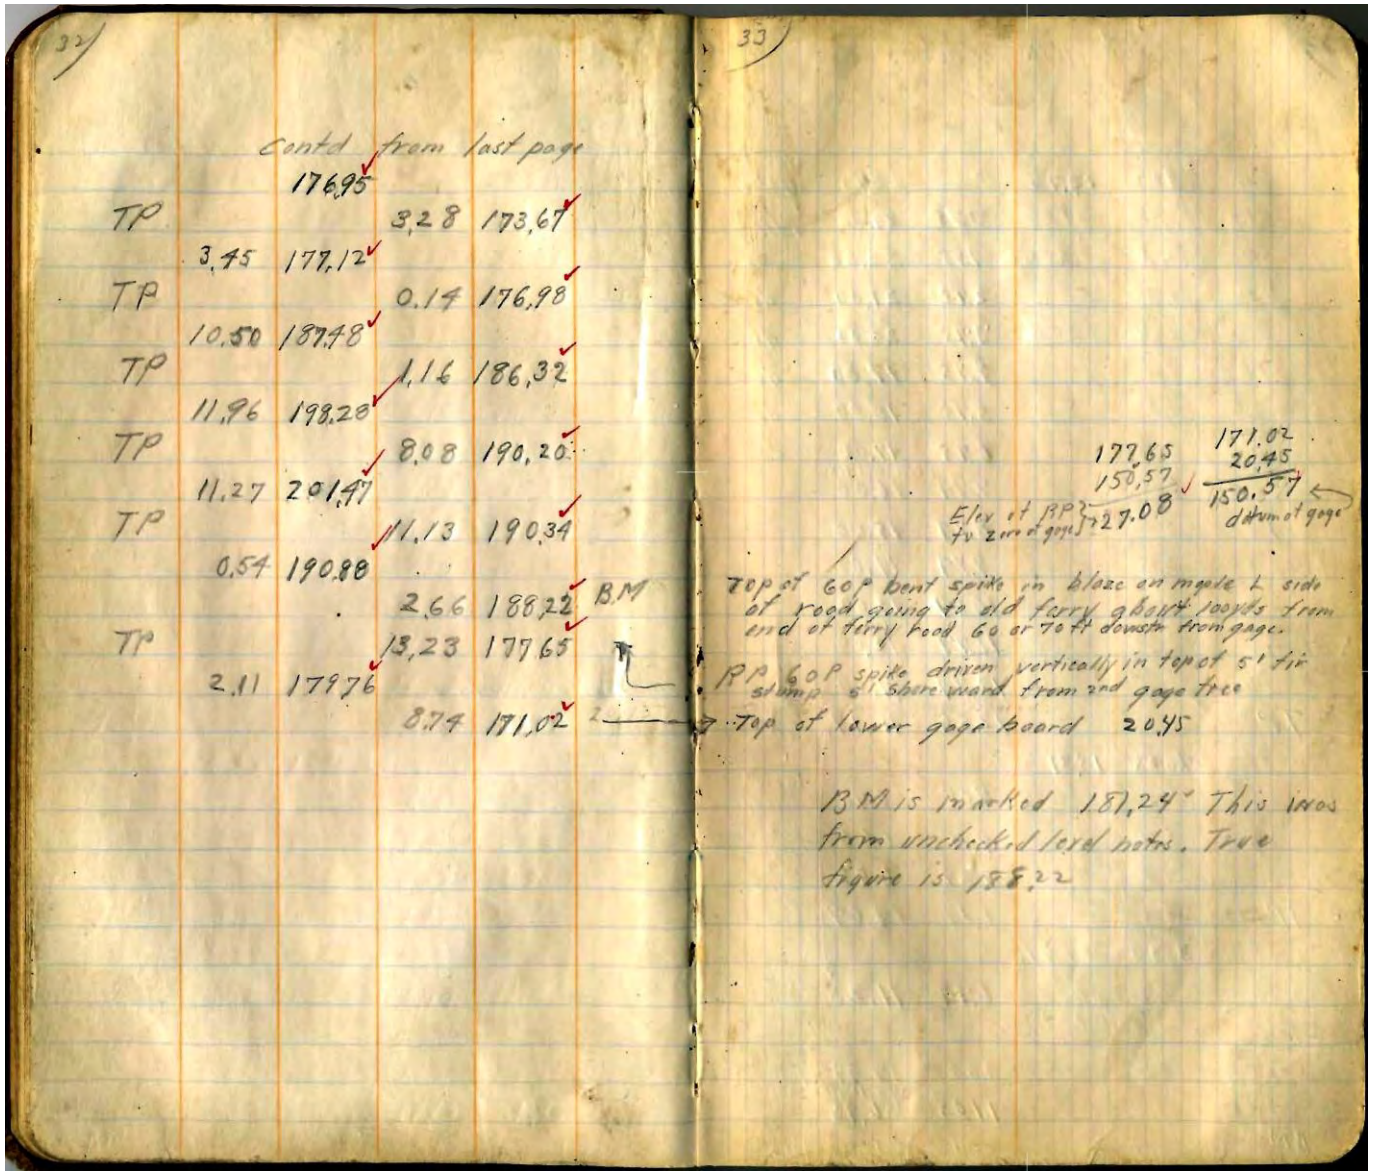
Stewart's field notes, pp. 30-31

On December 22nd, 1922, Stewart began the survey from the USGS benchmark located in Concrete and referenced in a USGS publication at the time (Bulletin 674, Spirit Leveling in the State of Washington, 1897 to 1917, Inclusive). This survey is documented on pp. 30-33 of Stewart's field notes. The survey proceeded from the USGS benchmark to the old Ferry Landing downstream of the Crofoot's Addition in Concrete. There Stewart set a benchmark at 188.22 feet msl and also set a reference point at 177.65 feet msl, as well as providing a reference to the gage he located there, noting "Top of lower gage board 20.45" equated to a msl elevation of 171.02. See the following figures, pp. 8-9:

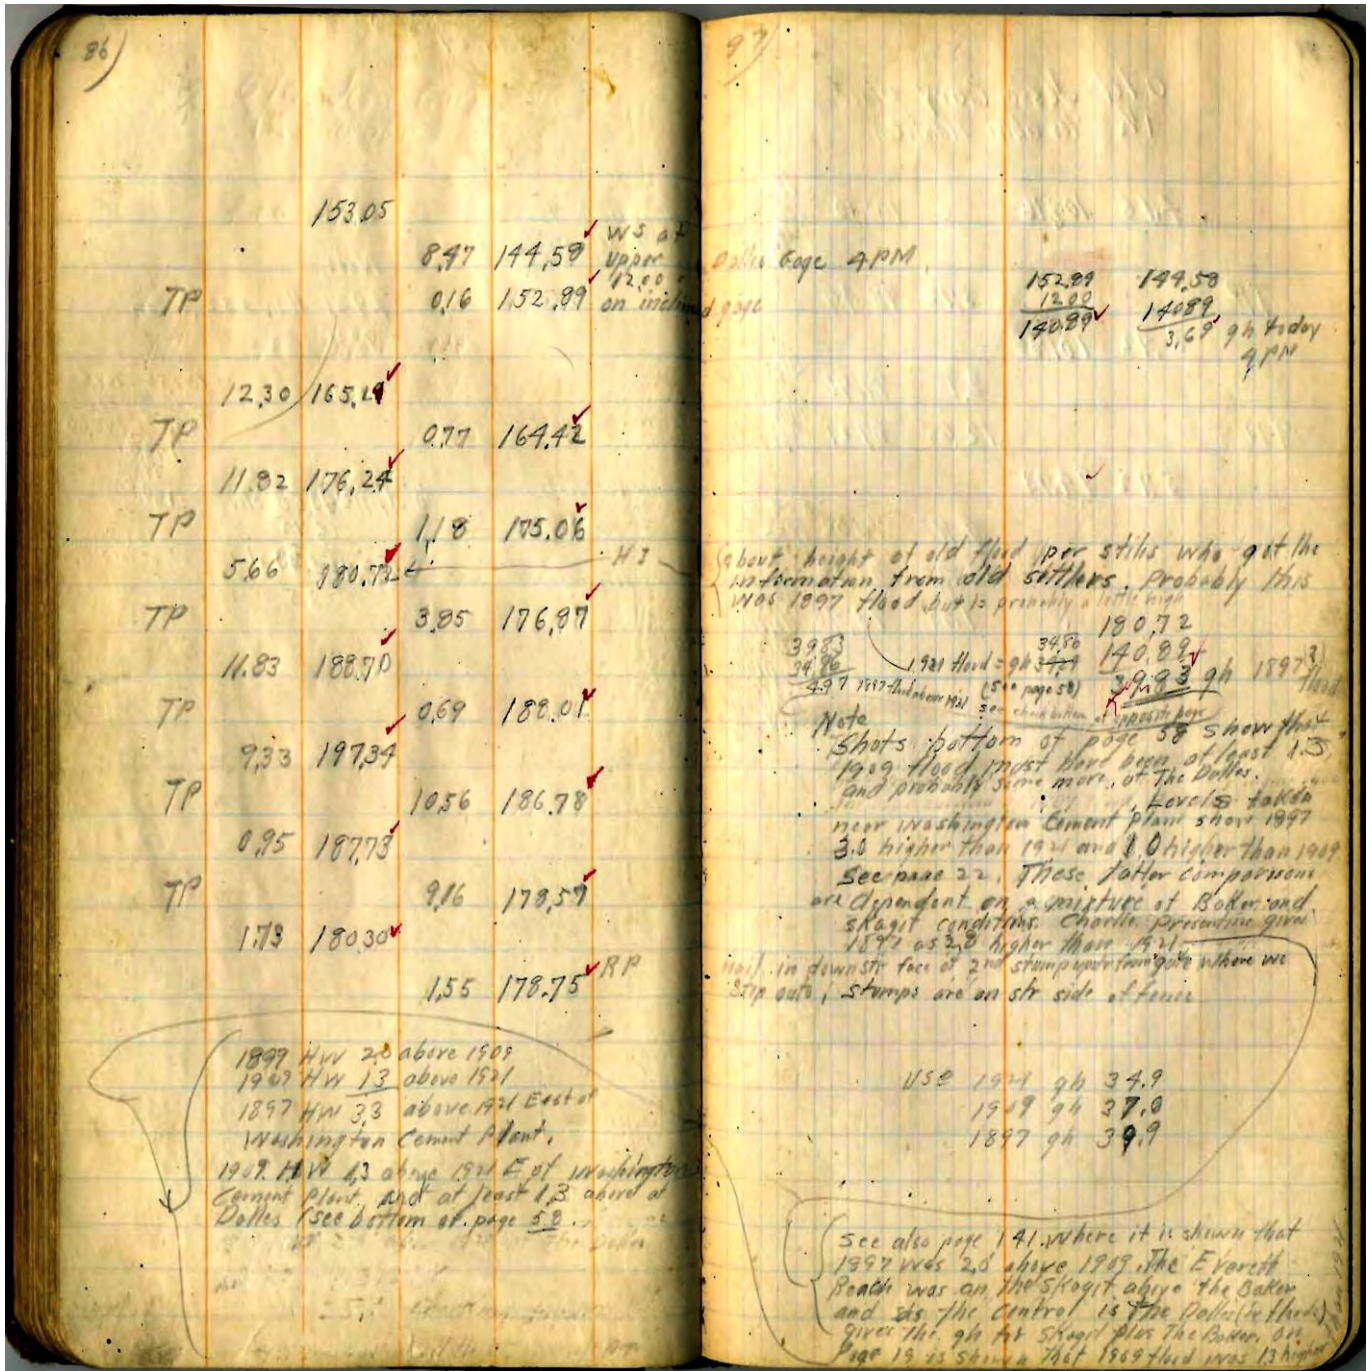
Stewart's field notes, pp. 84-85

Stewart then proceeded downstream through 9 turning points to the Upper Dalles gage, where he calculated the Upper Dalles gage datum, based on a gage reading of 12.00 equating to an elevation of 152.89 feet, giving a gage datum of 140.89 feet. Stewart then proceeded on downstream through 6 turning points to the Lower Dalles gage, where he set a reference point at elevation 178.75. See the following figures on pp. 11-13:

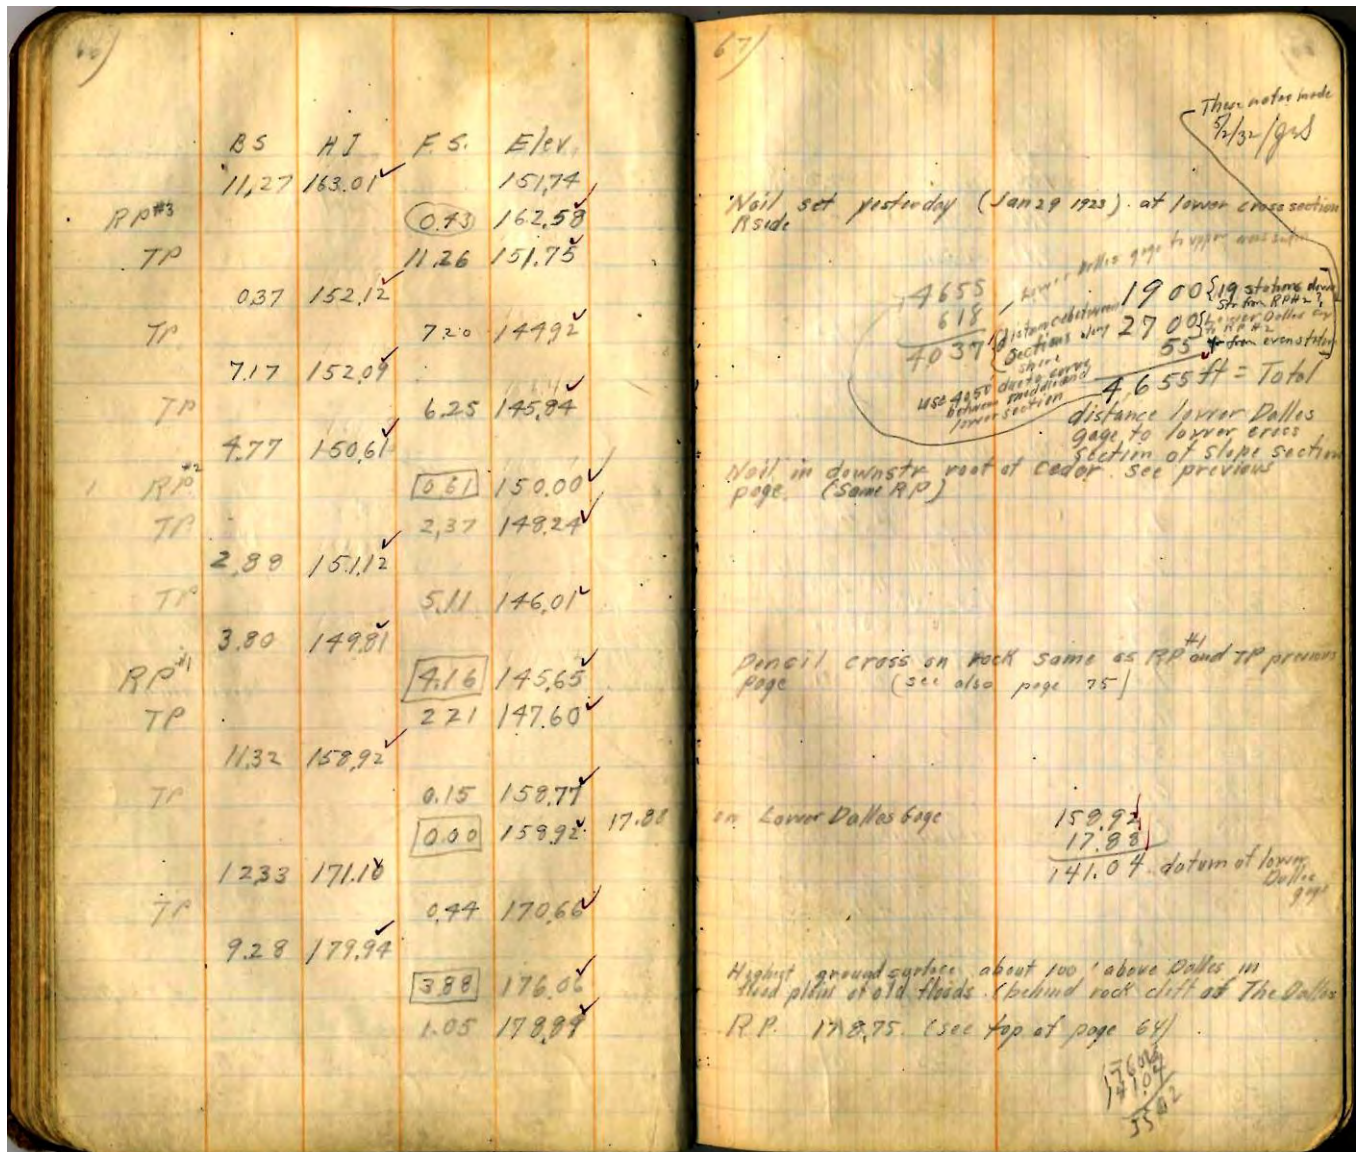
Stewart's field notes, pp. 64-65

Cities' Comment: On January 30th, Stewart surveyed from the Upper Dalles gage to the lower slope section, and back. During this survey he established the datum for the Lower Dalles gage. This survey closed to within 14/100ths of a foot at the reference point Stewart had established at the Upper Dalles gage. See below:

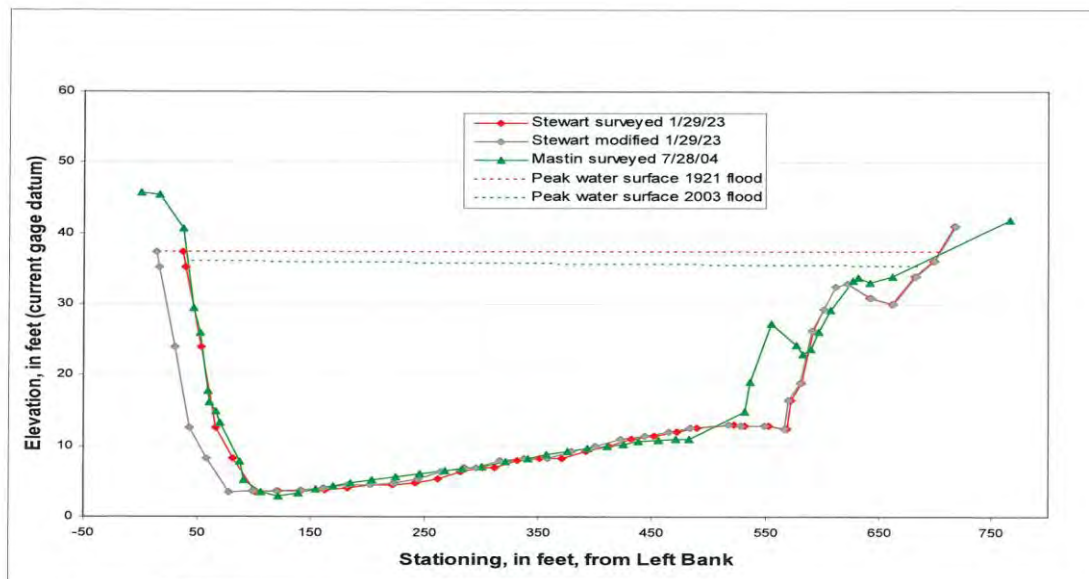
Figure 3. Slope Section XS3 - Skagit River near Concrete, WA

As the overlaid surveys demonstrate, this cross section has remained nearly the same over the years, especially along the left bank, and Stewart's adjustments for this lower cross section as

Cities' Comment: *Compelling evidence to adjust the cross sectional area of the lower slope section comes from the USGS' cross section measurements at Stewart's furthest downstream cross section. The following figure overlays Stewart's cross section with a cross section developed by USGS in 2004:*

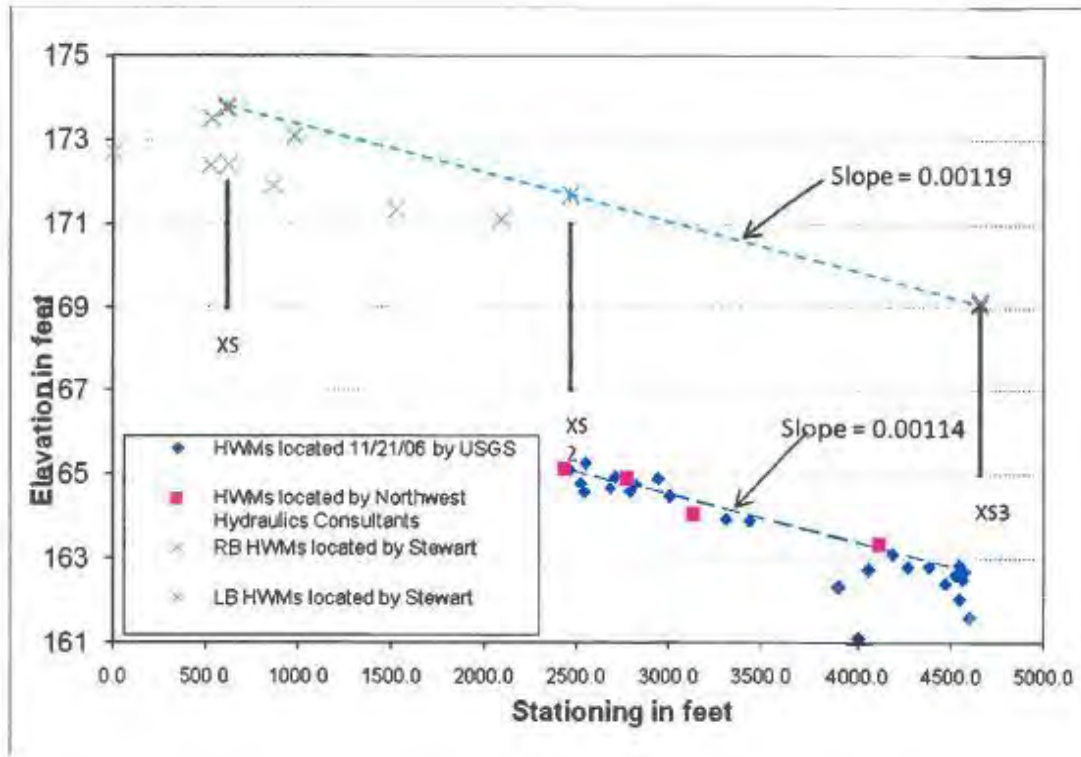
This slope has also been confirmed by other flood data. In November 2006, soon after a peak of 145,000 ft³/s, the USGS surveyed HWMs between locations approximating cross- sections 2 and 3 and defined a peak water slope of 0.00114 (fig. 1, Mastin 2007). This slope matches to within 3 significant figures the surface-water slope computed by Stewart.

Figure 1 -- High-water marks and peak water-surface profiles in the slope-area reach downstream of USGS streamgauge Skagit River near Concrete, WA Station Number 12194000 for the Dec. 1921 and Nov. 2006 floods.

Cities' Comment: *The USGS did not gather any data following the 2006 flood, upstream of XS2. This is a significant weakness, as the USGS only uses the lower slope section to attribute the hydraulic grade line to the entire slope-area reach.*

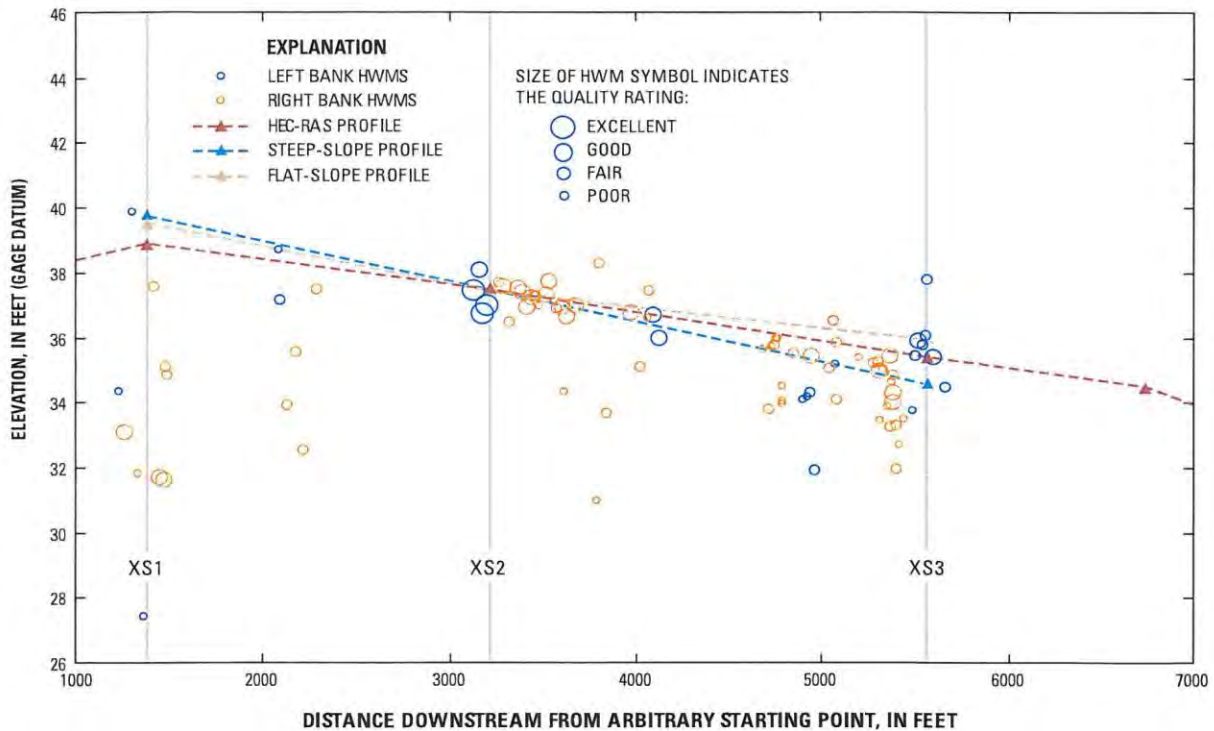
Note that the high water marks in the vicinity of cross section XS2 are well clustered, with "good" or "excellent" high water marks within a 2-foot range. The range of high water marks collected by the USGS in the vicinity of XS3 indicate that gathering high water marks in this area was a more difficult task than at XS2. In the case of XS1, it is clear the difficulty of gathering accurate high water marks is very challenging. Note that right bank marks rated "good" are 5-8 feet below the expected water surface elevation.

Figure 4. High-water marks (HWMs), flattest- and steepest-sloped water-surface profiles, and a HEC-RAS water-surface profile near cross sections XS1, XS2, and XS3, at Skagit River near Concrete, Washington.

The table below comes from the USGS 2005 report, and contains high water marks collected by the USGS 9-10 months after the October 2003 flood event. Shown below is a profile showing the high water marks surveyed by USGS in the summer of 2004 following the October 2003 flood of record.

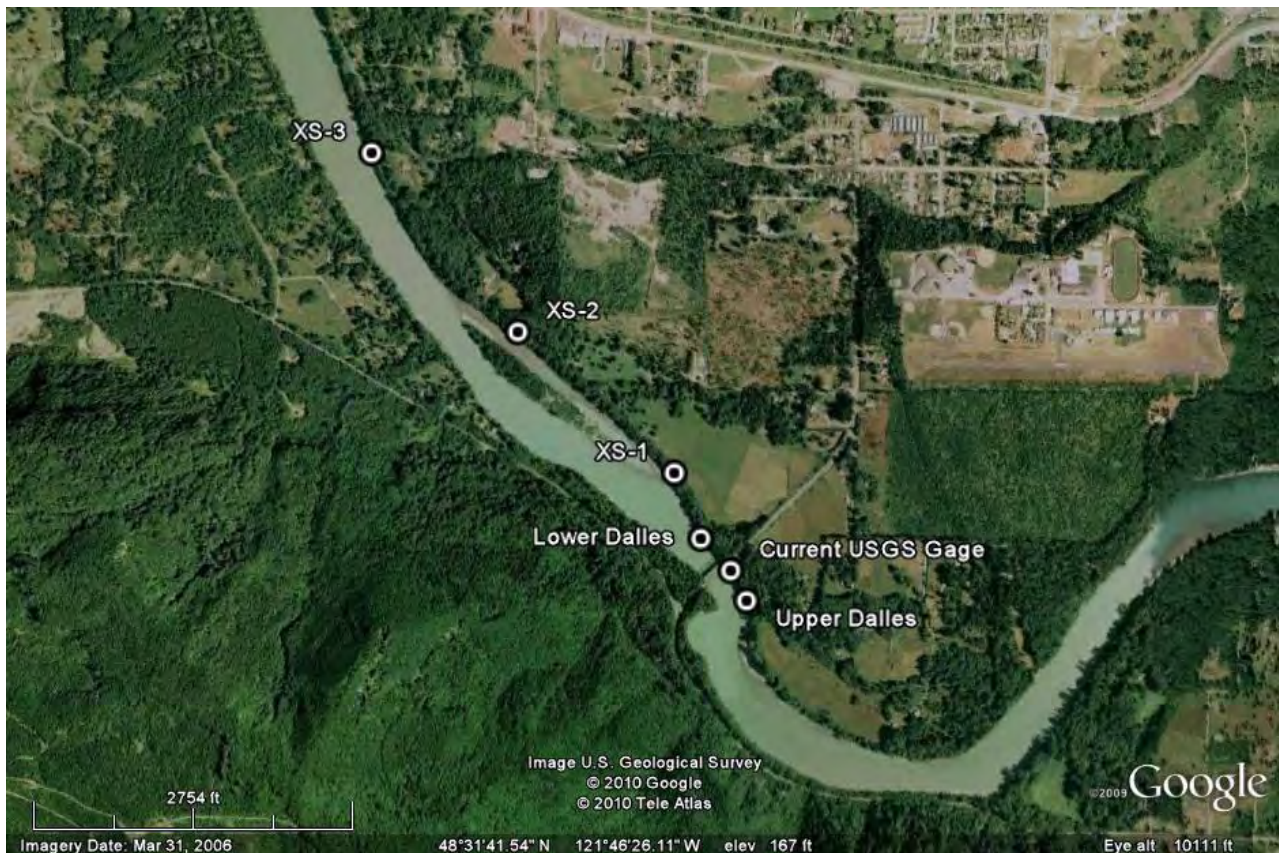
Aerial view of the Dalles gorge showing current and old gage locations and the locations of Stewart's slope-area cross sections XS1, XS2, and XS3.

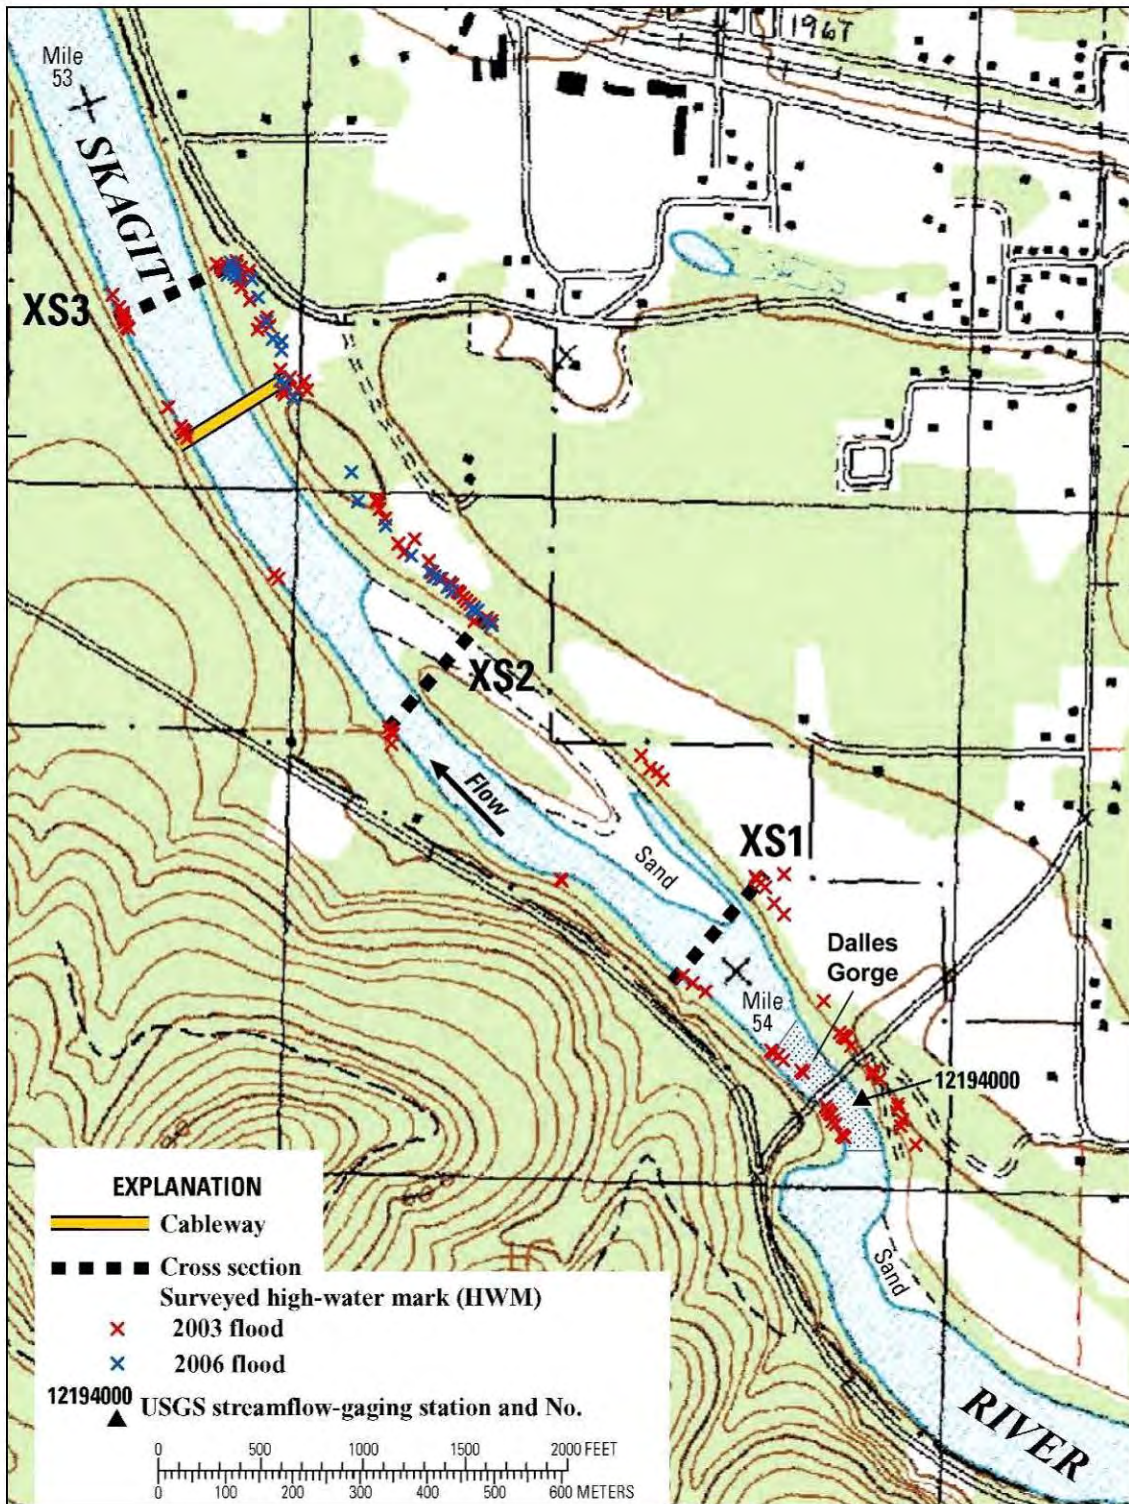
Topographic map of the slope-area measurement reach on the Skagit River near Concrete showing the three cross sections (XS1, XS2, and XS3), the streamflow gaging station, and HWMs from the 2003 flood and the 2006 flood surveyed by the U.S. Geological Survey (source of data: Scientific Investigation Report 2007-5159, USGS)

The figure on the next page, taken from the USGS 2007 report, shows the location of Stewart's cross sections in relation to the Dalles gorge; high water marks collected by the USGS following the 2003 Skagit flood of record and the smaller 2006 flood event, and the location of the USGS cableway.

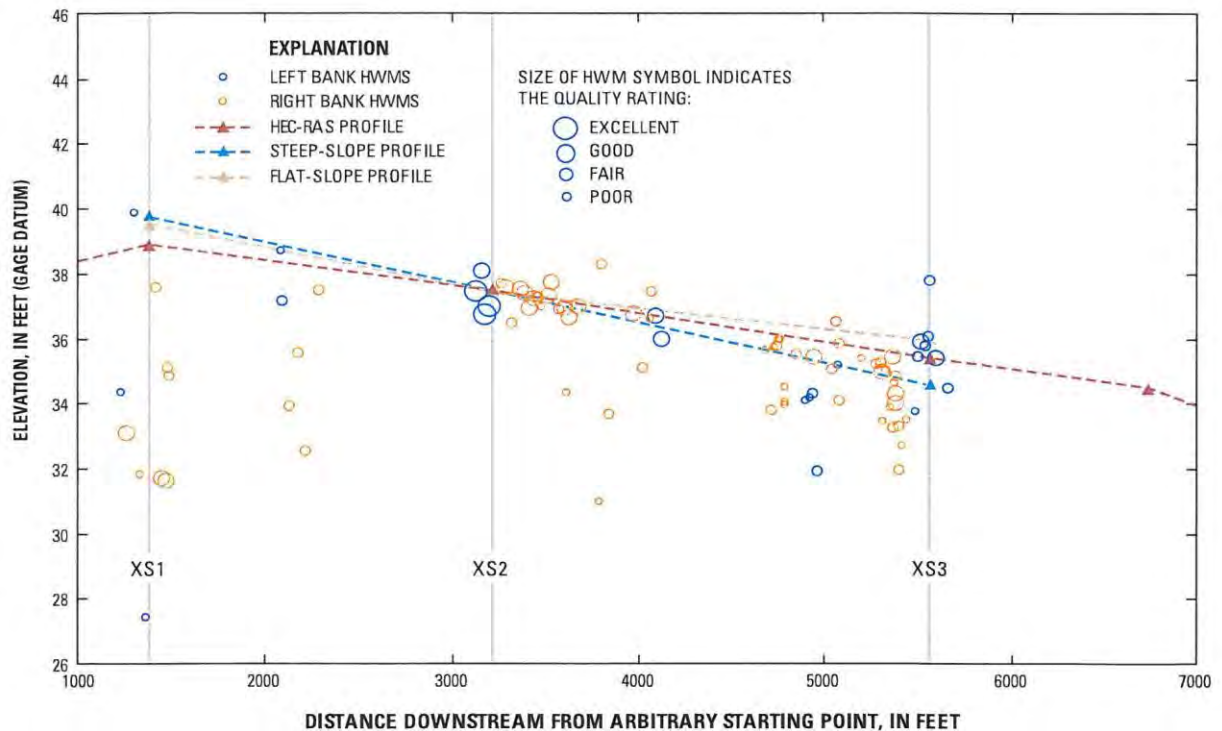
Figure 4. High-water marks (HWMs), flattest- and steepest-sloped water-surface profiles, and a HEC-RAS water-surface profile near cross sections XS1, XS2, and XS3, at Skagit River near Concrete, Washington.

Cities' Comment (continued): The data in Fig. 4 below was collected by the USGS in the summer of 2004, following the flood of record in October 2003. The high water marks in the vicinity of cross section XS-2 are well clustered. However, the range of high water marks collected by the USGS in the vicinity of XS-3 indicate that gathering high water marks in this area was a more difficult task than at XS-2. And, in the case of XS-1, it is clear the difficulty of gathering accurate high water marks is very challenging. Note that right bank marks rated "good" are 5-8 feet below the expected water surface elevation. Two left bank marks, both rated "poor," are over 5 feet different. But the marks rated "good" at XS-3 support a flatter slope profile between XS-1 and XS-2 than that utilized by the USGS.

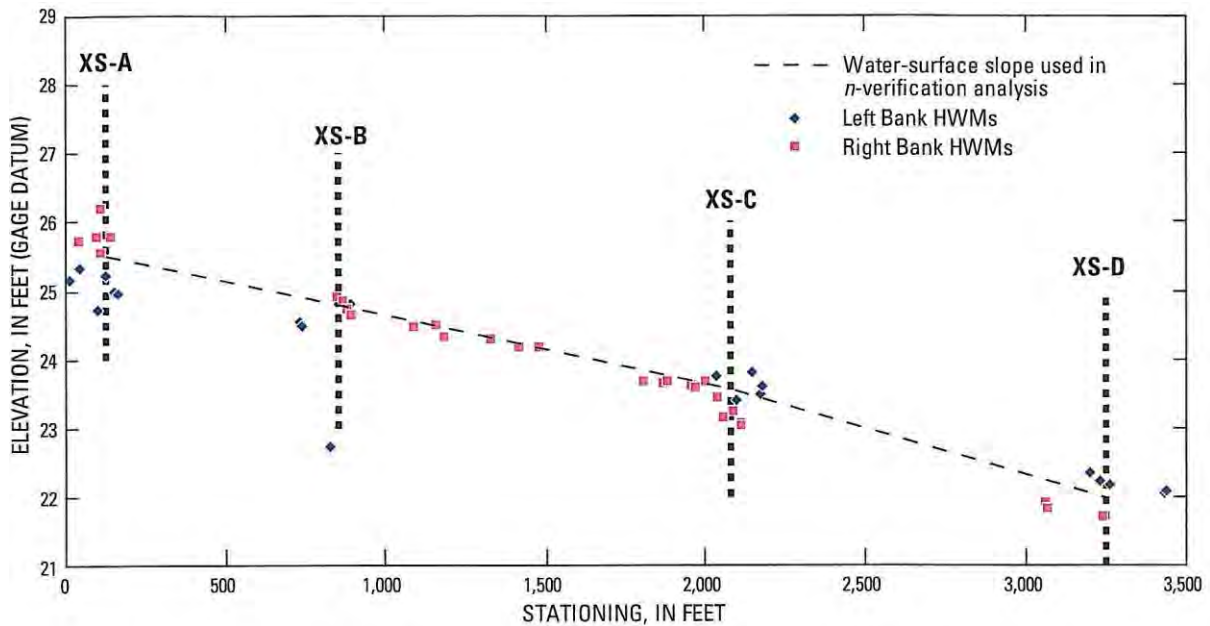
Figure 5. High-water marks (HWMs), cross sections (XS), and water-surface profile from the peak flow of November 27, 1949 on the Skagit River about 3,000–5,000 feet downstream of the streamflow-gaging station, Skagit River near Concrete, Washington (station No. 12194000).

Similarly, USGS, in its 2007 report, used high water mark information gathered below the Dalles reach following the flood of 1949. See Fig. 5 below. For reference, cross section "A" of the 1949 study is about 300 feet downstream of Stewart's XS1 cross section; cross section "D" of this study is about 700 feet upstream of Stewart's XS3 cross section (near the cableway). High water marks gathered by the USGS following the 1949 flood (peak discharge in this area 154,000 cfs) are shown on the next page in Figure 5 of the 2007 USGS report on the following page:

Cities' Comment (continued): As can be seen from the figure above, the 1949 data supports a flatter slope in the upstream reach, and a steeper slope in the downstream reach. In summary, we do not concur with the USGS methodology and do not concur that the information provided by the USGS in support of its slope-area calculations, particularly using the 2006 downstream high water marks and then extending the hydraulic grade line obtained from the downstream data, through the entire upstream reach. Stewart's work should be given deference unless it can be demonstrated through newer methodologies or clearly identified inconsistencies that Stewart's data should be modified. USGS has not done so.

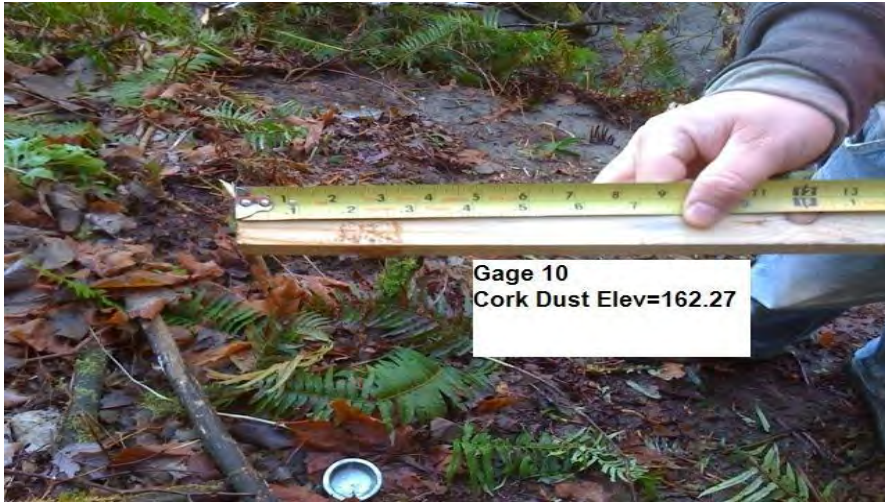
Photograph showing cork dust marks left on inside crest stage gage 200 feet upstream of the USGS Concrete gage at the Dalles, WA. December 2010.

crest stage gages upstream and downstream of the current USGS gage location. As it happened, a minor Skagit flood occurred on December 12, 2010, triggering a reading on one of the crest stage gages 200 feet upstream from the current USGS gage.³ The USGS stage elevation for this minor flood, with a discharge of 81,900 cfs at the Concrete gage, was 161.22 feet NGVD 29. The crest stage gage reading 200 feet upstream was 162.27 feet, for a difference of **1.05 feet** in a 200-foot distance. This data strongly infers an estimate of as much as a 2-foot drop between Stewart's Upper Dalles gage, located 300 feet upstream of the current USGS gage for the 1921 flood is reasonable for a flood discharge in the neighborhood of 170,000 cfs.

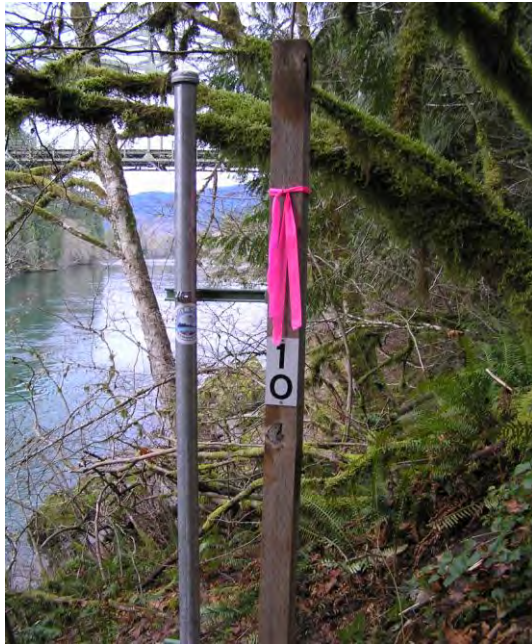
Skagit County Crest Stage Gage #10. Note the Dalles bridge 200 feet downstream. The current USGS gage is on the right bank just upstream of the bridge.

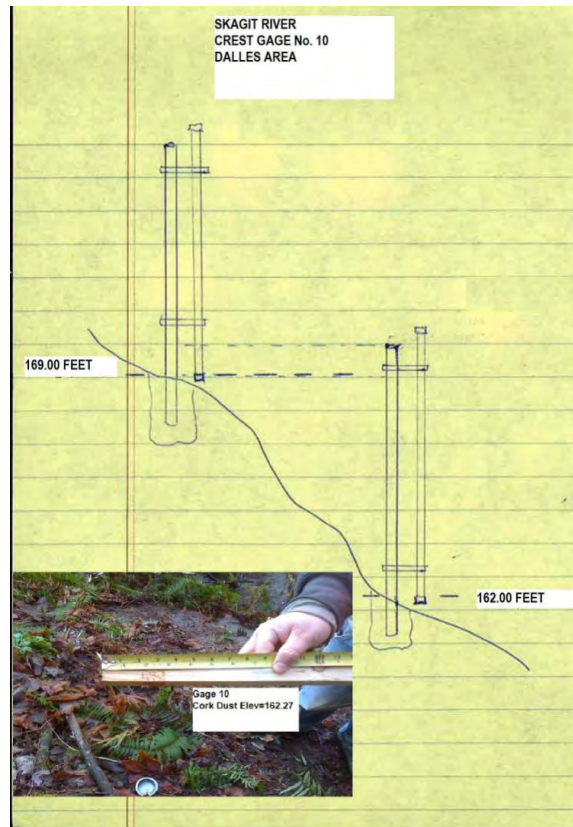
Schematic showing crest stage gage installation and cork reading from lower gage (#10) that was triggered during the minor flood event of Dec 2010.

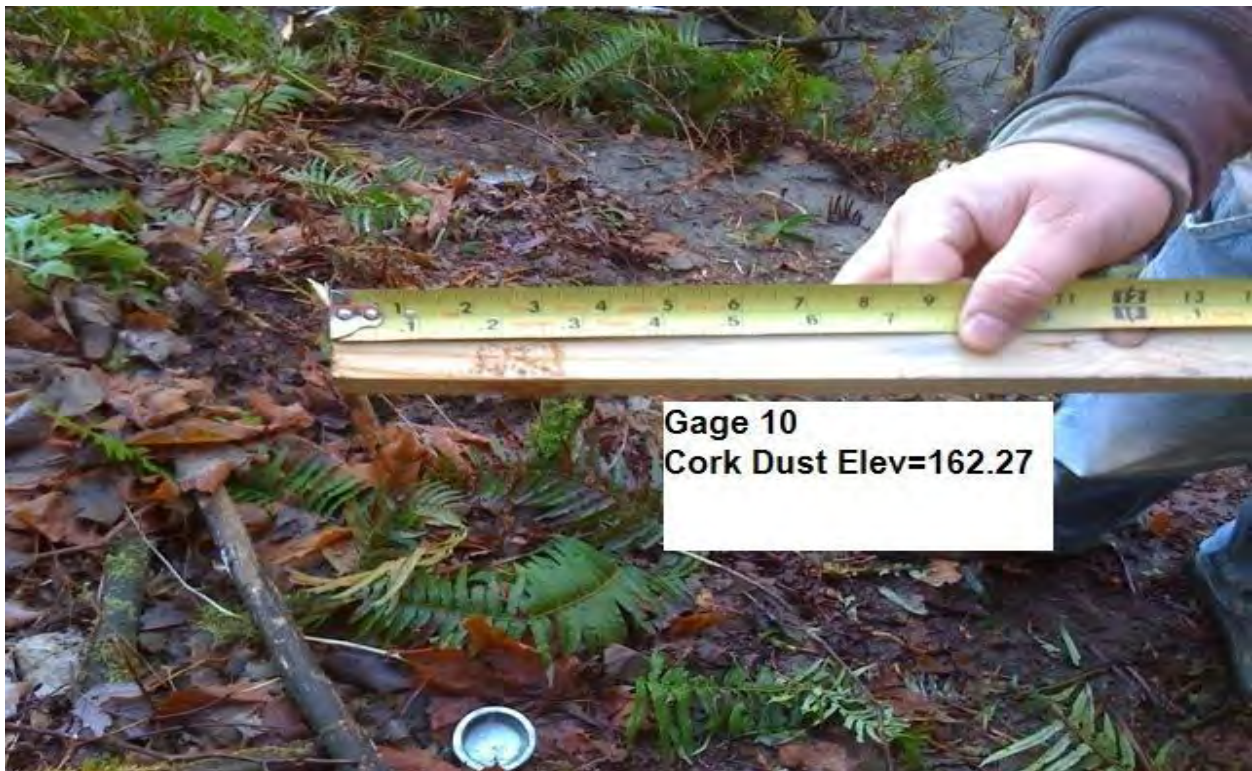
Photograph showing cork dust marks left on inside crest stage gage 200 feet upstream of the USGS Concrete gage at the Dalles, WA. December 2010.

Cities' Comment: *This information is inconsistent with recently gathered (December 2010) peak stage data 200 feet upstream of the current gage by Skagit County. The location of Stewart's Upper Dalles Gage was actually 300 feet upstream of the location of today's USGS station, (see PI Engineering, March 2011, section 2.3.2) At issue is the amount of head loss to assign to high water marks gathered in the vicinity of the Upper Dalles gage that are (or were) transferred to the current gage location, 300 feet downstream. Stewart, in 1922 and early 1923, and later a survey crew from Skagit County, surveyed 1921 high water marks at the Upper Dalles Gage, and these high water marks were later transferred directly to the*

current gage location without any adjustment for head loss through this gorge, which is significant and could easily amount to 1.5 – 2 feet in a flood of the magnitude of 1921. Recent new data collected by Skagit County (December 2010) strongly supports our assertion that these high water marks should have been adjusted for the head loss that is occurring and did occur in 1921 in this 300-foot reach. Pursuant to suggestions by the USGS to obtain head loss data through the Dalles gorge, Skagit County in November 2010 installed several crest stage gages upstream and downstream of the current USGS gage location. As it happened, a minor Skagit River flood occurred on December 12, 2010, triggering a reading on one of the crest stage gages 200 feet upstream from the current USGS gage. The USGS stage elevation for this minor flood, with a discharge of 81,900 cfs at the Concrete gage, was 161.22 feet NGVD 29. The crest stage gage reading 200 feet upstream was 162.27 feet, for a difference of **1.05 feet in a 200-foot distance**. This data strongly infers an estimate of as much as a 2-foot drop between Stewart's Upper Dalles gage, located 300 feet upstream of the current USGS gage for the 1921 flood is reasonable for a flood discharge in the neighborhood of 170,000 cfs. Nevertheless, PI Engineering's estimate of the head loss is only 1.2 feet – clearly conservative in light of this new data.

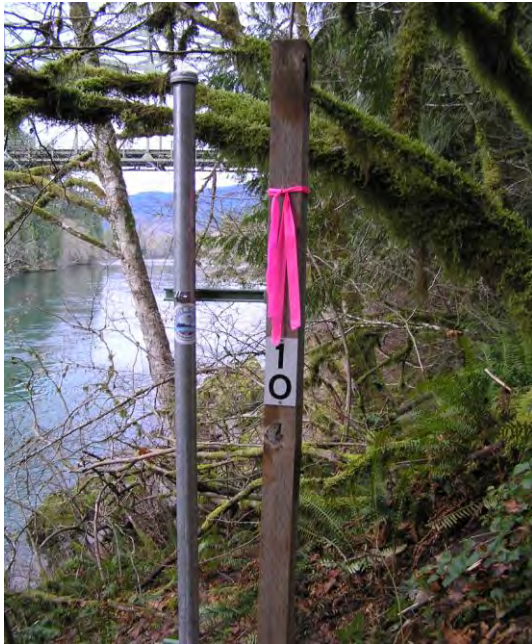
Skagit County Crest Stage Gage #10. Note the Dalles bridge 200 feet downstream. The current USGS gage is on the right bank just upstream of the bridge.

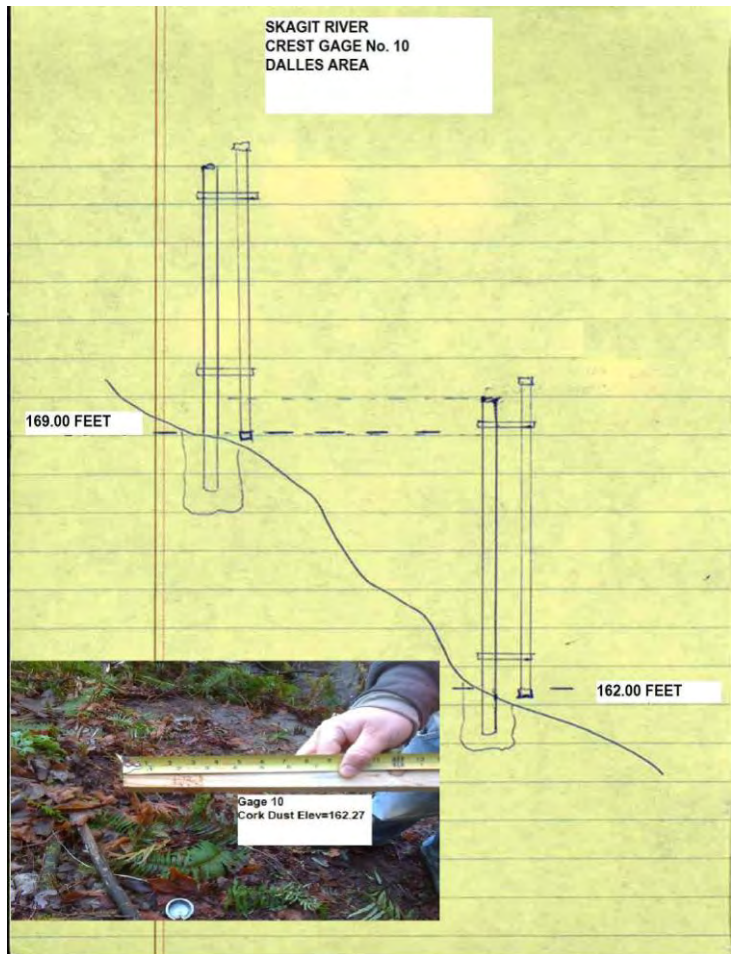
Schematic showing crest stage gage installation and cork reading from lower gage (#10) that was triggered during the minor flood event of Dec 2010.
