Update  
Skagit River Flood Issues

Presented To  
The  
Mount Vernon City Council

April 23, 2008

Chal A. Martin, P.E.  
Burlington Public Works Director / City Engineer

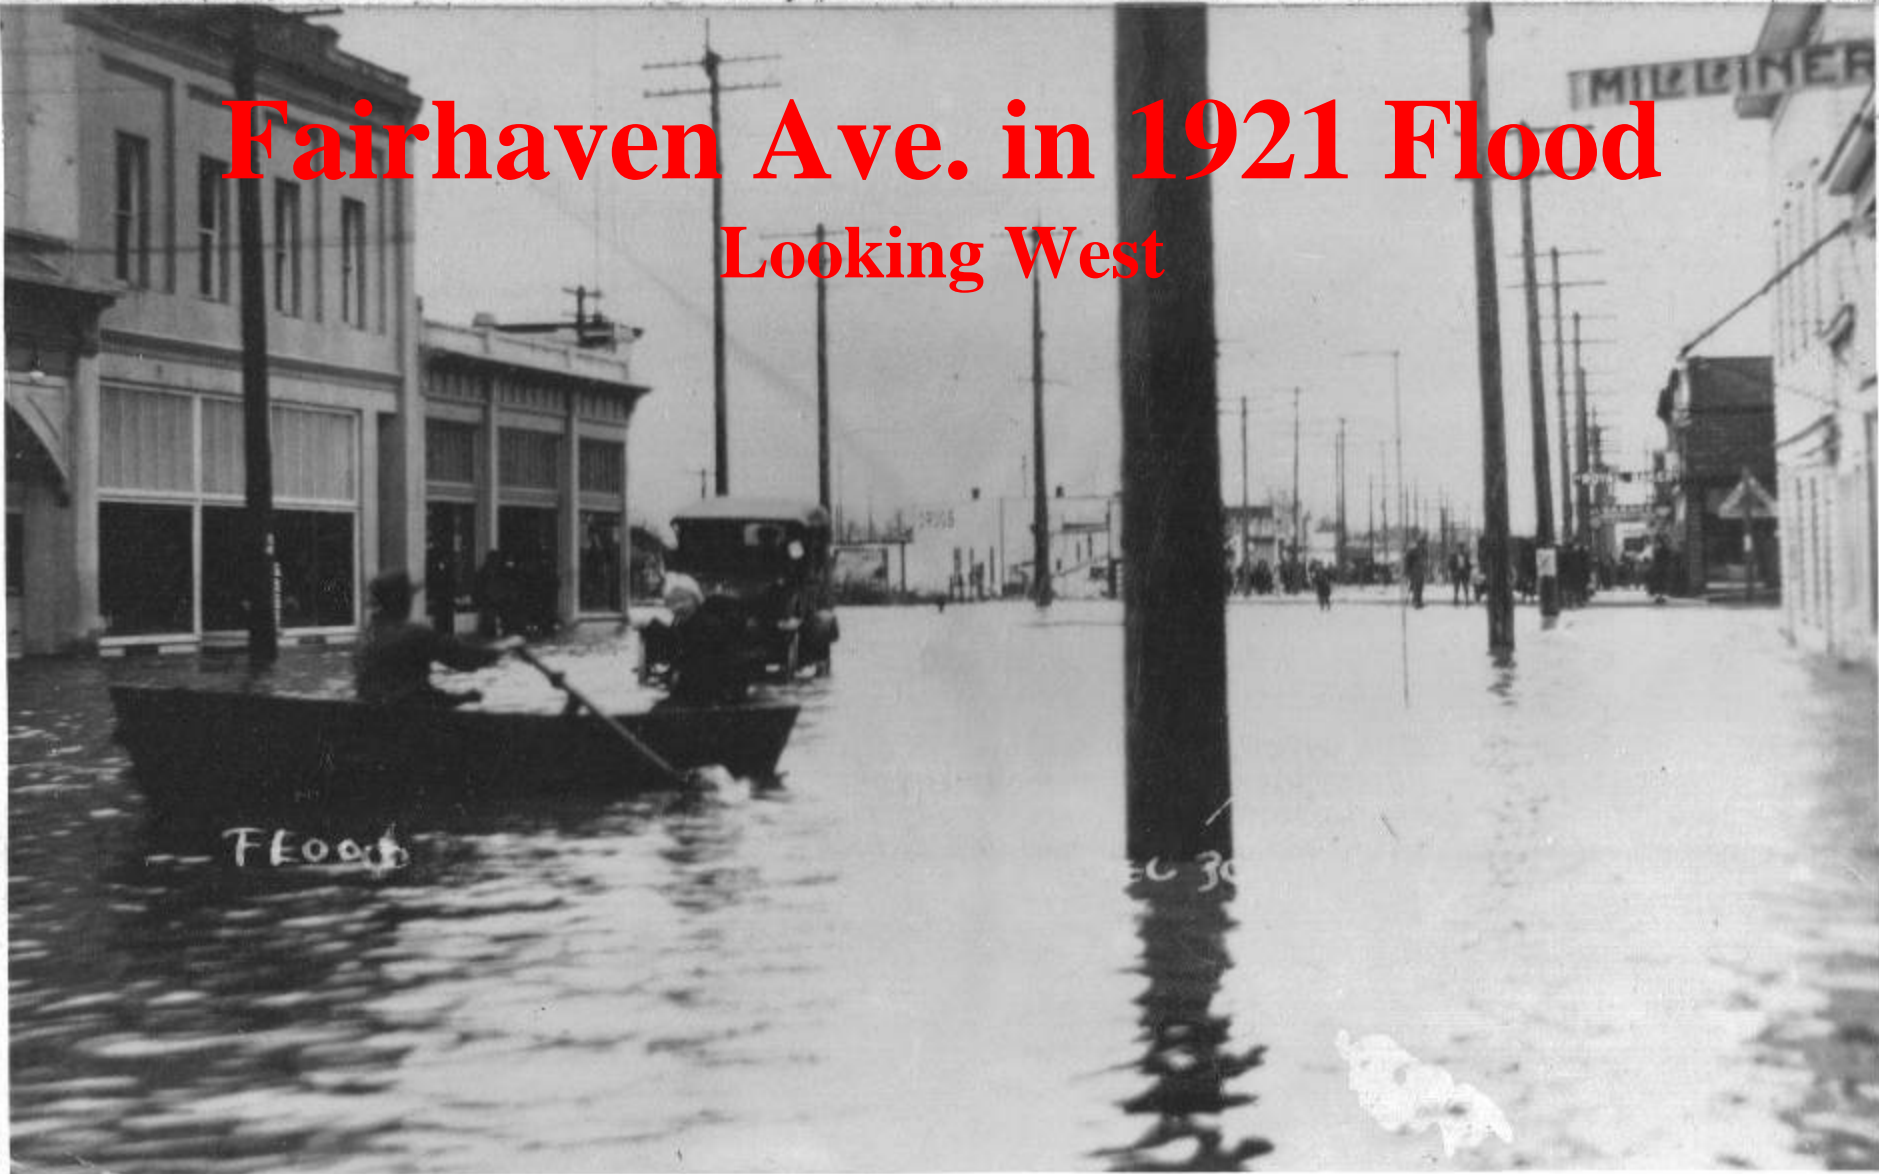
# Fairhaven Ave. in 1921 Flood

Flood of 1921 Fairhaven Street Looking West

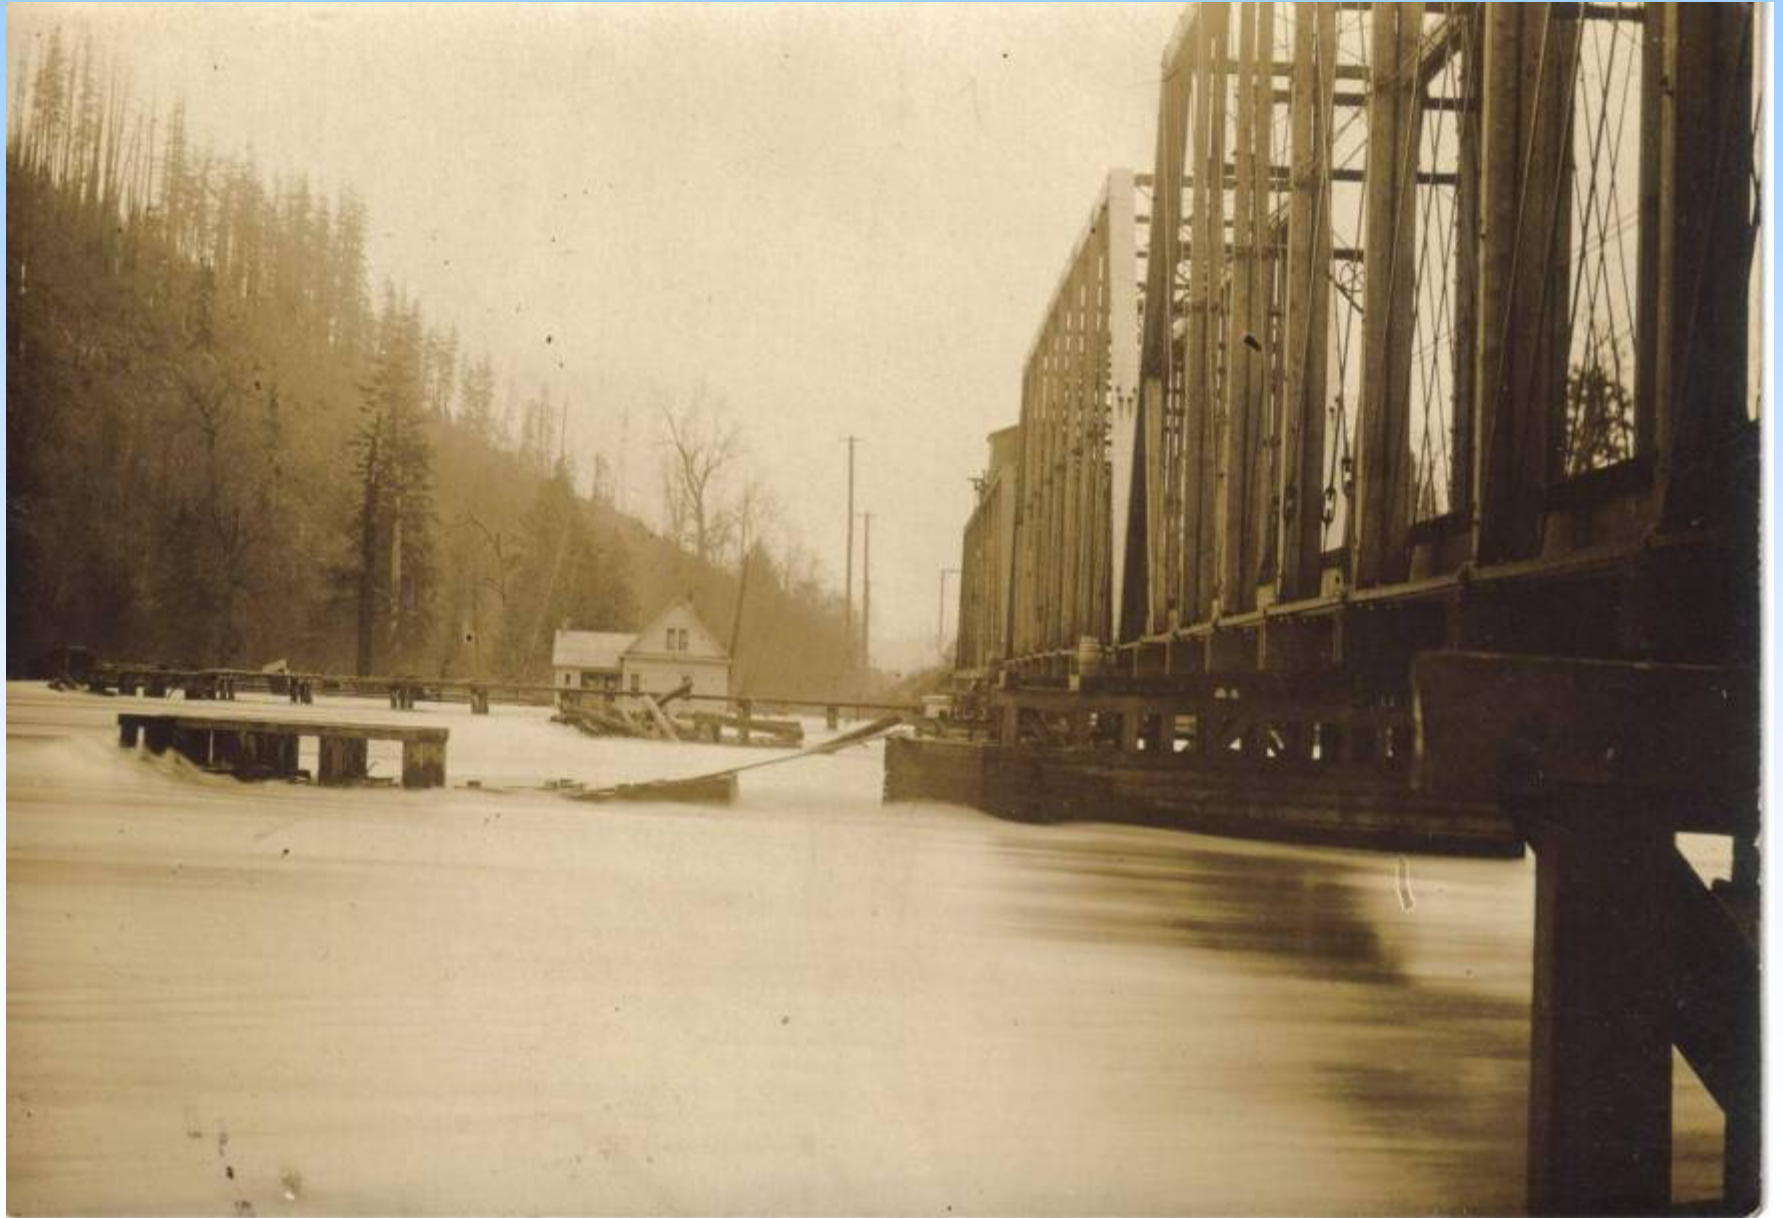
# At Sedro-Woolley – 1909

1909 flood:

Bigger in Sedro-Woolley than 2003 –  
(but not that much bigger)

- 190,000 cubic feet per second seems about right

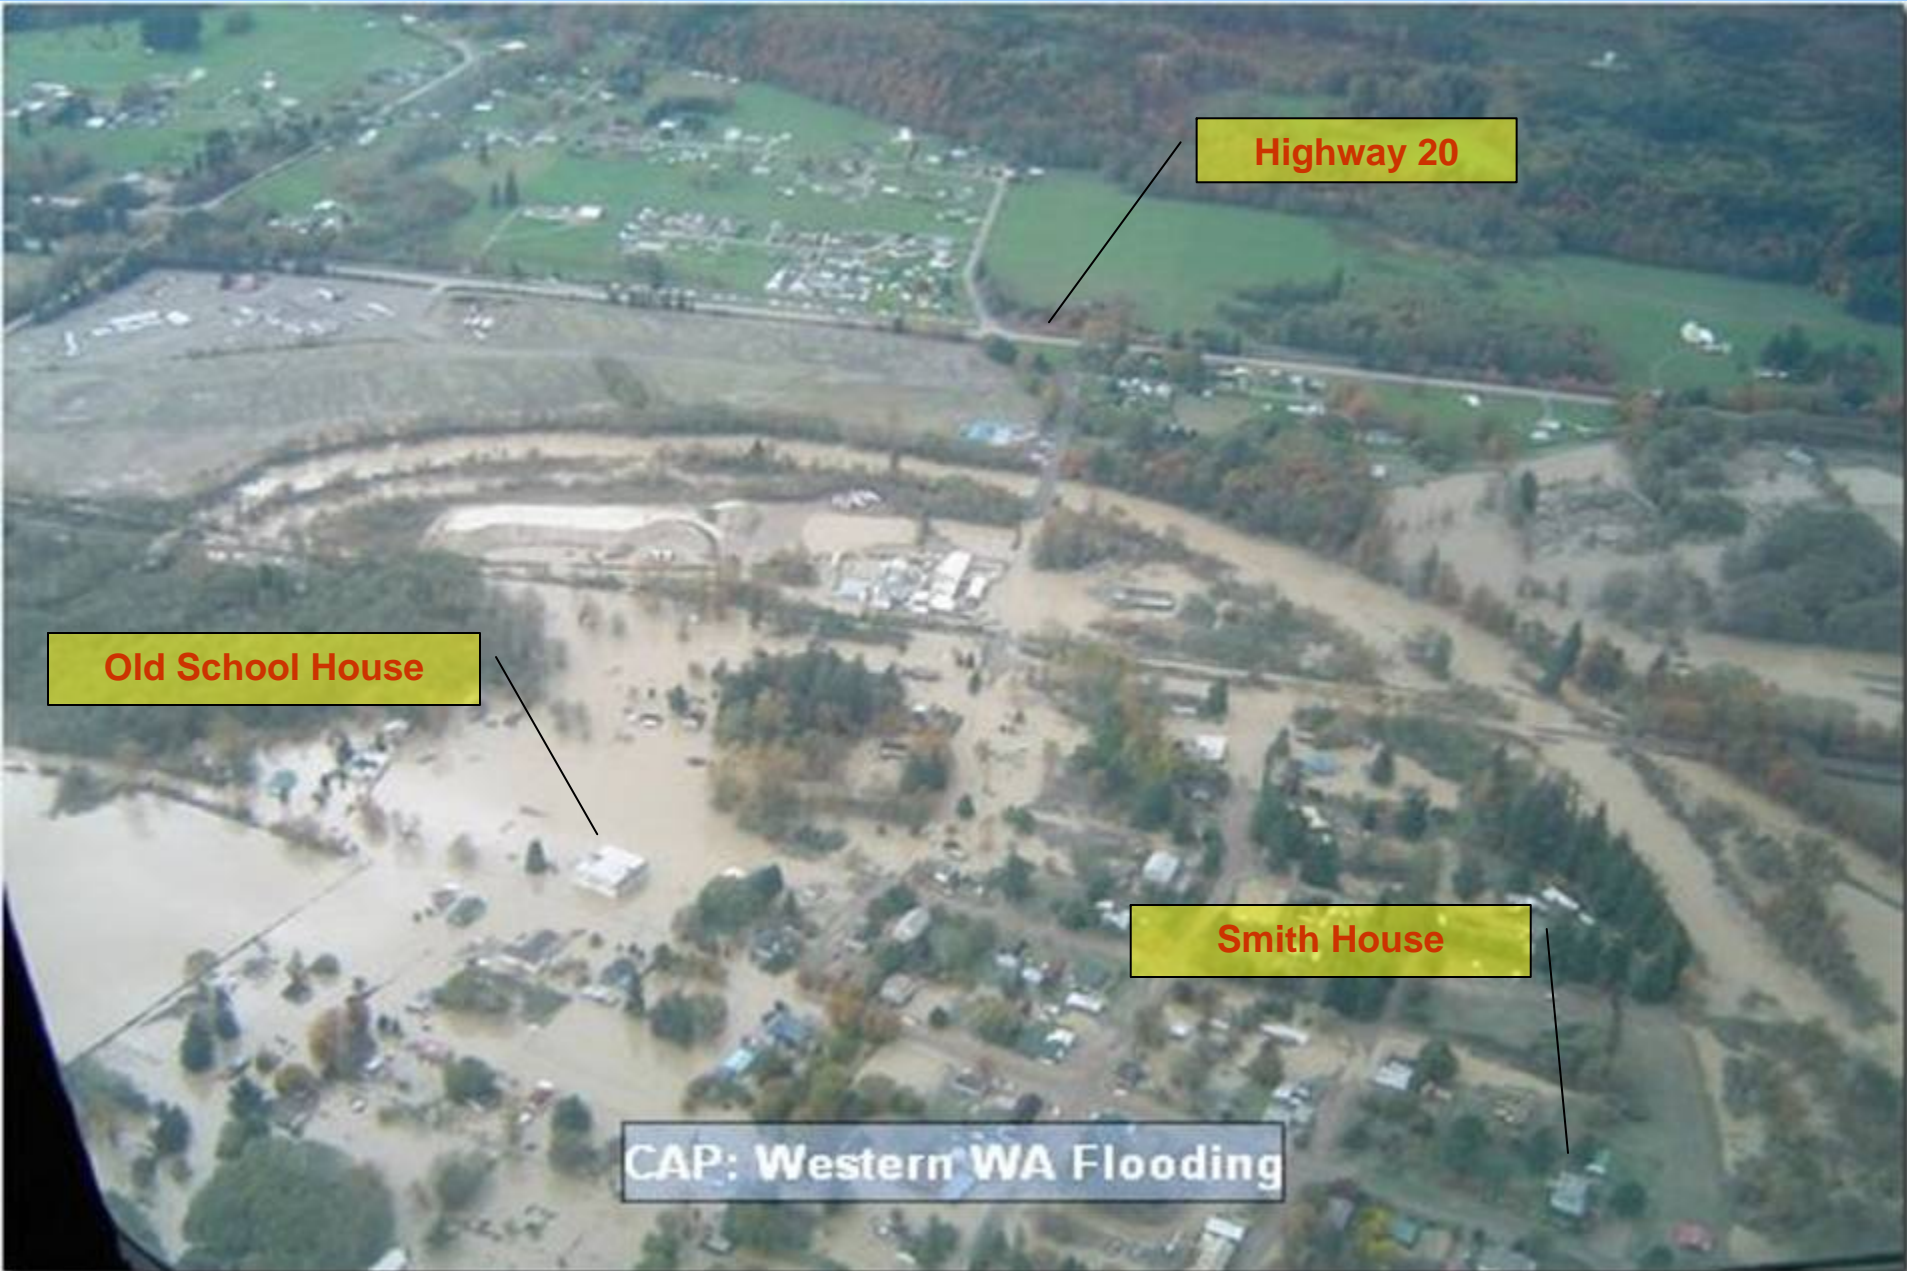
# At Hamilton

Highway 20

Old School House

Smith House

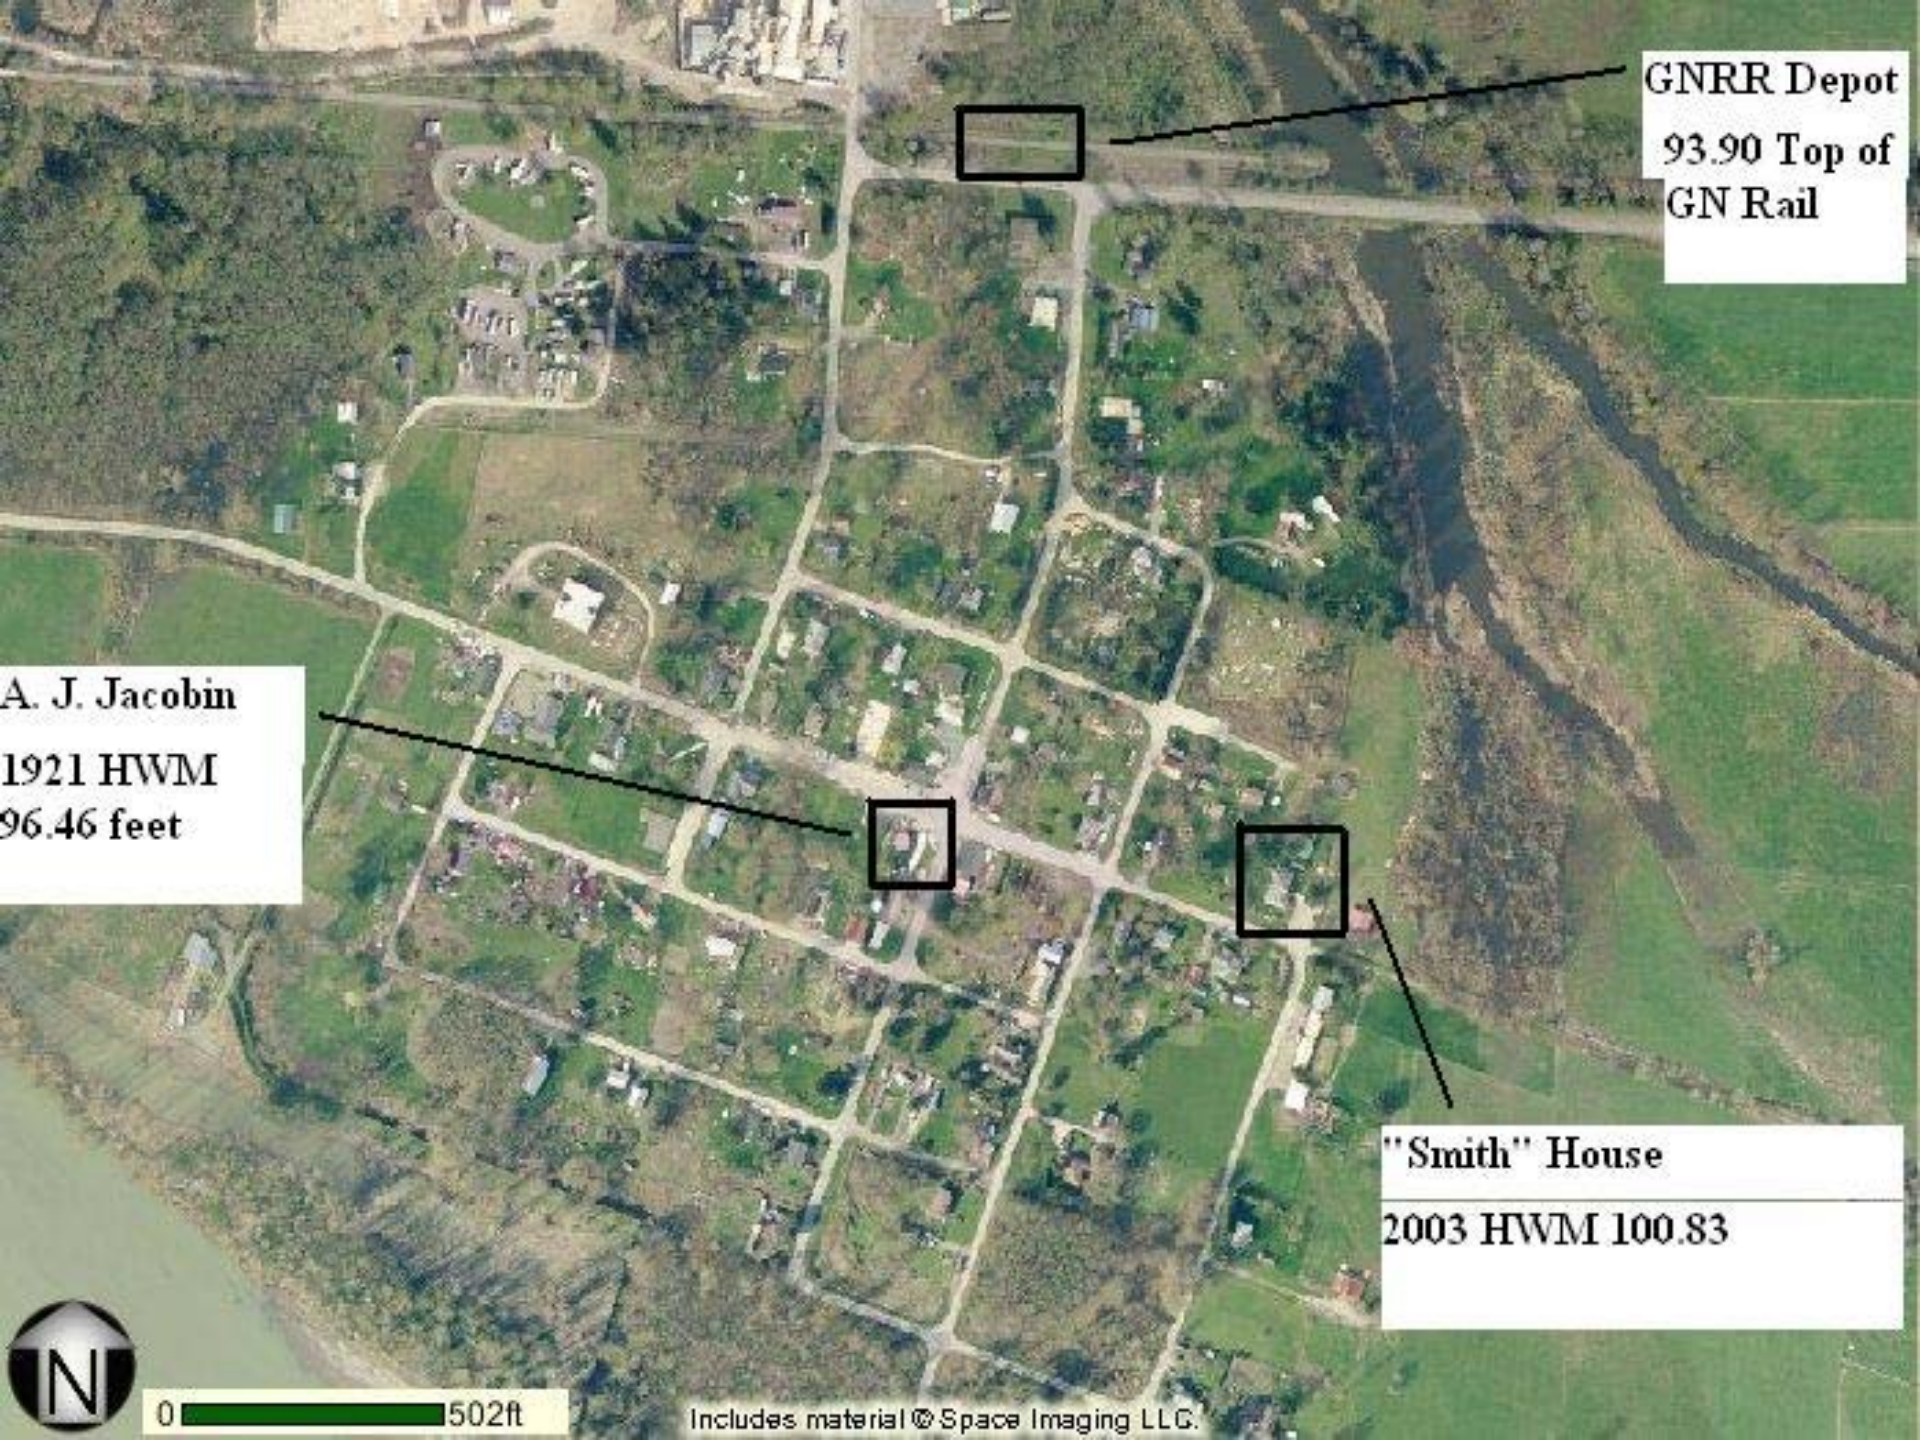
**GNRR Depot**  
93.90 Top of  
GN Rail

**A. J. Jacobin**  
1921 HWM  
96.46 feet

**"Smith" House**  
2003 HWM 100.83

<u>Year</u>	<u>Water Level in Hamilton, A. J. Jacobin Cigar Store And <b>Smith House</b></u>
1897	(no data)
1909	96.17
1917	95.62
1921	96.46
<b>1995</b>	<b>101.00</b>
<b>2003</b>	<b>100.83</b>

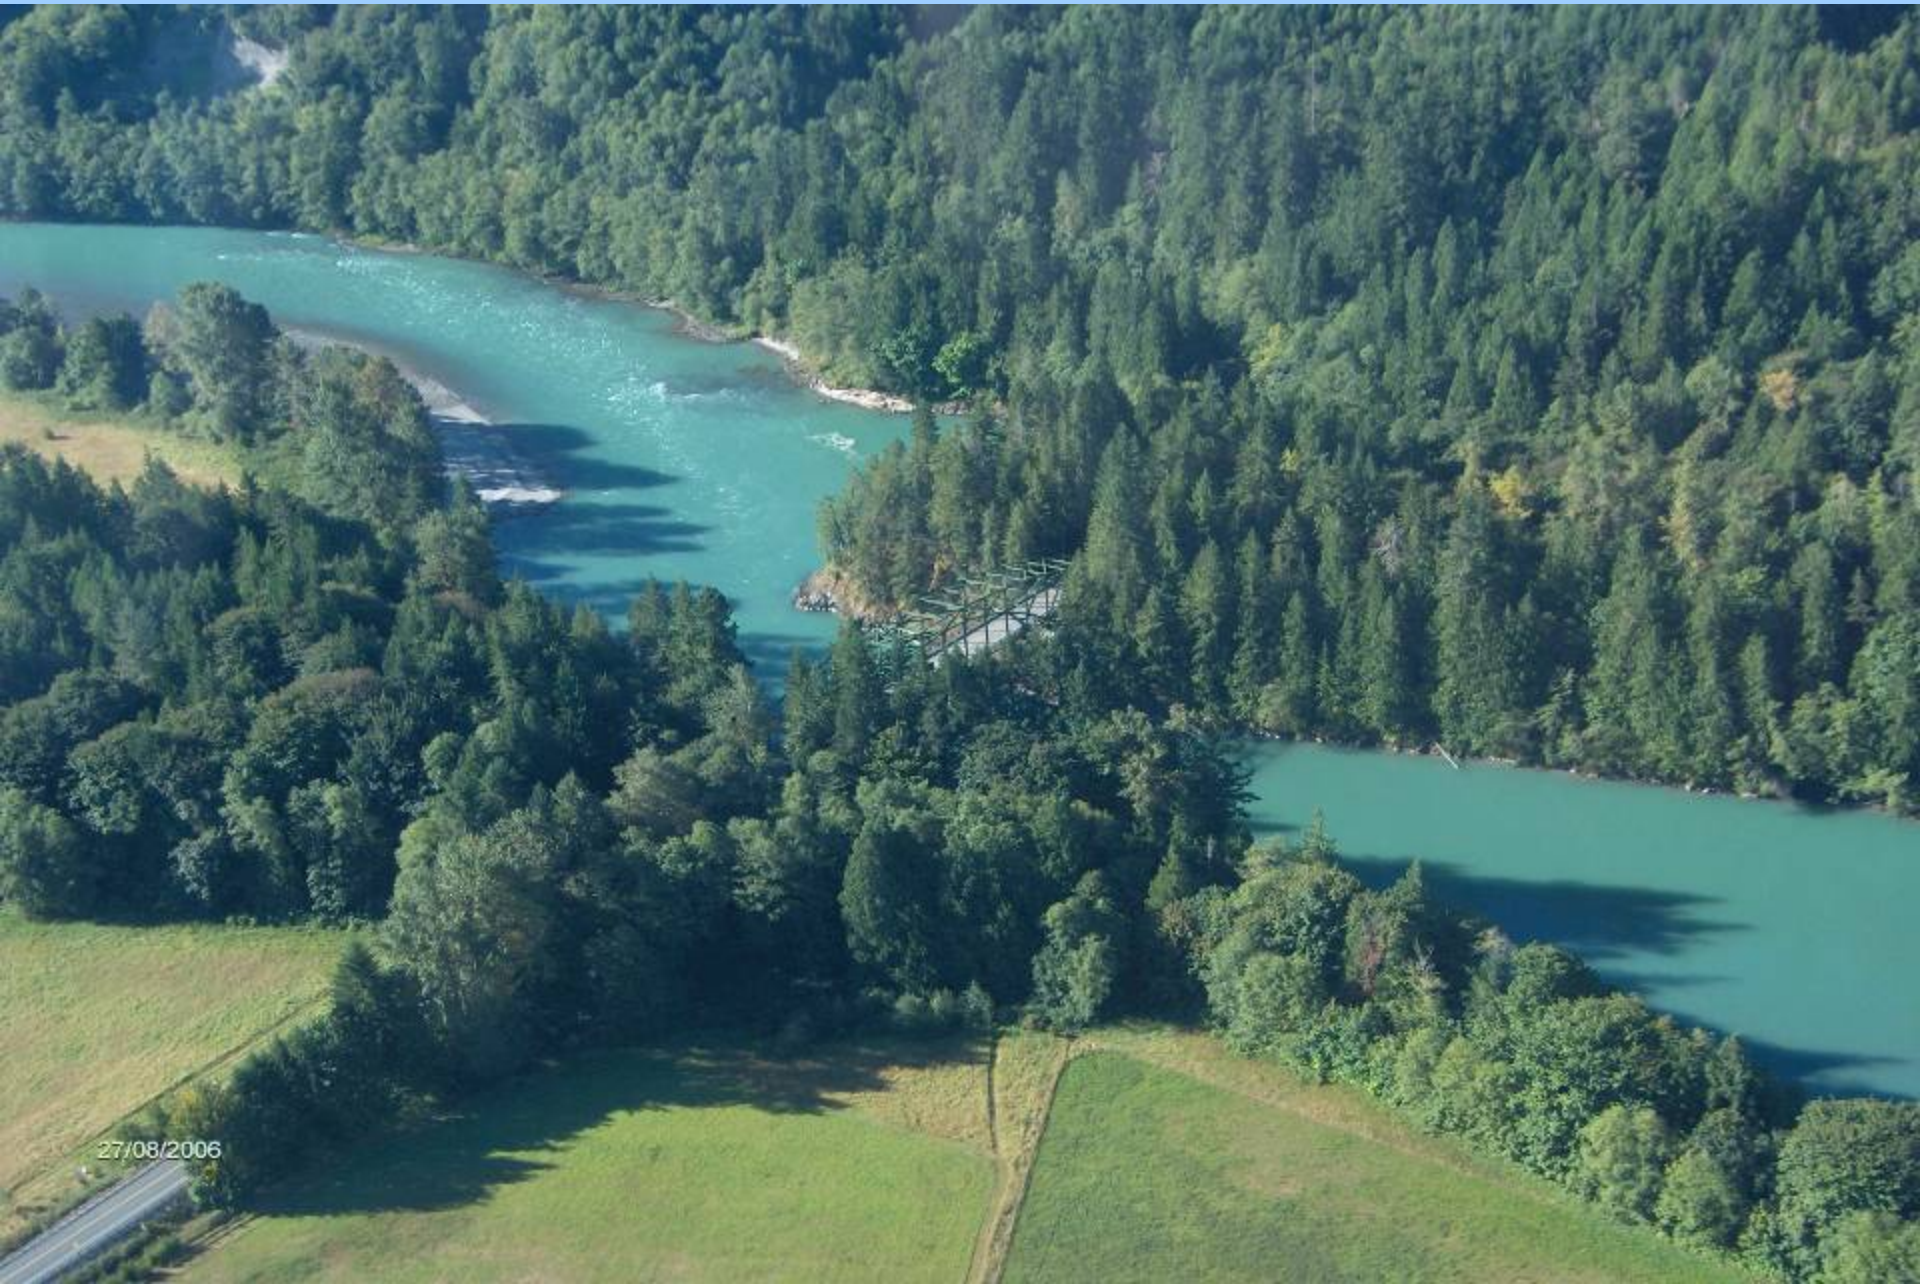
# At the Dalles

At The Dalles  
The man who lives at The Dalles showed the highest point 1921 flood reached. This point was 0.78 above sand we found in maple tree. We will use our levels on sand however as they are comparable with other points.

Later levels show his mark nearer right. We found (near B that H.W. mark was .57 above sand in rough (see bottom page 175) gey 3/19/23

25 ft below upper Dalles cross section  
 found 1921 H.W. mark to be 0.57' above  
 mark on maple used previously as 1921  
 H.W. This maple was 25 ft above cross  
 section.

- It would have been difficult for Stewart to accurately ascertain the stage of the 1921 flood at the Dalles.
- We will not be able to resolve our differences with USGS / COE on the Dalles stages, so we are focusing on other flood marks in Concrete instead

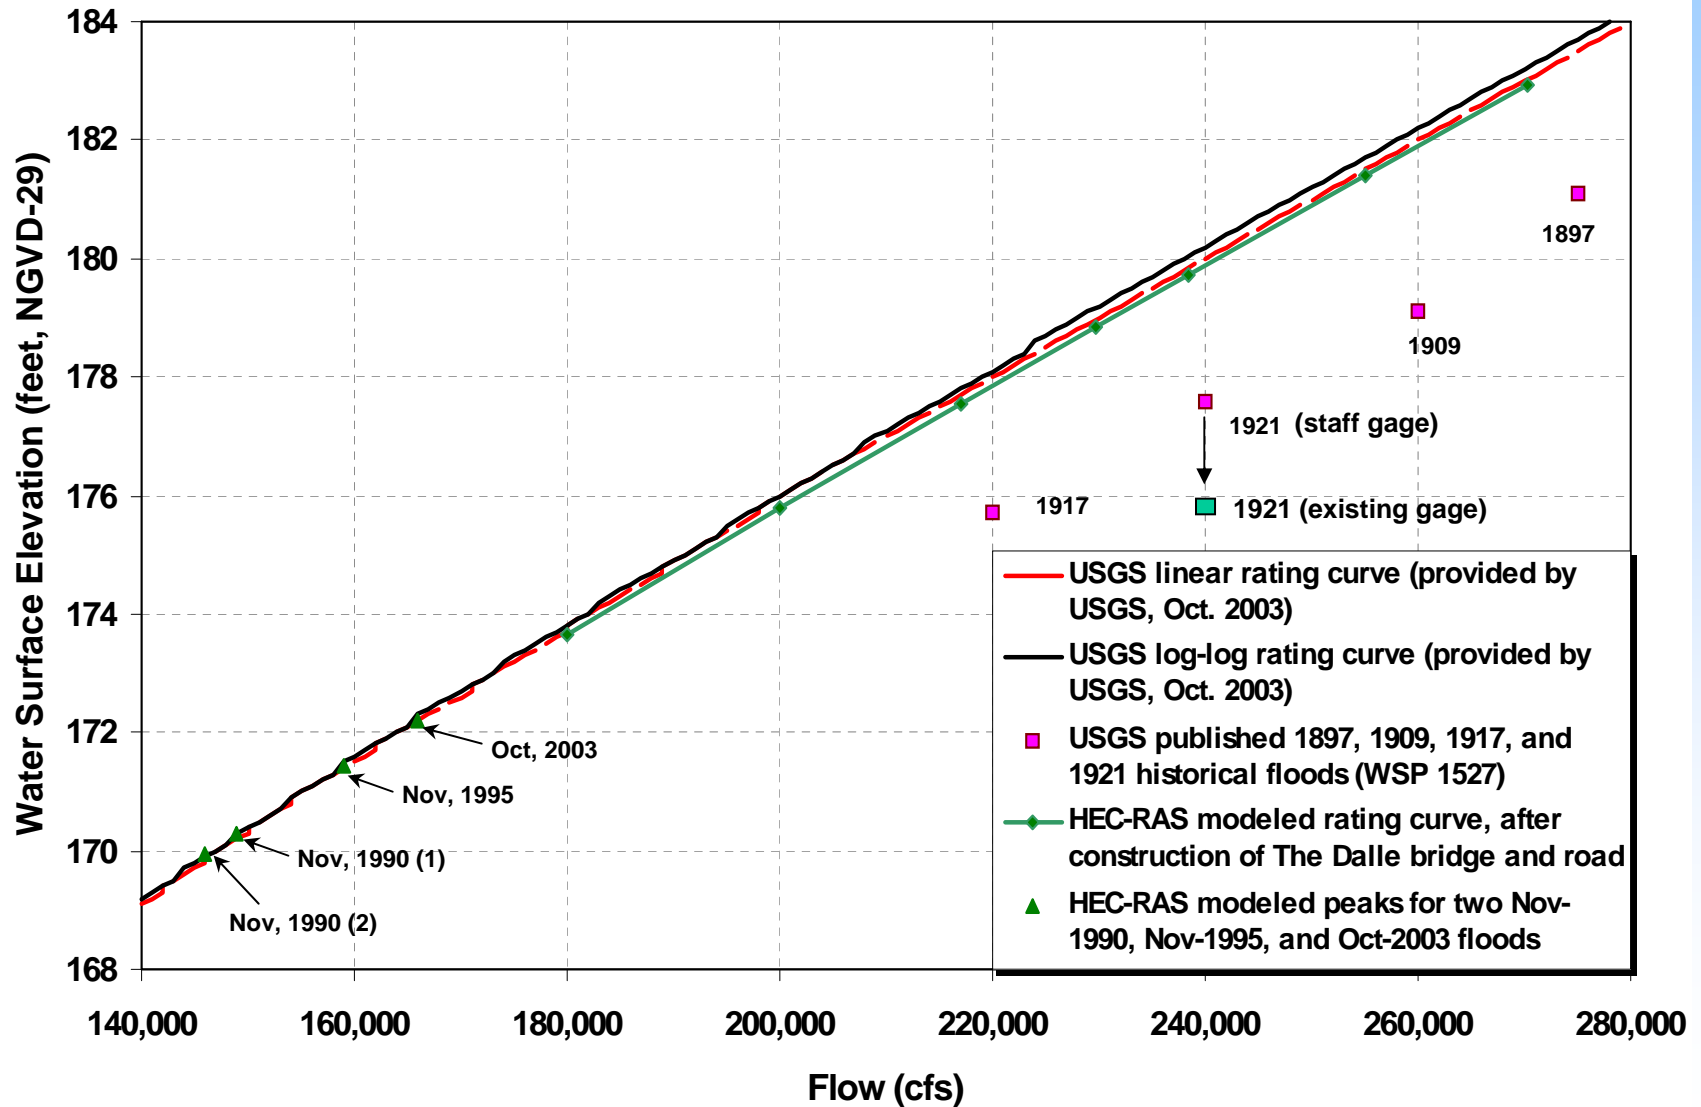
# Rating Curves of the Skagit River near Concrete (Existing Gage) (PI Engineering, 2005)

- Stewart Notes **47.6 feet** (but discharge estimate 240,00 cfs (since reduced to 228,000 cfs by USGS) (unregulated)
- 2003 HWM **42.2 feet** (166,000 cfs) (regulated) (this is accurate)
- Rating curve chart (not “appropriate” to extend the rating curve more than 20% or so -- but it could still be correct)

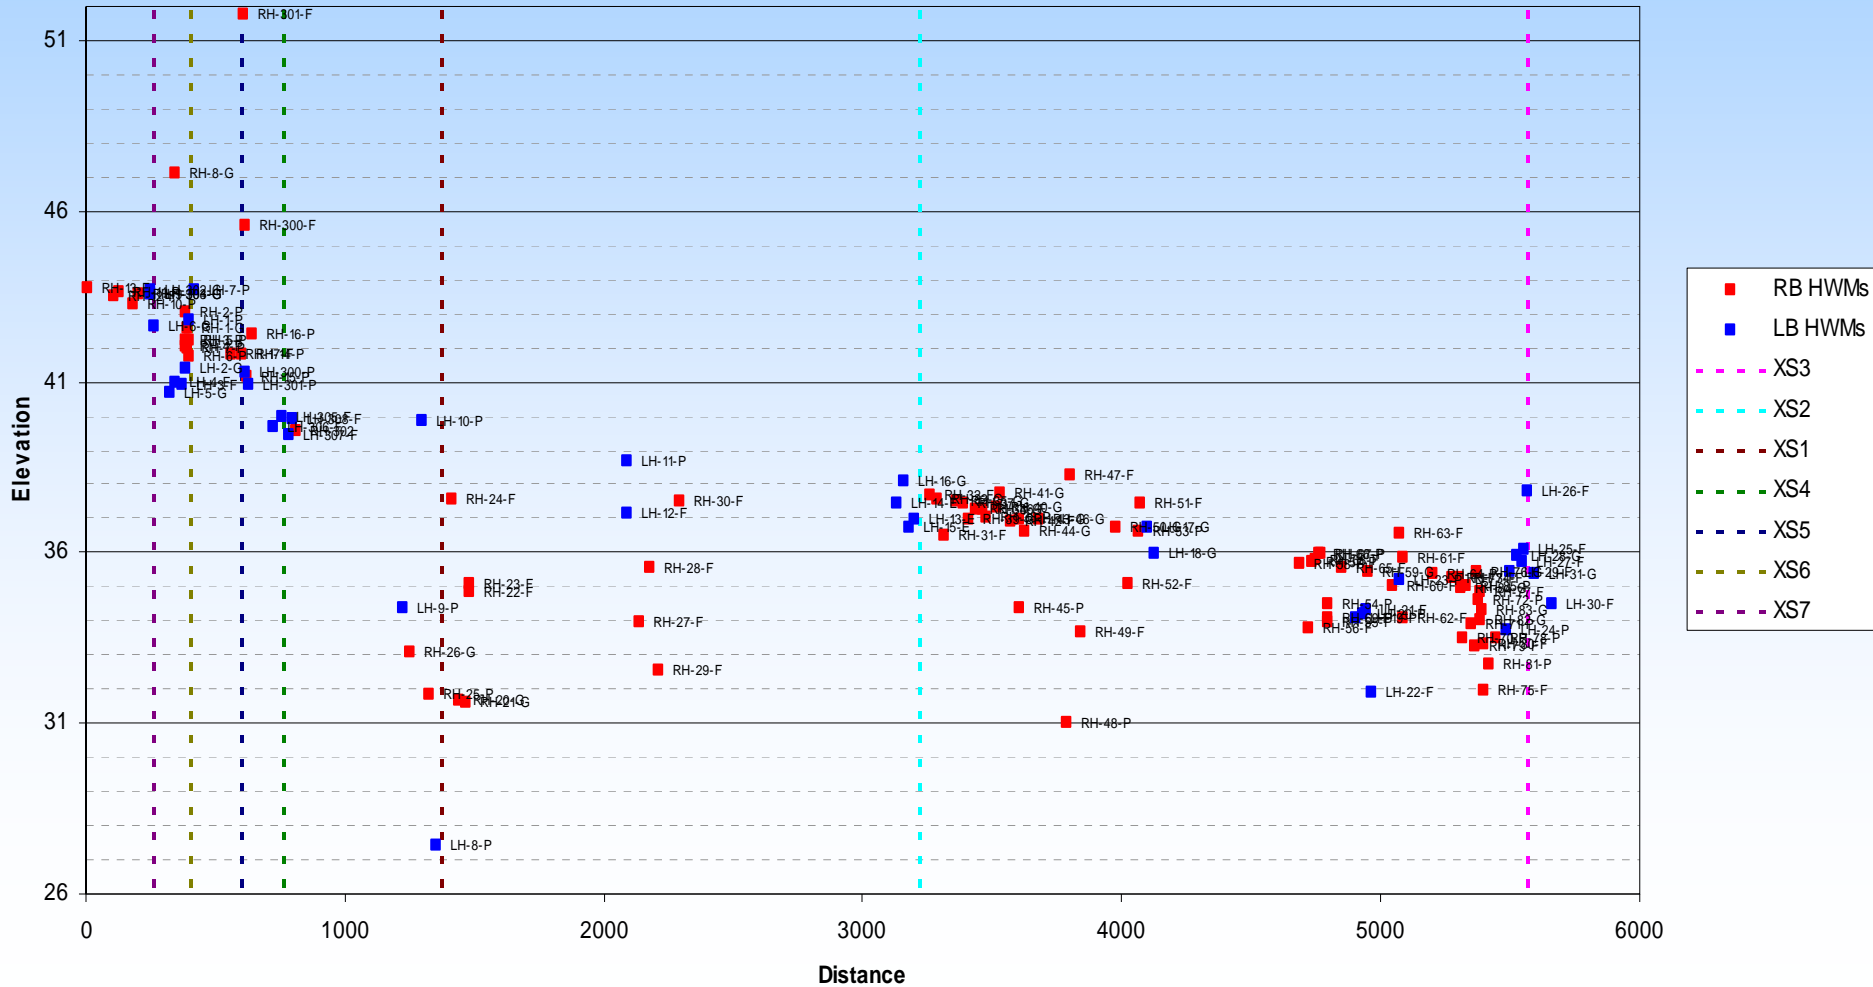
## USGS High Water Marks Profile Plot at the Dalles, 2003 Flood

# Is the Concrete Reach right for the Slope/Area Method?

High Water Marks

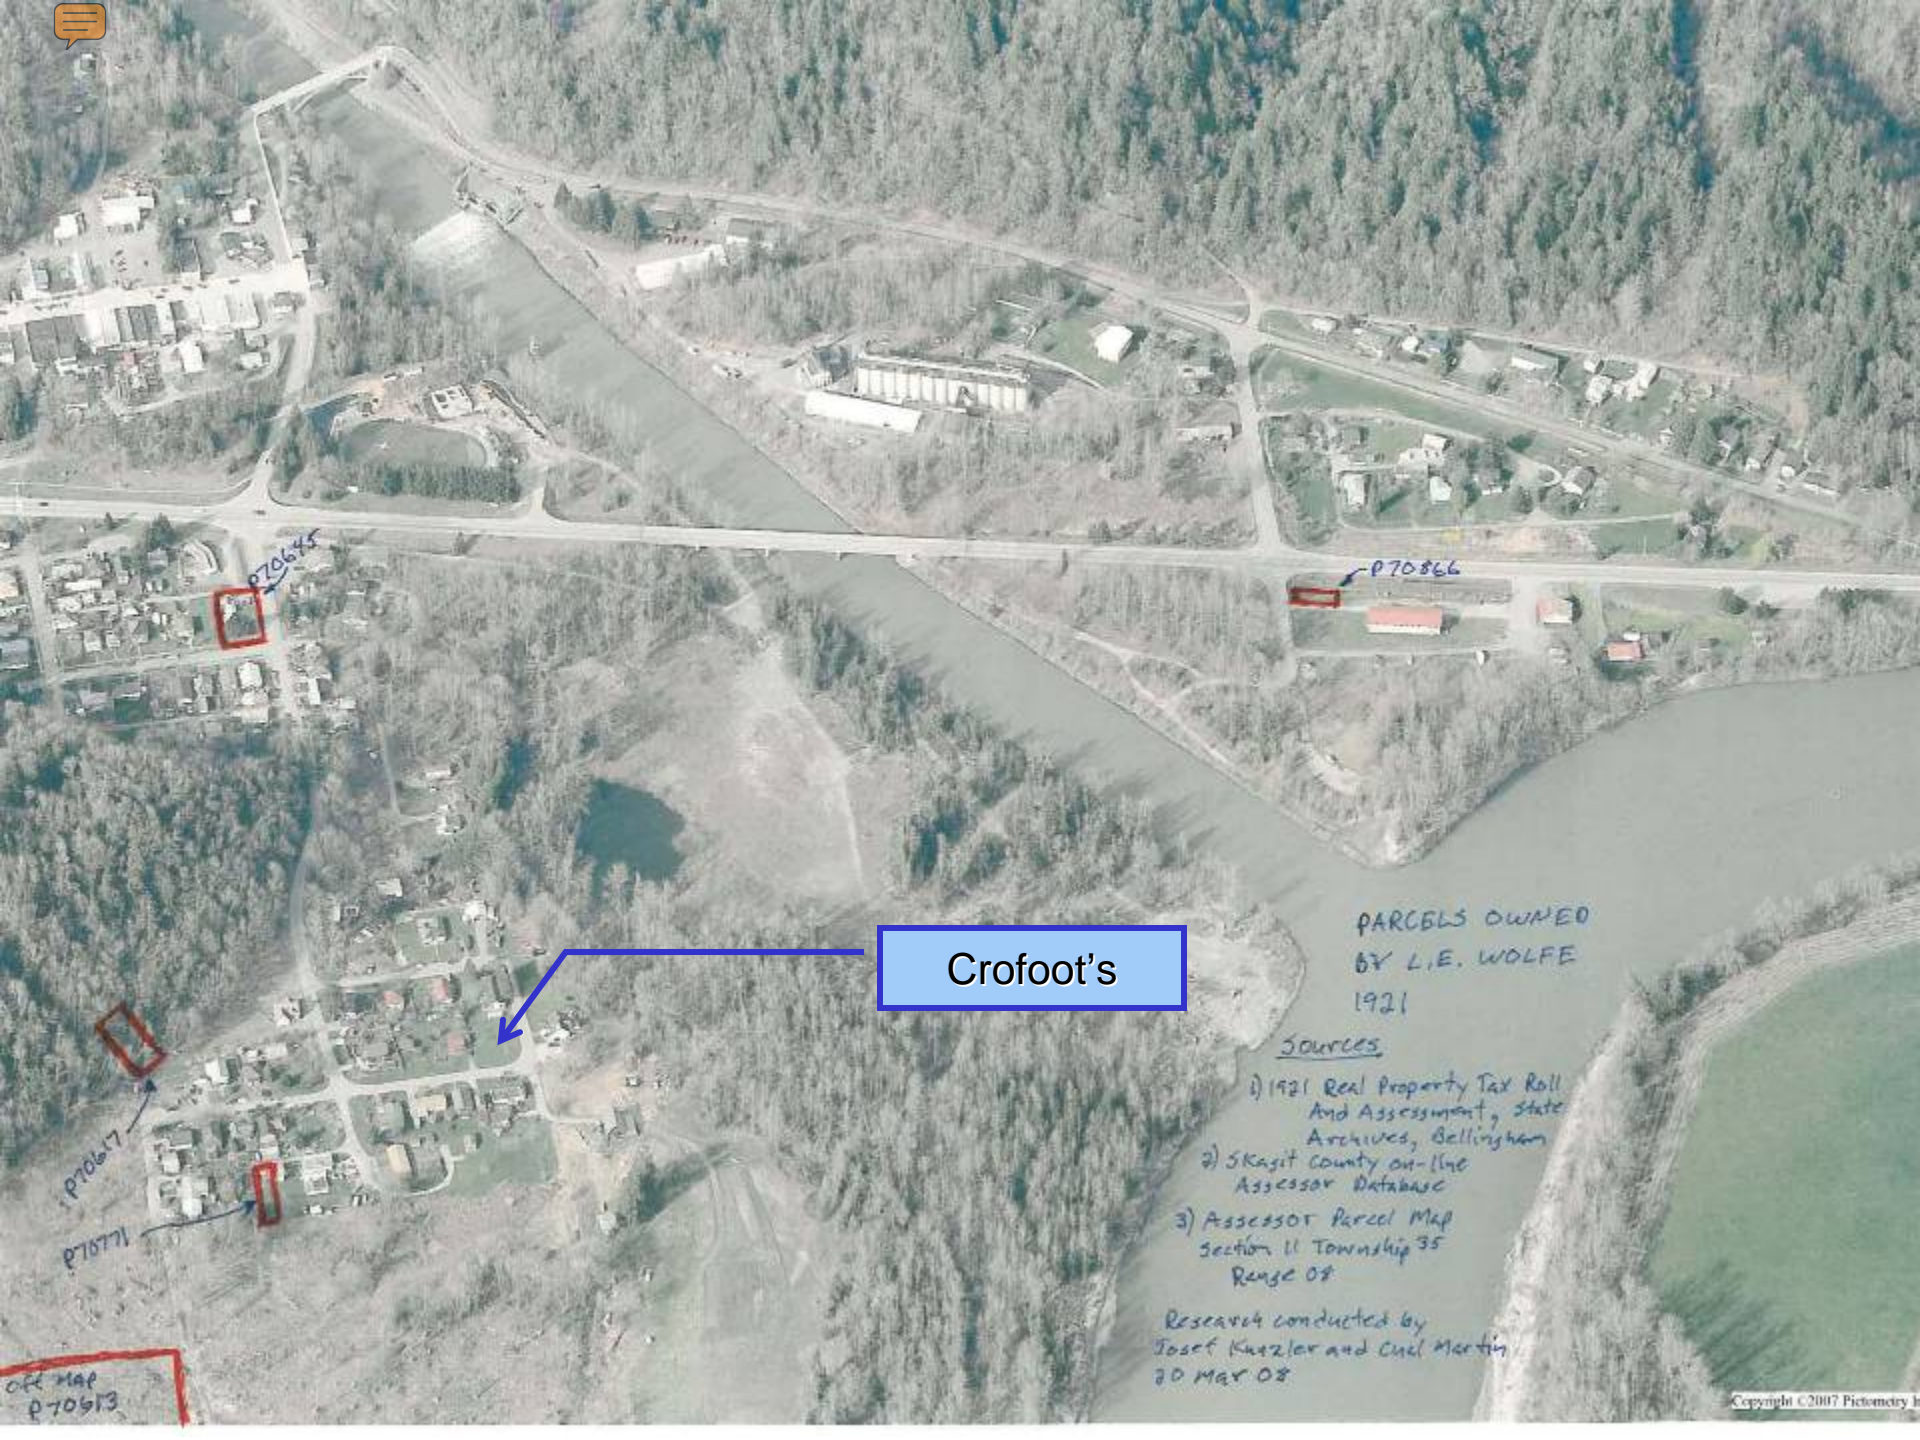
Crofoot's

PARCELS OWNED  
BY L.E. WOLFE  
1921

- 1) 1921 Real Property Tax Roll And Assessment, State Archives, Bellingham
- 2) Skagit County on-line Assessor Database
- 3) Assessor Parcel Map Section II Township 35 Range 08

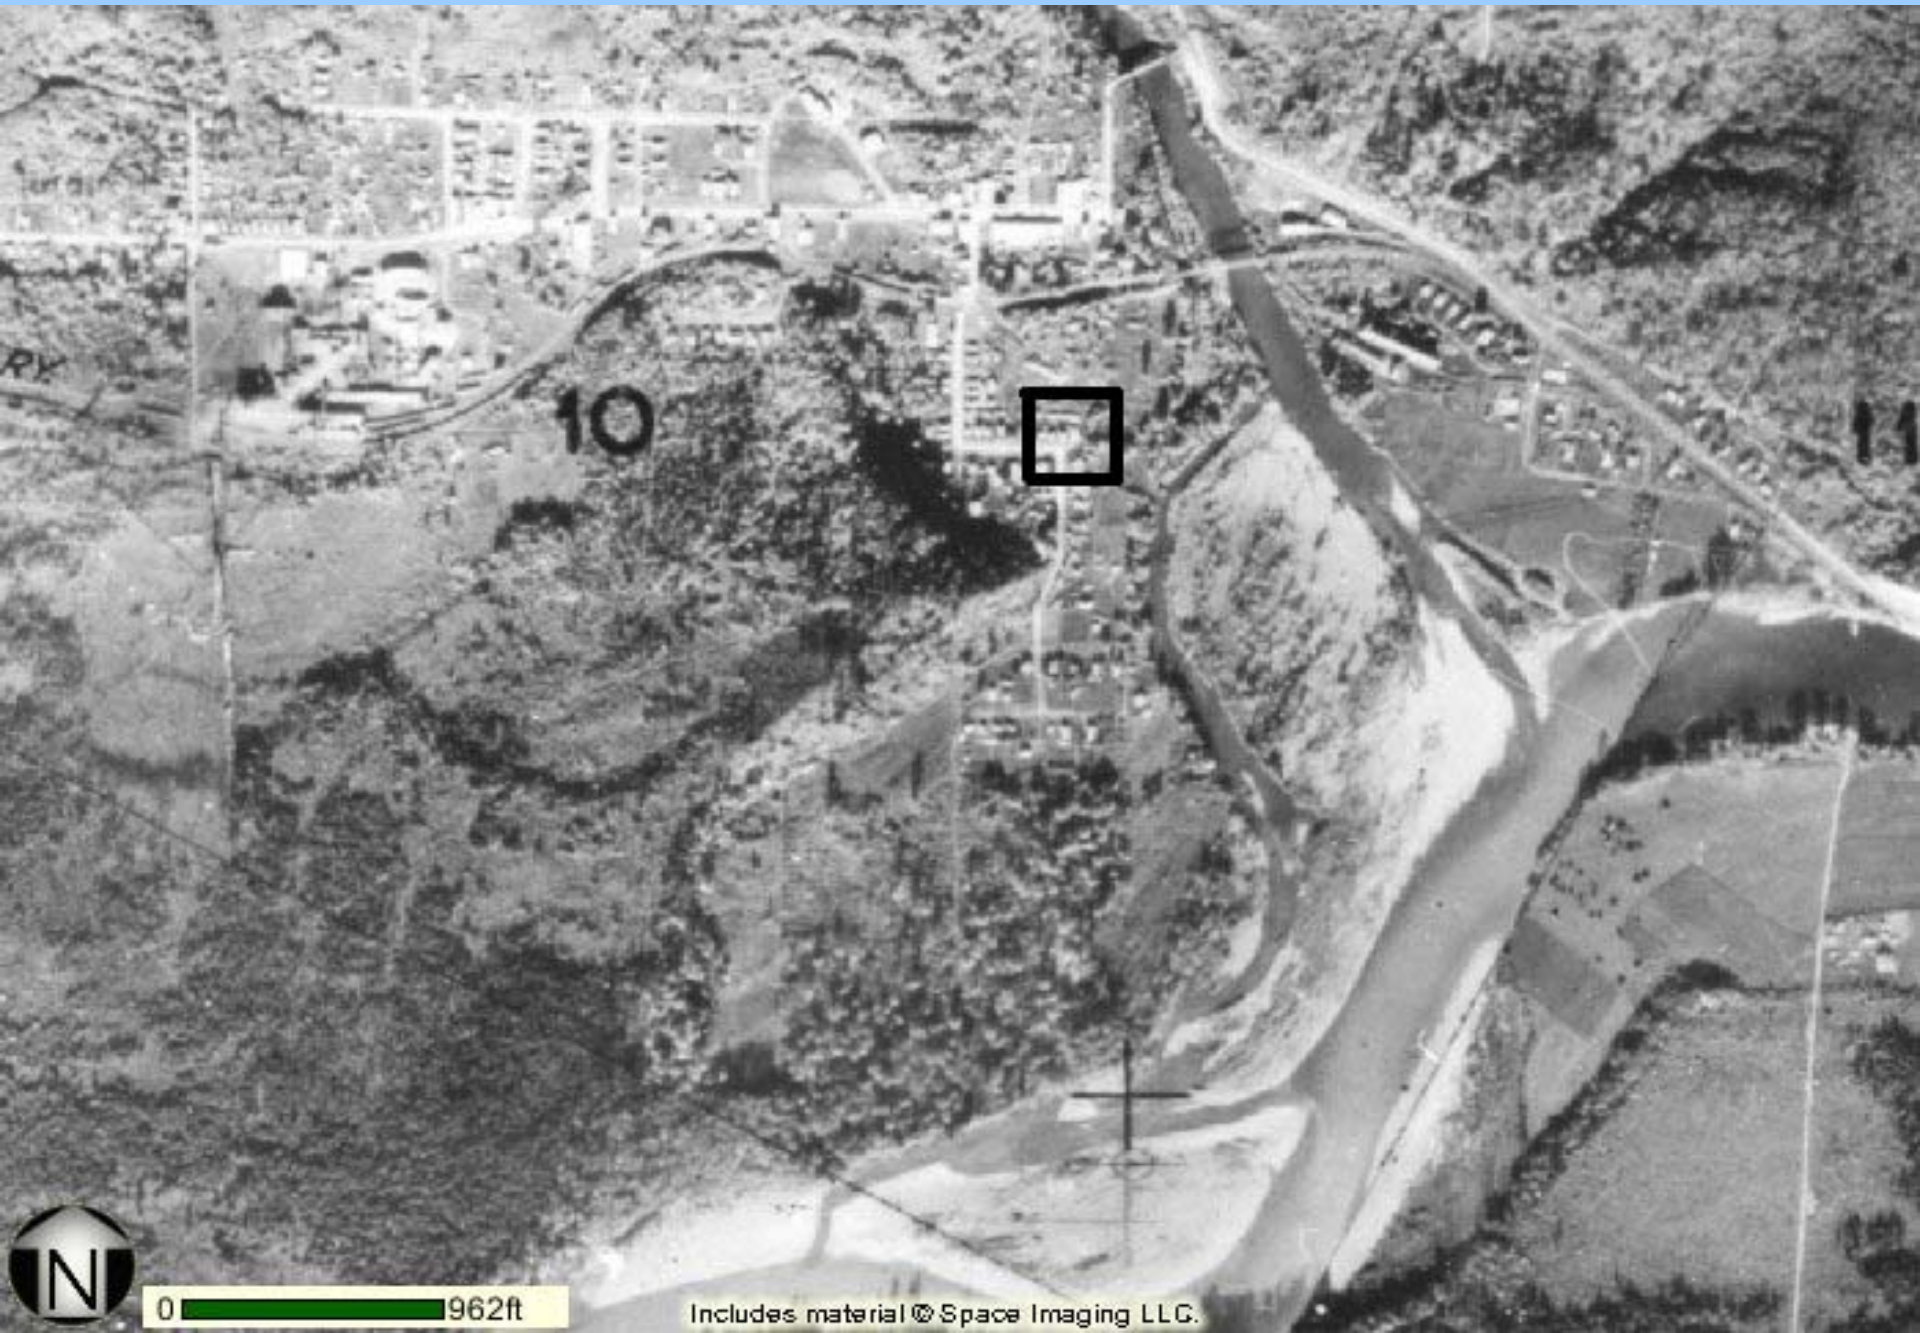
# L.E. Wolfe Residence, 1922

“About three o’clock in the afternoon it went over the banks in Crofoot addition and the residents of that part of town began to move out ... The waters also crept up around some of the dwellings in East Concrete, and some of the residents moved out for the night. **In Crofoot addition** only three residences remained above the high water mark, **the water being to a depth of an inch to 14 inches in the others.** No particular damage was done, except for small articles outside being washed away, and the job of cleaning out the mud left by the flood. ... **In East Concrete practically no damage was done.**” *Dec. 17, 1921 Concrete Herald “Skagit River Goes On Wild Rampage; Light Damage Here”*
