Update  
Skagit River Flood Issues

Presented To  
The  
Mount Vernon City Council

April 23, 2008

Chal A. Martin, P.E.  
Burlington Public Works Director / City Engineer

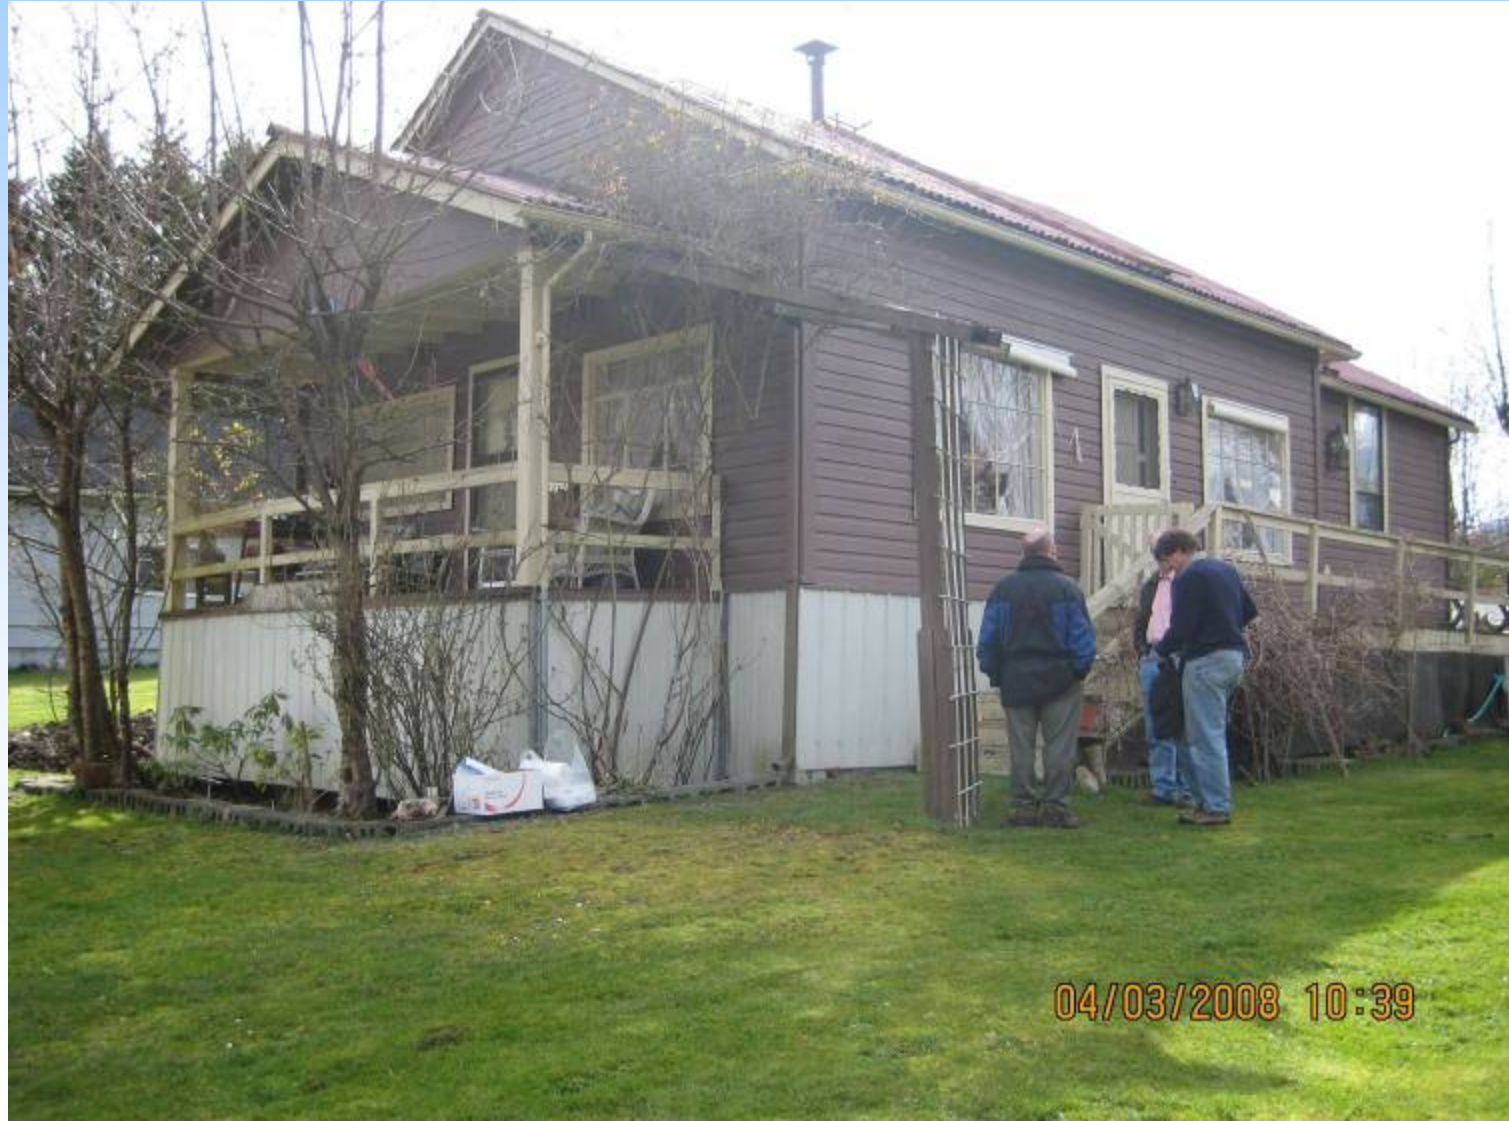
Ripple House, Built 1900  
First Floor Elevation 185.44  
(1921 Stewart mark at Wolfe residence 183.55)  
1909 Theoretical Water Level – 190.00

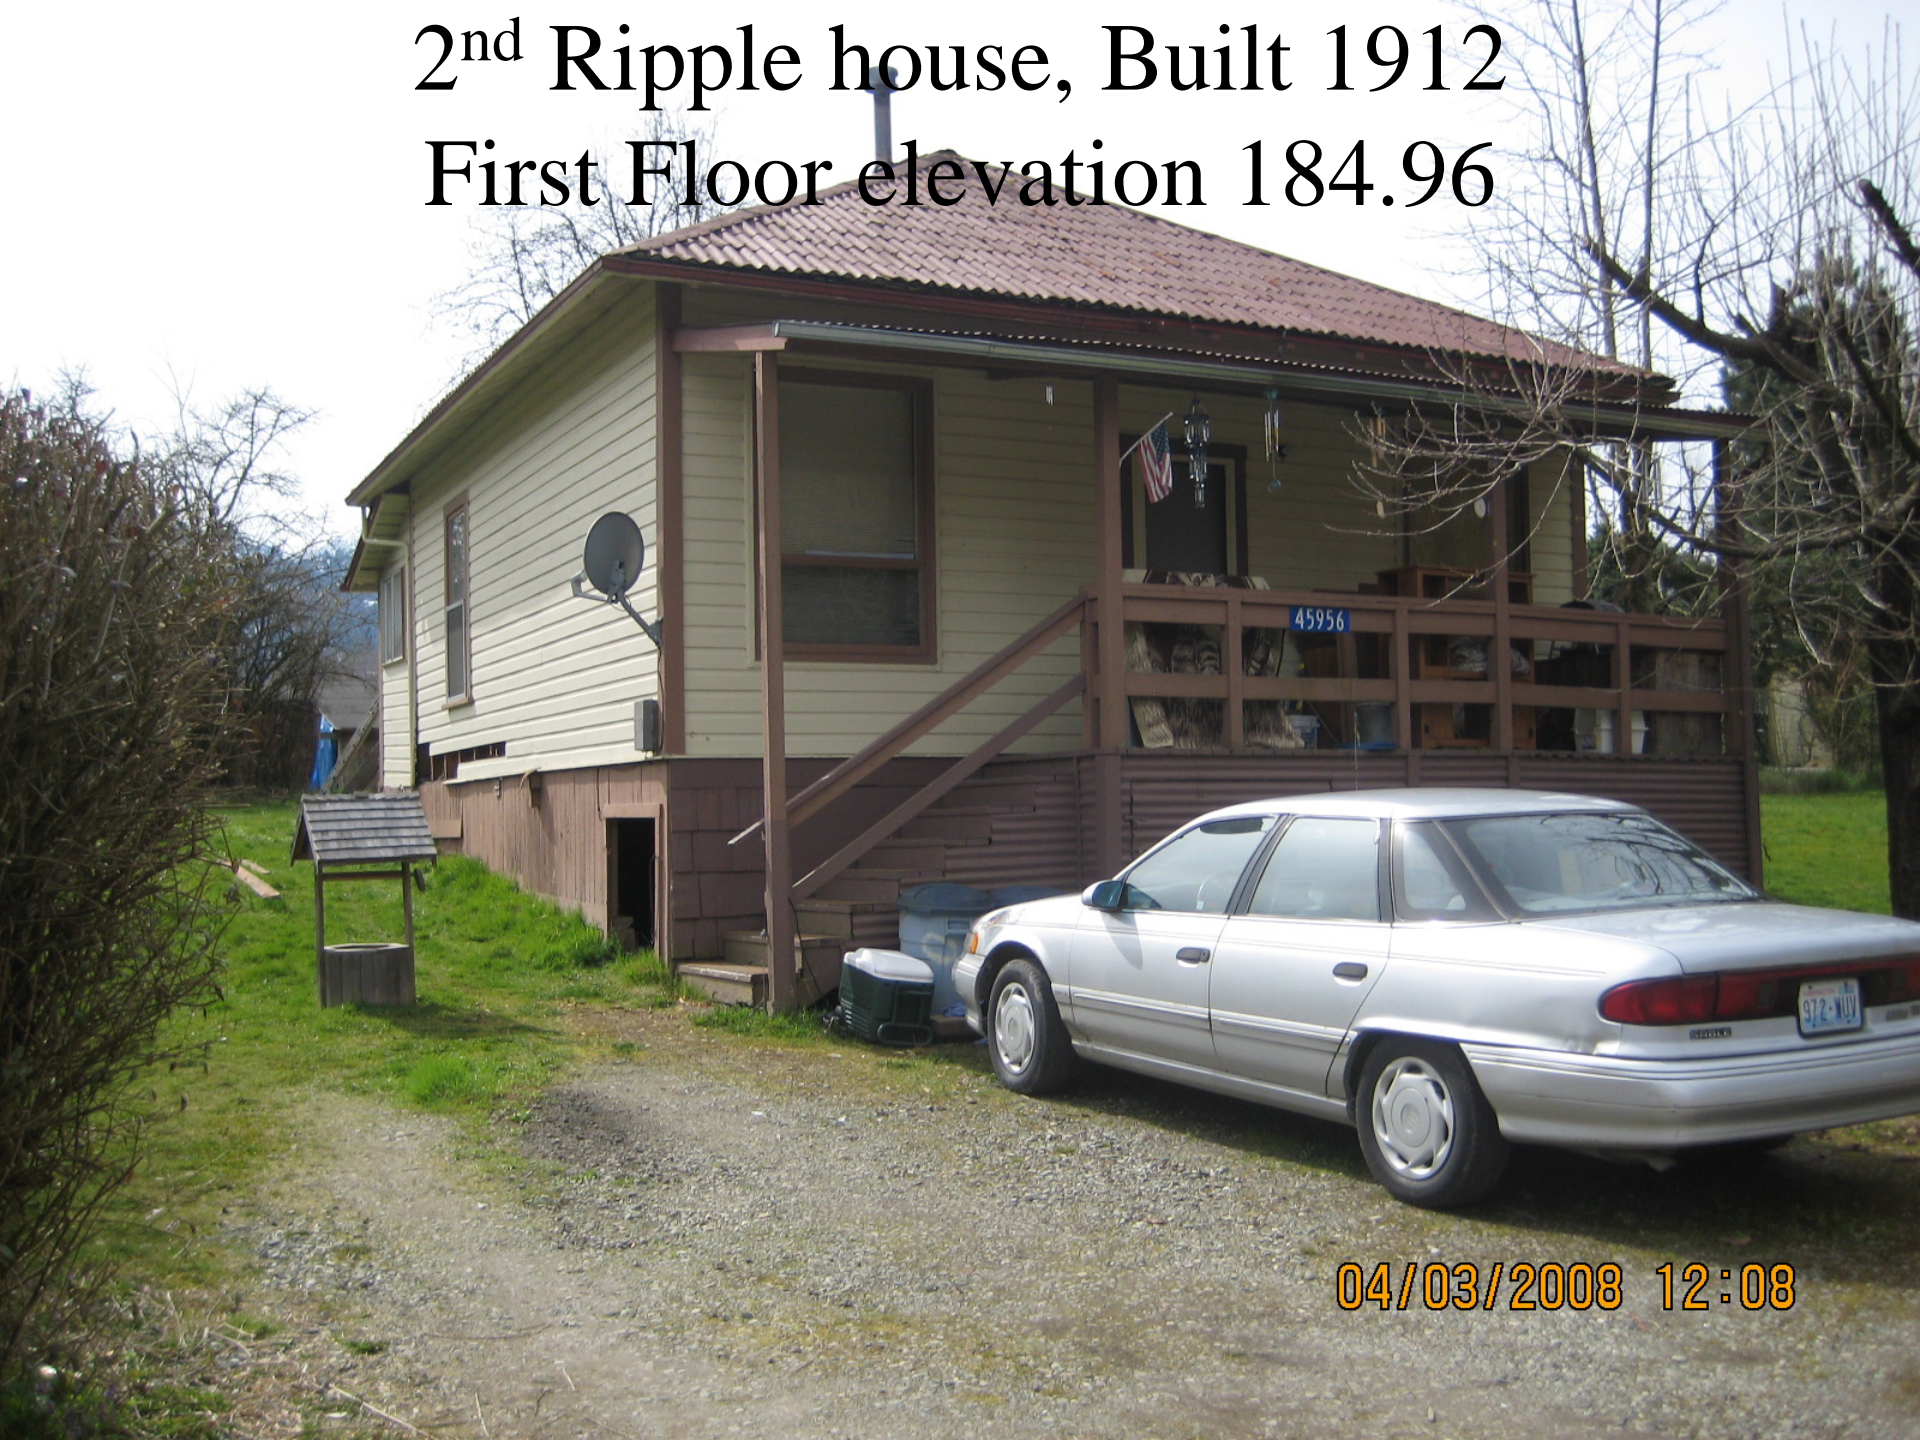
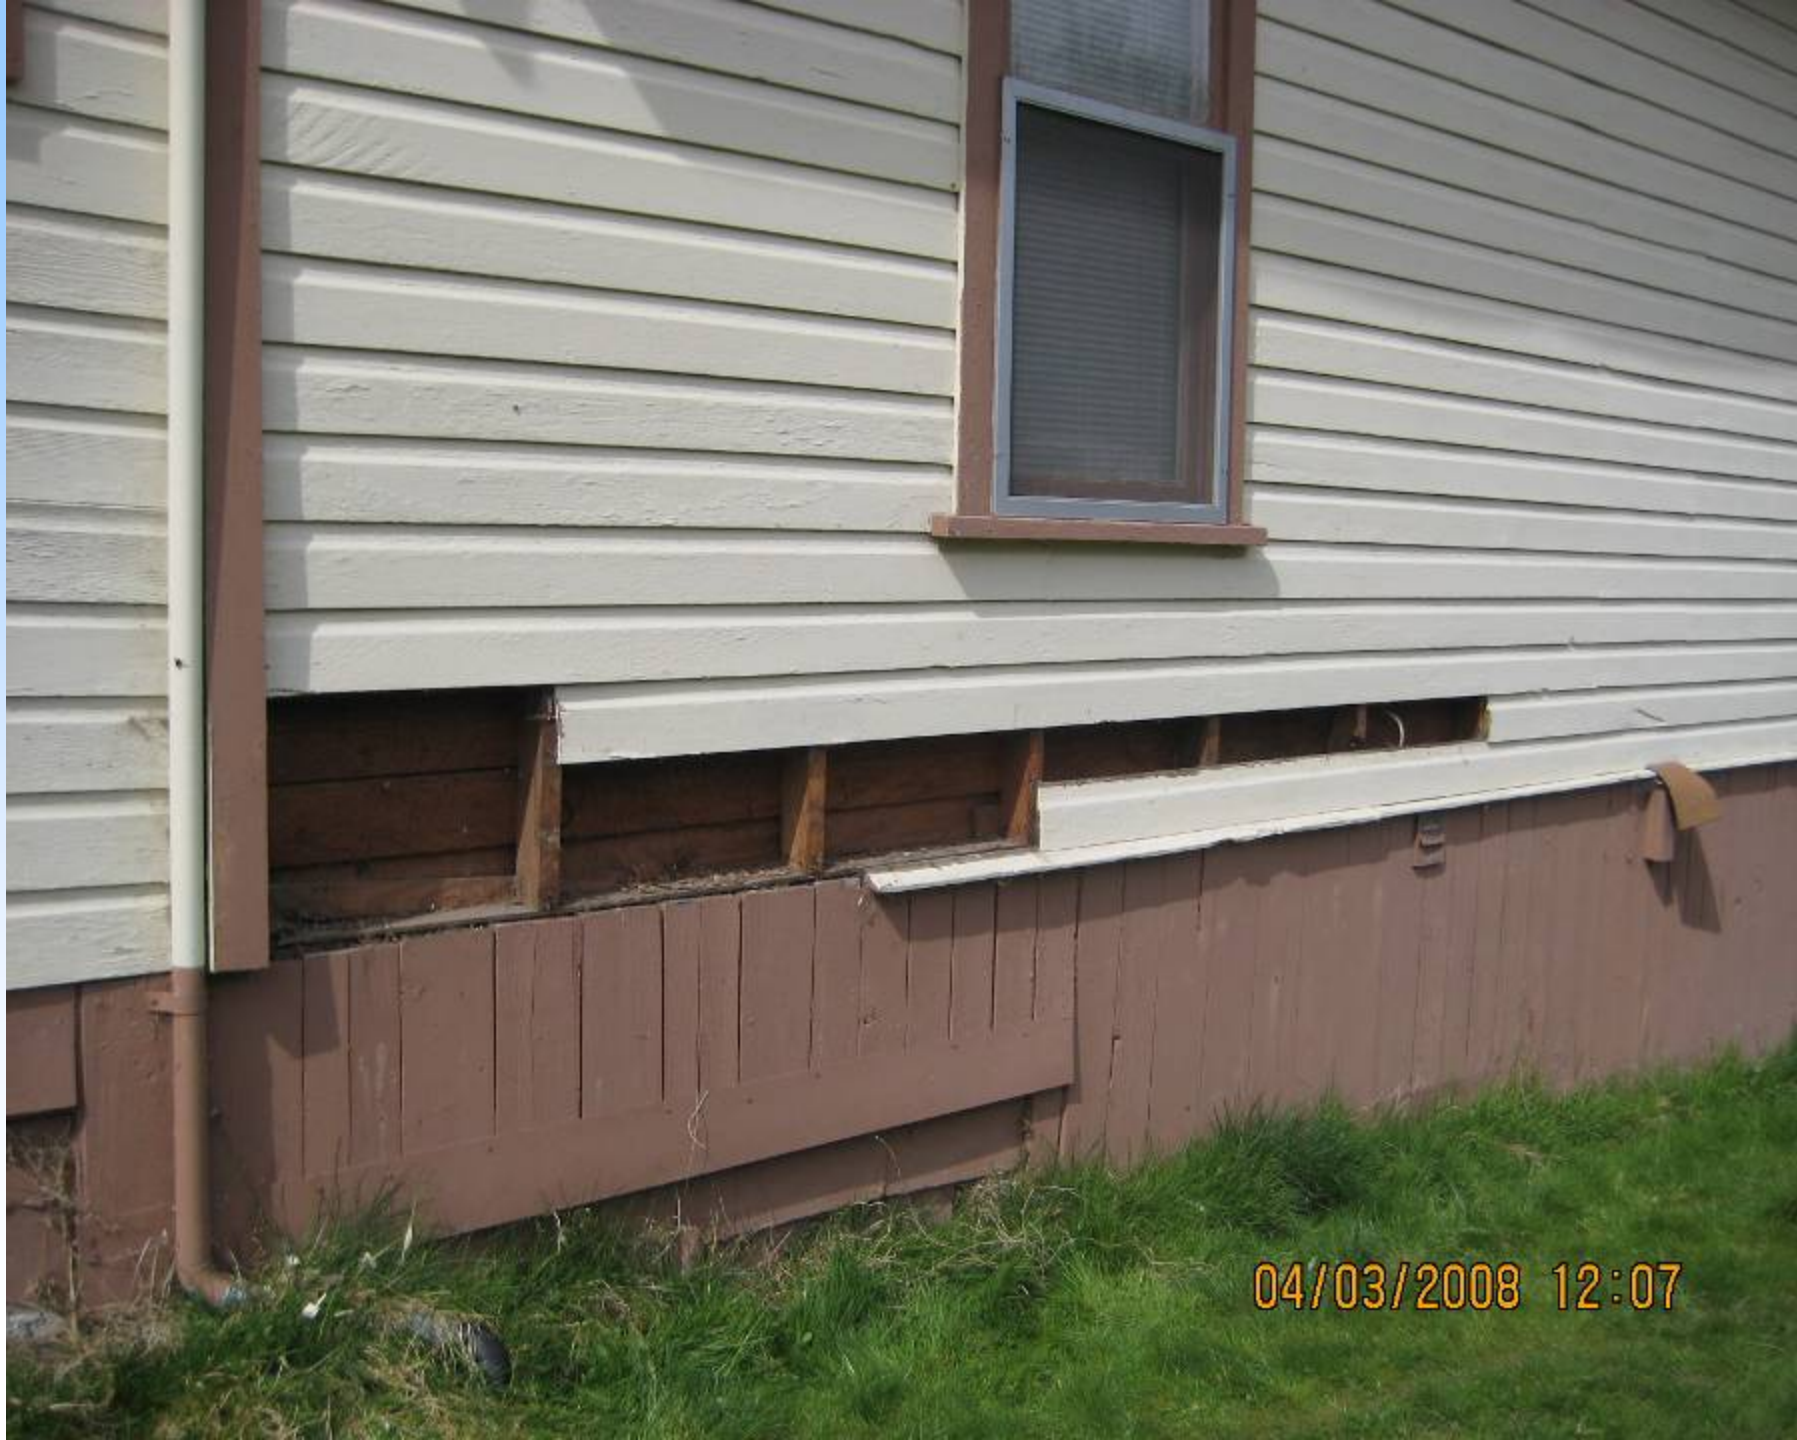
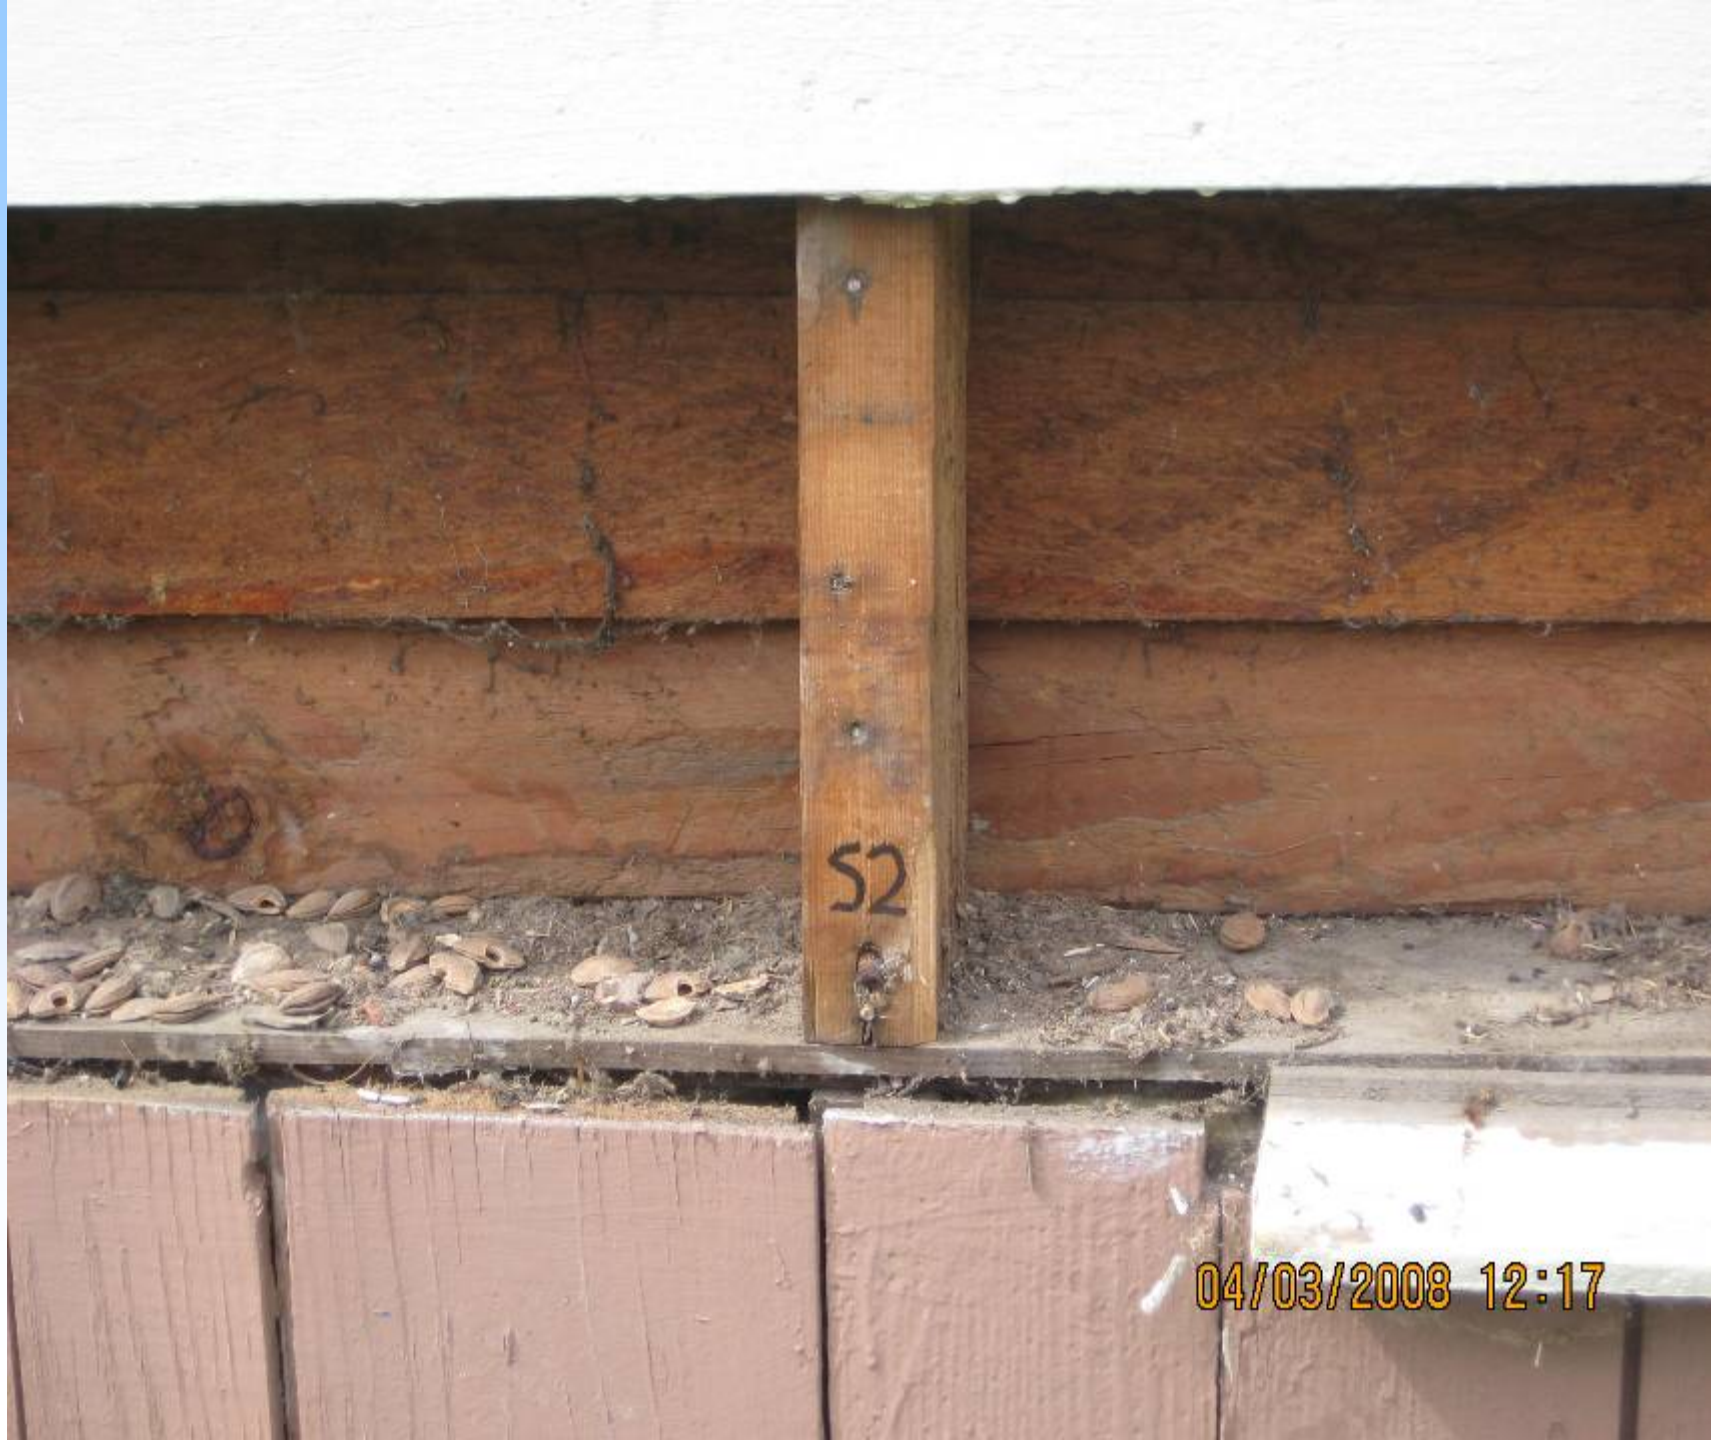
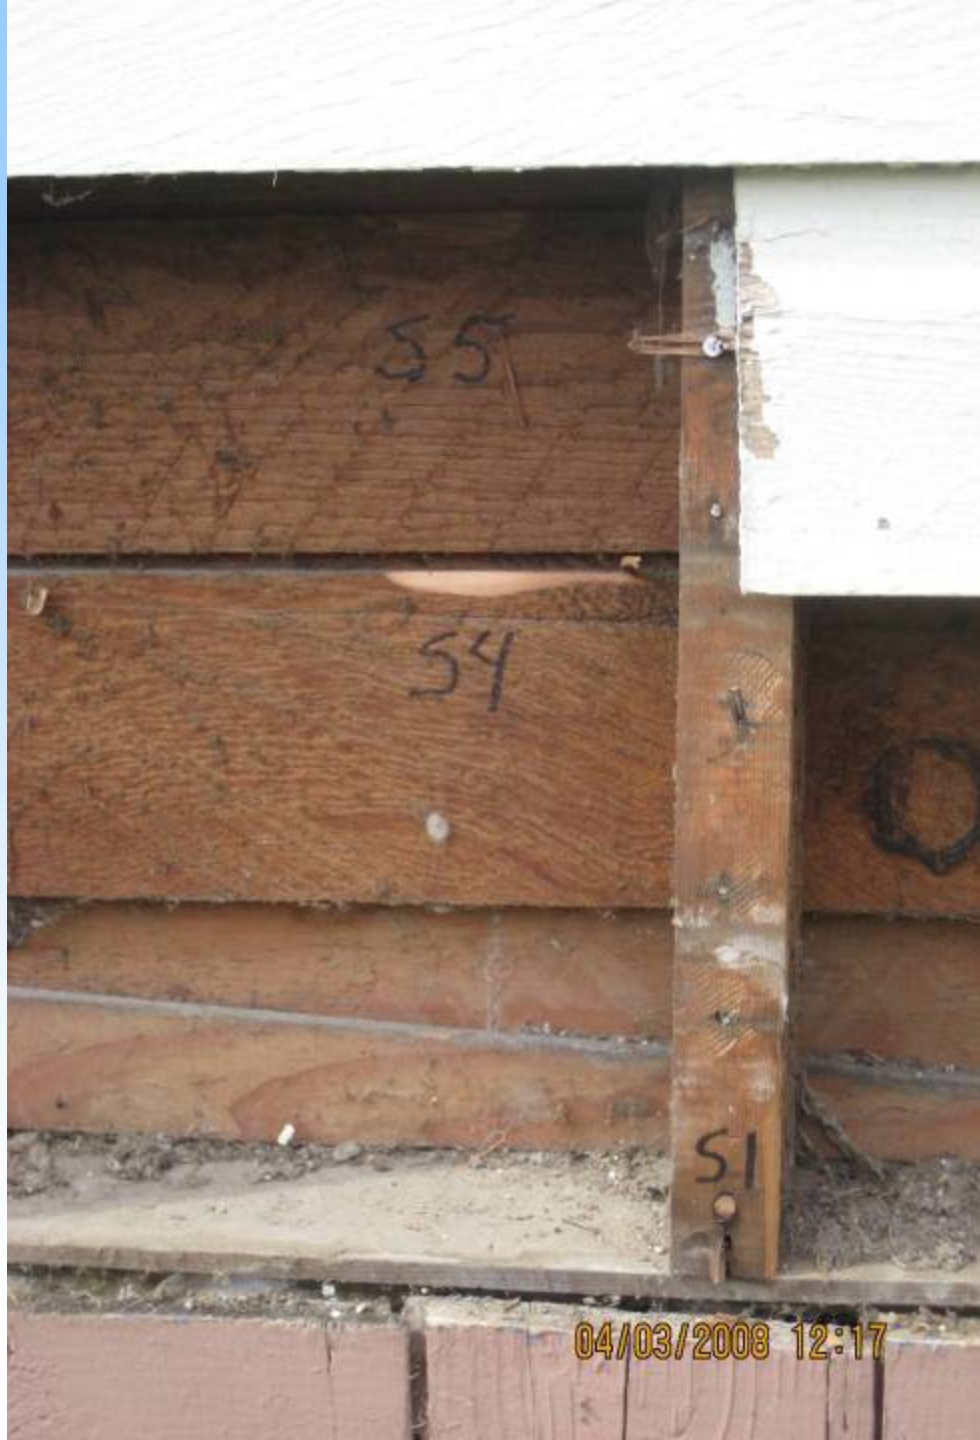
2<sup>nd</sup> Ripple house, Built 1912  
First Floor elevation 184.96
