Considerations regarding Partial Accreditation of Dike, Drainage, and Irrigation District 12 Levee System

Chal Martin, P.E.
Public Works Director
City of Burlington

September 15, 2008

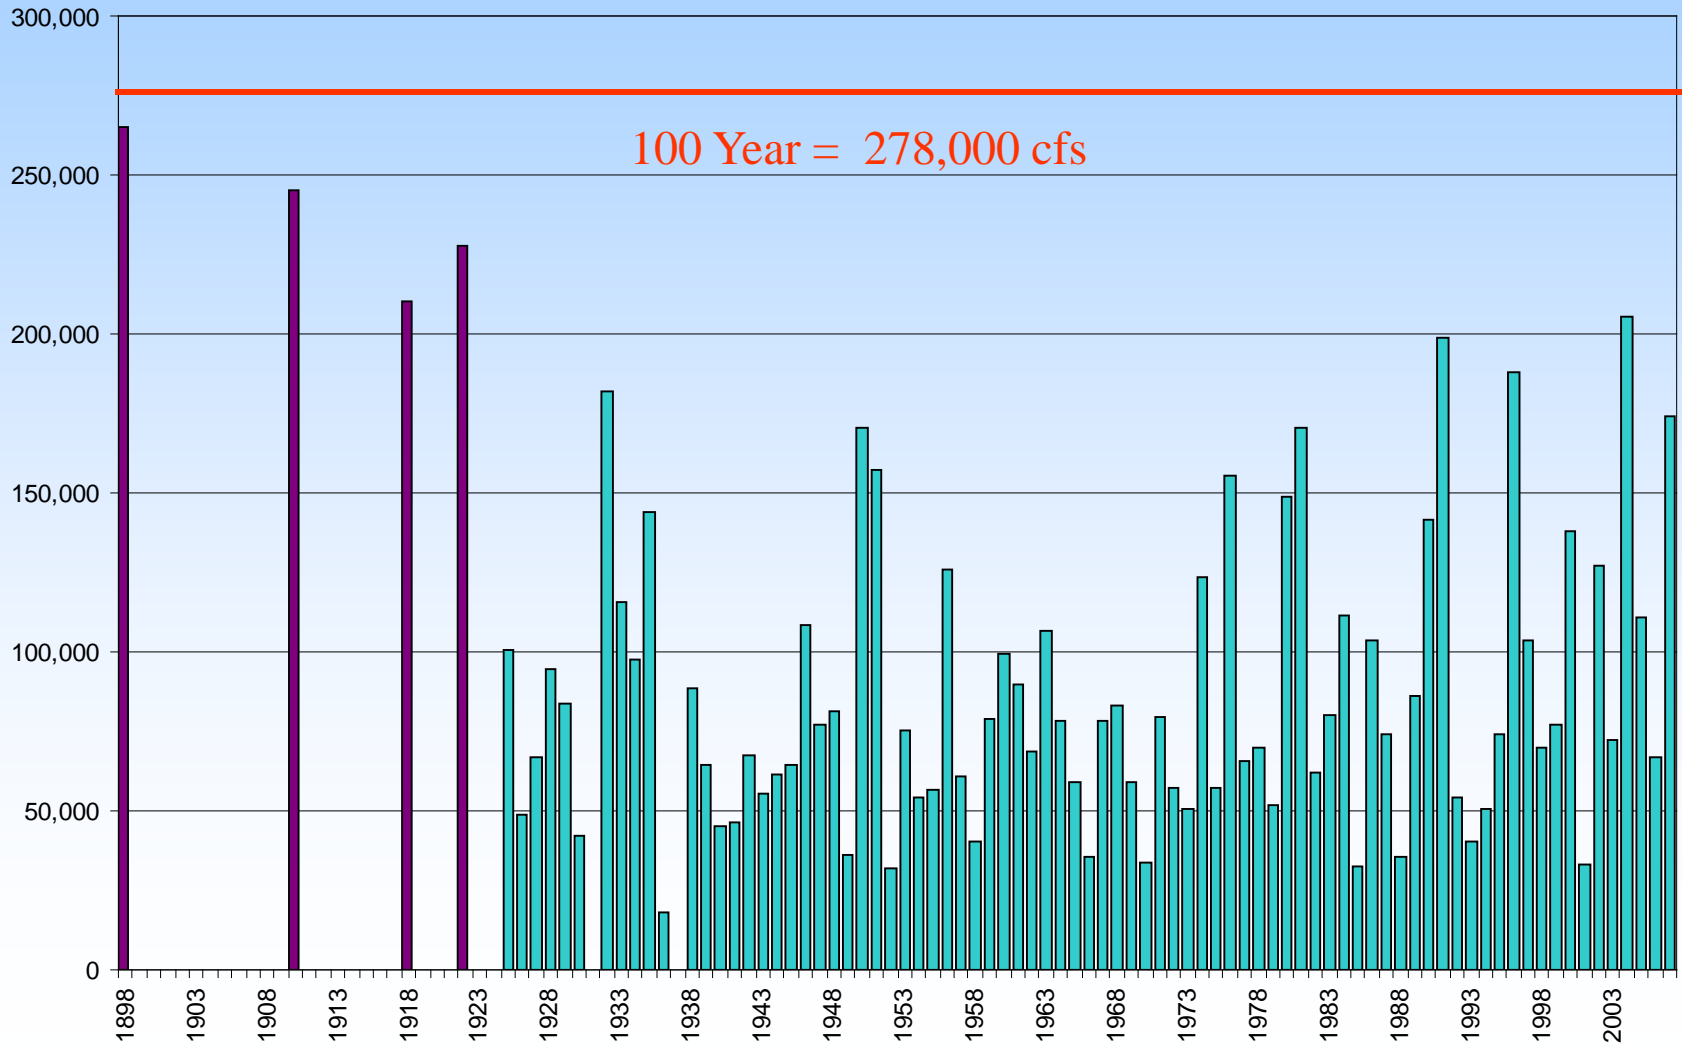
Skagit River Winter Unregulated Annual Peak Flows Concrete – COE Frequency Distribution (April 2008)

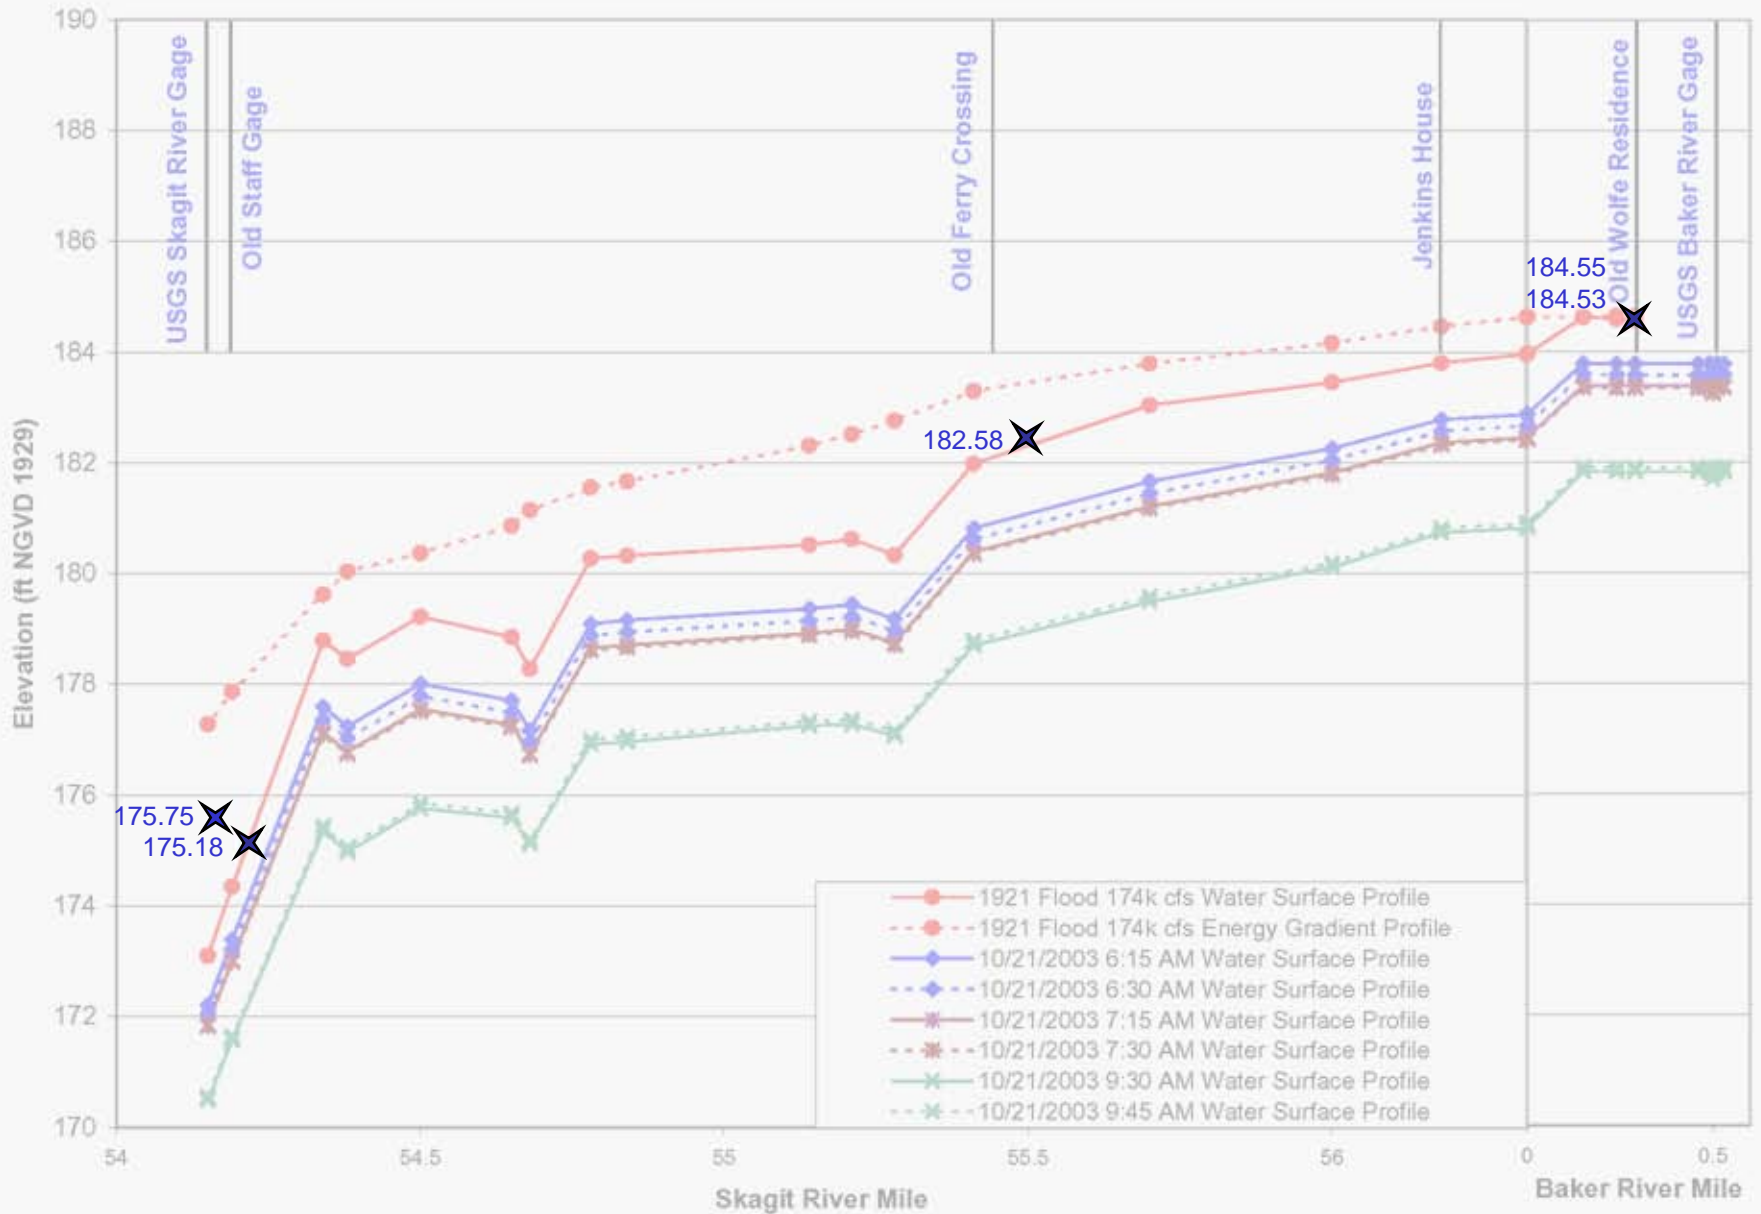
Stewart Surveyed 1921 High Water Marks

- Hydraulic model shows a peak discharge for the 1921 flood of **174,000 cfs**, based on Stewart's survey notes from 1922 –

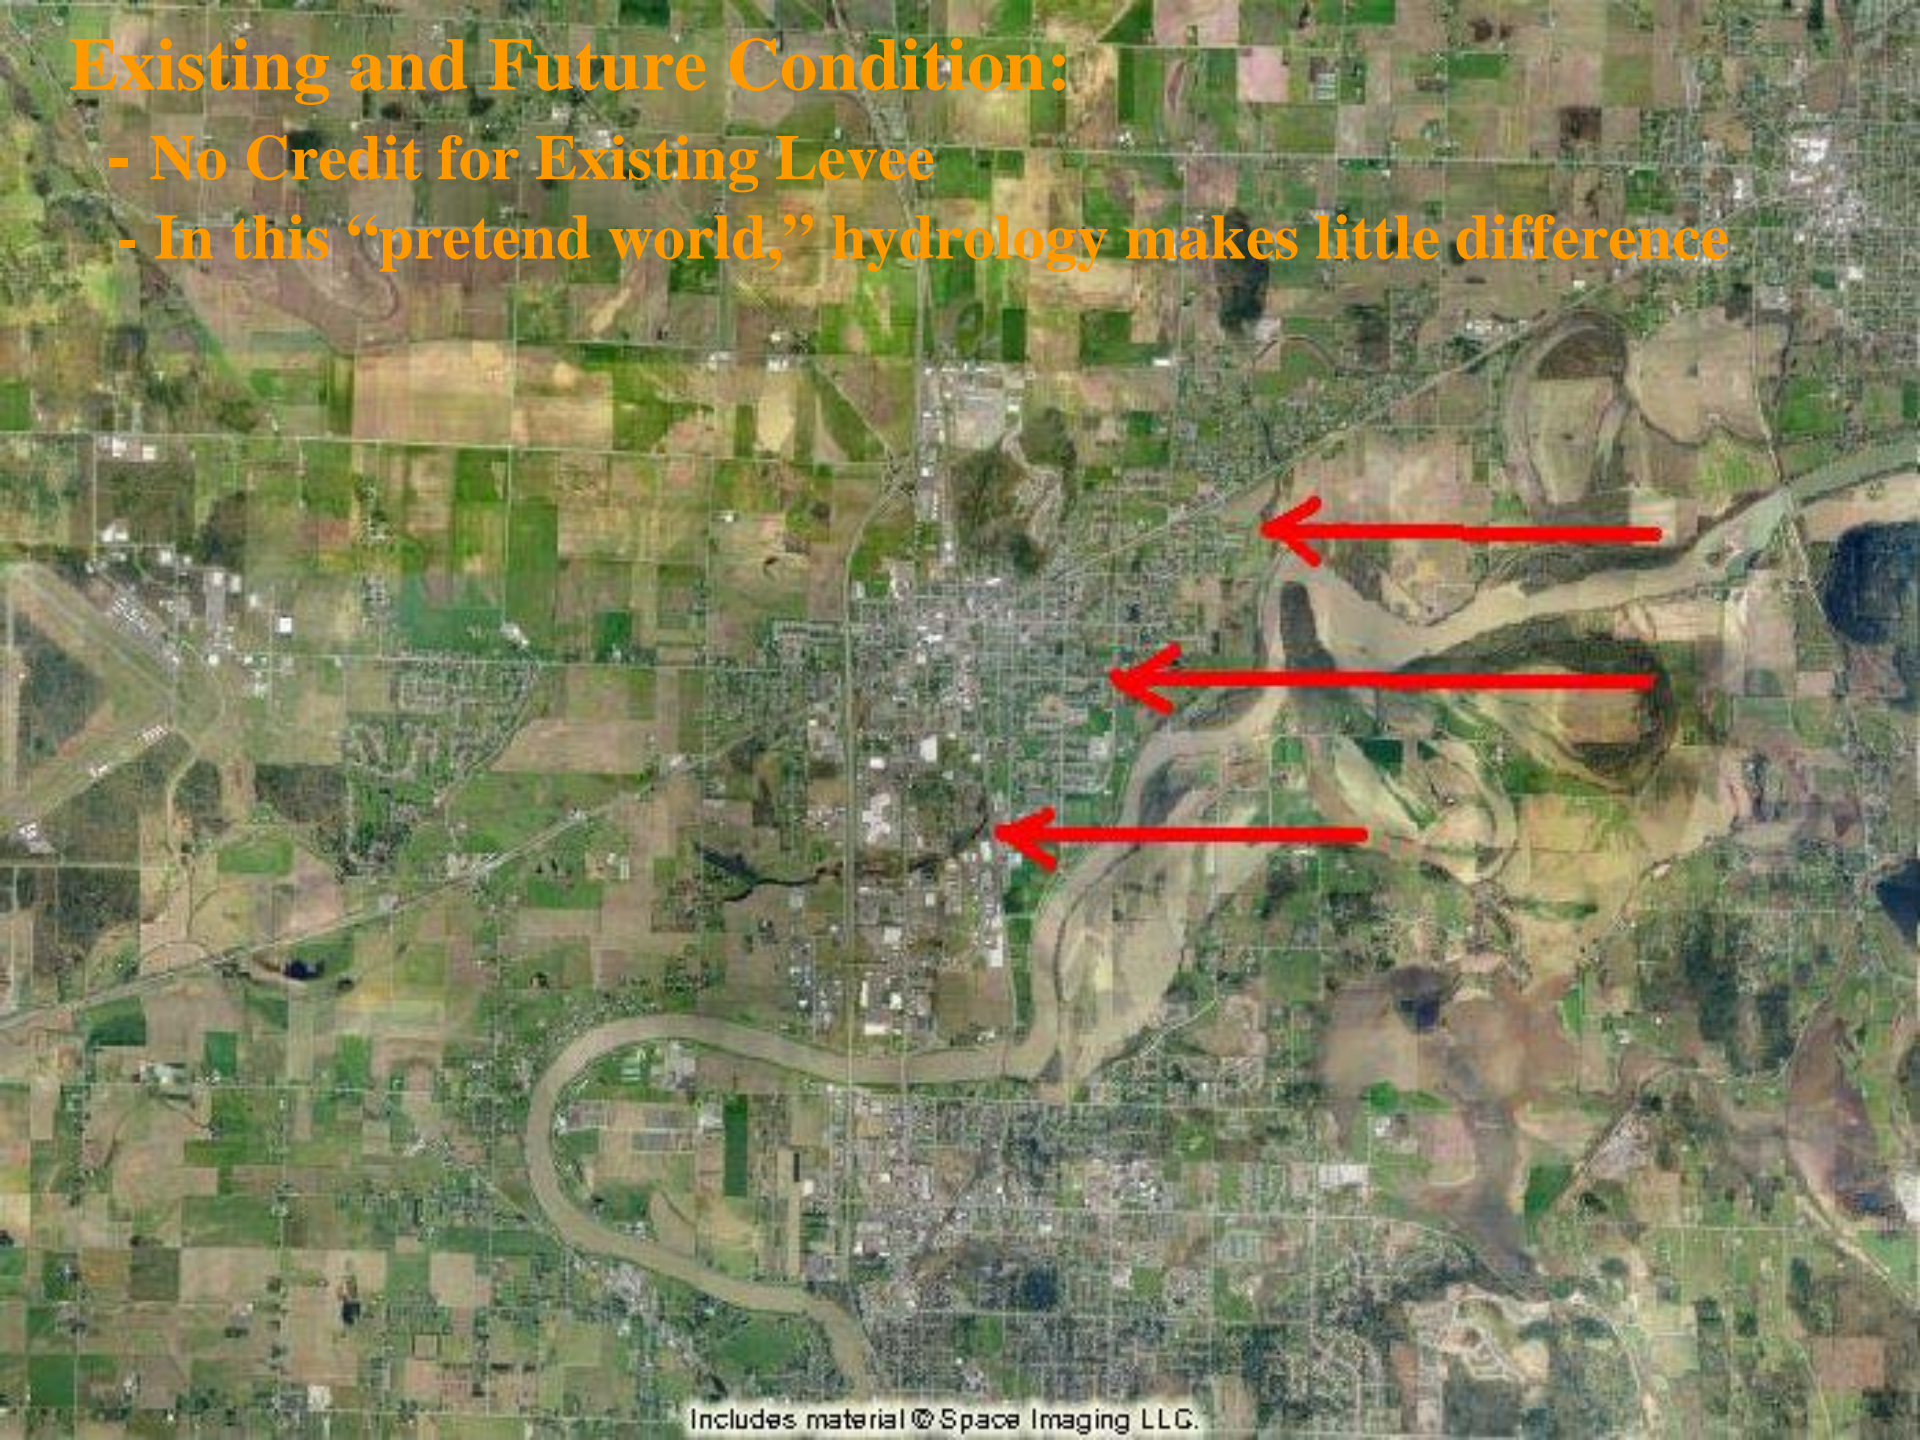
Existing and Future Condition:

- No Credit for Existing Levee
- In this “pretend world,” hydrology makes little difference

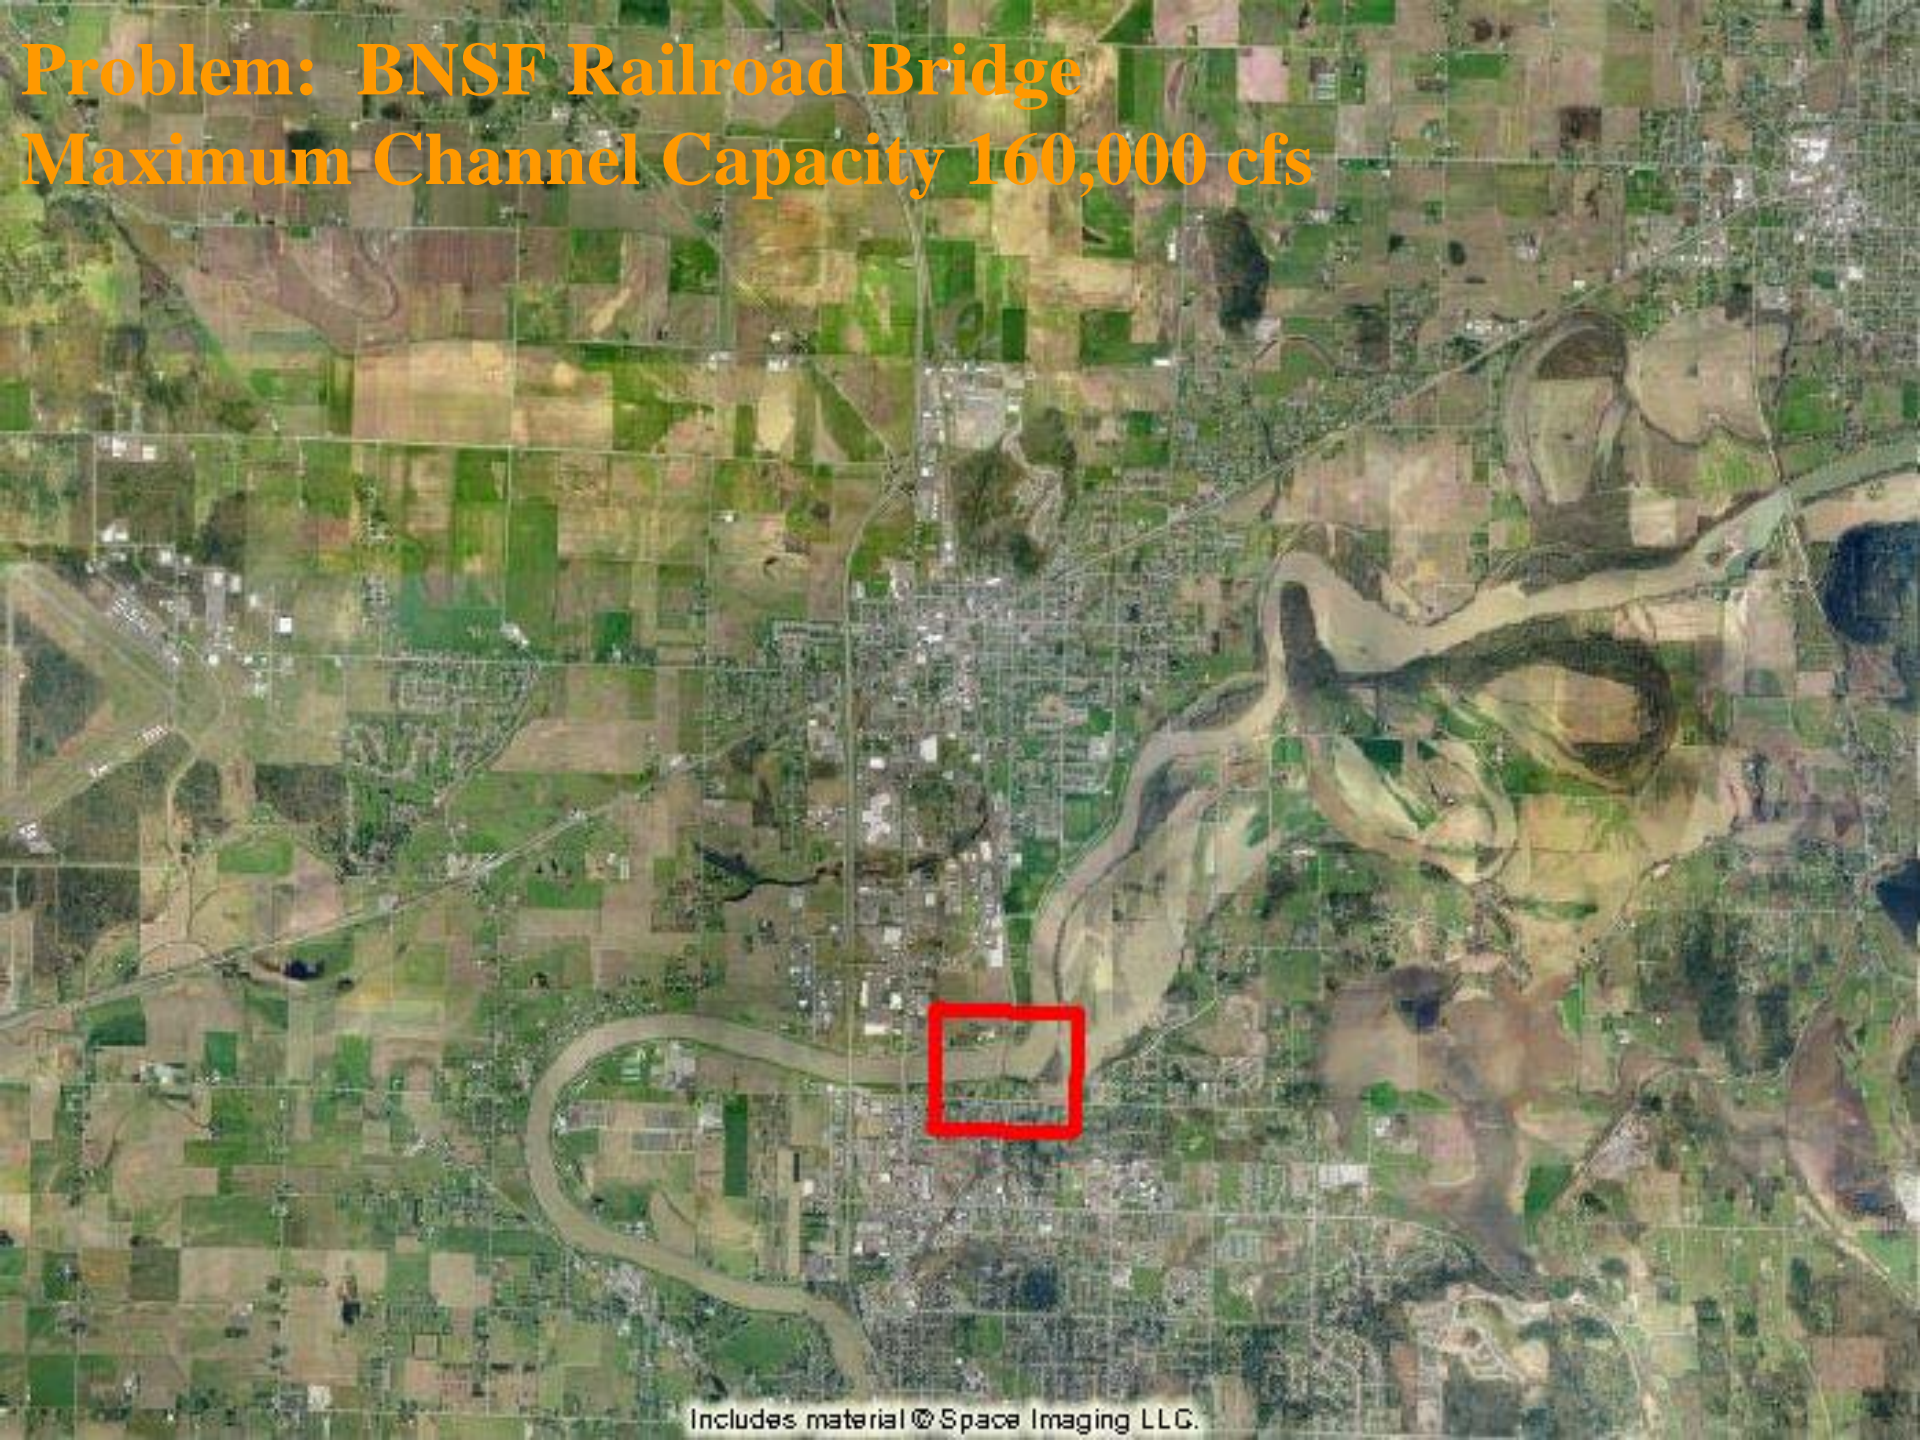
Problem: BNSF Railroad Bridge
Maximum Channel Capacity 160,000 cfs

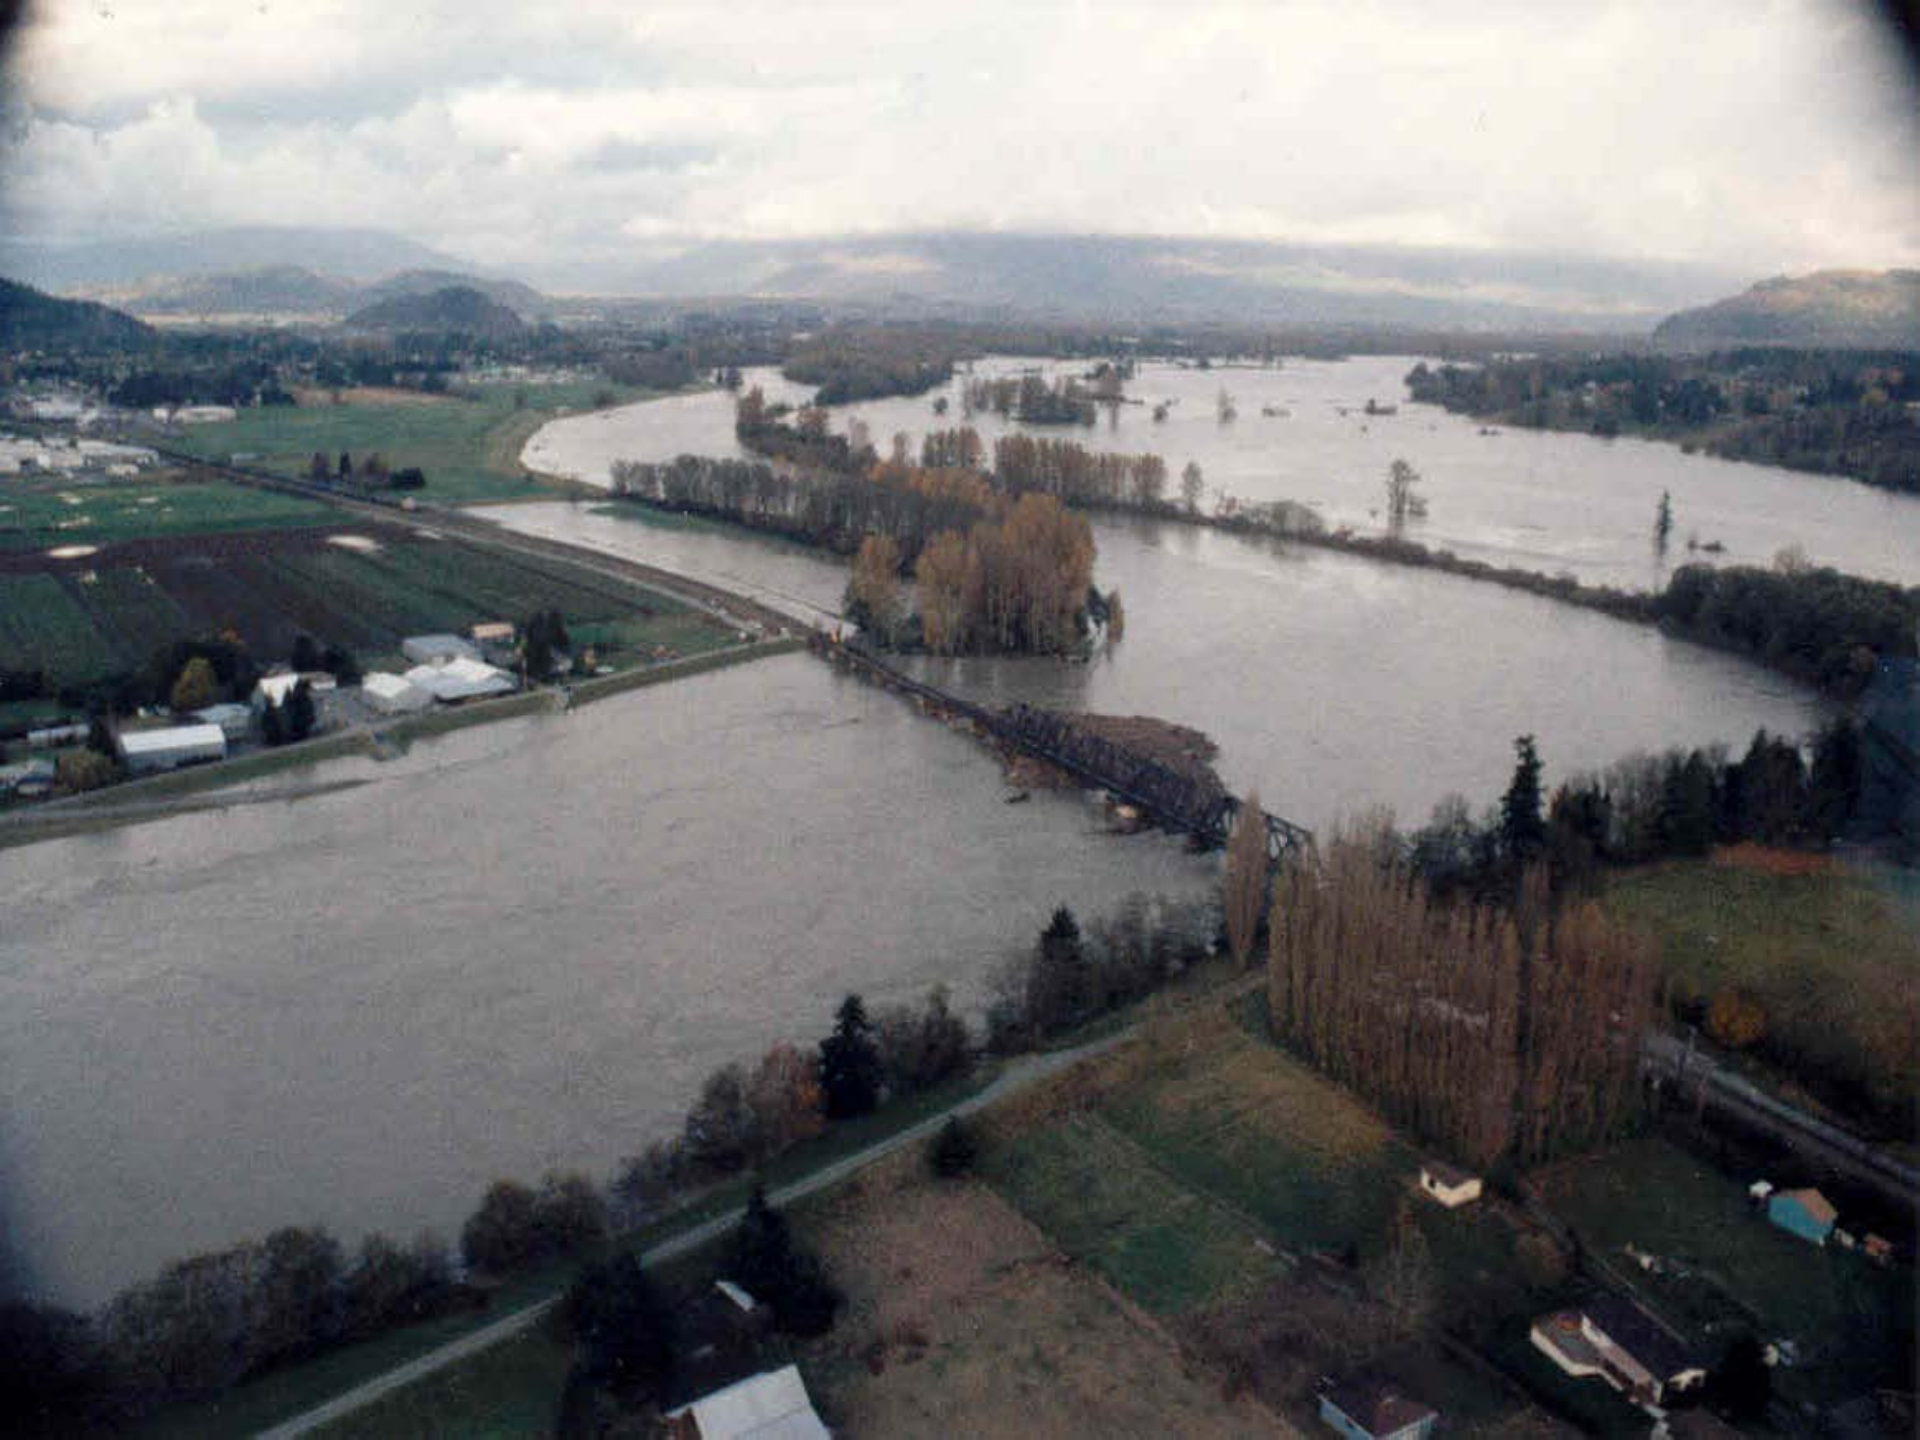
1995 Peak Flow 149,000 cfs

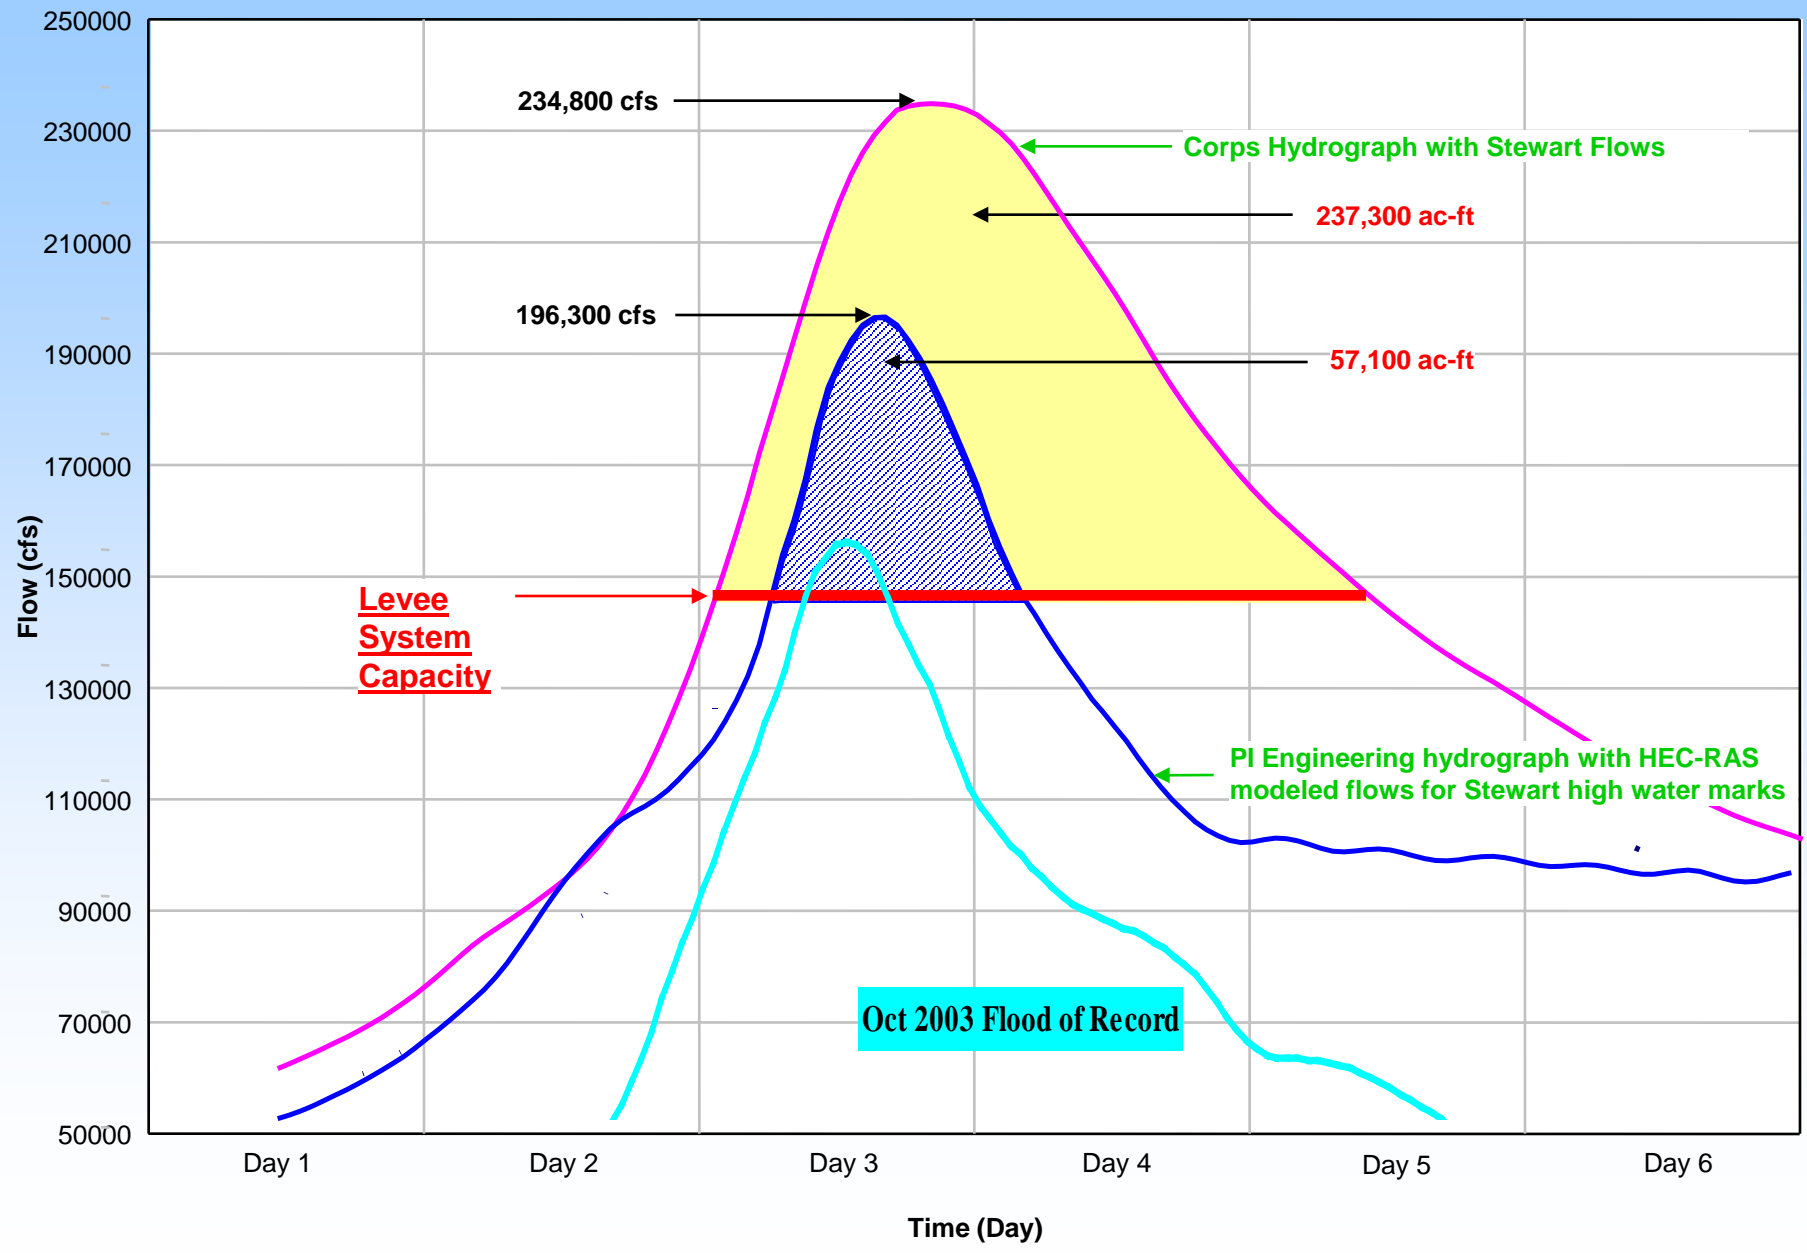
FEMA 100-year Flood Hydrographs at Sedro Woolley (with existing flood storage)

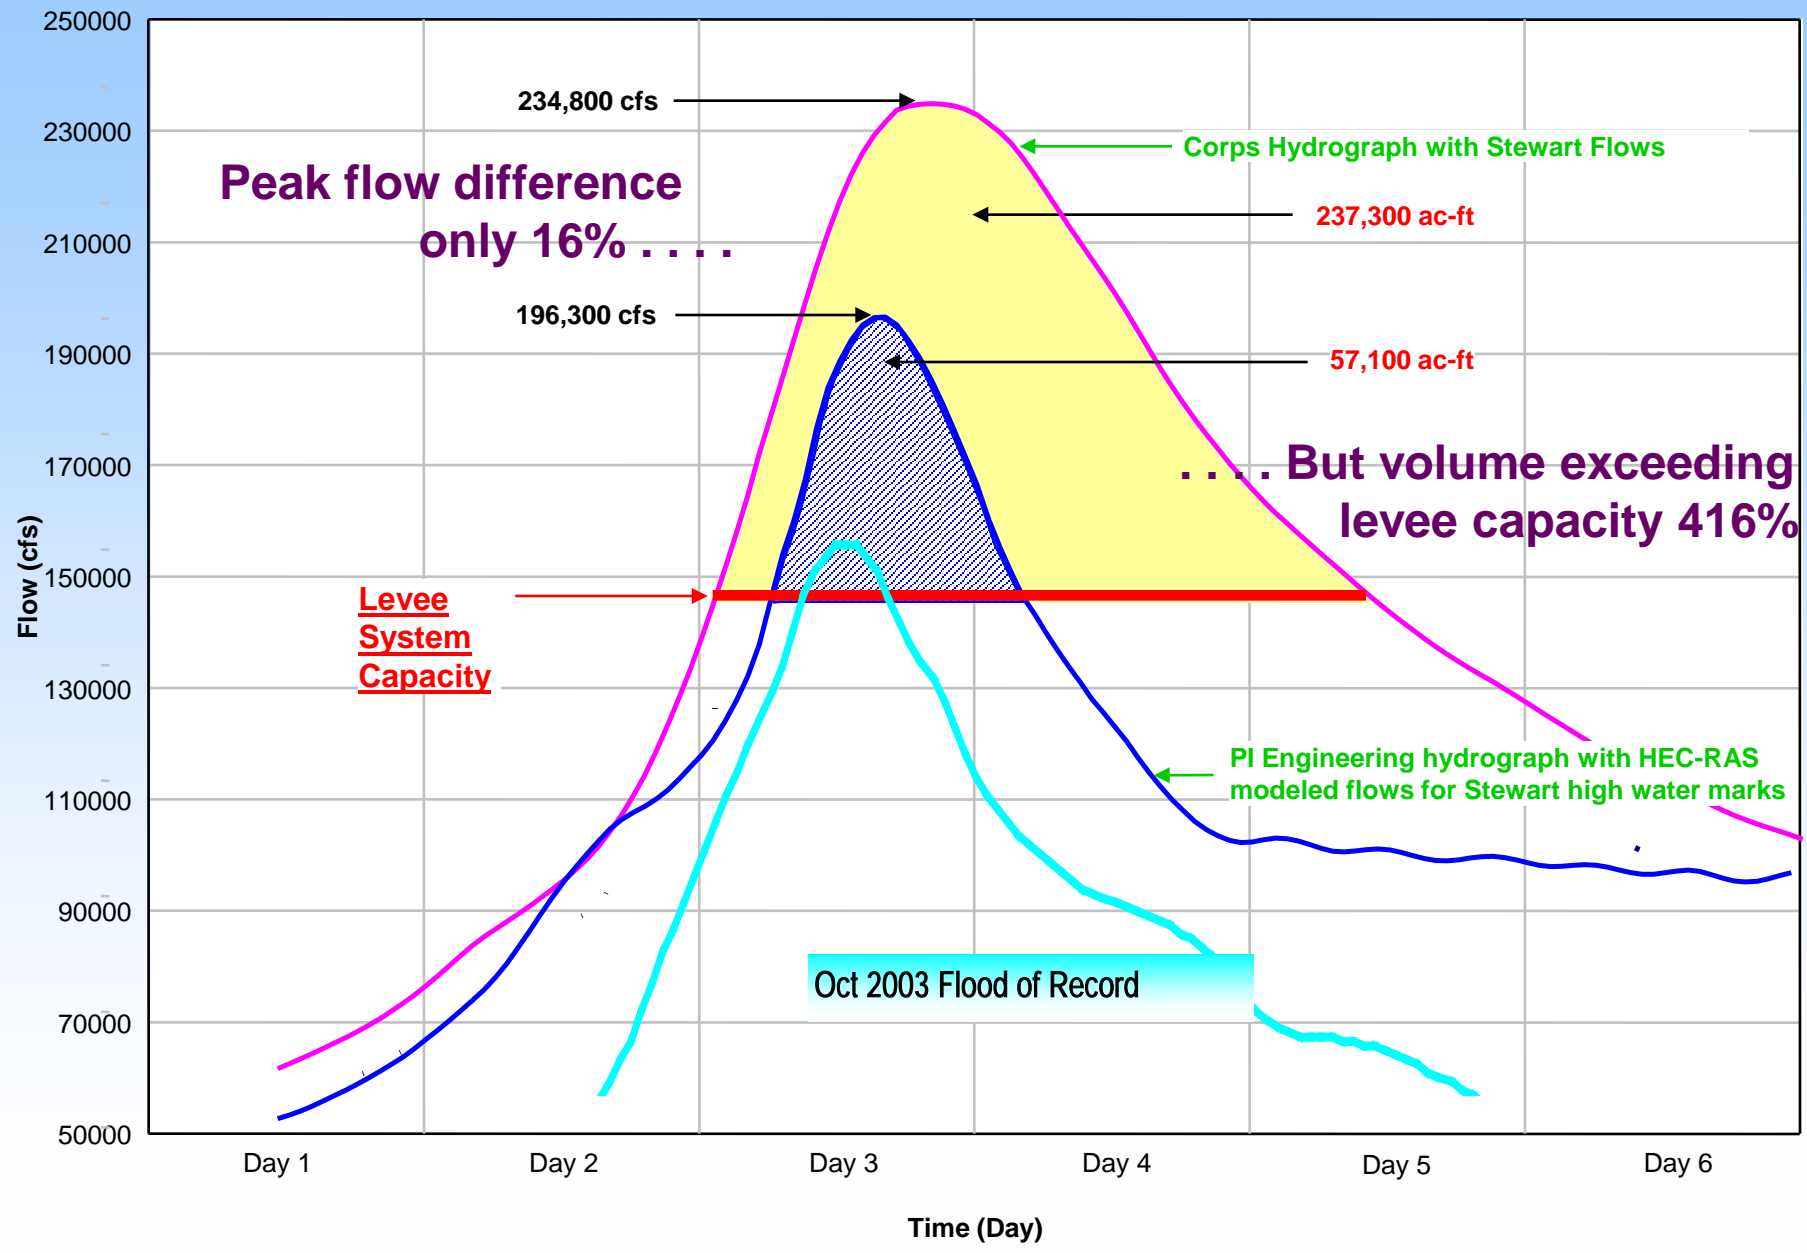
FEMA 100-year Flood Hydrographs at Sedro Woolley (with existing flood storage)
