Skagit River Historical Flood Elevations and Peak Flow Estimates

Skagit River GI H&H Technical Workshop

Wednesday, June 17, 2009

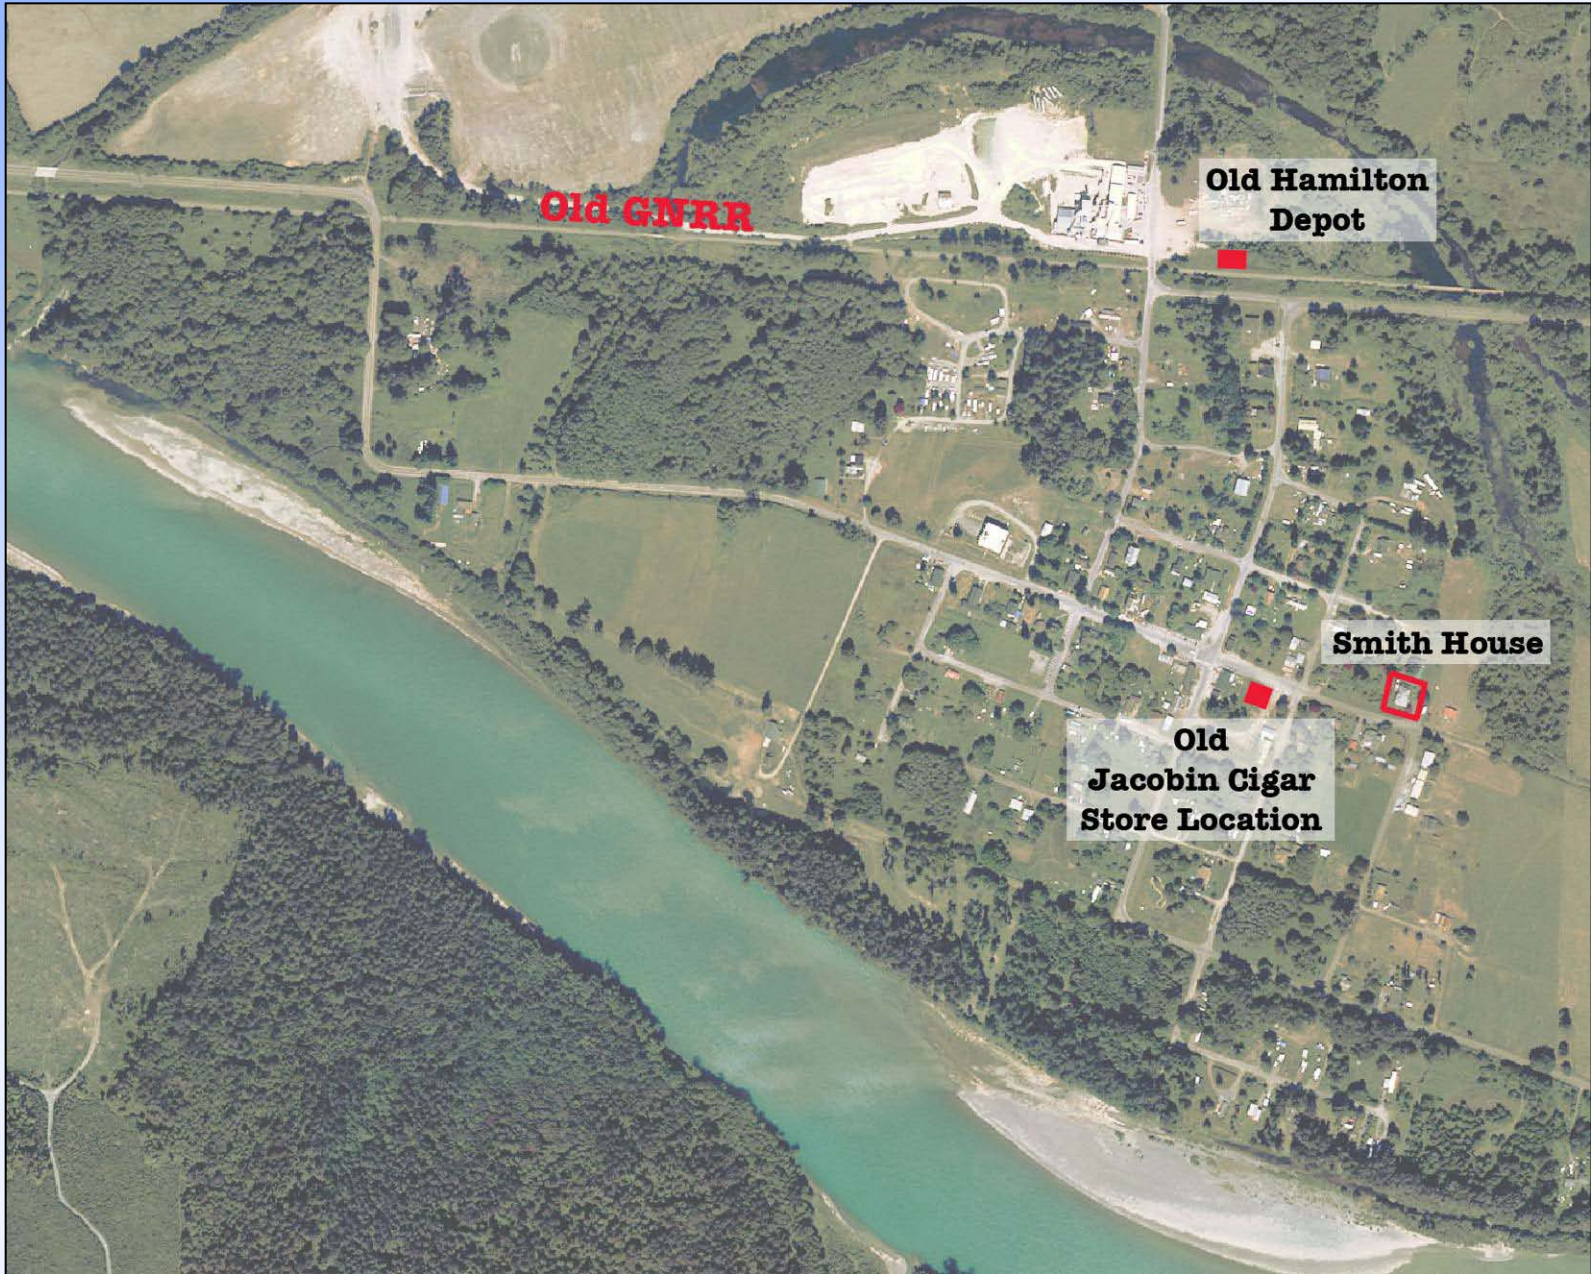
Aerial Photo of Hamilton Area

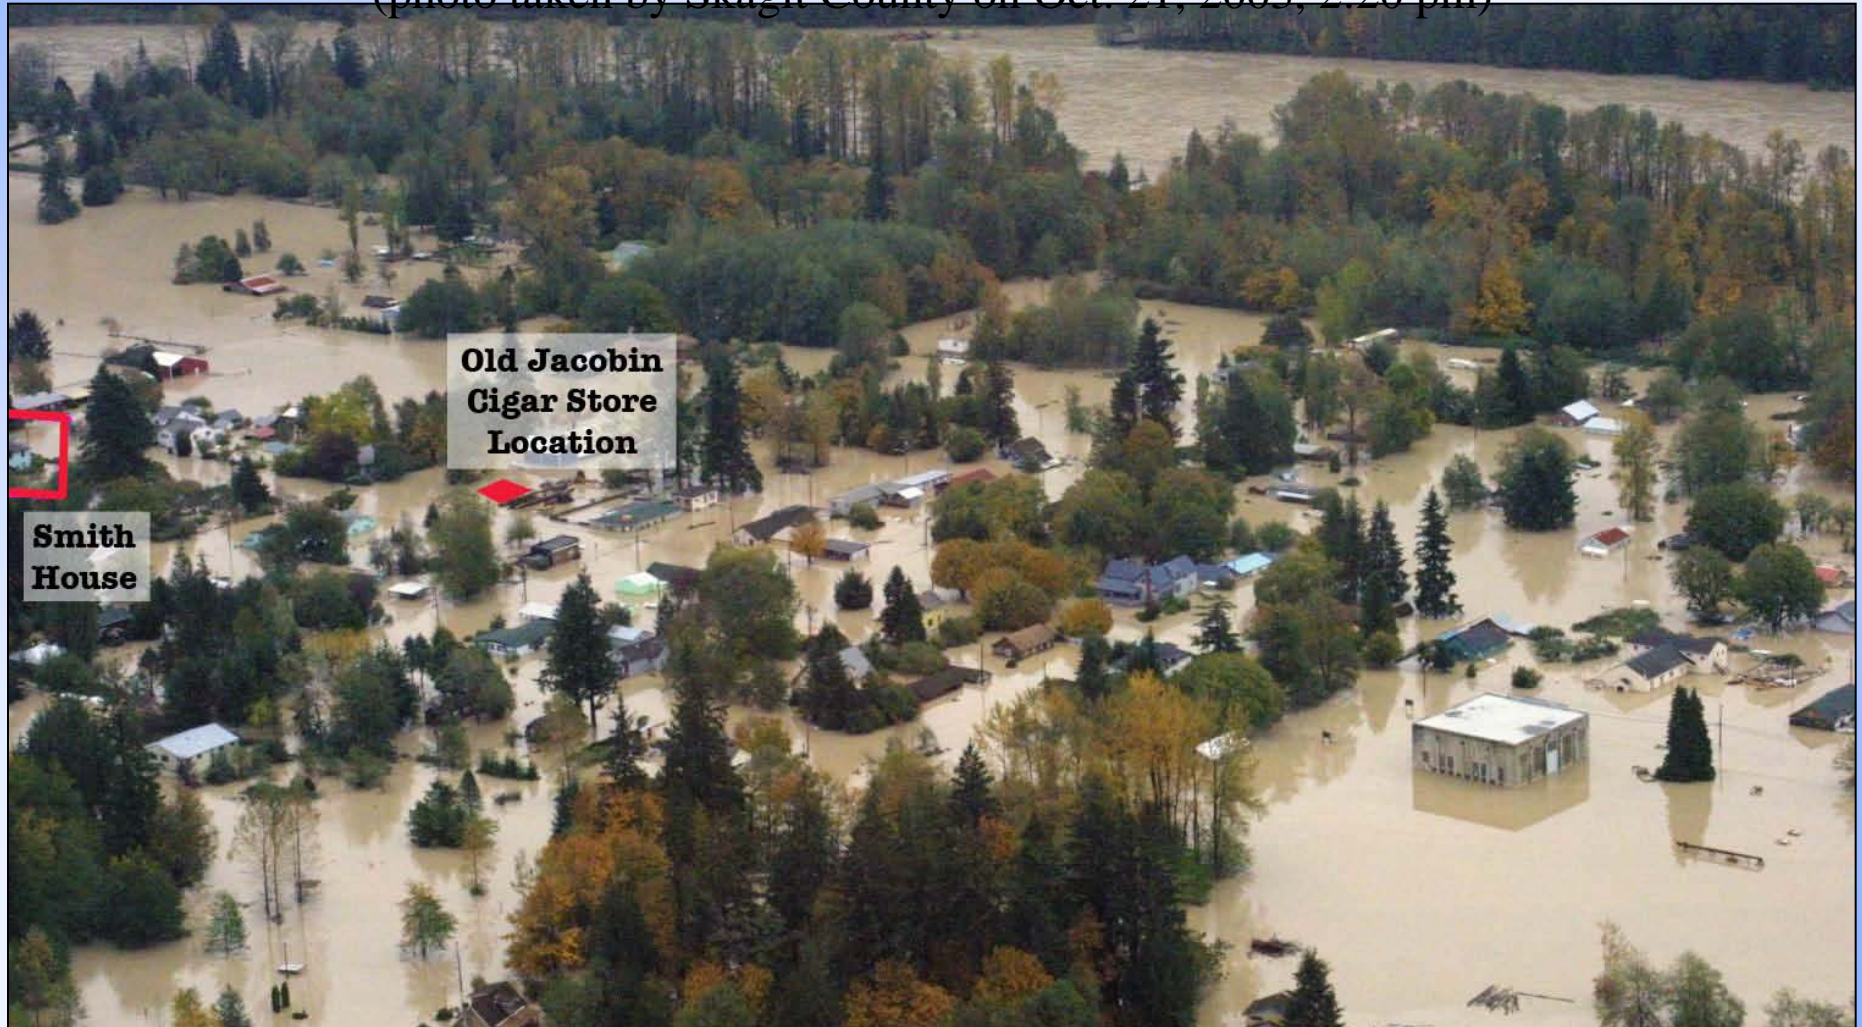
2003 Flood in Hamilton

Photo showing WS El. 98-100, 145,000 cfs

Flood Peak WS El. 99-101, 165,000 cfs at 9:30 am

(photo taken by Skagit County on Oct. 21, 2003, 2:20 pm)

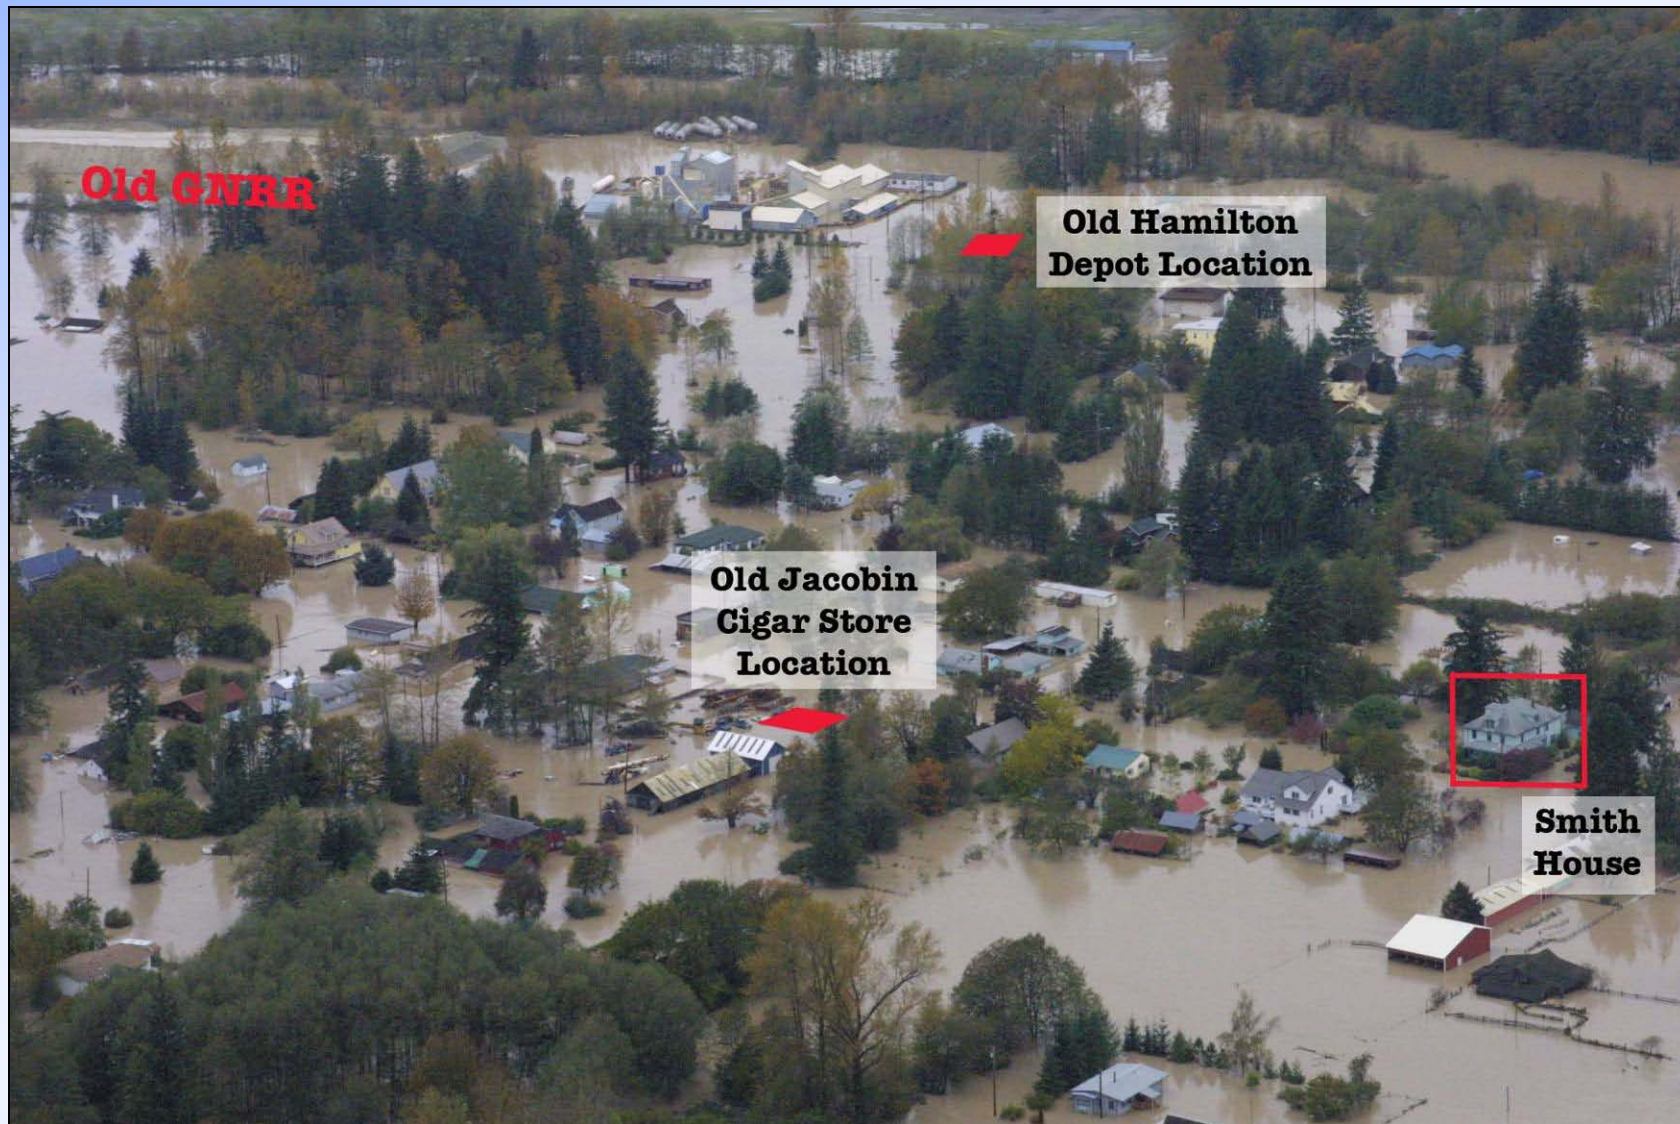
2003 Flood in Hamilton

Photo showing WS El. 98-100, 145,000 cfs
Flood Peak WS El. 99-101, 165,000 cfs at 9:30 am
(photo taken by Skagit County on Oct. 21, 2003, 2:40 pm)

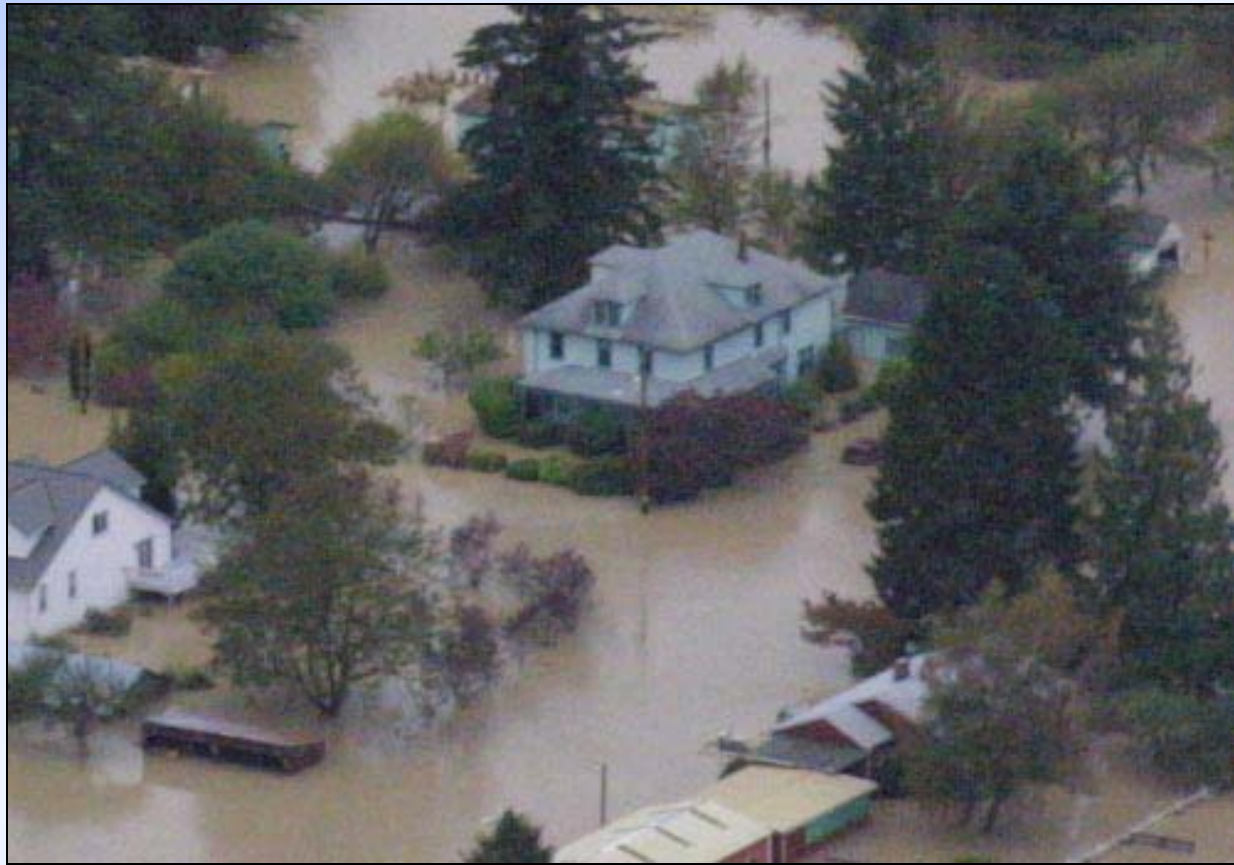
Smith House in Hamilton during Oct. 21, 2003 Flood

Photo showing WS El. 100, 145,000 cfs (2:40 pm)

Flood peak WS El. 101, 165,000 cfs (9:30 am)

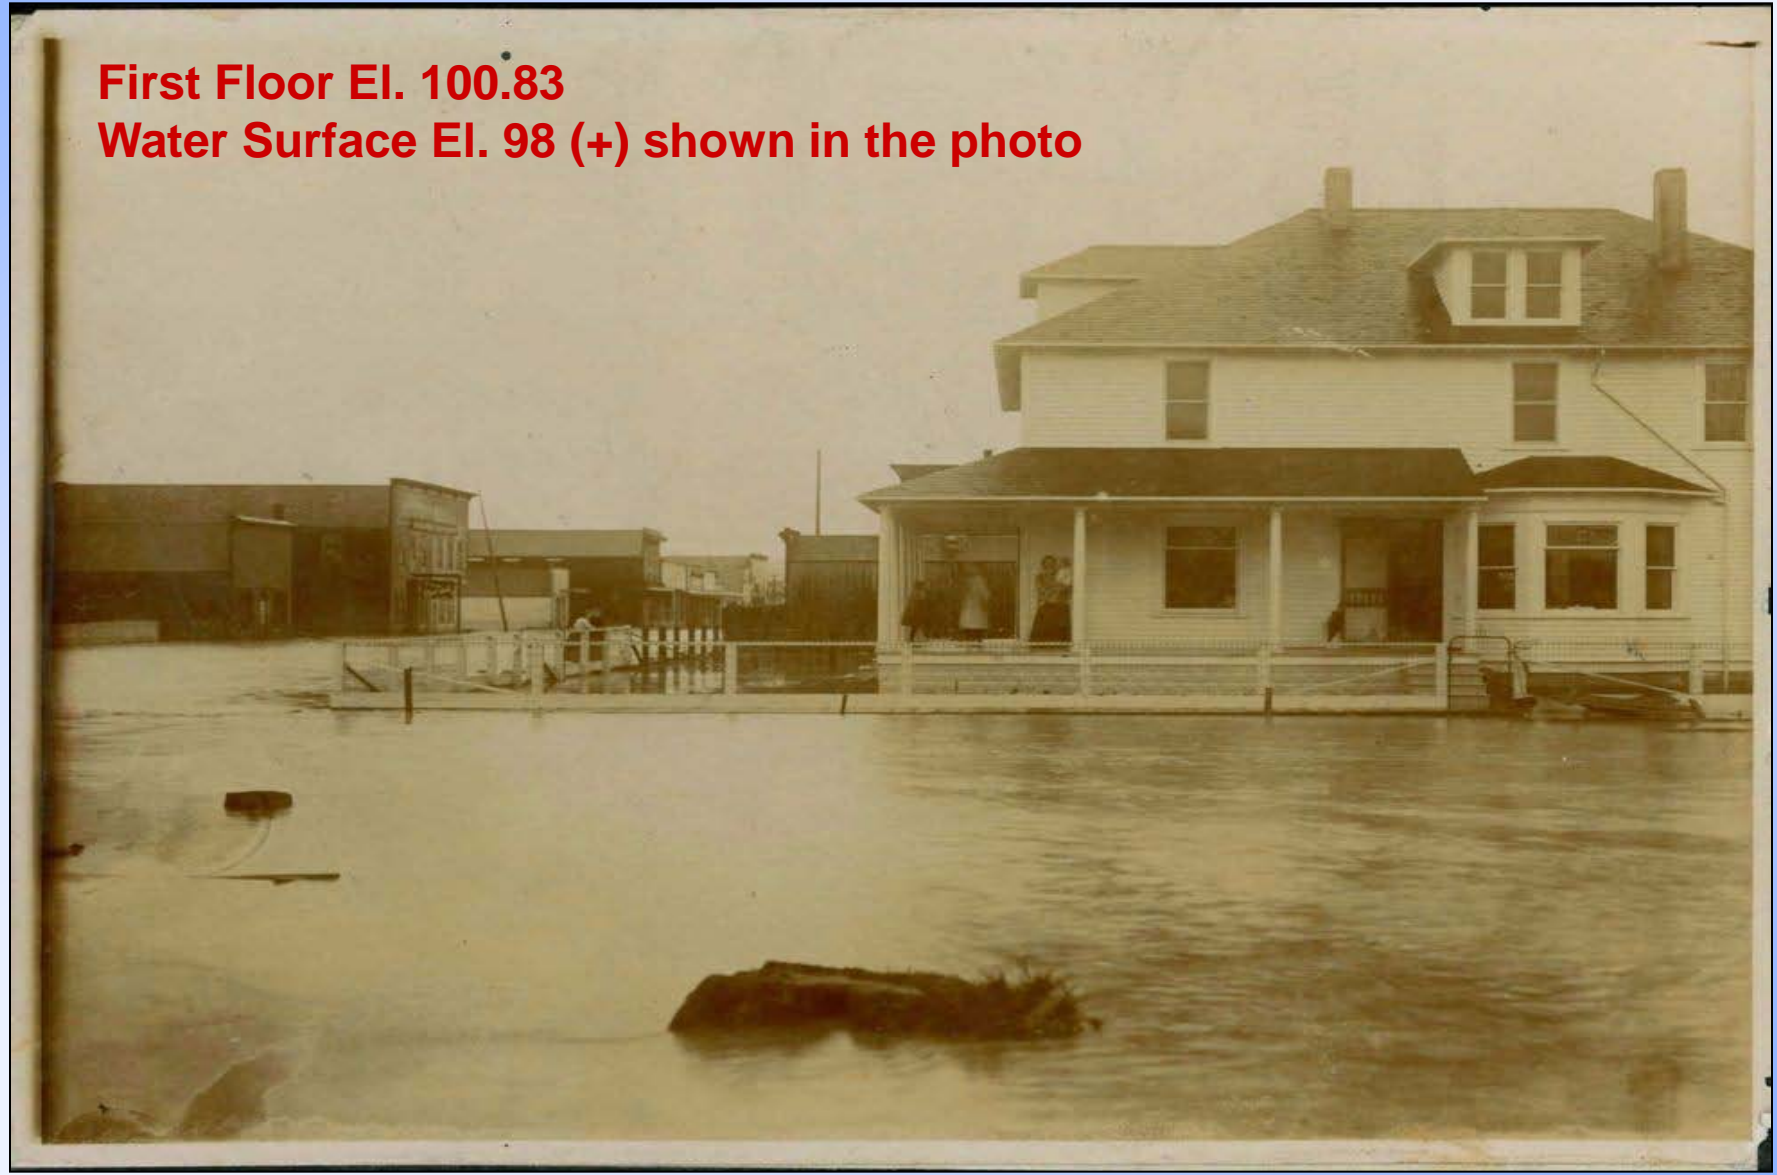
Smith House in Hamilton, undated photograph of the 1909, 1917, or 1921 flood event (Hamilton Museum archives)

First Floor El. 100.83

Water Surface El. 98 (+) shown in the photo

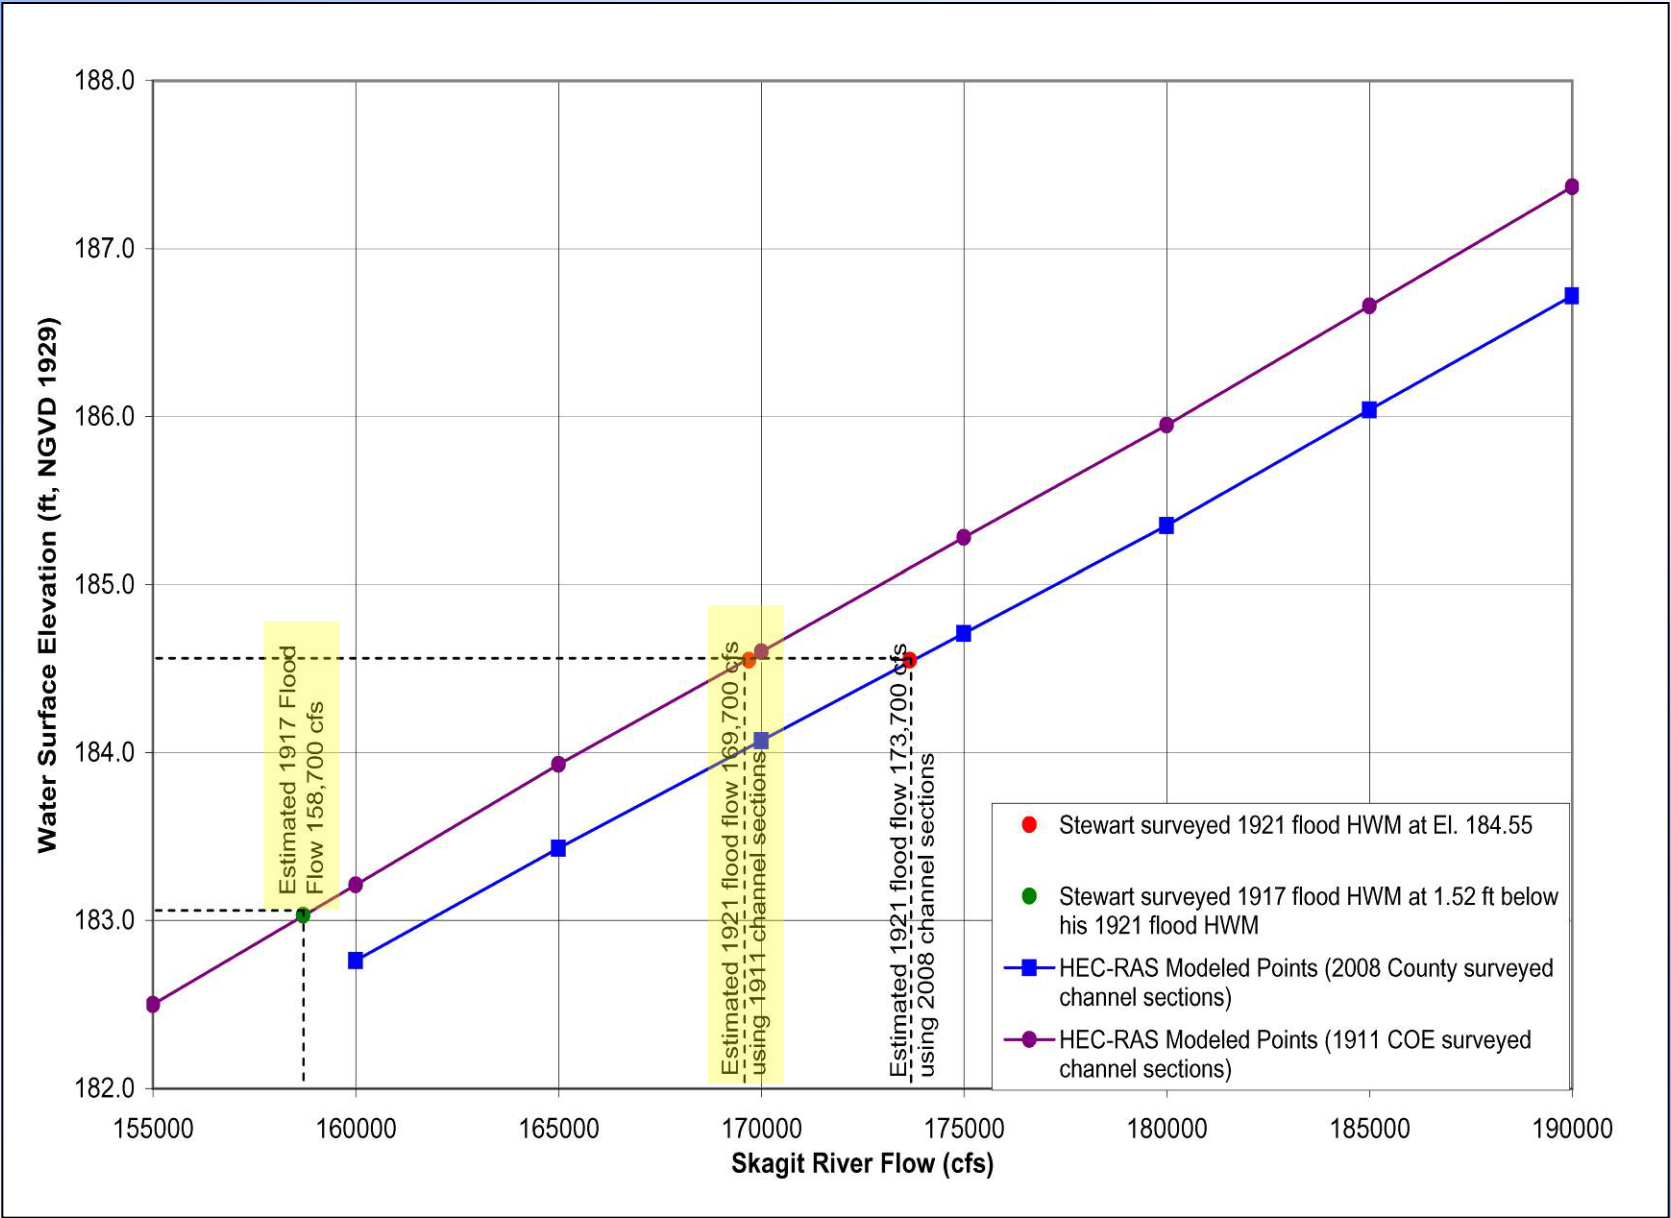
Flood Stage-Discharge Curve at Wolfe Residence in Concrete

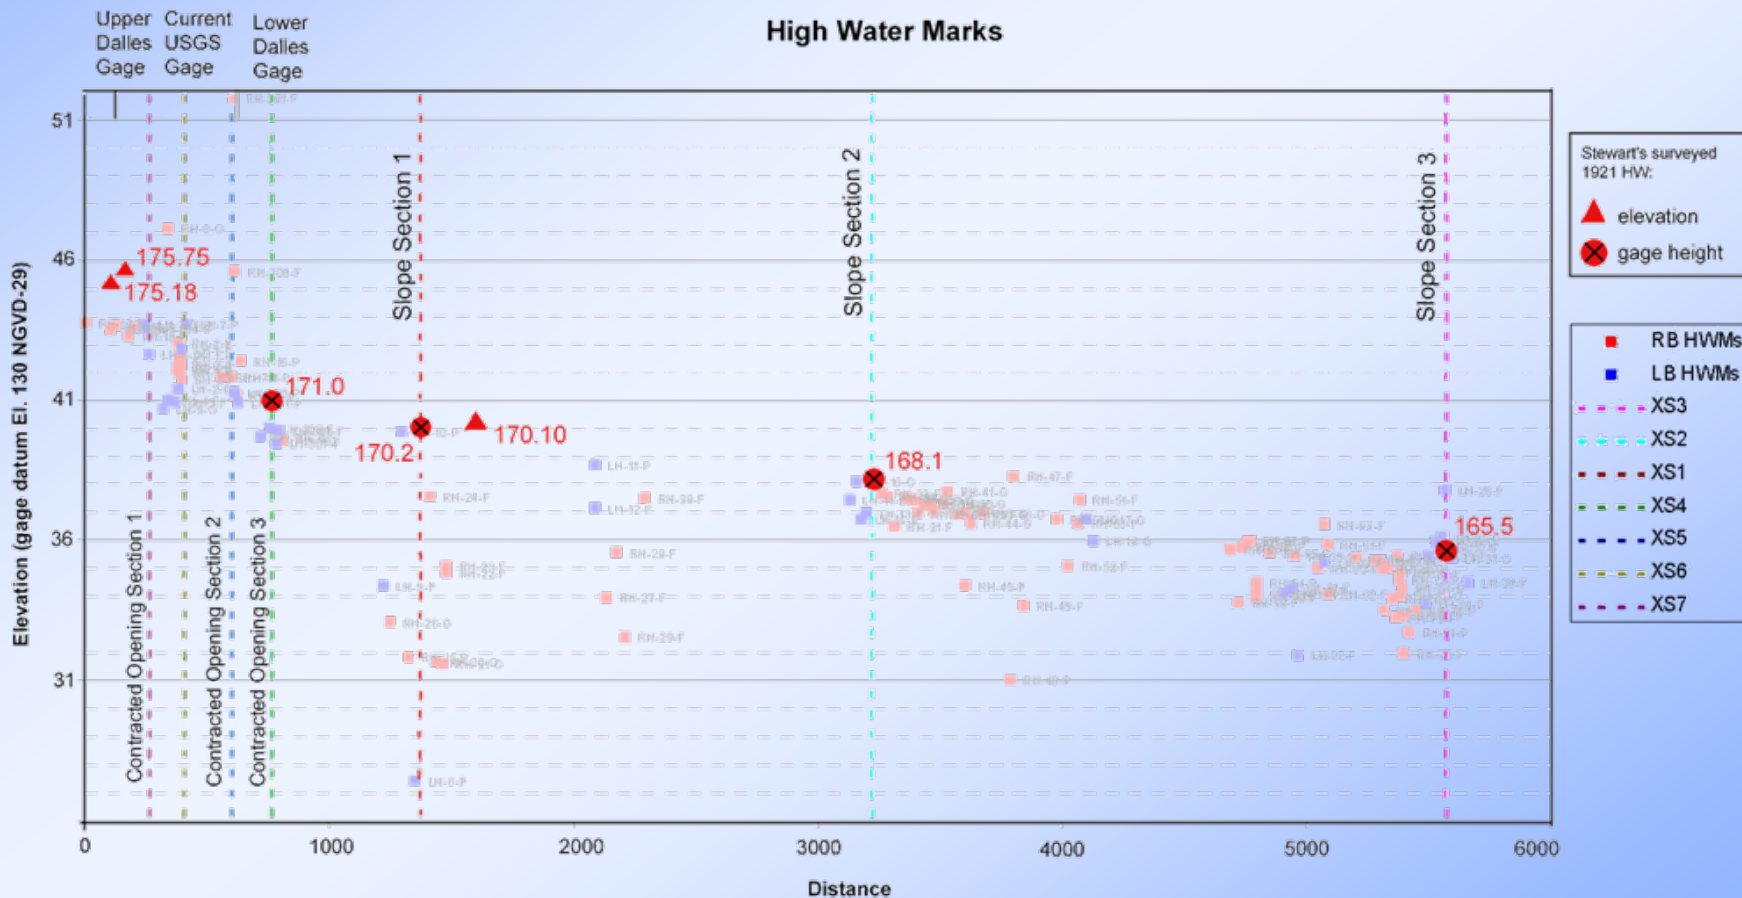
Stewart's Surveyed 1921 High Water Marks in the Dalles

Stewart's surveyed 1921 HW elevations (El.) and elevation differences (h) (quoted from Stewart's survey notes and Exhibit B of his unpublished 1923 report):

- El. 175.75 and El. 175.18 at the upper Dalles gage (notes, pp. 86-87, gage heights added to gage datum El. 140.89)
- El. 170.10 at 865 ft below the lower Dalles gage (notes, pp. 64-65)
- $h = 4.2$ ft for the 560 ft distance between his "contracted opening" section 1 (100 ft below the upper Dalles gage) and section 3 (the lower Dalles gage) (p. 14, Exhibit B)
- $h = 2.11$ ft between his "slope" section 1 (618 ft below the lower Dalles gage) and section 2 (2,479 ft below the lower Dalles gage) (p. 2 & p. 9, Exhibit B)
- $h = 2.62$ ft between his "slope" section 2 and section 3 (4,655 ft below the lower Dalles gage) (p. 2 & p. 10, Exhibit B)
- $h = 4.73$ ft between his "slope" section 1 and section 3 (p. 11, Exhibit B)

Based on these Stewart's numbers, the following 1921 HW elevations were estimated:

- El. 171.0 at the lower Dalles gage
- El. 170.2 at the "slope" section 1
- El. 168.1 at the "slope" section 2
- El. 165.5 at the "slope" section 3

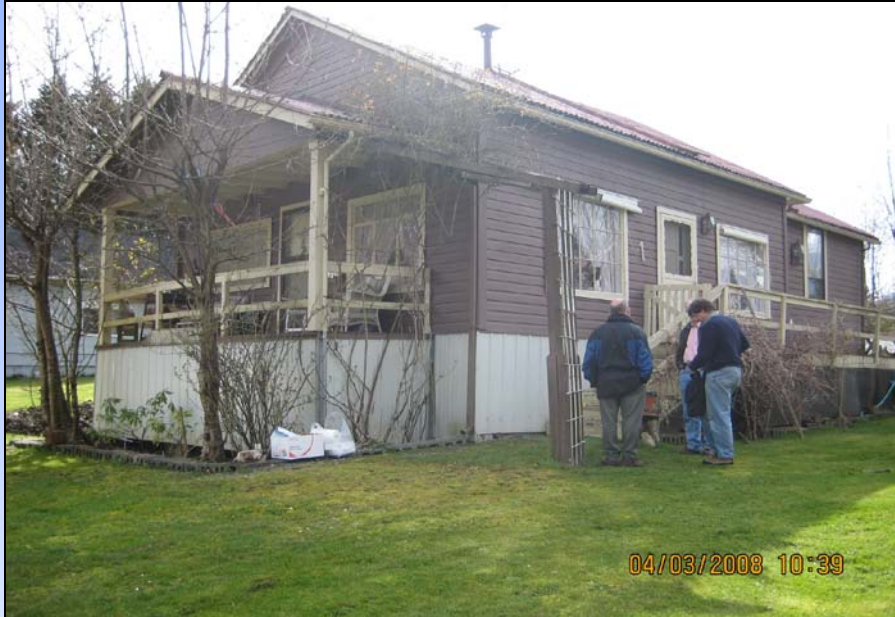
Crofoot Parcels and First Floor Elevations (2008 surveyed by County)

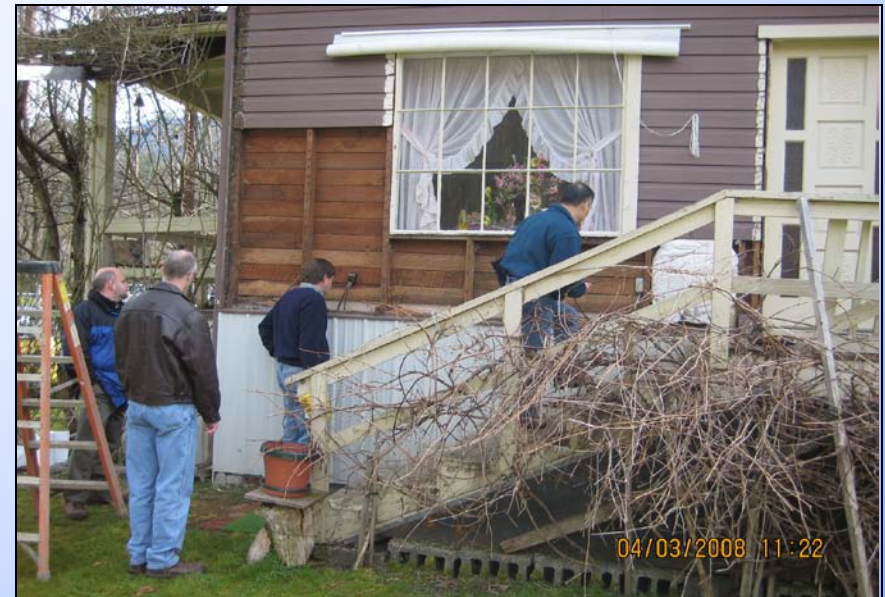
Ripple House #1, parcel #70749

Ripple House #1,
45968 Albert Street,
Crofoot Addition, Concrete

Ripple House #1 with exterior
siding removed for inspection of
interior wall cavity.
First floor elevation 185.51

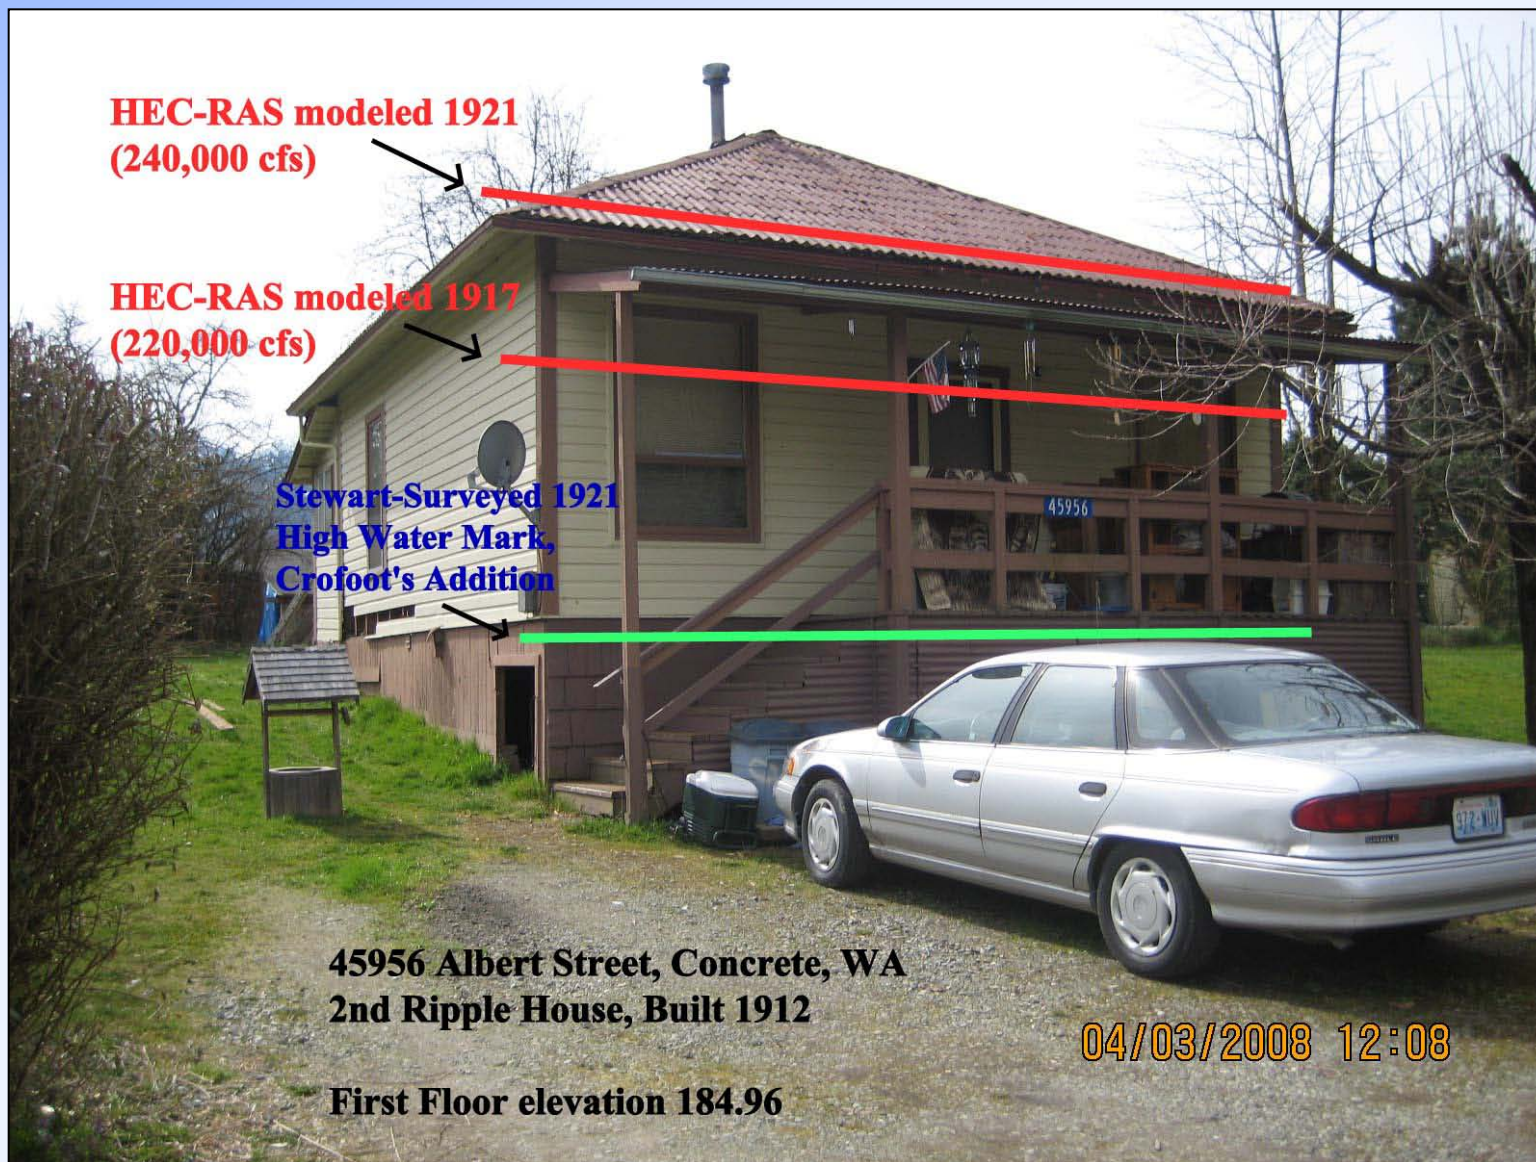
Ripple House #2, parcel #P70748

First Floor Elevation 184.96. Annotated photo showing exterior siding removed for inspection of interior wall cavity

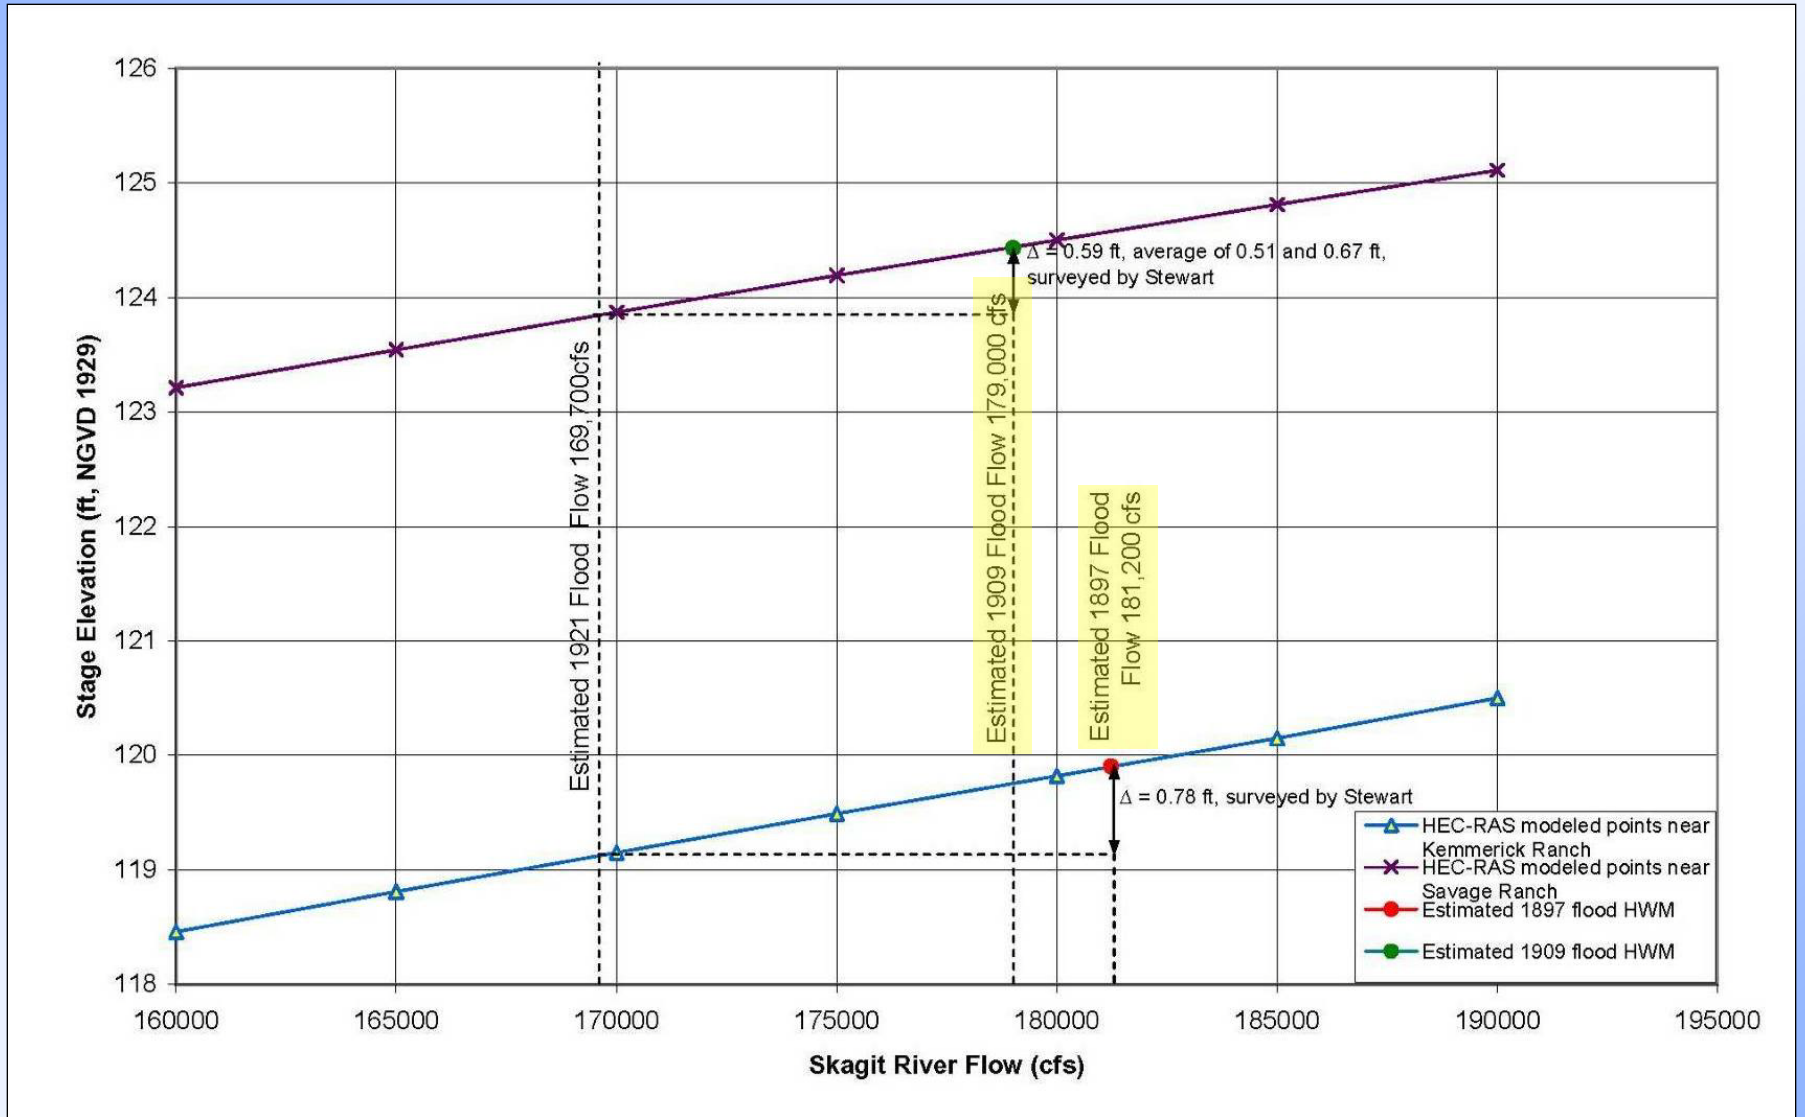
Flood Stage-Discharge Curves at Kemmerick and Savage Ranches near Birdsvie

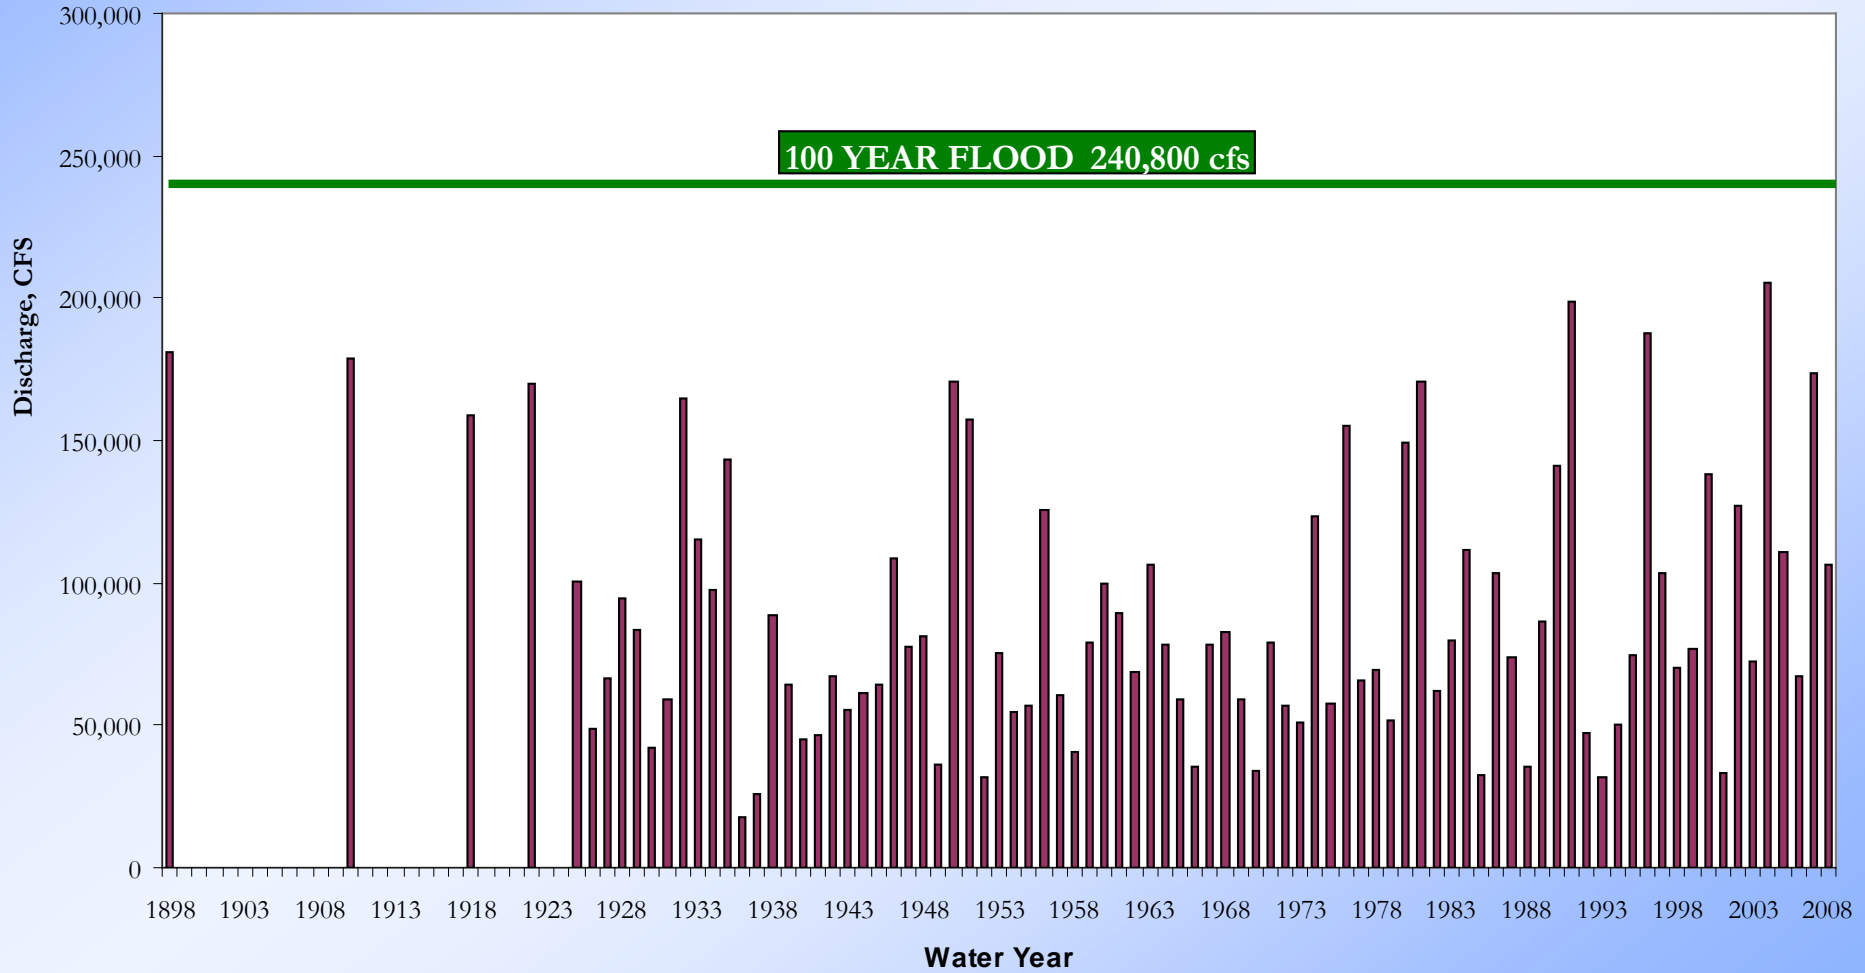
SKAGIT RIVER WINTER UNREGULATED ANNUAL PEAK DISCHARGES (PIE) Water Year 1898 to 2008 - USGS Gage near Concrete, WA

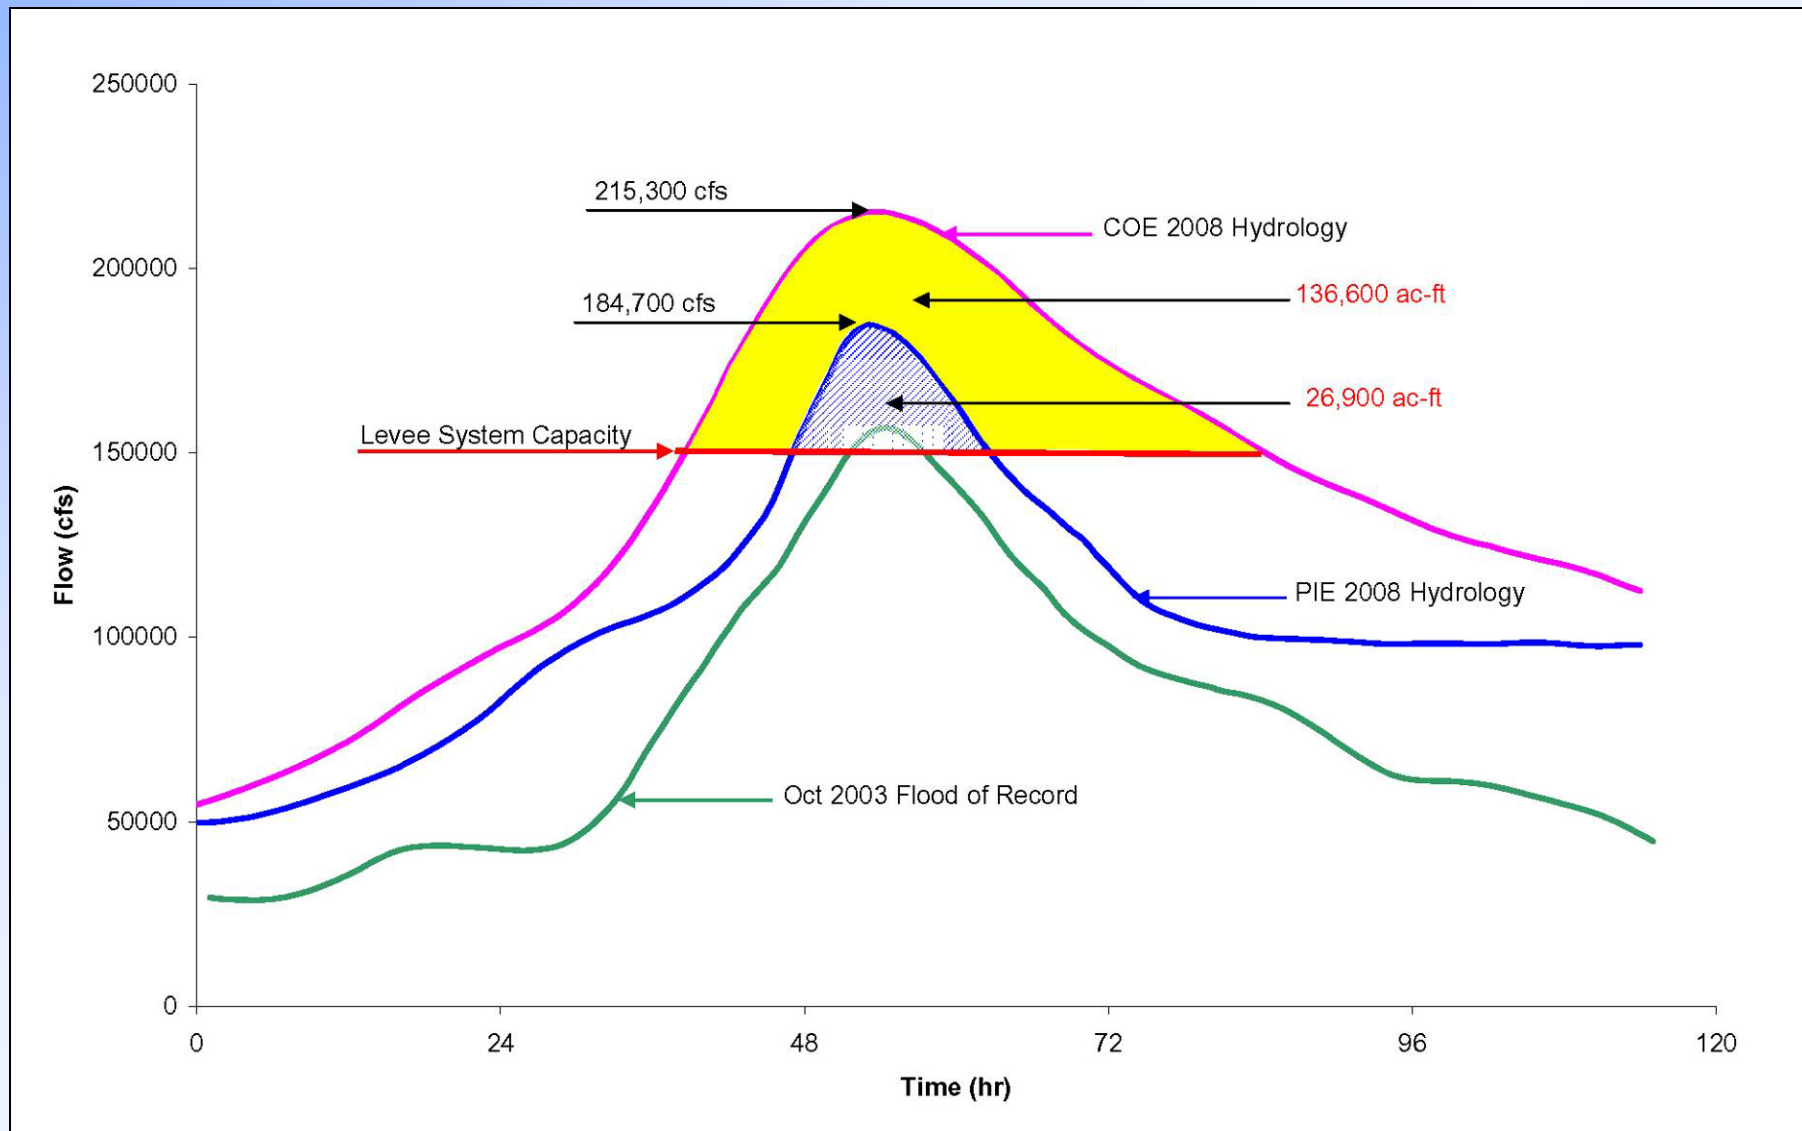
FEMA 100-Year Flood Hydrographs at Sedro Woolley (with existing flood storage)
