Skagit River Hydrology Issues

Presented to the Burlington City Council July 24, 2008

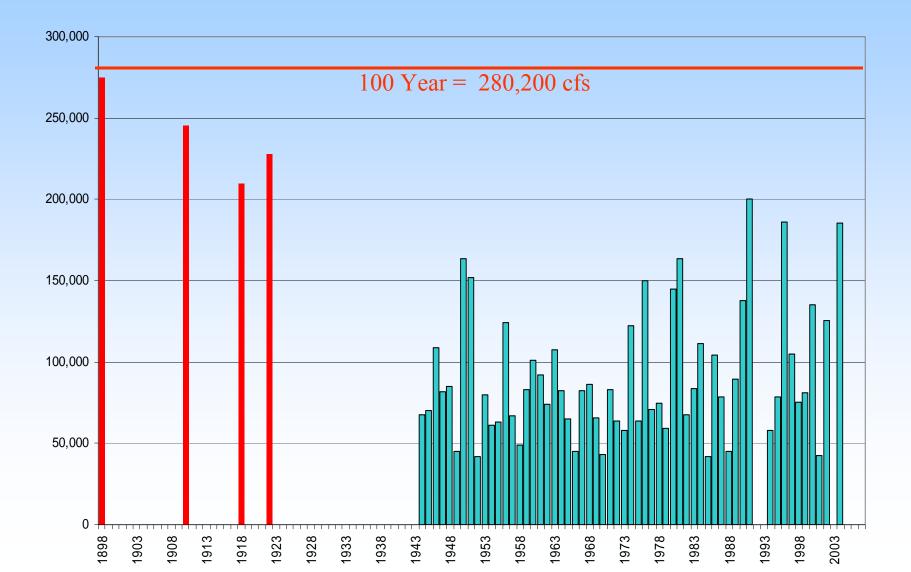
Winter Unregulated Annual Peak Flows Skagit River Near Concrete: Corps of Engineers Data Set (November 2005)

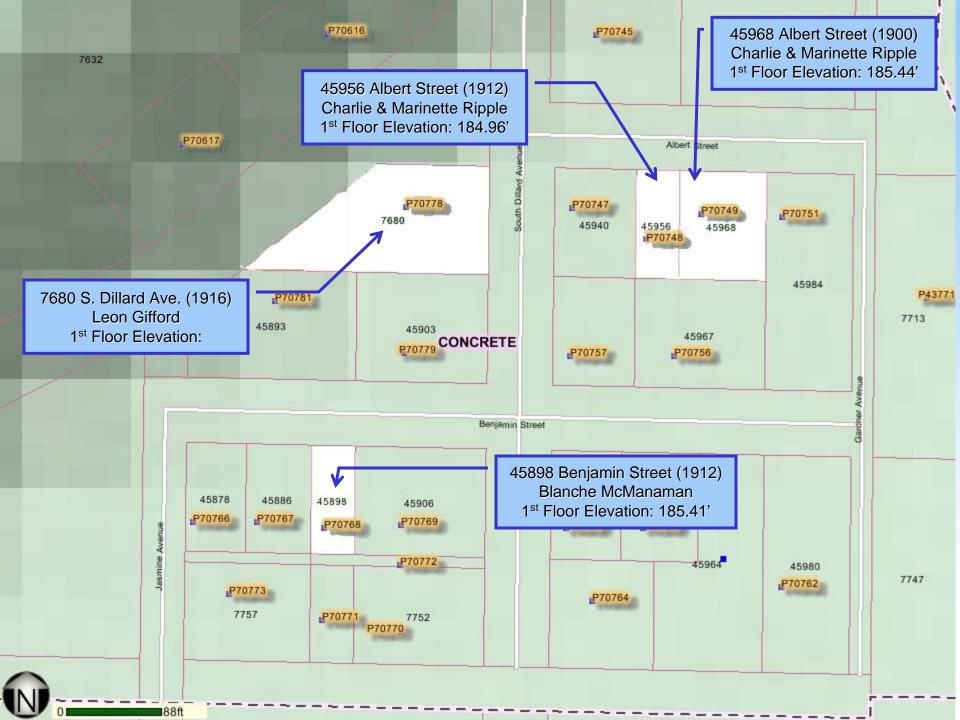
Ripple House, Built 1900 First Floor Elevation 185.44 (1921 Stewart mark at Wolfe residence 183.55) 1909 Theoretical Water Level – 193.4)

R-4	Wood chip	Board sheathing West ext. wall opening	Moderate deposits of silt-size siliceous mineral grain insect parts, and other biological materials	
R-5	Wood chip	Board sheathing West ext. wall opening	Traces of dust to silt-size mineral grains and biological materials	
R-6	Wood chip	Board sheathing West ext. wall opening	Moderate deposits of insect parts and other biological materials, traces of dust-size mineral grains	
R-7	Wood chip	Board sheathing West ext. wall opening	Moderate deposits of insect parts and other biological materials, traces of dust-size mineral grains

Preliminary Conclusion: Possibly flooded above FF, but unsure if house was elevated and also, forensic evidence is inconsistent (see sample D10)

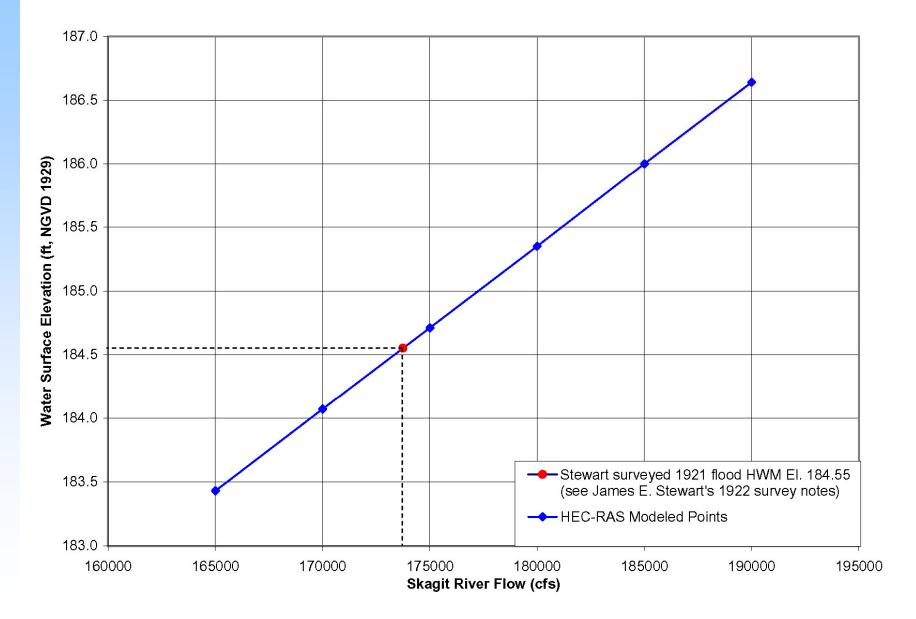
Flood Stage-Discharge Curve at Wolfe Residence in Concrete

Hydraulic model shows a peak discharge for the 1921 flood of 174,000 cfs, based on Stewart's survey notes from 1922 – peak flood elevation of 184.55 feet

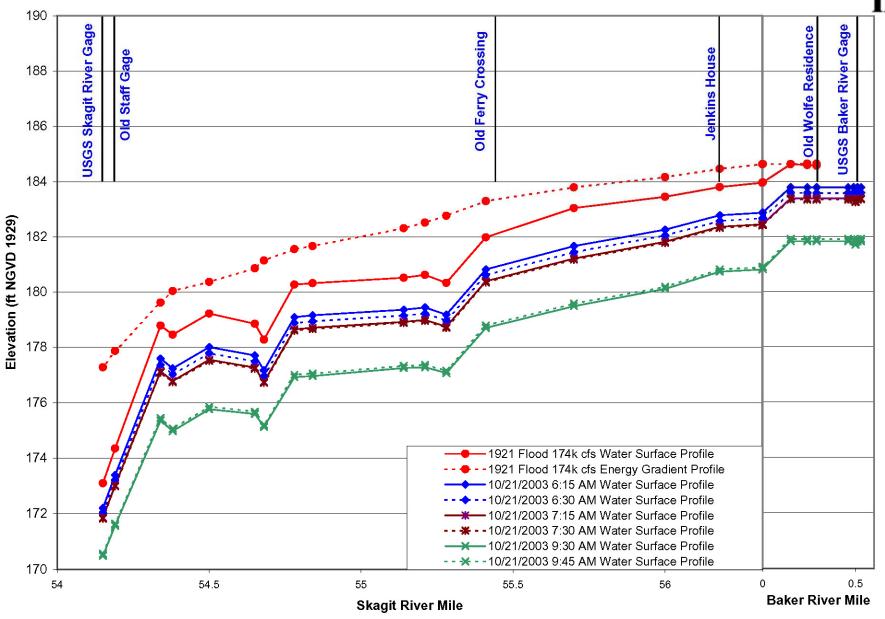
HEC-RAS Modeled Flood Profiles

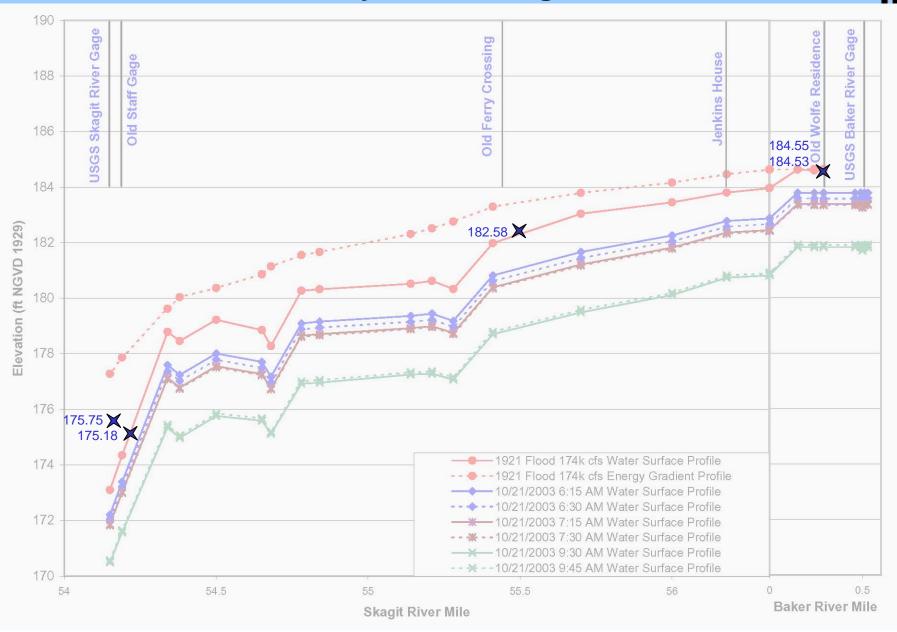
Stewart Surveyed 1921 High Water Marks

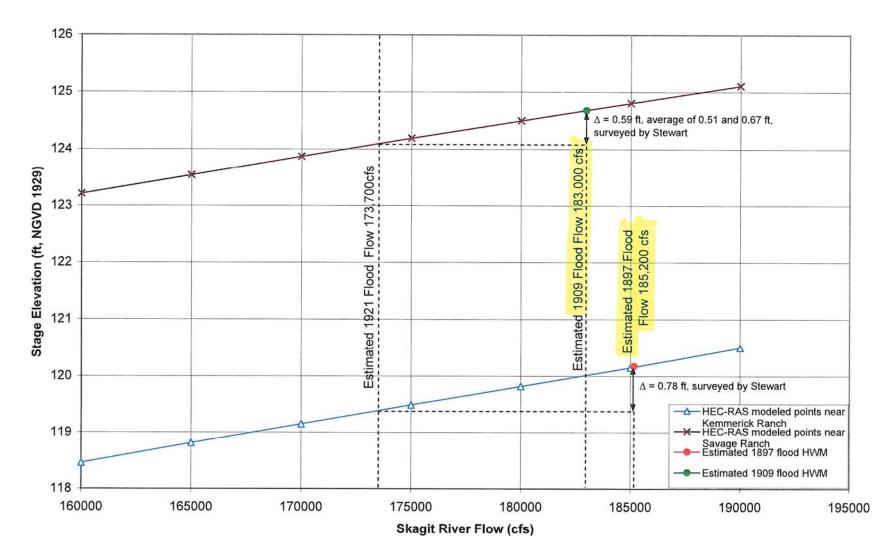
Flood Stage - Discharge Curves at Kemmerick and Savage Ranches near Birdsview

- Extend hydraulic model from a known stage/discharge at Concrete (2003 166,000 cfs)
- Dial Stewart's actual 1922 survey marks into the hydraulic model to obtain the discharge of the 1921 and 1917 events
- Use existing model and Stewart's surveyed high water marks to determine the 1897 and 1909 flood discharges
- Results:
- 1921: 173,700 cfs
- 1917: 162,100 cfs
- 1909: 183,000 cfs
- 1897: 185,200 cfs

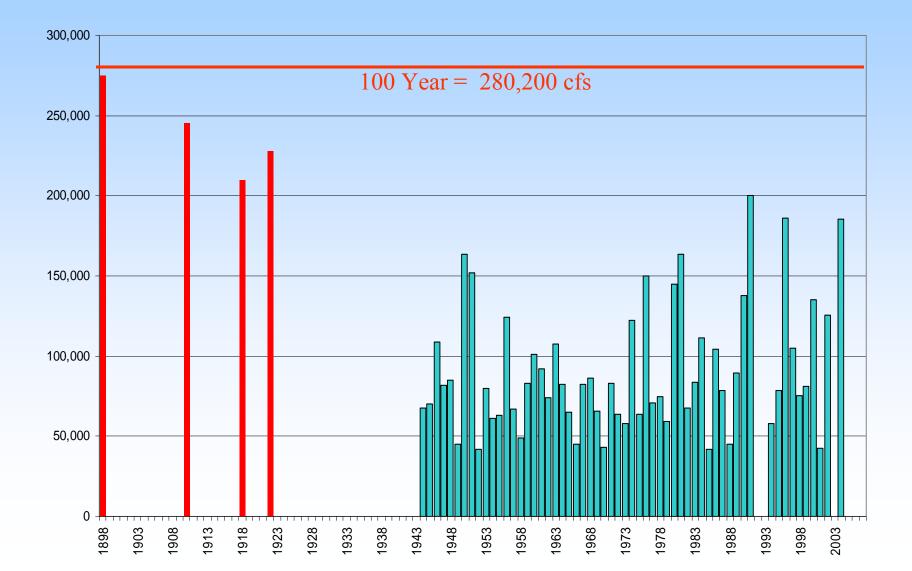
Winter Unregulated Annual Peak Flows Skagit River Near Concrete: Corps of Engineers Data Set (November 2005)

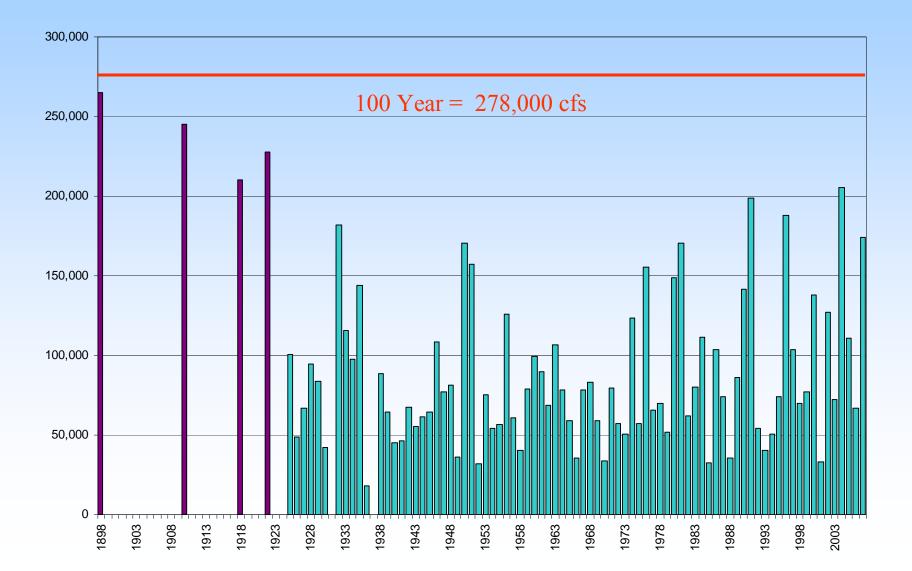
Skagit River <u>Winter Unregulated</u> Annual Peak Flows Concrete – COE Frequency Distribution (April 2008)

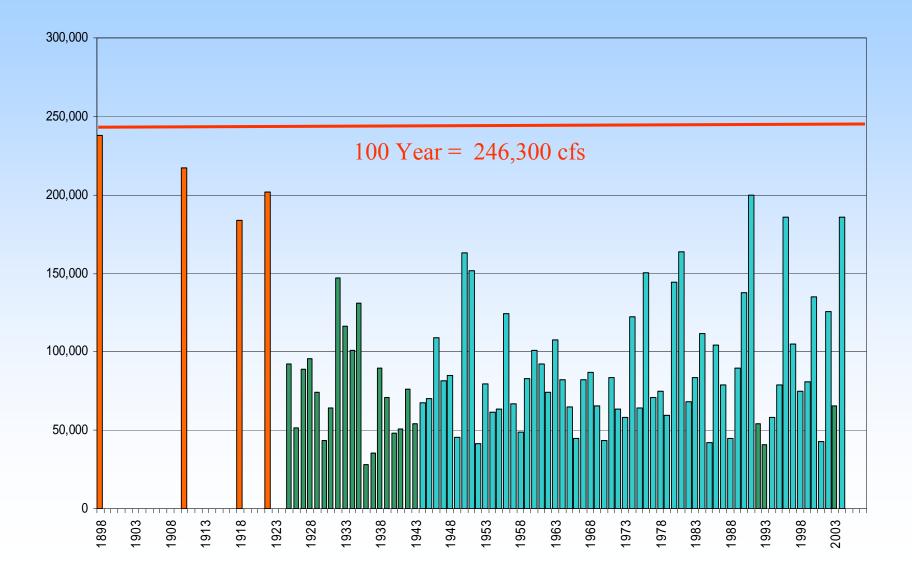
Winter Unregulated Annual Peak Flows Skagit River Near Concrete: PI Engineering Data Set (December 2005)

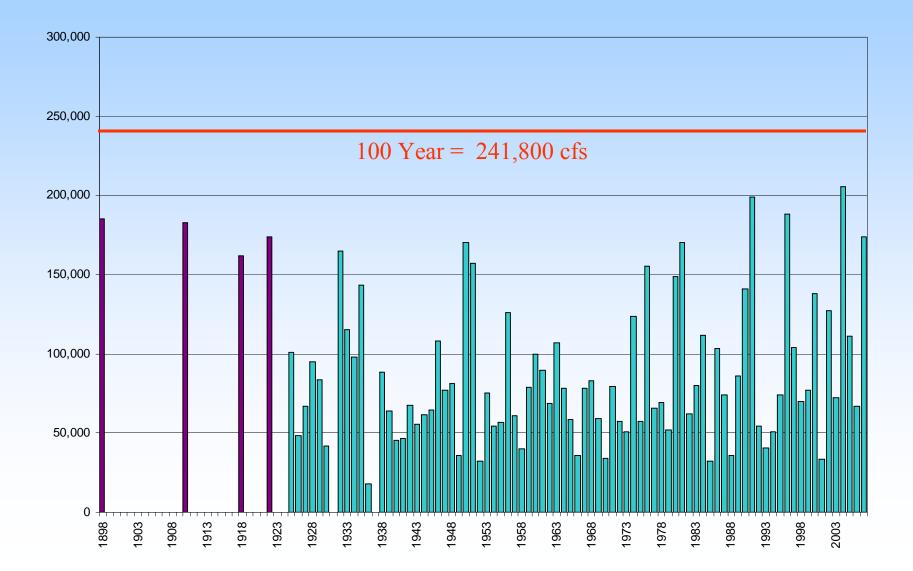
Winter Unregulated Annual Peak Flows Skagit River Near Concrete: Draft PI Engineering July 2008

- Historic peak flows
 - 1921: 173,700 (maybe 170,000)
 - 1917: 162,100
 - 1909: 183,000
 - 1897: 185,200
- 1932 165,000 (not 182,000)
- Peak to 1-day flow ratio 1.21 instead of COE's
 1.18

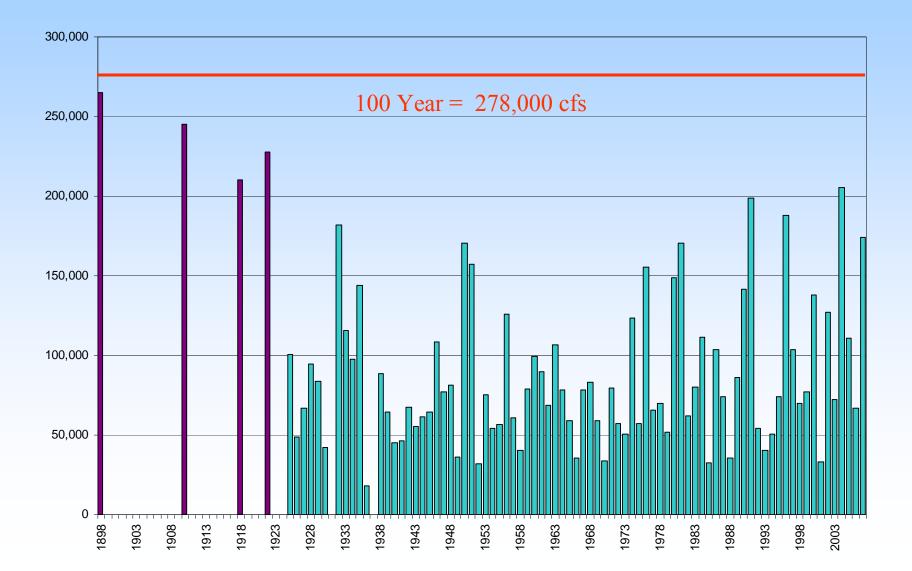
Skagit River <u>Winter Unregulated</u> Annual Peak Flows Concrete – COE Frequency Distribution (April 2008)

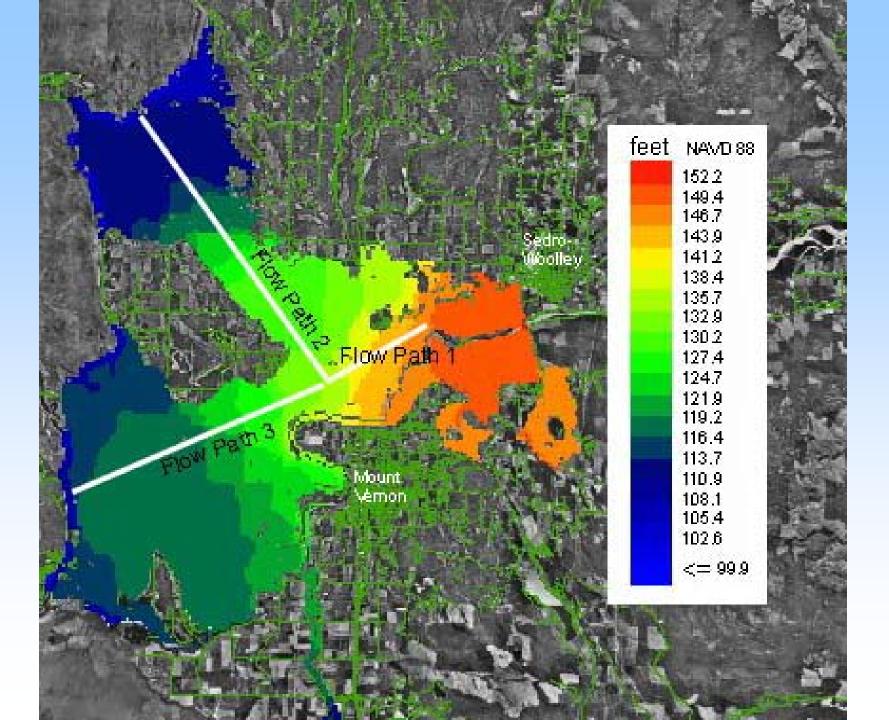
There are 5 floodplain flow paths that are used to develop water surface profiles in the overbank areas in the lower basin below Sedro-Woolley. Figures 24, 25, and 26 show the locations of these flow paths. These flow paths are delineated by attempting to follow the quickest drop to the sea which defines the most likely path the overbank flows will follow.
