Chapter 6 - Flood History in the Skagit River Basin

Skagit River Comprehensive Flood Hazard Management Plan - DRAFT

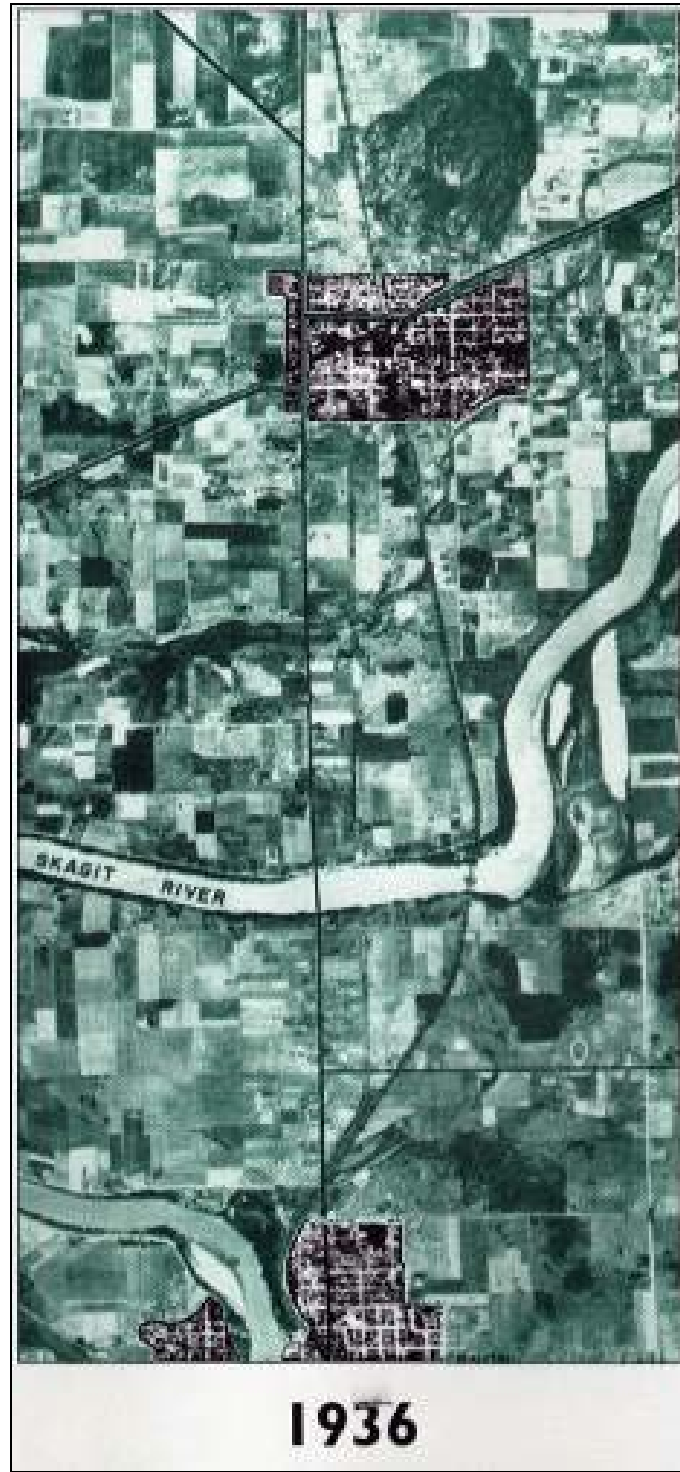
Picture above depicts the City limits of Burlington in 1936. The reference in the article above to “nearly a mile south of Burlington” would have put the break in the general vicinity of Gages Slough.

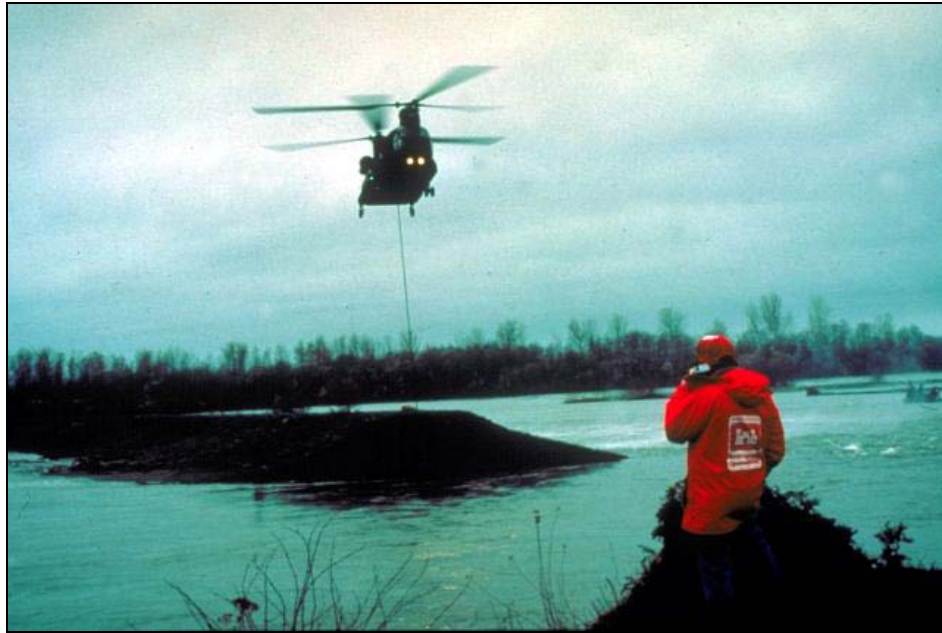
Levee Break on Fir Island (2001)
(Courtesy of U.S Army Corps of Engineers)

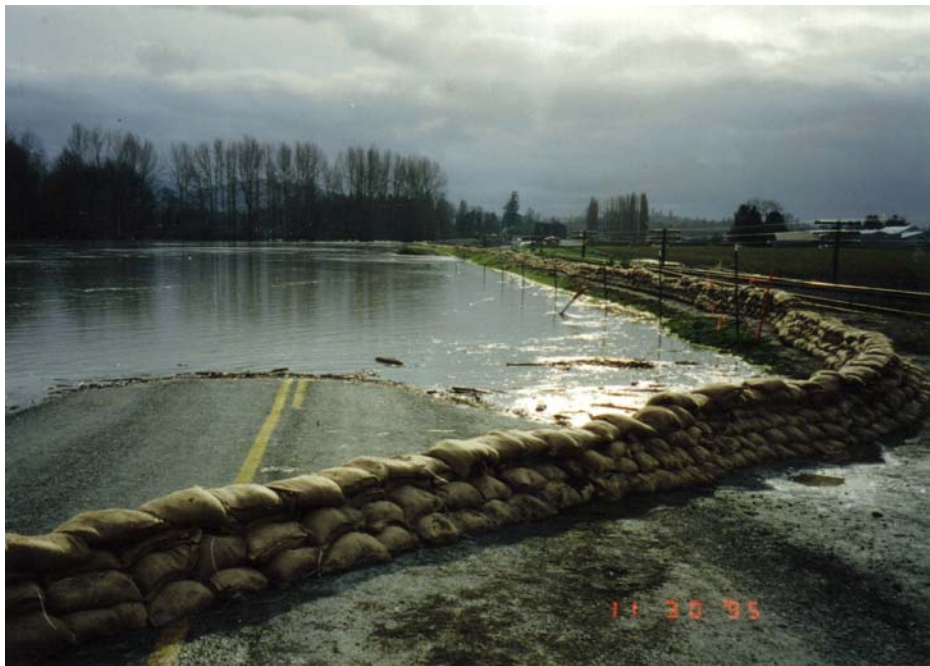
Sandbagging along Whitmarsh Road, Burlington, WA
(Courtesy of Dike District 12)

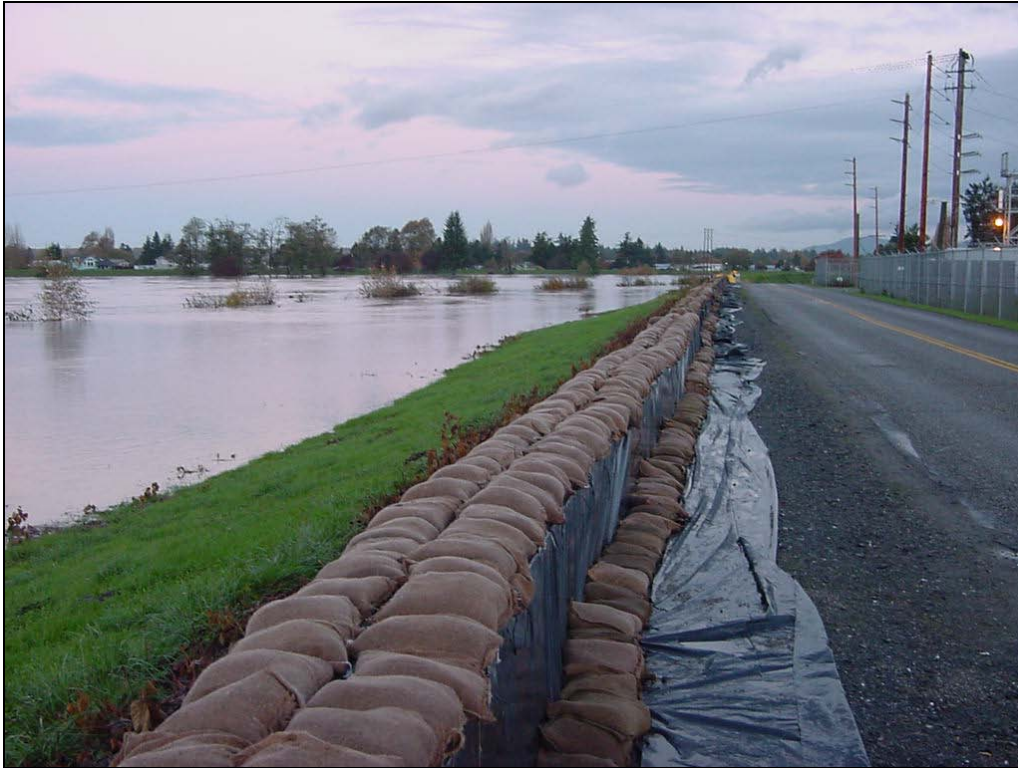
Flood Fighting Efforts to Save Water Treatment Plant
(Courtesy of Willy LaRue, City of Anacortes, WA)
