REPORT OF LAND DAMAGE IN  
SKAGIT SOIL CONSERVATION DISTRICT  
SKAGIT COUNTY, WASHINGTON

FEBRUARY 9-13, 1951

PHOTOS ON FLOOD OCCURRING IN  
SKAGIT SOIL CONSERVATION DISTRICT  
February 9-13, 1951

The following photos have been compiled to show a cross-section of the scope and damage caused by the flood which occurred in the Skagit Soil Conservation District February 9-13, 1951. This report supplements the narrative and statistical report previously submitted.

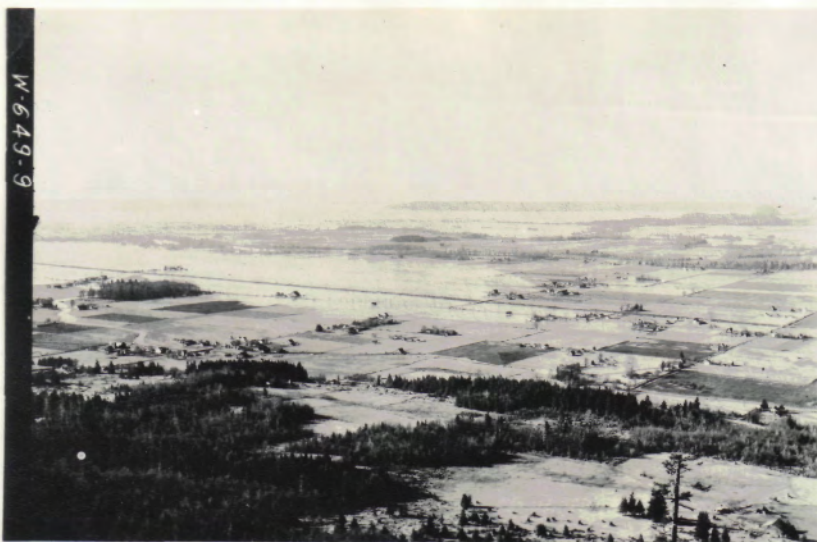
W-649-9

Looking southeast from Little Mountain near Mount Vernon, showing Highway 99 and adjoining cropland under water to a point one mile south of Mount Vernon. The area of Fir Island west of Dry Slough is under water in center background.

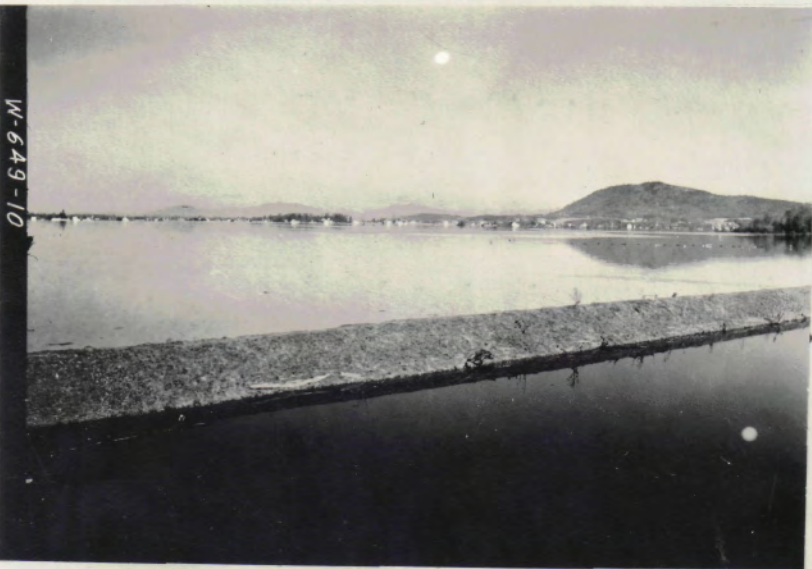
W-649-10

Looking north from high ditch near point one mile east of Conway, showing cropland under water. Little Mountain in right background.

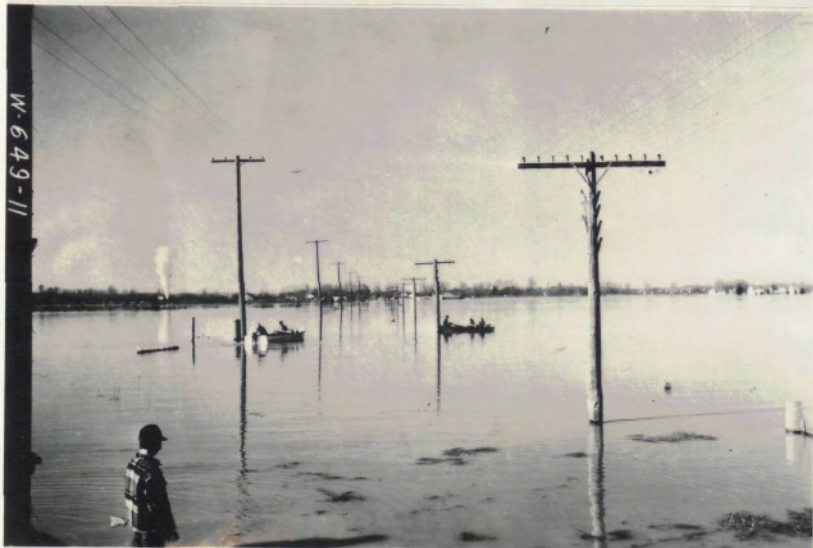
W-649-11

Looking west from point near Conway grade school toward Conway, showing Conway-McMurray highway under water. Farmsteads were accessible to farmers only through use of boats. This section of highway was under water seven days, after which it was used as a detour for Highway 99 traffic.

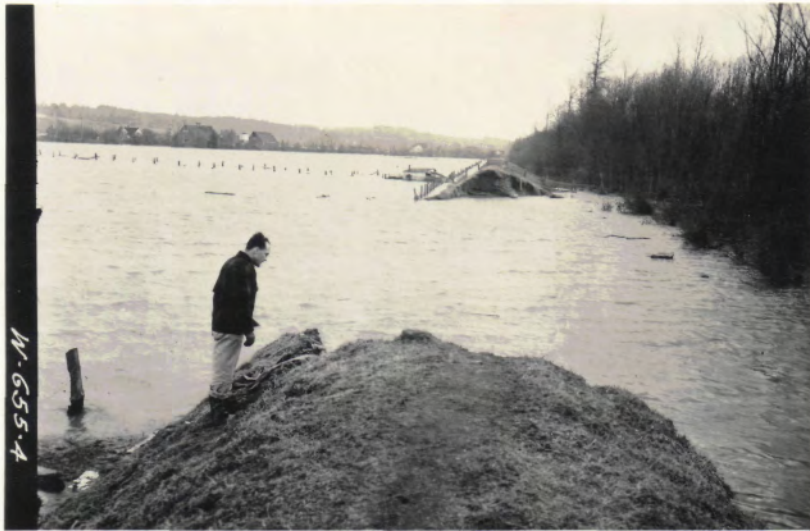
At Conway the dike on the east side of the South Fork of the Skagit river broke, inundating an area extending from approximately one mile south of Mount Vernon to an area south of Stanwood in Snohomish county. More than 250 Skagit county homes were damaged to an extent of \$500,000 as a result of the high water.

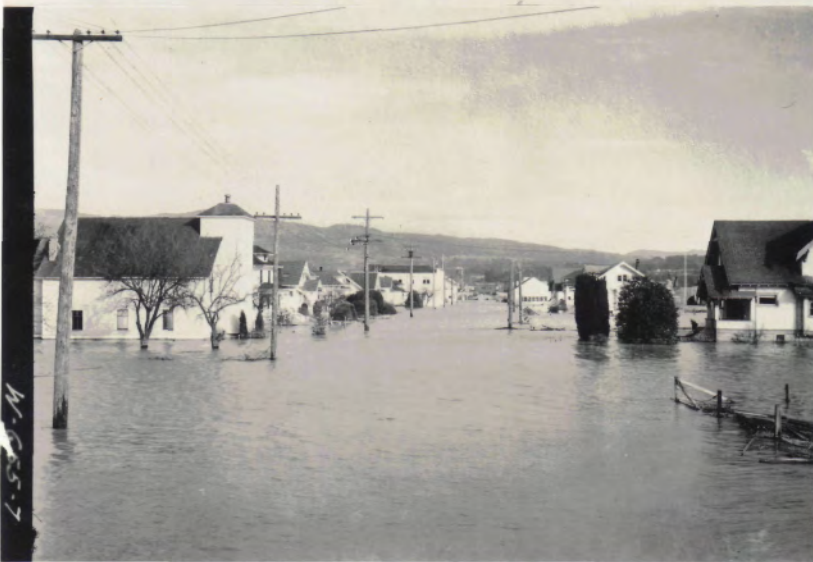
Looking east down main street in Conway showing high water on February 14th. Water remained high in the Conway area for approximately 10 days. Many homes and farmsteads were inaccessible except by boat during this period.

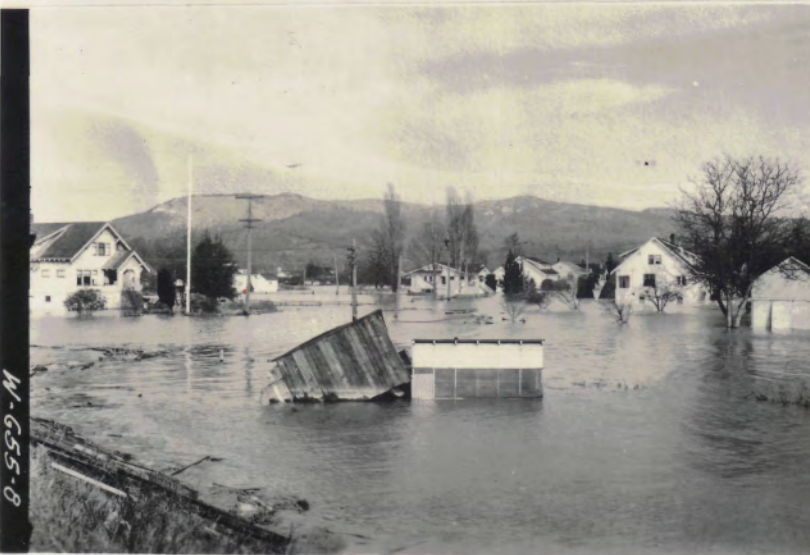
A few small buildings were moved by the flood at Conway. Many older homes in this area had first floors above the water line. Lack of electric power and domestic water supply added to the inconveniences caused by the flood.

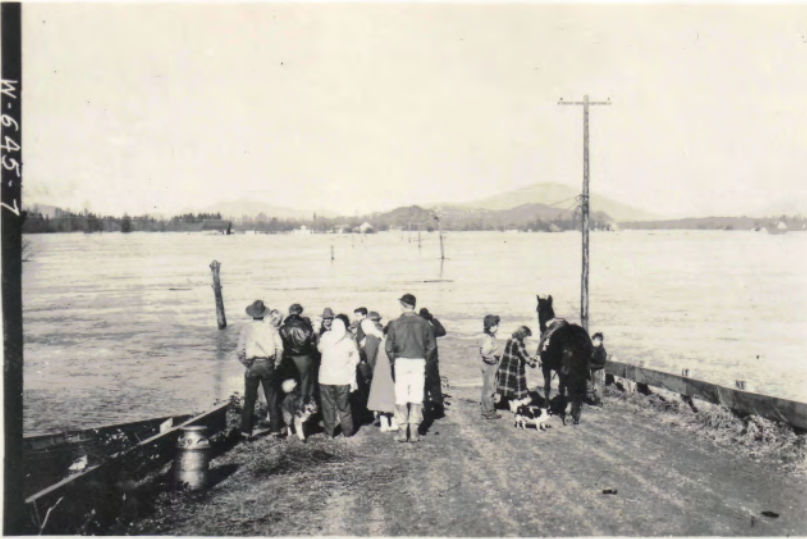
W-645-7

Looking north down County highway in Nookachamps area three miles northeast of Mount Vernon. This undiked area provides a flood basin for the Skagit river at high water. Road was inundated to a depth of eight to ten feet.

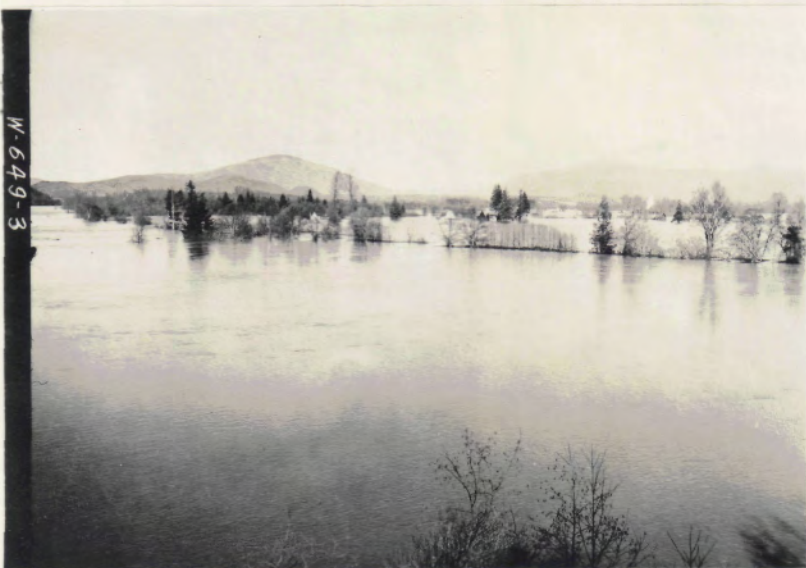
W-649-3

Looking northeast across Nookachamps creek, showing vast flooded area extending from near Burlington to Clear Lake and Beaver Lake area.

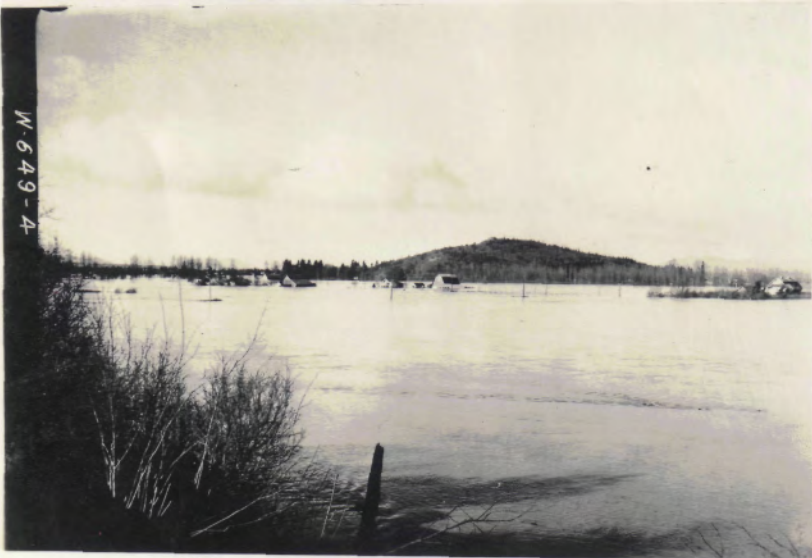
W-649-4

Looking northwest across Nookachamps basin toward Burlington hill. Continuing high water completely filled this storage basin, causing lower river to rise higher than the 1949 flood.

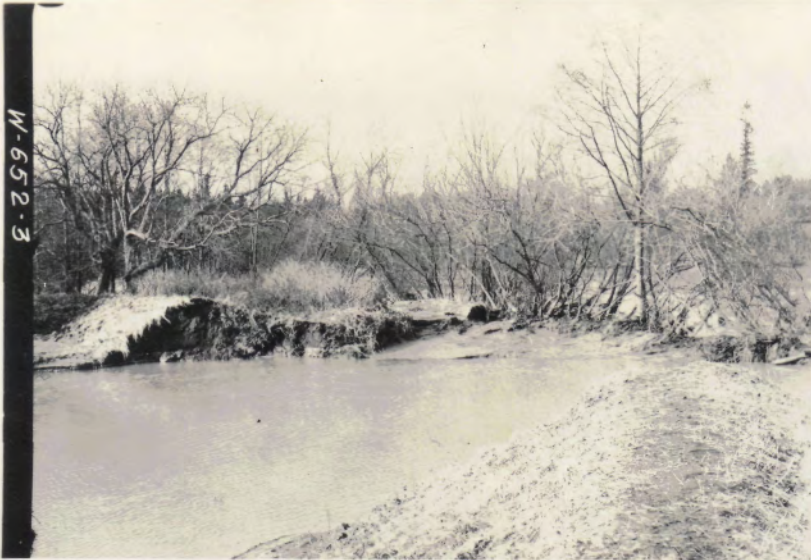
Dikes along the Skagit river from Burlington to the mouth of the river were severely taxed at many points. Emergency sandbagging prevented many breaks. The Moore dike break below the North Fork bridge flooded the west half of Fir Island.

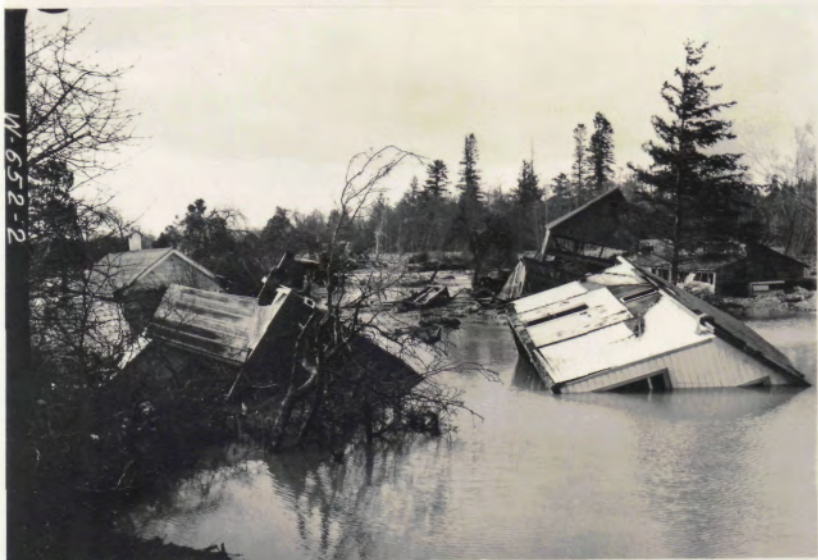
At the Moore farm the water destroyed the house, barn and machine shed. Parts of these buildings were carried away as swirling waters cut into the subsoil.

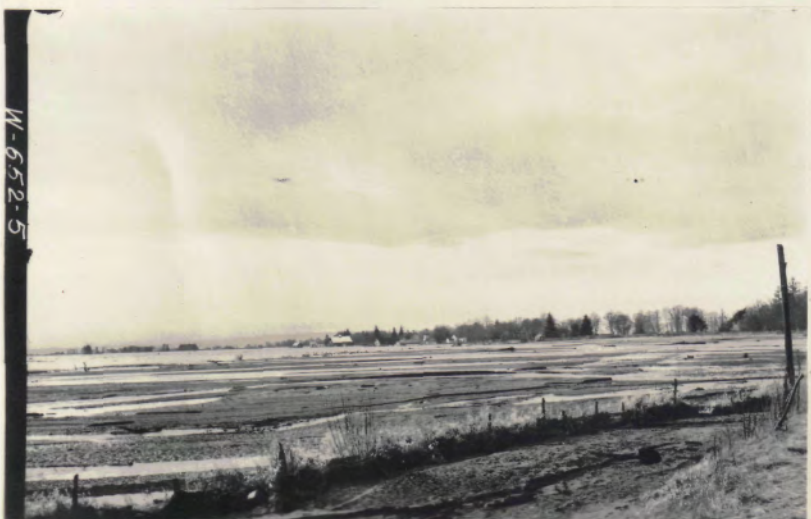
On February 12th extreme high water on Fir Island had receded, leaving deposits of coarse sand, debris and silt on the land. Water still remained on lower lying areas. Skagit river course is adjacent to trees in right.

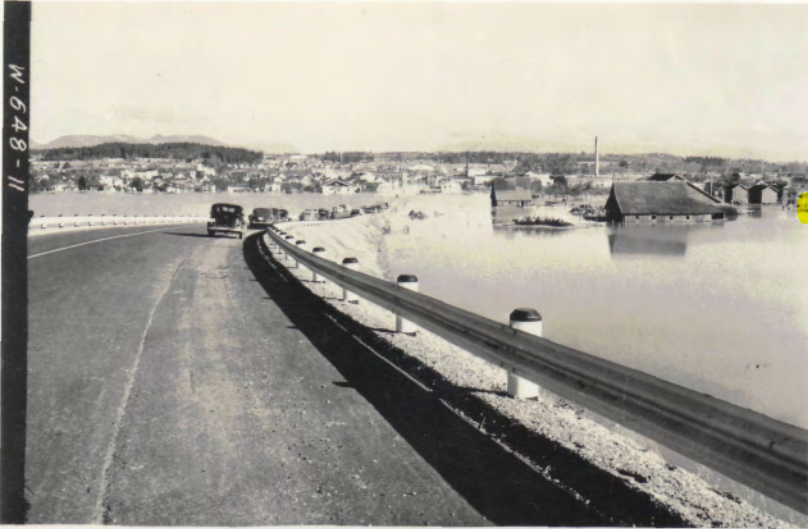
Skagit river flood water did extensive damage in the Stanwood area five miles south of the Skagit County line. Looking east toward Stanwood and East Stanwood from Camano Island viaduct, showing extensive damage to farmsteads, business and residential property.

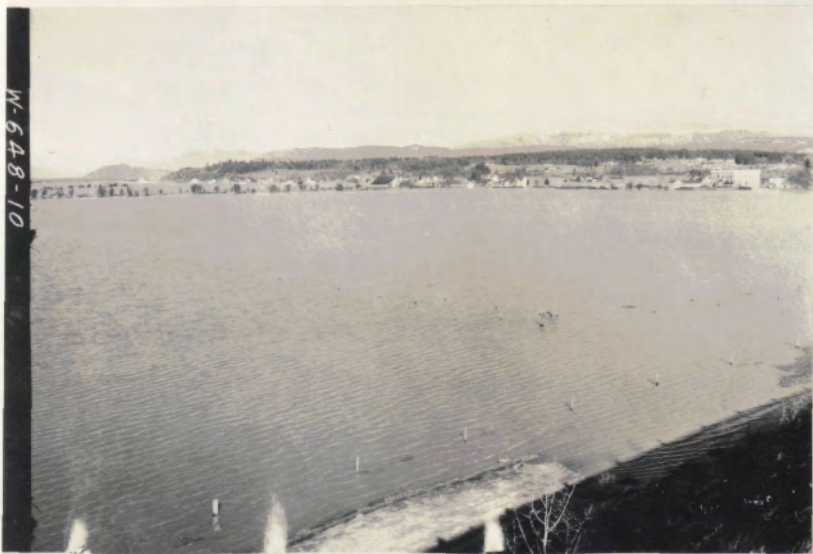
Looking northeast from Camano Island viaduct across fertile bottomland soils toward Mount Baker and up-river watershed which contributed to flood.

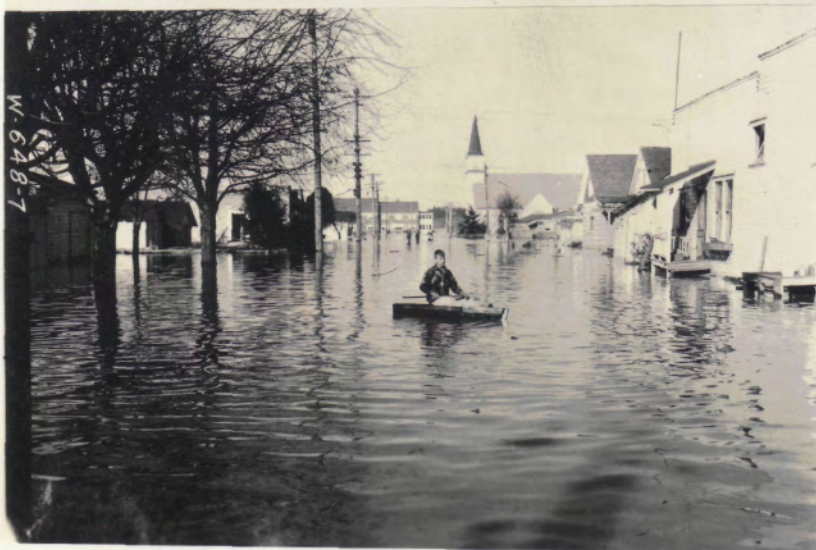
Looking up Stanwood street showing high water.

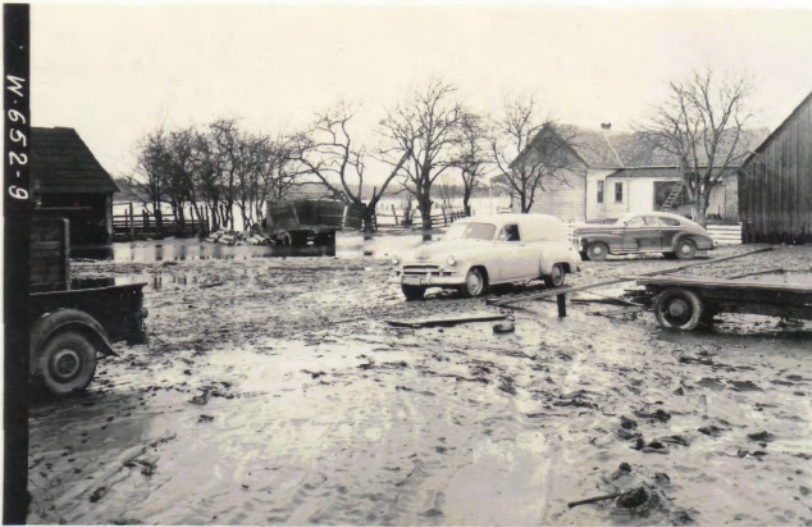
W-652-9

Livestock with a value of \$25,000 or more was lost. The flood warning system and the cooperation of persons with equipment for moving livestock prevented losses from being higher. On the Van OsenBrugger farm flood waters reached the height of approximately four feet.

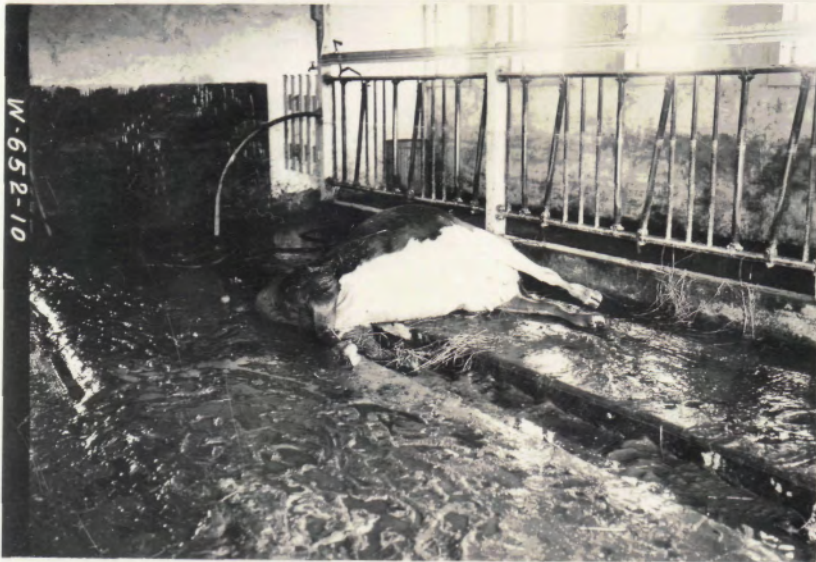
W-652-10

Thirty-five Guernsey dairy cattle were lost on the Van OsenBrugger farm which became isolated as a result of dike breaks at the North Fork bridge and Dry Slough.

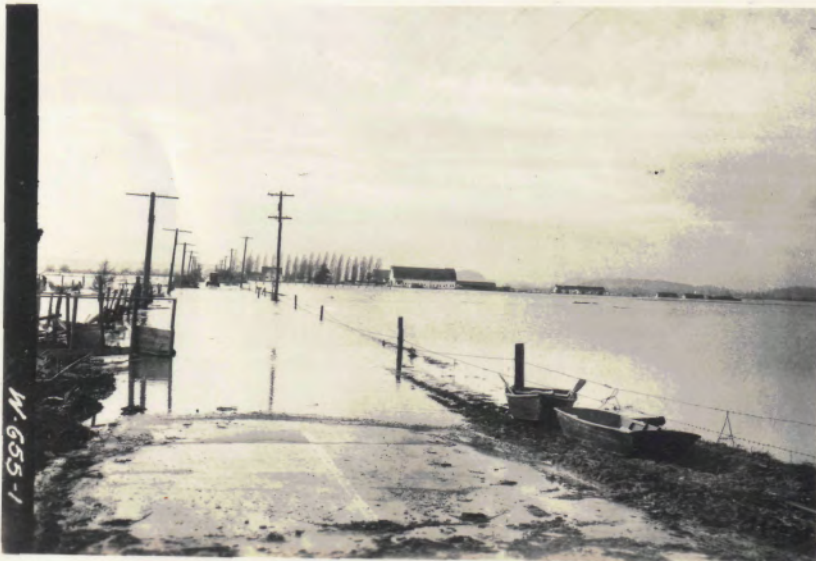
W-653-1

Looking west from Dry Slough dike toward Claude Davis farm, showing County road grader making first trip to clear debris from road on February 14th. Frame for labor tent house shown in left foreground.

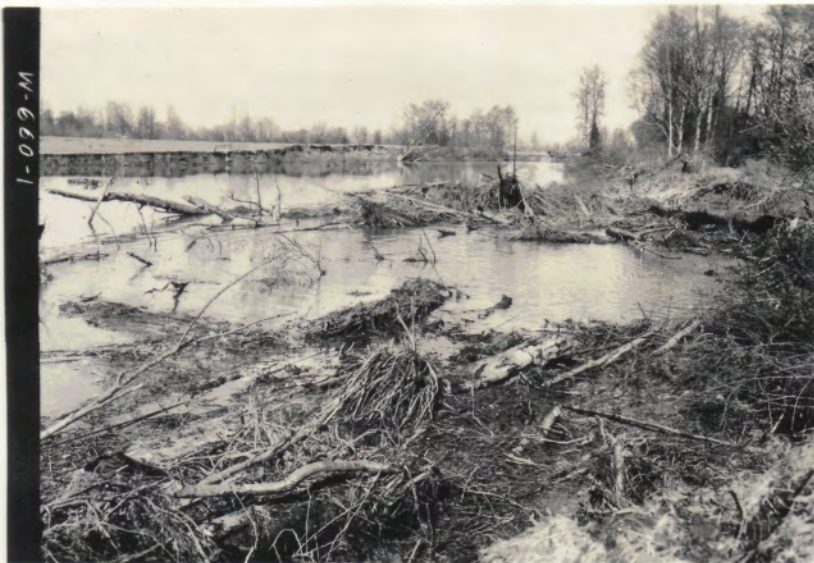
The Dry Slough dike break released Skagit River water to the western part of Fir Island, covering the area between Dry Slough and Deer Slough with many feet of water. The break cut a new channel through the Lee and Tellesbo properties, making many acres unfit for further agricultural use. Deposits of coarse sand caused additional damage.

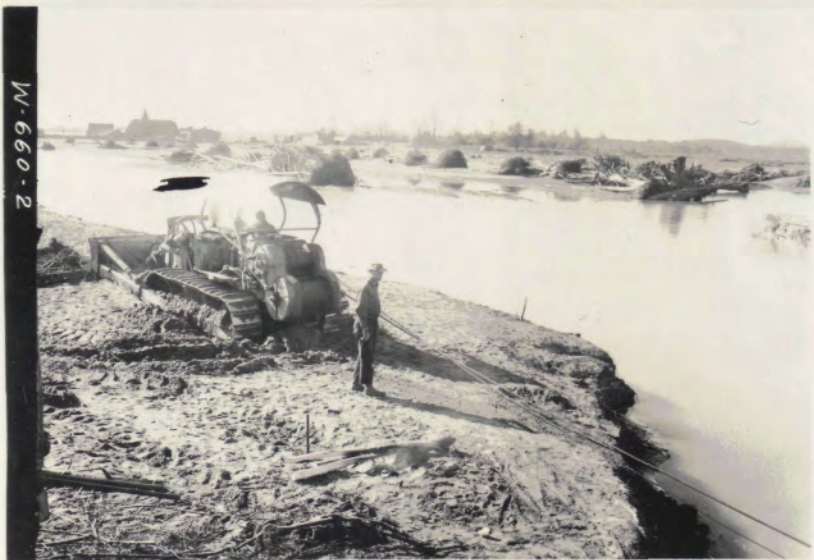
Looking southwest from point near upper end of Dry Slough break, showing extensive channeling and uprooted trees across Lee farm. Lee farmstead in left background.

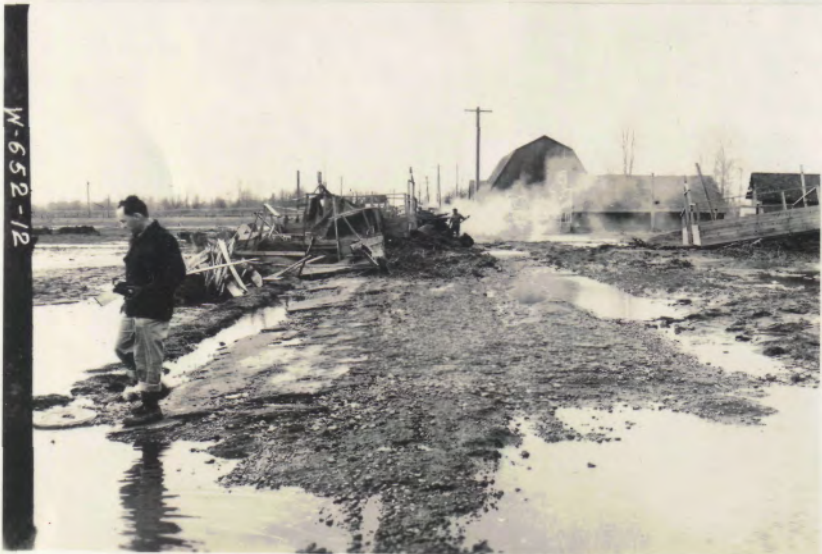
Looking west down County road past Noble Lee farm. County equipment is clearing debris including transient labor tent houses from road.

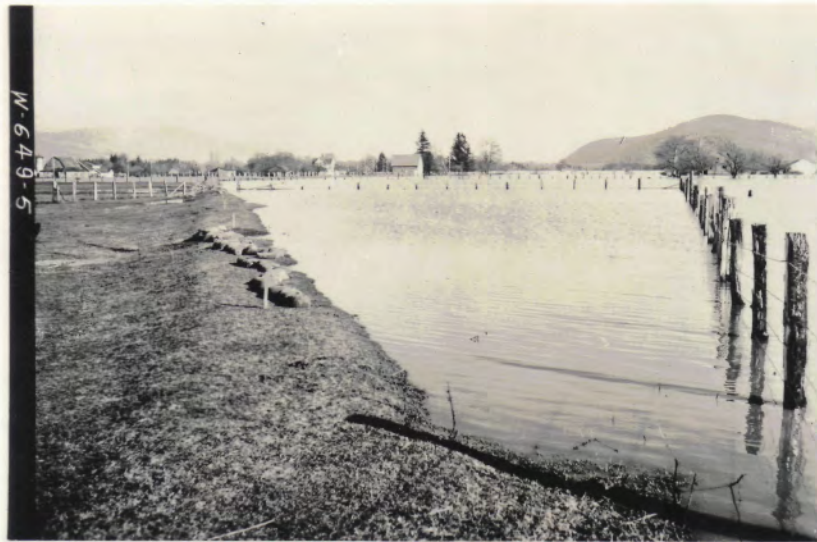
W-649-5

One-half mile east of Burlington. Water was within inches of the top of dike at many points immediately east of Burlington. All day and all night effort with sandbags by volunteers saved the city. 35,000 acre feet of water were stored behind Ross Dam during the critical period which doubtless saved dikes in Burlington, Avon and Mount Vernon areas.

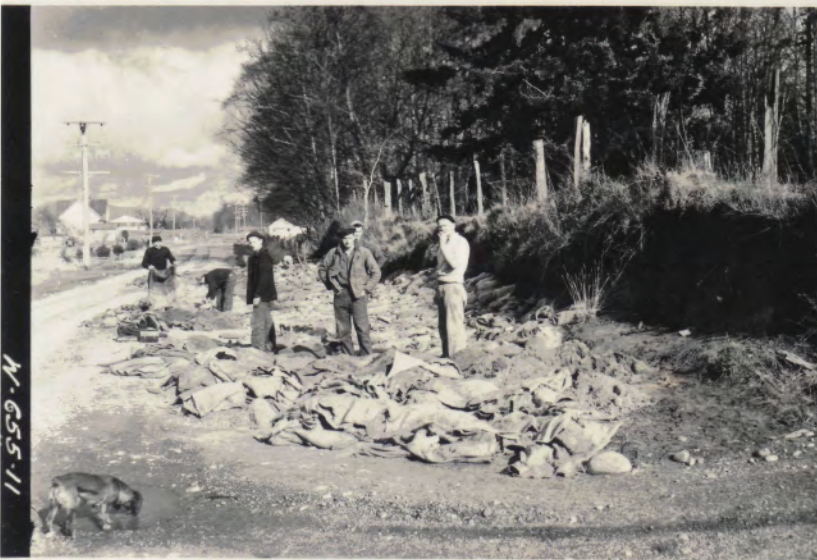
W-655-11

This crew within the city limits of Burlington are emptying sandbags after flood danger had receded. Sandbags saved this dike when water began seeping through it near its base.

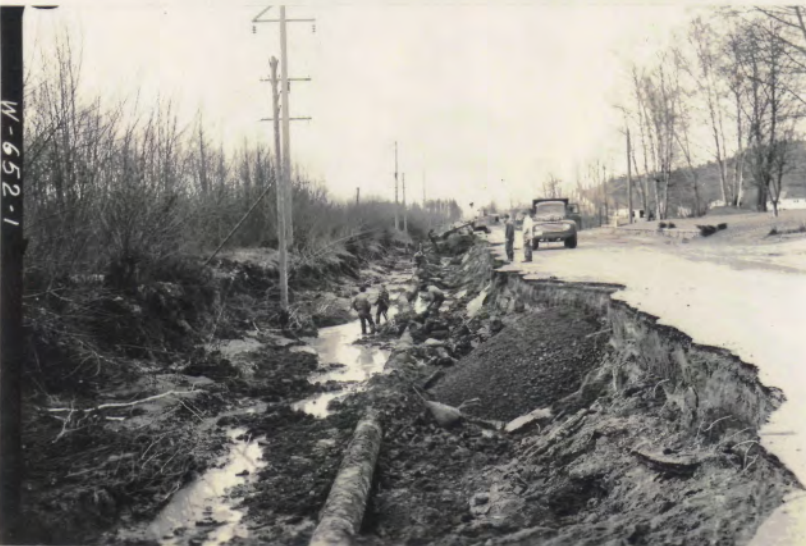
W-652-1

Burlington's water supply was interrupted when flood waters poured over the state highway between Burlington and Sedro Woolley, washing out highway and P.U.D. water line.

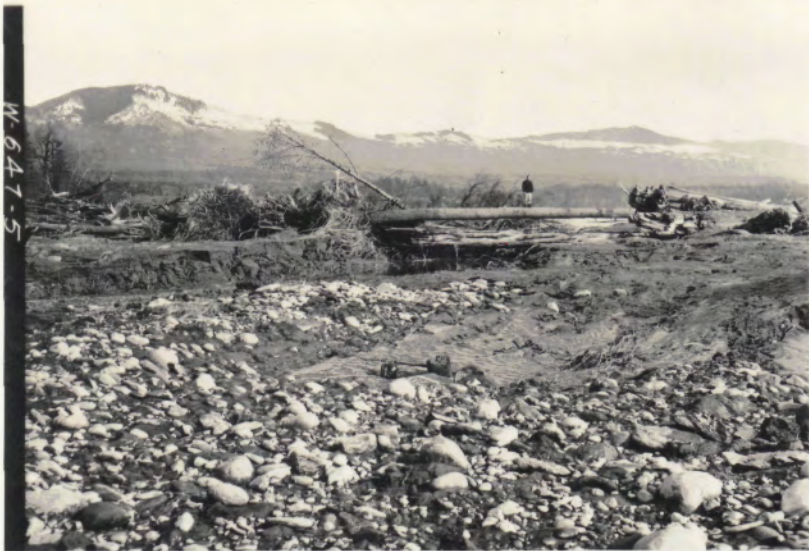
Most of the land on Cochrehan Island south of the State highway between Lyman and Hamilton was under water. Most severe damage occurred where river broke across Nelson farm. Water breaking over debris caused extreme channeling, exposing gravelly substratum, leaving many acres of land unsuited to further agricultural use.

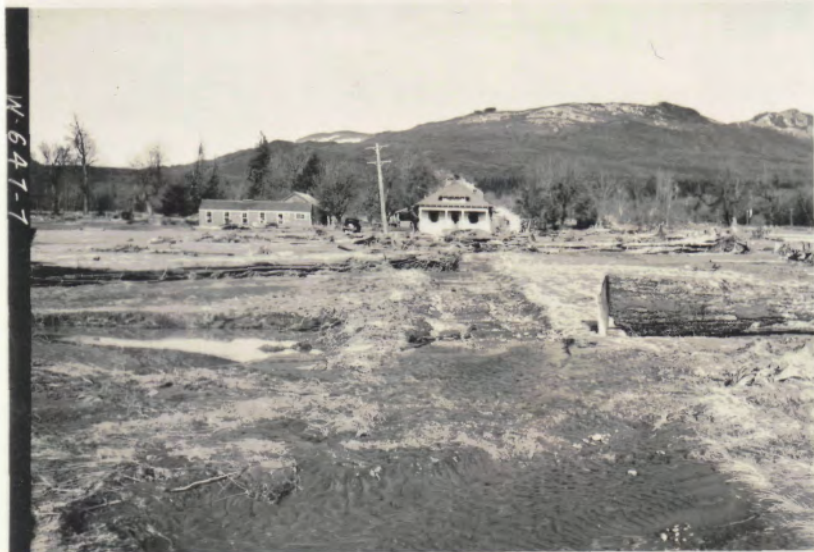
The importance of vegetative cover as protection against erosion was demonstrated repeatedly during the flood. The graveled farm road in center of this picture was washed down a depth of one foot or more while the adjoining pasture sod held soil in place except where sod mantle was broken as a result of debris deposition.

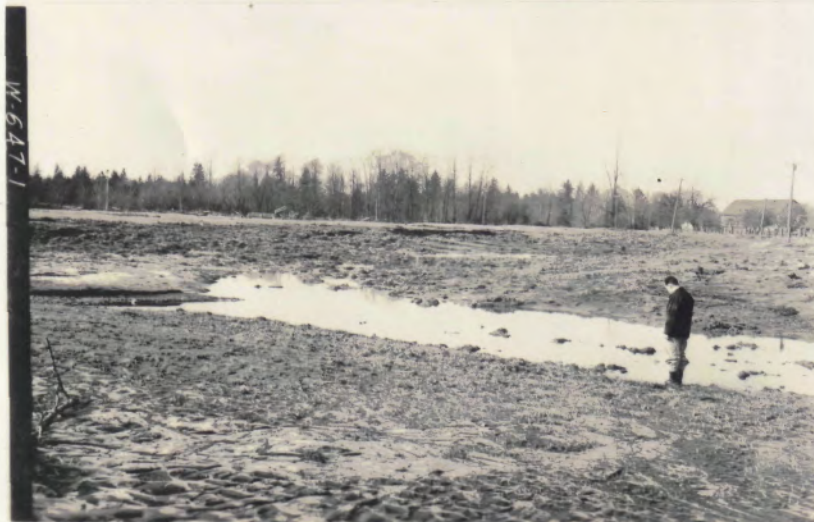
Light leveling operations on this farm had removed protective sod. As a result severe erosion and channeling took place. Where sod was undisturbed little or no soil was lost.

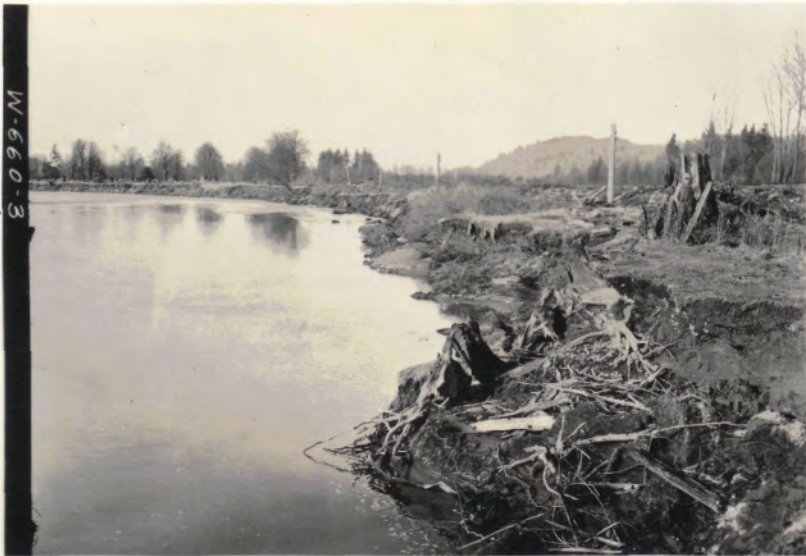
The Skagit river above Sedro Woolley did extensive stream-bank damage at many places and the deposition of sand and debris resulted in substantial channel changes at many points.

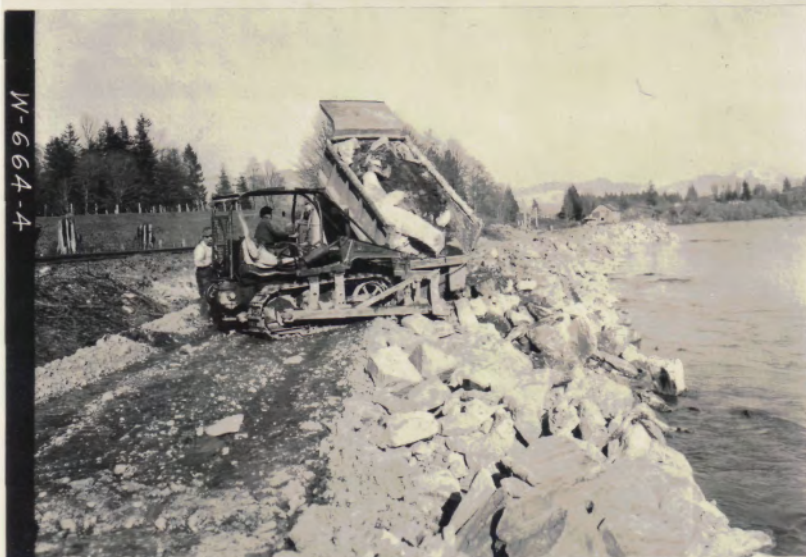
By March 19th the Great Northern Railroad had almost completed revetting the river bank with heavy rock in order to protect the railroad.

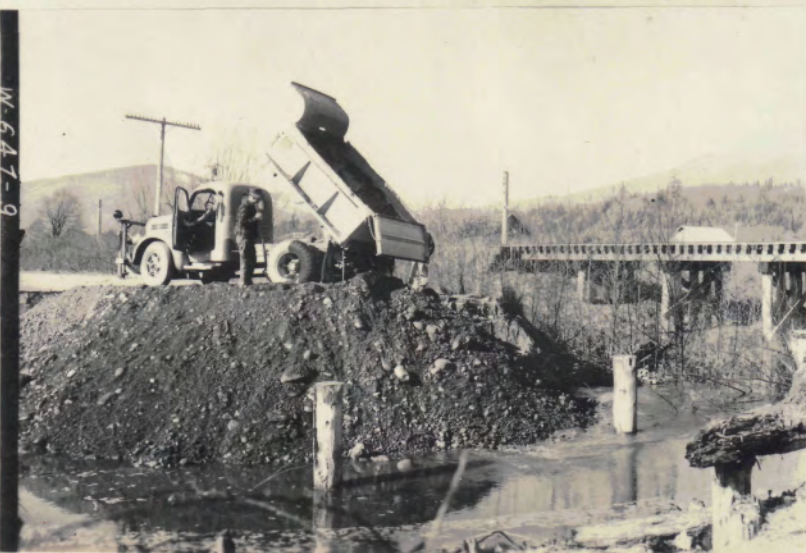
The State highway between Hamilton and Concrete was completely washed out at a point two miles east of Hamilton. Access to points up-river was possible through the use of Sound View Logging Company road from Hamilton to Grandy Creek near Birdsview.

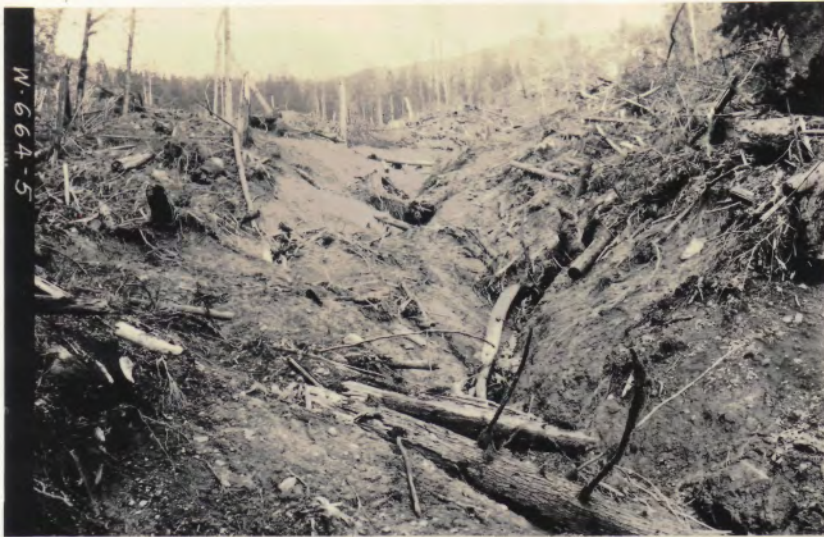
N-664-5

Erosion along the small streams tributary to the Skagit river in the upper Skagit area is a major and recurring problem. This small stream channel above Faber Ferry four miles east of Concrete is very inactive. Jams of logging debris have formed small dams which break, cutting out the toe of the slope and carrying loads of debris, rock, gravel and silt. Entire area above bottom of stream channel is generally unstable.

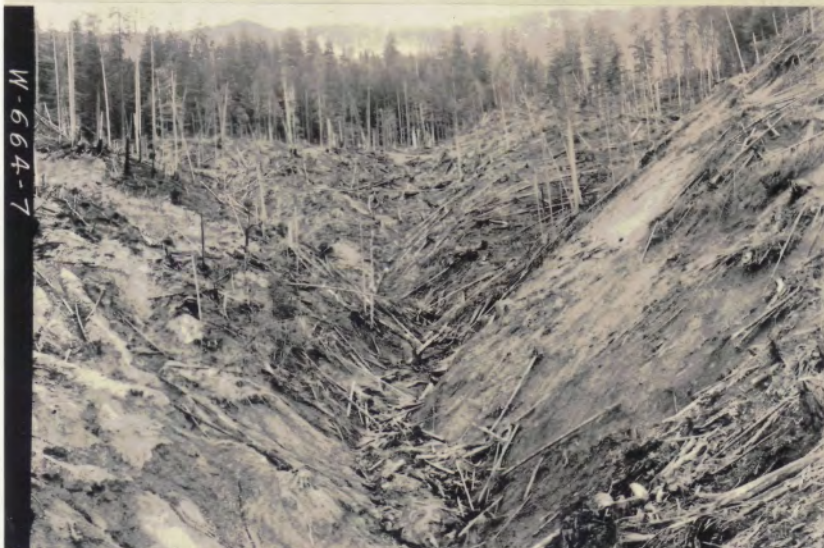
N-664-7

Looking up creek channel toward upper watershed and timber line above Faber Ferry, showing severe erosion and slippage. Logging debris in stream channel piles up to form dams which further cut out toe of slope. Run-off from these areas is very rapid during periods of heavy precipitation or rapid snow melt. This area was logged in 1948 and 49. A clean slash burn was made in November, 1949 and severe slippage and erosion damage resulted in November, 1949 and February, 1951.

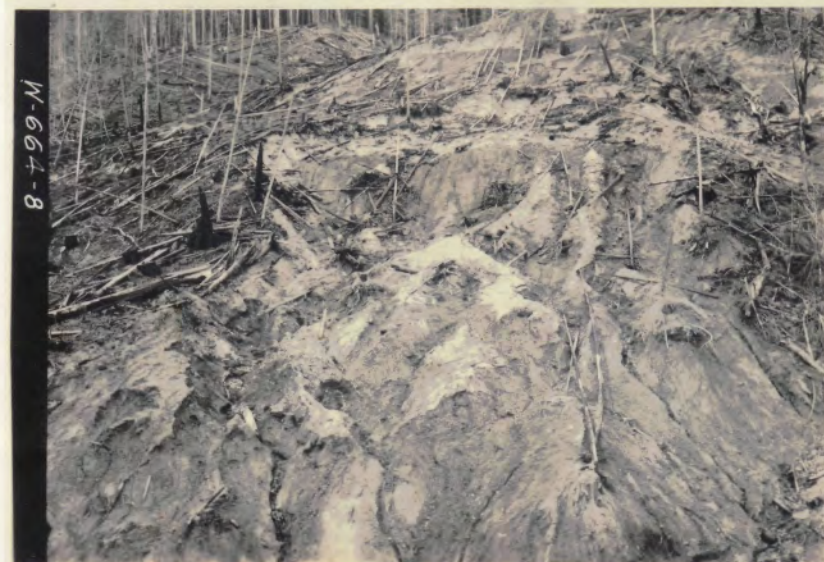
N-664-8

View of severely eroding hillside on 60% slope. Area of several acres is very unstable. Slippage and severe erosion begins at timber line.

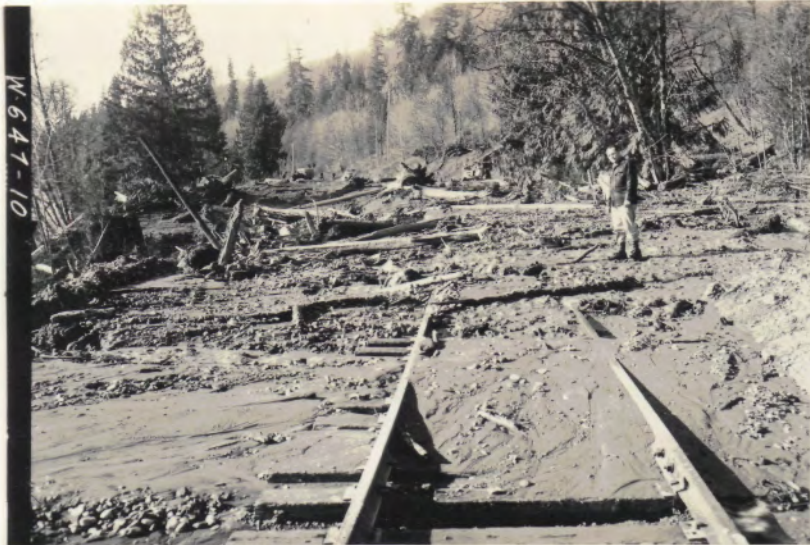
Many small tributaries of the Skagit river did extensive damage to highways, railroads and farm land. They also contributed largely to debris and silt which the river carried at flood stage. At Faber Ferry four miles east of Concrete the State highway, county approach to the ferry, and Great Northern Railroad were completely covered with debris for the second time in 15 months.

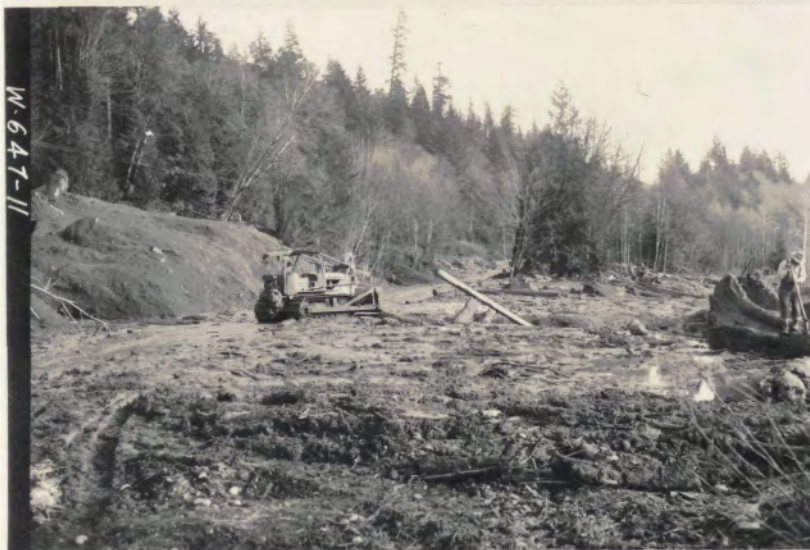
County equipment was quickly on the job to open the highway at Faber Ferry so that mail and other essentials could reach residents south of the river.

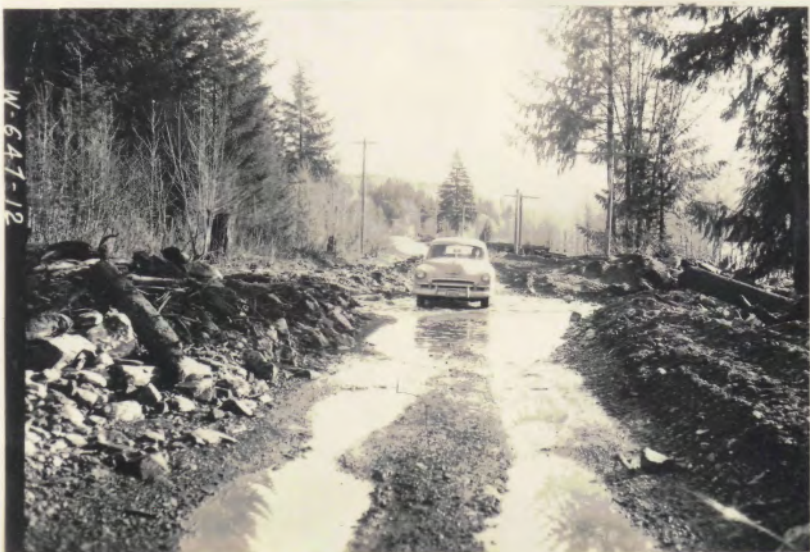
The culvert under the State highway at Damnation Creek between Concrete and Rockport was completely plugged and the Great Northern Railroad in the right was washed out as a result of small stream erosion and flooding. It required approximately one month to repair damage to railroad and restore railroad traffic between Sedro Woolley and Rockport.

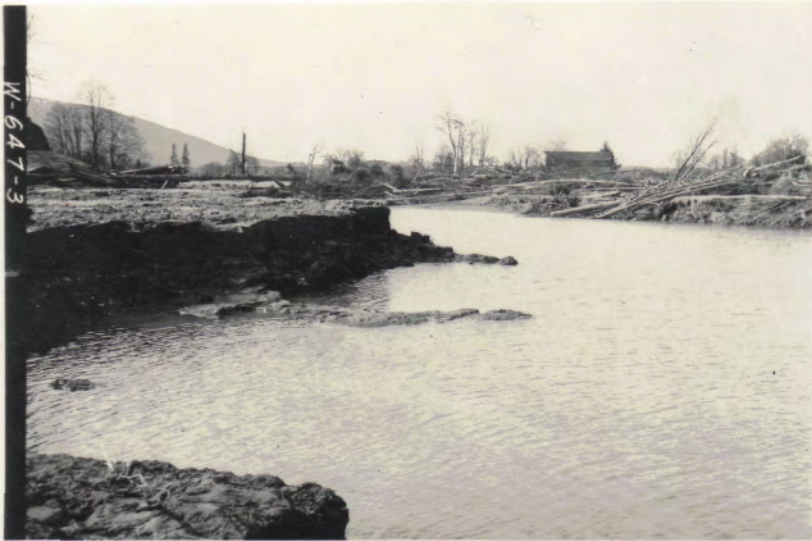
The Skagit river started a new channel through the Nelson farm on Cockrehan Island three miles southeast of Lyman. The area in foreground was once a cleared cropland field.

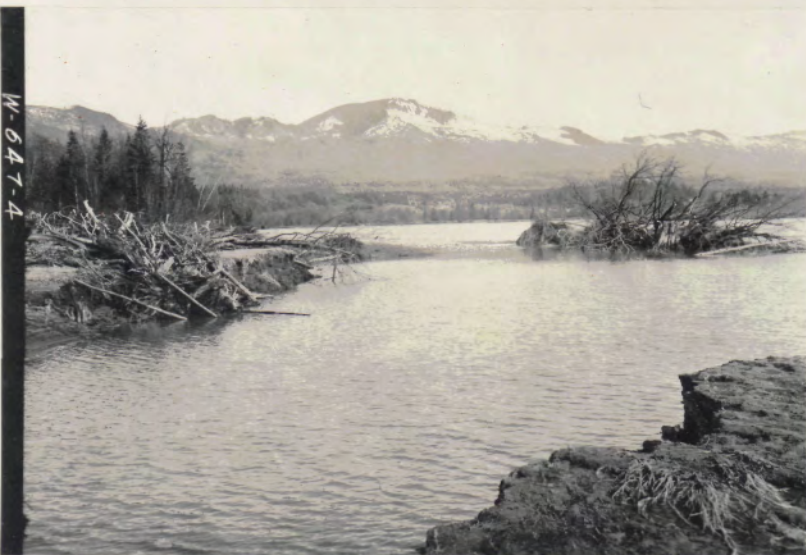
Looking northeast from Nelson farmstead toward Skagit river, showing new river channel. Severe erosion was aggravated by debris. Timber adjacent to river bank was removed in land clearing, thereby allowing debris to cross land. Area in left protected by timber had high water and sand deposition but only slight erosion.

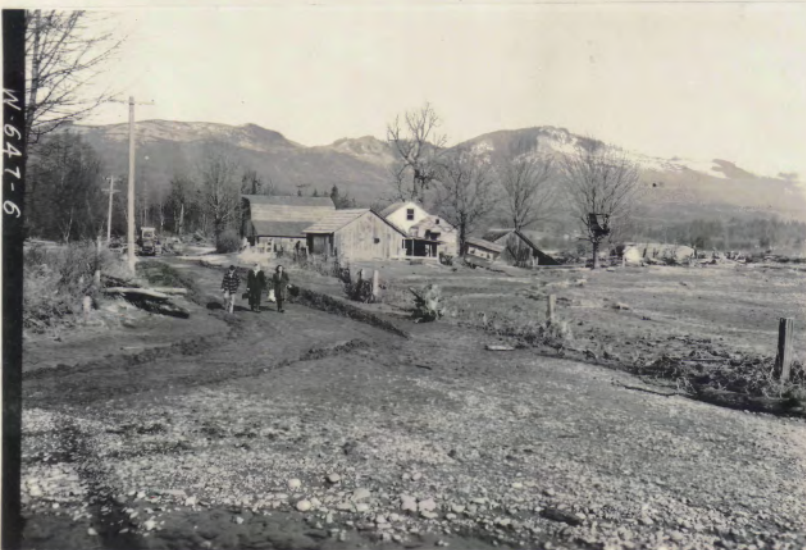
Looking at Nelson farmstead, with bulldozer clearing County road in left. Poultry house in right of picture destroyed, with loss of 200 chickens.

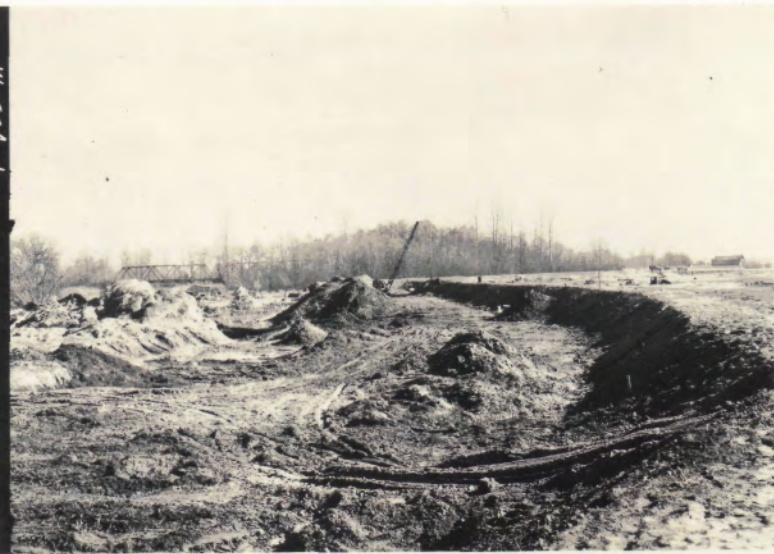
W-664-1

County and State work together to restore dike near Moore Slough break at North Fork bridge. Temporary dike in right of picture which is 950 feet long was constructed in 15 days with use of dragline. Temporary dike will be raised and widened to form permanent structure. Moore farmstead in left will be outside new dike.

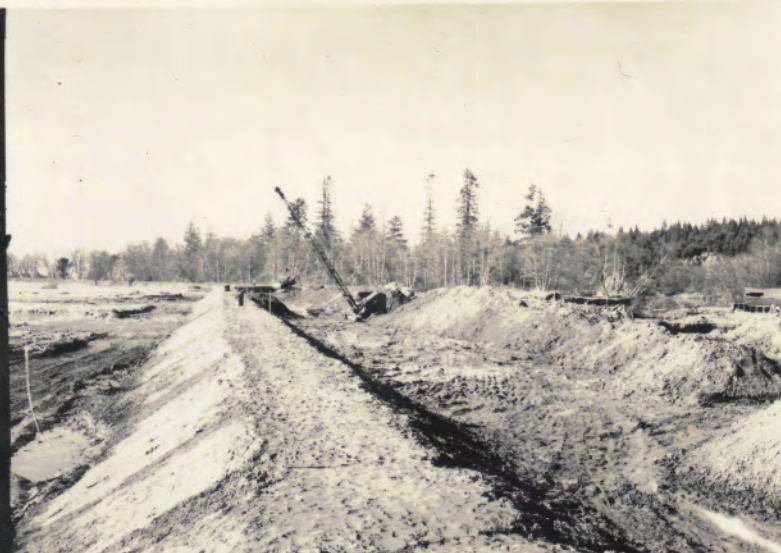
W-660-12

Looking southwest across temporary dike at Moore break being constructed through cooperation of State and County. Skagit river channel through trees in background.

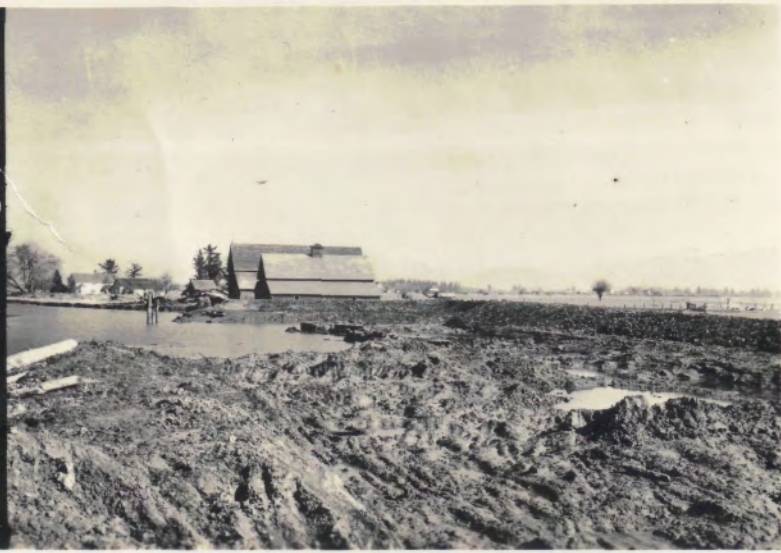
W-664-2

Looking northeast toward Boswyk farmstead on Fir Island, showing new dike construction. Old dike in left along with granary was completely washed out when flood waters from Dry Slough break swept down to lower end of diking district.

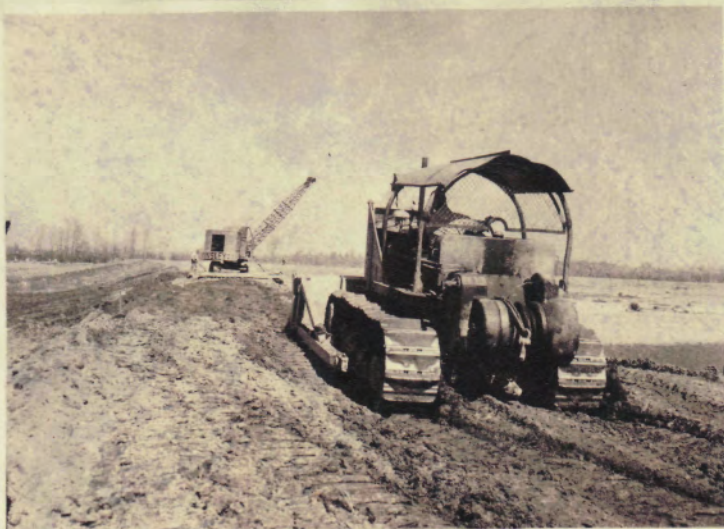
The raising and strengthening of Skagit River dikes received high priority in the activities of farmers in the lower Skagit area as a result of the severe February 1951 flood. Most of the dikes below Mount Vernon were raised through cooperation of the State, Federal Government and local diking districts. Draglines, bulldozers and carryalls were used.

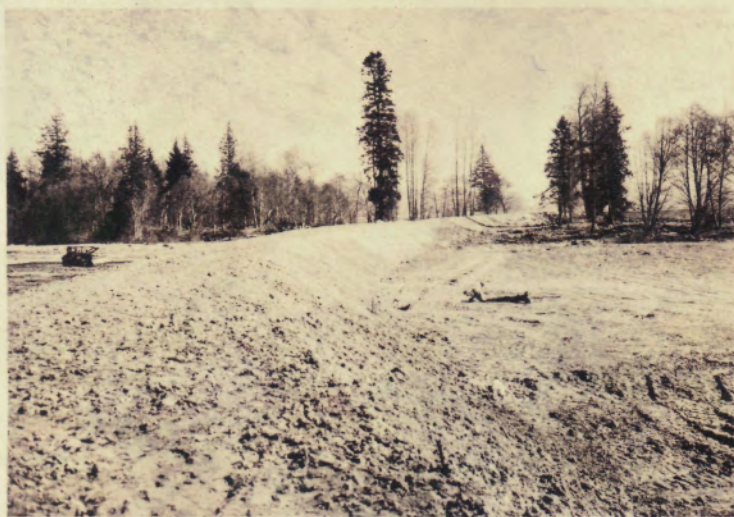
This completed section of dike in the Dry Slough area provides protection for the area which was most severely damaged by the Dry Slough break in the 1951 flood.

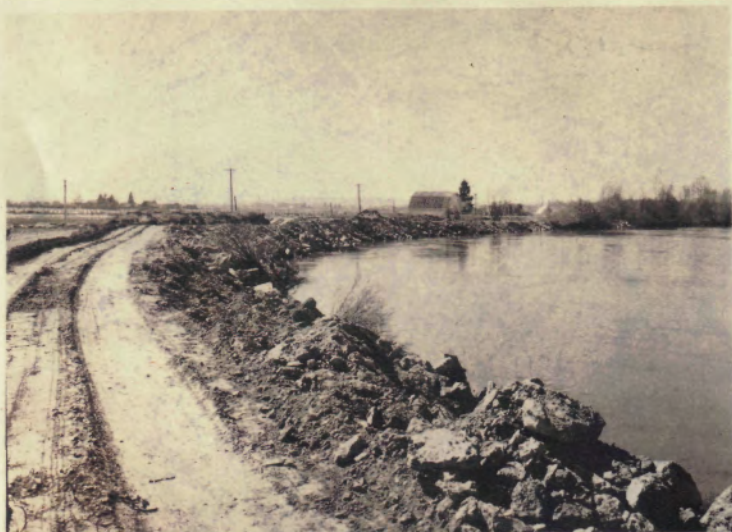
Heavy rock has been dumped along many feet of river bank where erosion is most serious. This section of dike on Fir Island above the North Fork bridge has been raised, widened and re-vetted.
