RE-EVALUATION OF THE MAGNITUDE OF HISTORIC FLOODS ON THE SKAGIT RIVER NEAR CONCRETE REVISED FINAL REPORT

MAY 2009

nhc northwest
hydraulic
consultants

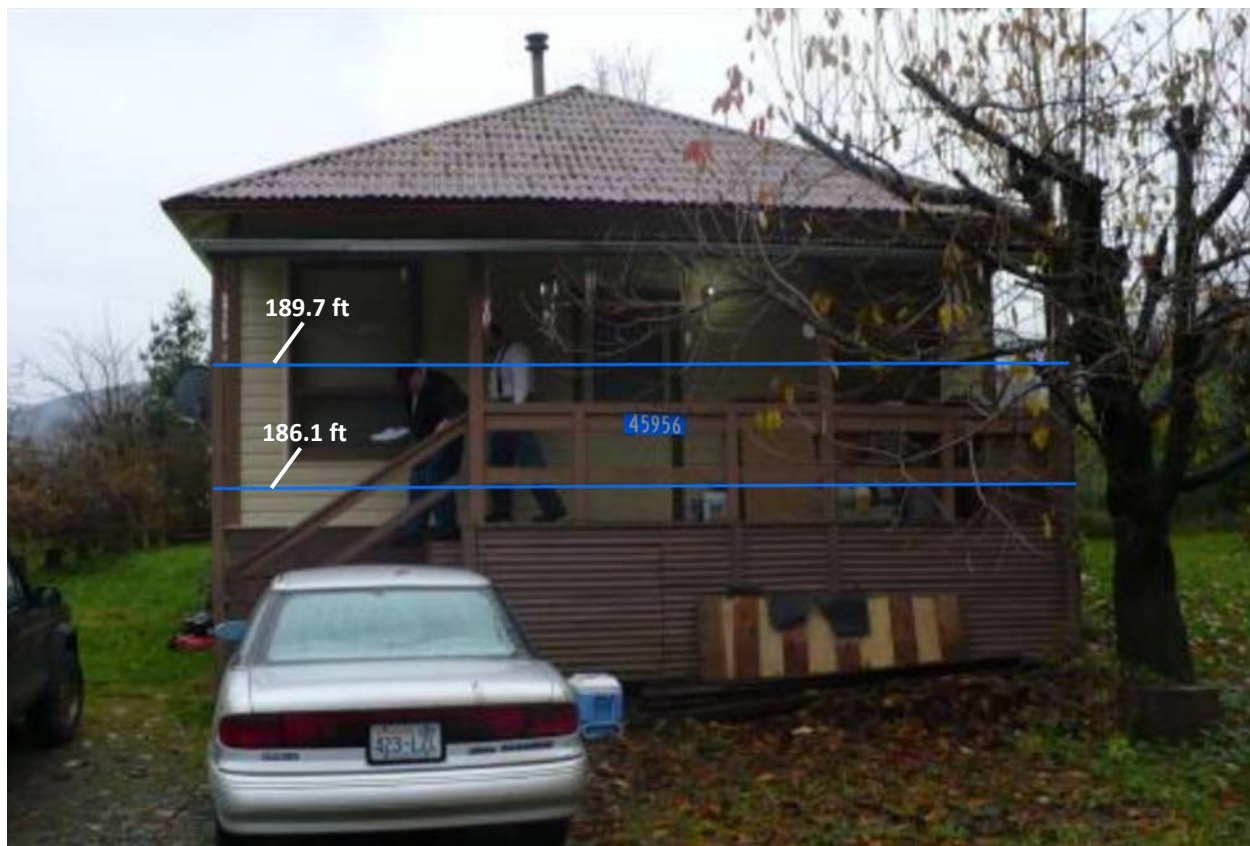
Figure 10. 45956 Albert Street.

The lowest existing residence dating from 1921 that has been identified in the Crofoot Addition is 45956 Albert Street, with a finished floor elevation of 184.93 feet NGVD 1929⁴. It is possible that other lower residences existed in 1921 that have since been demolished, or otherwise modified, but we have no way of either identifying such residences or of determining their elevations. Assuming the maximum reported depth of water of 14 inches was above the finished floor level at 45956 Albert Street, gives a maximum December 1921 water surface elevation in the Crofoot Addition of at most 186.1 ft. The only house dating from 1921 in East Concrete for which we have a finished floor elevation is 46335 Forest Place at 186.61 ft. Visually, this house appears to be one of the lowest, if not the lowest, house dating from 1921 in East Concrete. From the FIS (Federal Emergency Management Agency, 1989), the head loss between Crofoot and East Concrete is roughly 0.5 feet at a discharge of 226,000 cfs (the currently published 1921 peak discharge is 228,000 cfs), which would put the water level at 46335 Forest Place essentially at the finished floor level. This seems inconsistent with the statement in the Concrete Herald article that the “*waters also crept up around some of the dwellings in East Concrete*”, so the estimated 1921 peak water level of 186.1 ft. in the Crofoot Addition is probably high. Nevertheless, we have taken the estimate of 186.1 ft NGVD 1929 as the best estimate of high water level in the Crofoot Addition in the December 1921 flood and the basis for estimating the December 1921 peak discharge in Section 3.0 of this report.
