## RE-EVALUATION OF THE MAGNITUDE OF HISTORIC FLOODS ON THE SKAGIT RIVER NEAR CONCRETE FINAL REPORT

OCTOBER 2008

**nhc** northwest  
hydraulic  
consultants

nhc project # 21637

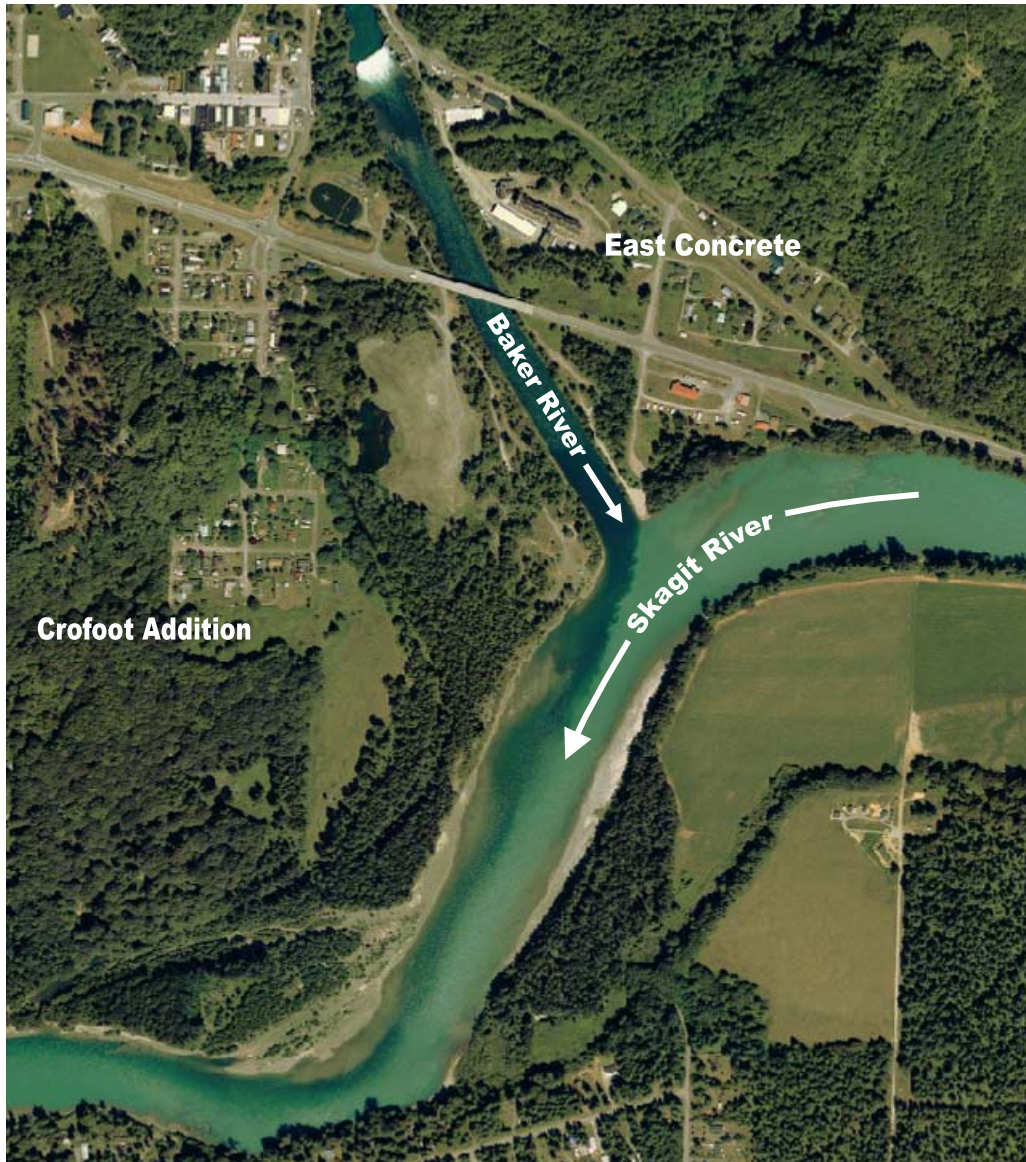
**Figure 1. Crofoot Addition of Concrete, WA (2001).**

The Crofoot Addition is that area of Concrete in the Skagit and Baker River floodplains south of the present alignment of SR-20 and immediately west of the confluence of the Baker and Skagit (see Figure 1). East Concrete is in the floodplain immediately east of the Baker River.

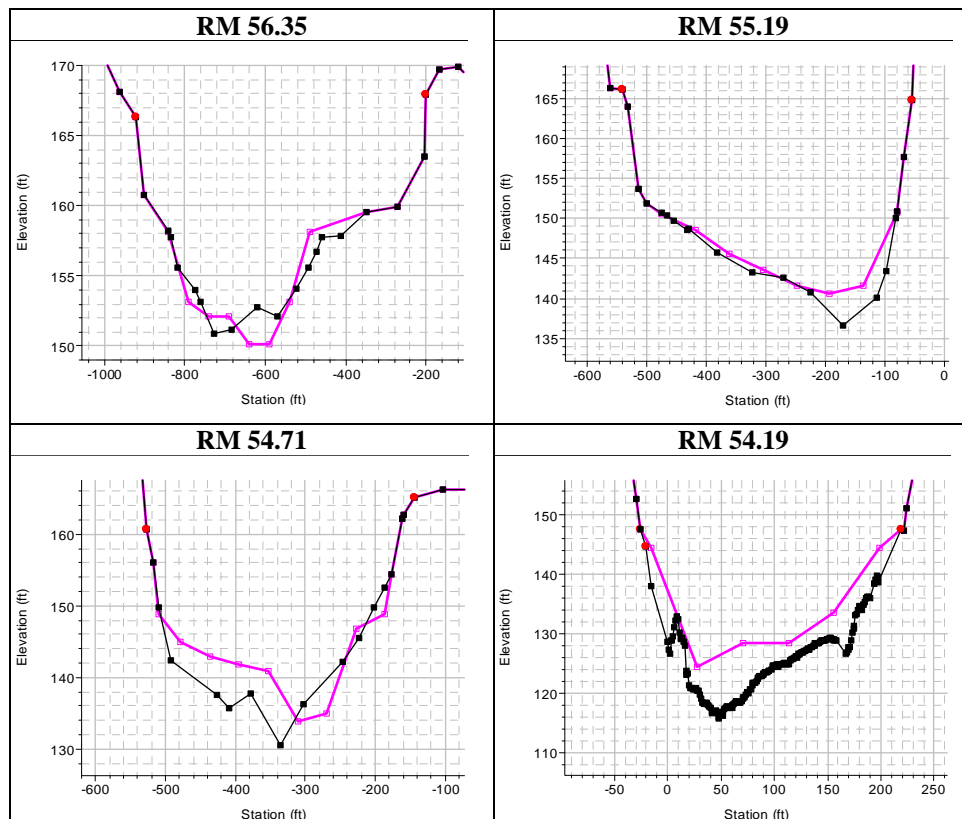
**Figure 5. Comparison of Cross-Section Geometry Between 1911 (pink) and 2003 (black).**

Selected in-channel cross-sections from the 1911 survey are compared with cross-sections from the current condition HEC-RAS model in Figure 5, and the thalweg profile from 1911 is compared against that from the current condition HEC-RAS model in Figure 6. The comparison shows relatively small differences in channel geometry between 1911 and the present. The channel in the current condition model is on average about 4 feet deeper than in 1911 over much of the reach between The Dalles and the confluence with the Baker River. Below The Dalles to RM 53.1, differences are not as consistent. In general, the current condition channel below The Dalles is somewhat deeper than the 1911 channel, except between RM 53.3 and RM 53.94 where the 1911 channel is locally deeper.
