Re-evaluation of the 1921 Peak Discharge at Skagit River near Concrete, Washington

Scientific Investigations Report 2007–5159

By M.C. Mastin

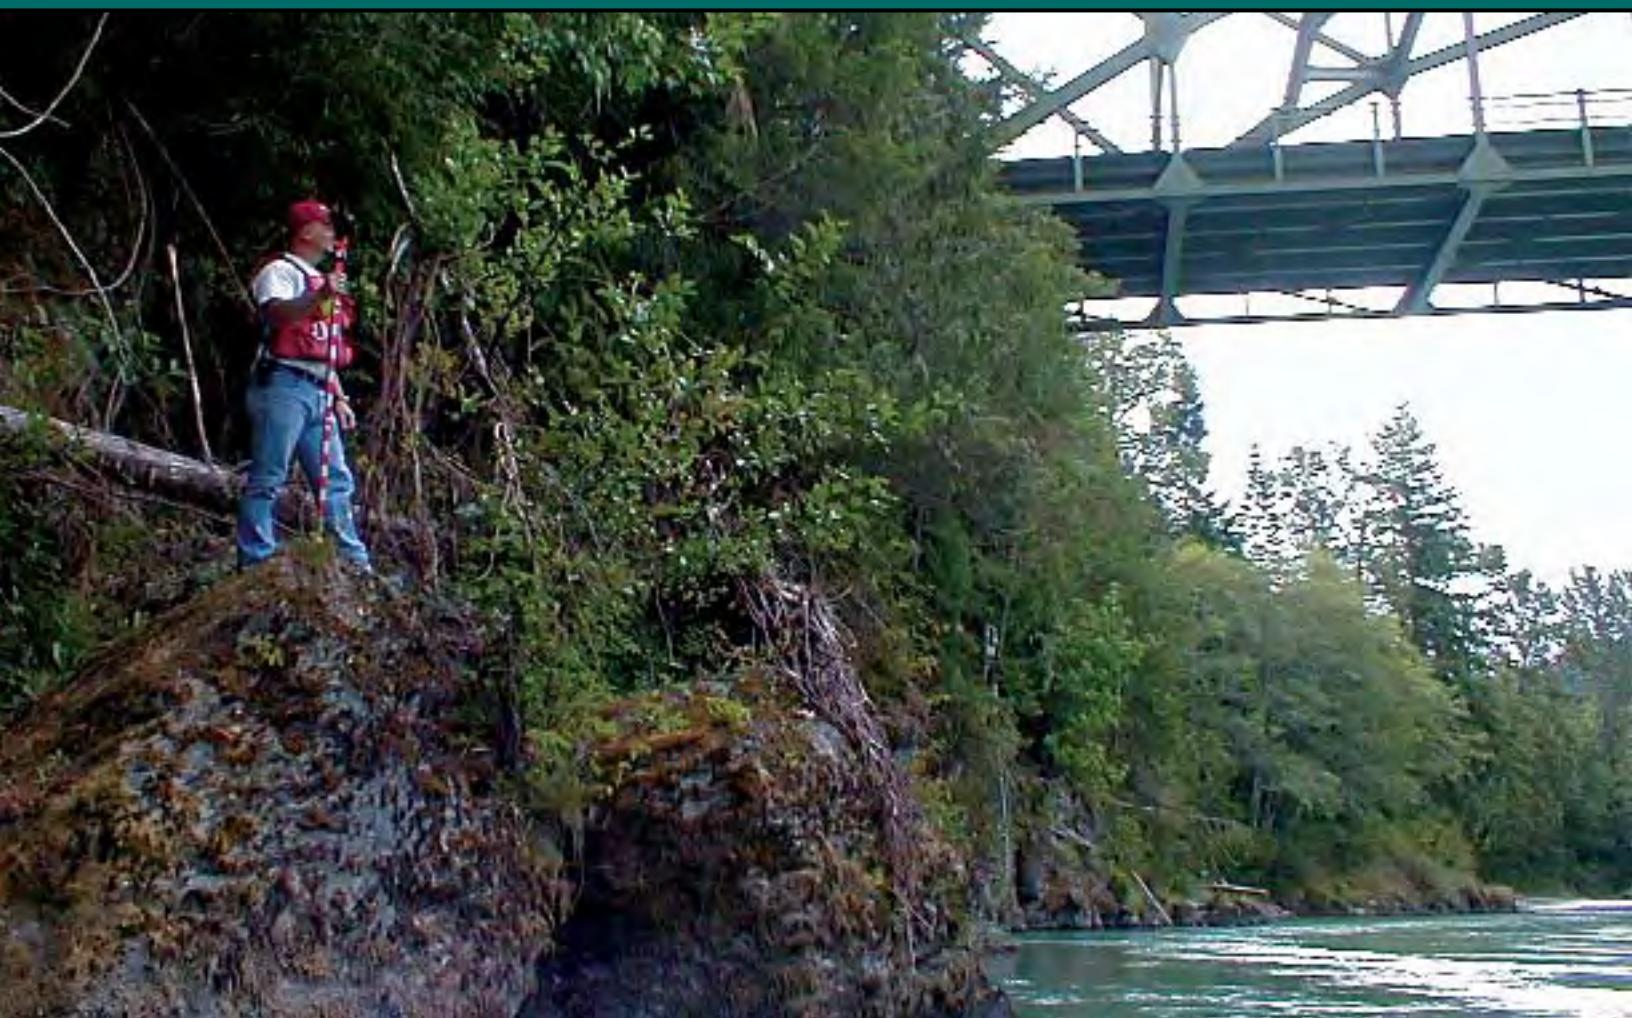
Cover: Photograph of Darrin Miller, U.S. Geological Survey, surveying a high water mark left from the 2003 flood on the right bank of the Skagit River on the mouth of the Dallas Gorge near Concrete, Washington. (Photograph taken by Jeffrey Paulat, U.S. Geological Survey, August 2004).

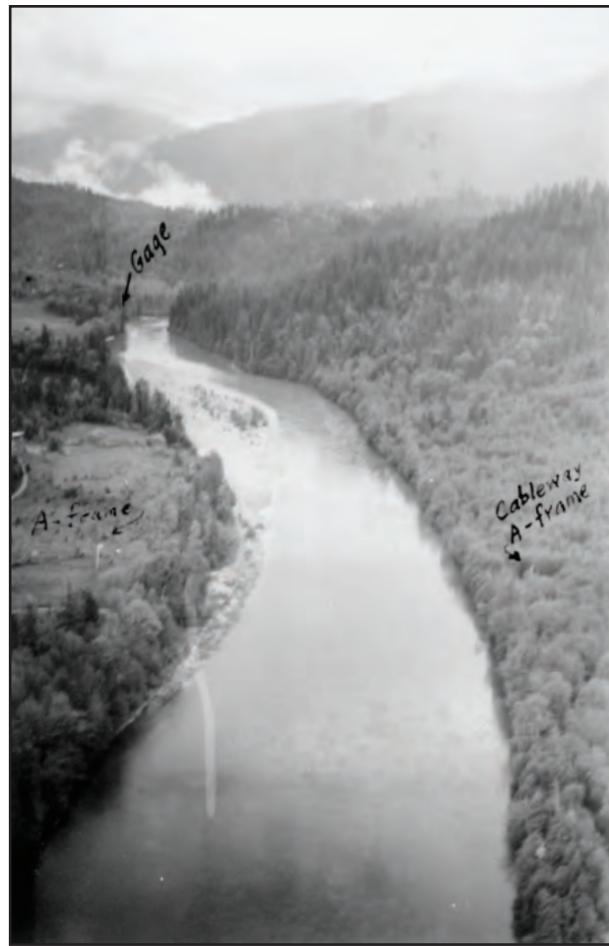
A. Skagit River near Concrete, Washington. Looking downstream from top of gage house. Photograph taken by J. Bonner, U.S. Geological Survey, June or July 1932.

B. Skagit River near Concrete, Washington. Looking upstream. Photograph taken from helicopter by F. Veatch., U.S. Geological Survey, May 8, 1948.

Figure 4. Historical photographs showing only small, sparse brush on the island/bar near cross section 2, Skagit River, Washington. Historical photographs on file at the U.S. Geological Survey, Washington Water Science Center.
