HYDRAULIC ANALYSIS – SMITH HOUSE FLOOD STAGES

Technical Memorandum

Hydraulic Analysis – Smith House Flood Stages

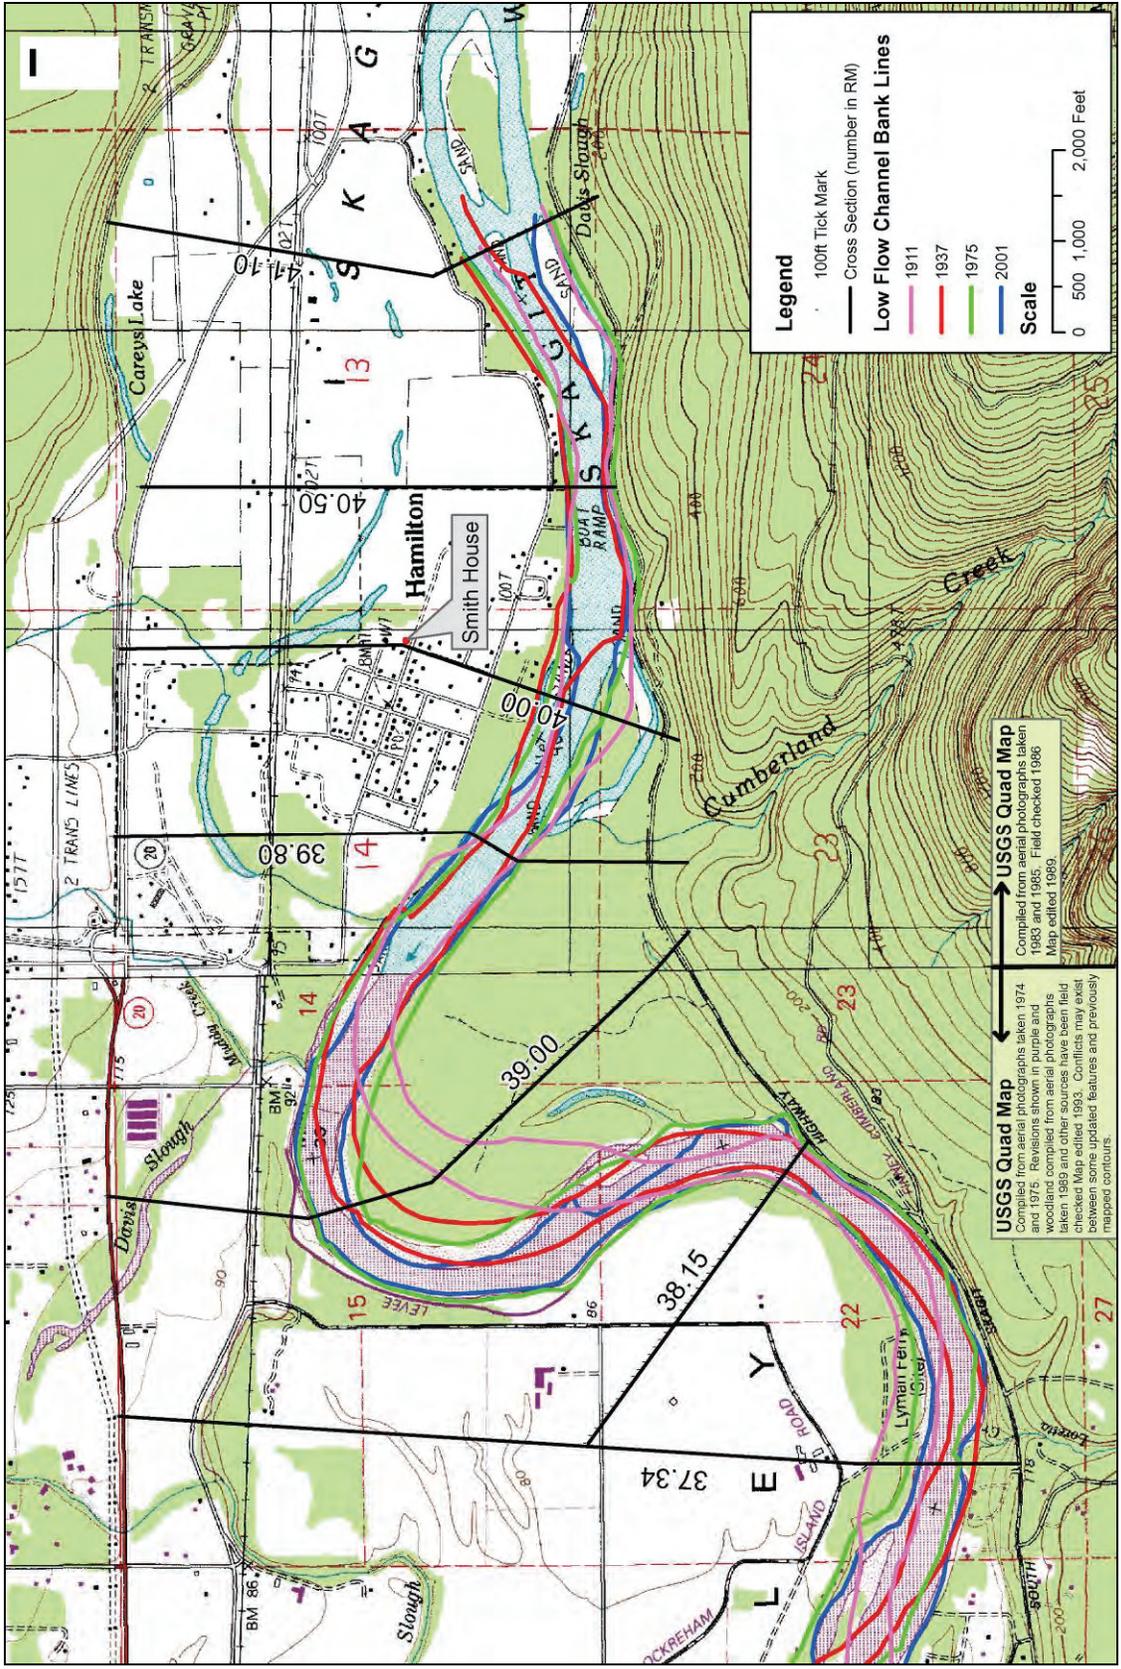
Figure 1. Location map

Also shown in Figure 1, are locations of low flow channels plotted from the 1911 and 1975-76 Corps surveys, and the 1937 and 2001 aerial photographs, overlaying on the USGS quad maps. As shown on the plots, the channel shift in the 2-mile reach downstream of Hamilton, particularly at RM 39.00, is significant between 1911 and 1975. The shift after 1975 appears to be minimal. The HEC-RAS model uses the 1975 Corps surveyed channel and cross section data with exception of the RM 40.00 and 40.50, which were surveyed in 2007 by Skagit County as previously discussed.

The unsteady flow HEC-RAS model developed for Skagit County by PIE (2005) was used in this hydraulic analysis to estimate the potential 1909, 1917, and 1921 flood stages at the Smith House (RM 40.00) based on Stewart’s estimated peak discharge values at Concrete (RM 54.15). This model was further calibrated for the 1995 and 2003 high water marks at the Smith House. Table 2 shows the calibration results. Further refinement of the model included adding two new cross sections (at RM 40.00 and RM 40.50) recently surveyed by Skagit County and provided in January 2007 by the City of Burlington. Figure 1 shows locations of the Smith House and the model cross sections in the Hamilton vicinity.

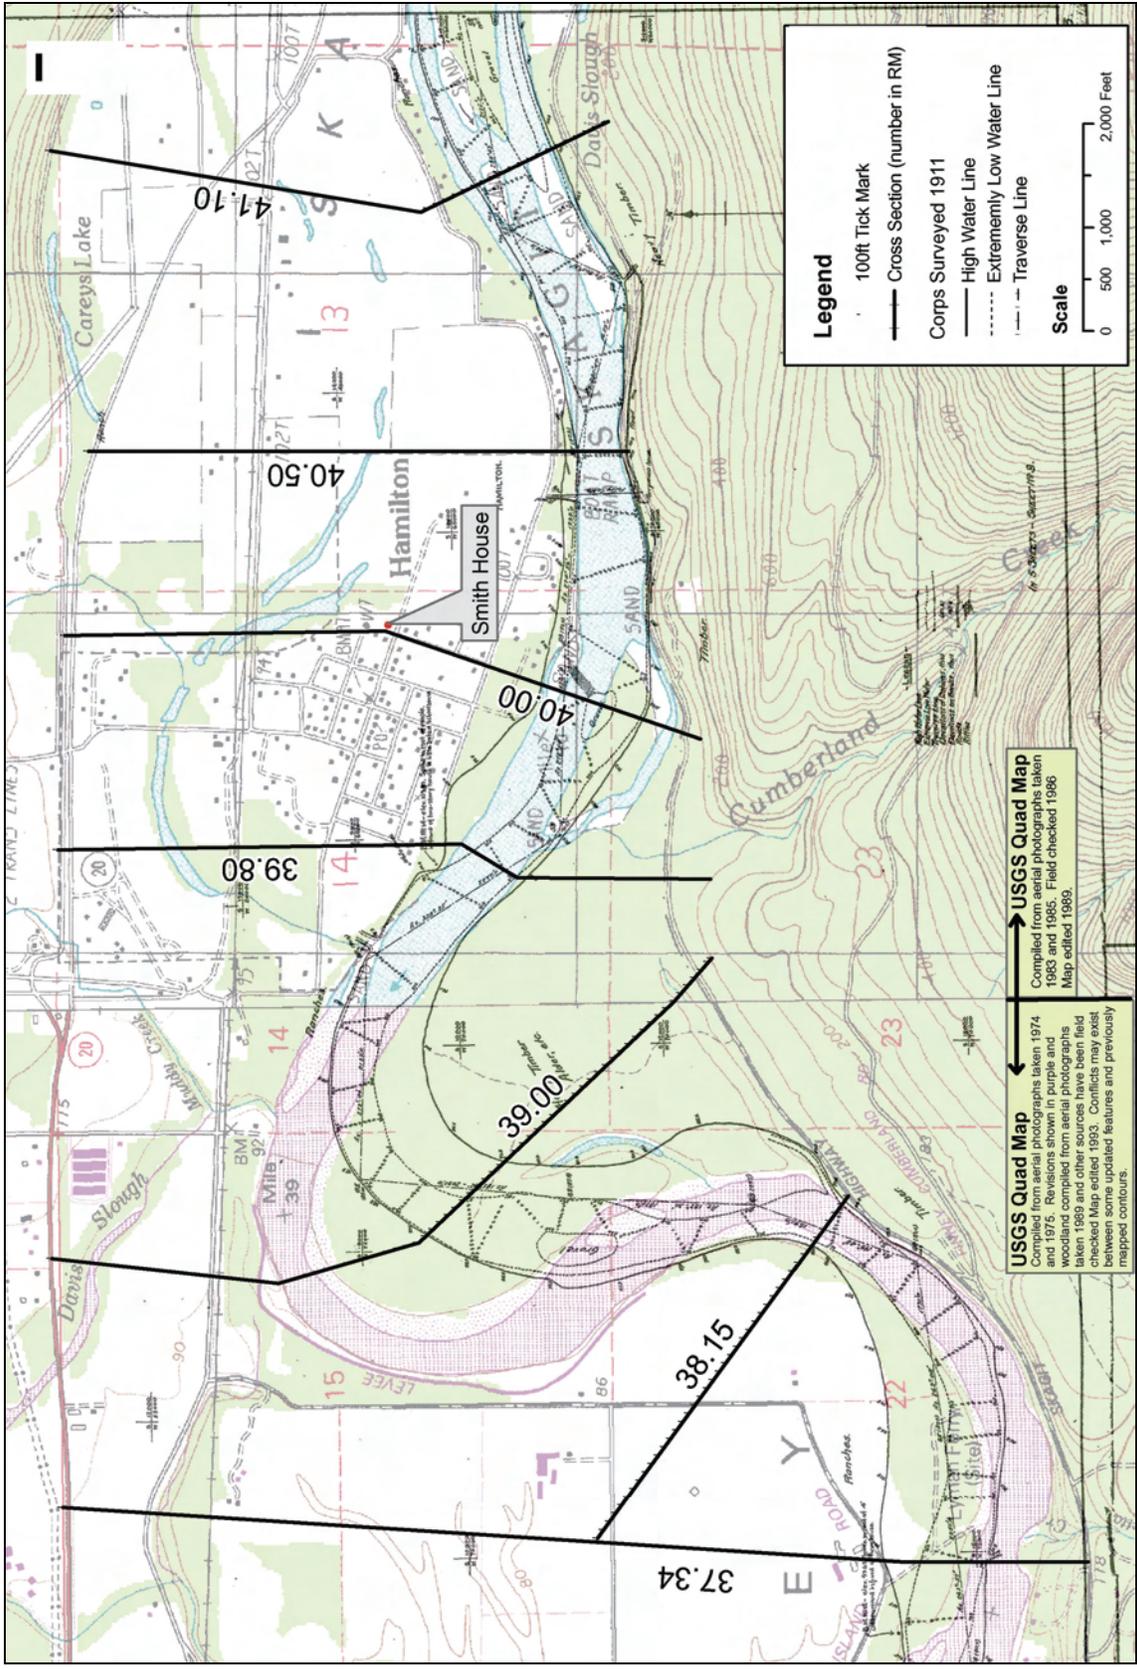
Figure 2. 1911 Corps Survey on USGS Maps

The 1911 Corps complete survey, including extreme low-water and high water lines overlaying the USGS quad maps, is shown on Figure 2. This 1911 survey is believed to closely represent the river alignment during the 1909, 1917, and 1921 floods. The USGS quad maps closely represent the river alignment encountered during the 1995 and the 2003 floods. Throughout the Hamilton Reach between RM 37.34 and 41.10, the low flow channel width and depth in 1911 were about the same as those surveyed in 1975. The high flow channel width was about 1,200 feet wide at RM 39.00 in 1911, versus 800 feet in 1975, and remained approximately unchanged at other cross section locations. Detailed topographic data for the channel and banks are available from the 1975 survey but not available from the 1911 survey.

- Delete the Cockreham Levee (approximately one mile long) as it did not exist prior to its construction in the 1950s.
- Shorten the channel length from 10,245 feet based on the 1975 Corps survey to 8,197 feet based on the 1911 Corps survey between RM 38.15 and RM 39.80.
- Increase the high flow channel width at RM 39.00 from 800 feet surveyed in 1975 to 1,200 feet based on the 1911 survey map. This would increase the area in the high flow channel by approximately 50 percent.

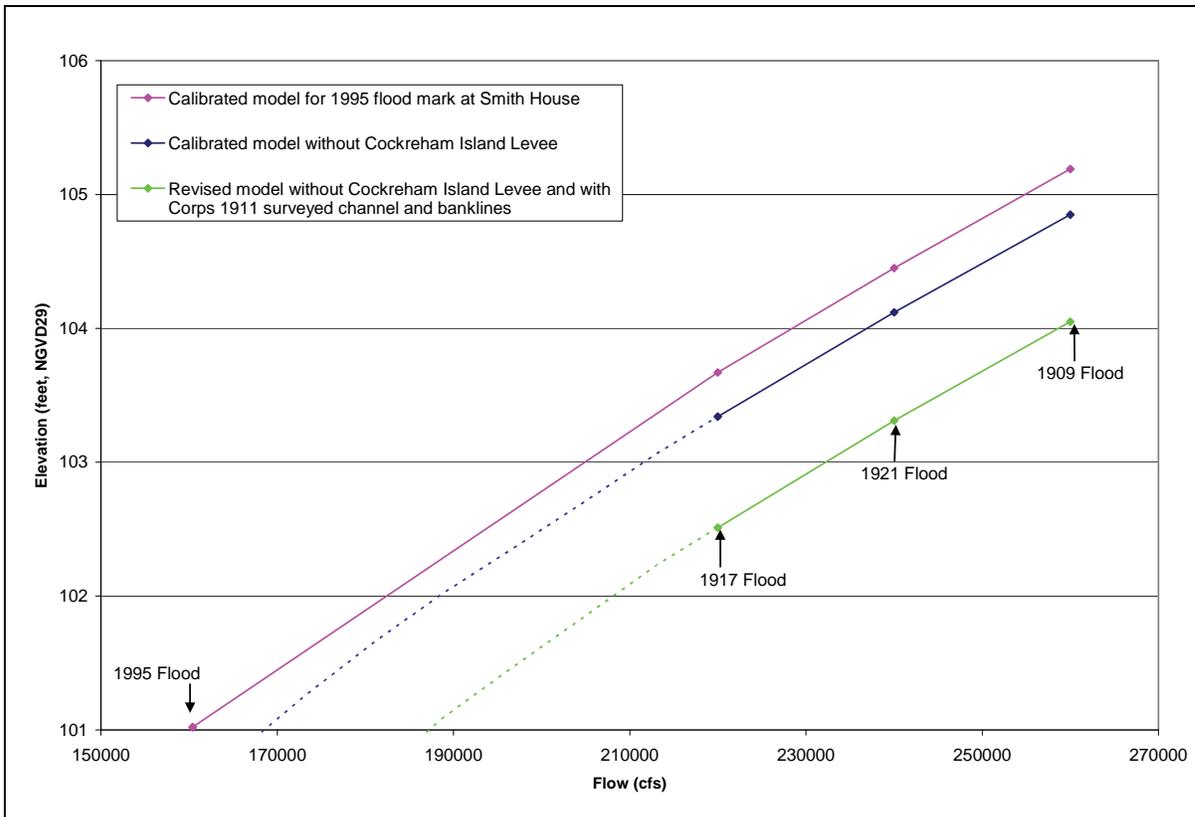
Figure 3. Rating Curves at RM 40.00 (Smith House)

Figure 3 plots the model run results. As shown in the figure, the flood stages (El. 104.05, 102.51, and 103.31) are 3.05, 1.51, and 2.31 feet higher than the observed 1995 flood mark (El. 101.00) at the Smith House for the Stewart estimated 1909, 1917, and 1921 flood peaks, respectively. Since no flood marks were higher than the observed 1995 flood mark at the Smith House, it is not possible to have the modeled historic flood stages to be higher than the

observed 1995 flood stage. The only possibility is that the peak values estimated by Stewart for these floods are unreasonably high. Based on the 1911 Corps channel survey in the Hamilton area, channel geometry reasonably reflecting the conditions of the river existing during the Stewart estimated flood events was incorporated in the revised HEC-RAS model. The maximum flood peak for the revised model that could possibly occur without exceeding the 1995 flood mark of El. 101.00 at the Smith House would be approximately 188,000 cfs.

- Stewart estimated peak discharges of 260,000, 220,000, and 240,000 at Concrete for the 1909, 1917, and 1921 floods, respectively, are unreasonably high if the high water marks observed at the Smith House (built in 1908) were not higher than the observed 1995 flood mark at the house.
- If these Stewart estimated peak discharges were accurate, the flood stages based on the 1911 channel for the 1909, 1917, and 1921 floods at the Smith House would be 3.05, 1.51, and 2.31 feet,

respectively, higher than the observed 1995 flood mark at El. 101.00.

- Based on the 1911 Corps survey river channel and banklines, the maximum peak flow for the 1909, 1917, and 1921 floods would be about 188,000 cfs without causing any flood mark higher than the observed 1995 flood mark at the Smith House.
- The 1918 Stewart estimated peak flows of 185,000 and 175,000 cfs for the 1909 and 1917 floods compare reasonably well with the modeled maximum flow of 188,000 cfs for these events.
