APPENDIX I

REVIEW OF SELECTED HISTORICAL LITERATURE PRE-GAGED FLOOD EVENTS ON THE SKAGIT RIVER

SYNOPSIS BY CHAL MARTIN

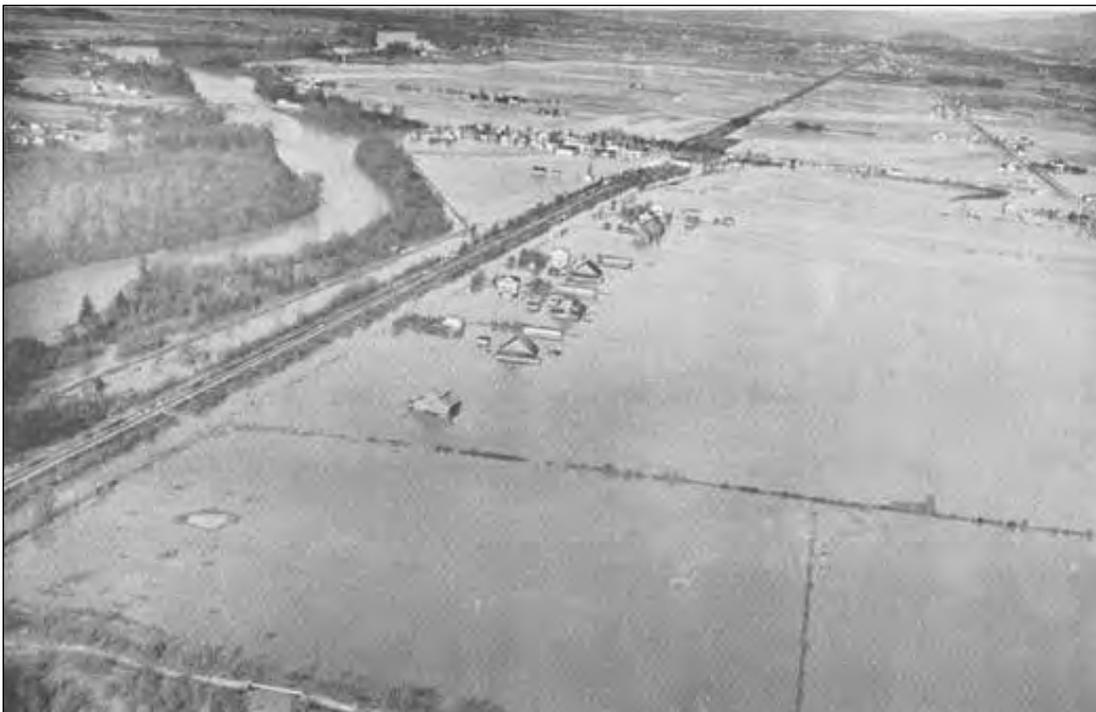
Photo 1. Conway, Washington, during February 1951 Flood. View is northerly, with the South Fork shown to the left.

The U.S. Army Corps of Engineers, Seattle District Draft Flood Insurance Study Hydraulics Summary (1 May 2008), cites the photograph above and states, “On February 11, 1951, the Skagit River near Mount Vernon gage reached 144,000 cfs, which is roughly a 25-year flood event. The levee system in this reach failed and the flooding in this area can be seen in Figure 31. The Mount Vernon Argus dated 2/15/51 states that “Conway residents declared the 1951 flood was two feet, ten inches below the 1921 inundation in their community.” This would make the 1921 flood similar in depth to the 100-year modeled flood estimate.” Work products provided by the U.S. Army Corps of Engineers, Seattle District, pursuant to ongoing flood insurance studies indicate an equivalent peak discharge for the 100-year regulated flood event at Mount Vernon to be about 208,000 cfs. Would a flood of this magnitude, or even larger (current USGS estimate of the 1921 flood is 228,000 cfs) in 1921 have resulted in flood depths in Conway about three feet higher than in 1951? That certainly is a distinct possibility. But it is also a reasonable possibility that a much smaller flood in 1921 could have caused higher flooding the same area than in 1951, depending on a number of circumstances. Were the levee failures in the same area? Where, specifically, was the newspaper account referring to – was it referring to the east side of the South Fork of the river, or the west side of the South Fork? This is important and intriguing documentation, but it is anecdotal and not specific enough to use as a reasonable basis for verifying the nature and extent of the 1921 flood, or compare the 1921 event to 1951 in this location. Further, there are significant complexities involved in attempting to reconstruct the overall picture of 1921 levee failures and the particulars of the 1921 levee system. Without information

about the exact location of the differential water surface levels reported by the newspaper, the location of the levee failures in 1921, and the nature of the levee system at the time, this photograph cannot be used to validate the notion that the 1921 peak discharge was 228,000 cfs. This information does not take away from the possibility that the 1921 228,000 cfs peak flow estimate may be correct. Neither does it take away from the possibility that the 1921 peak flow was much less.

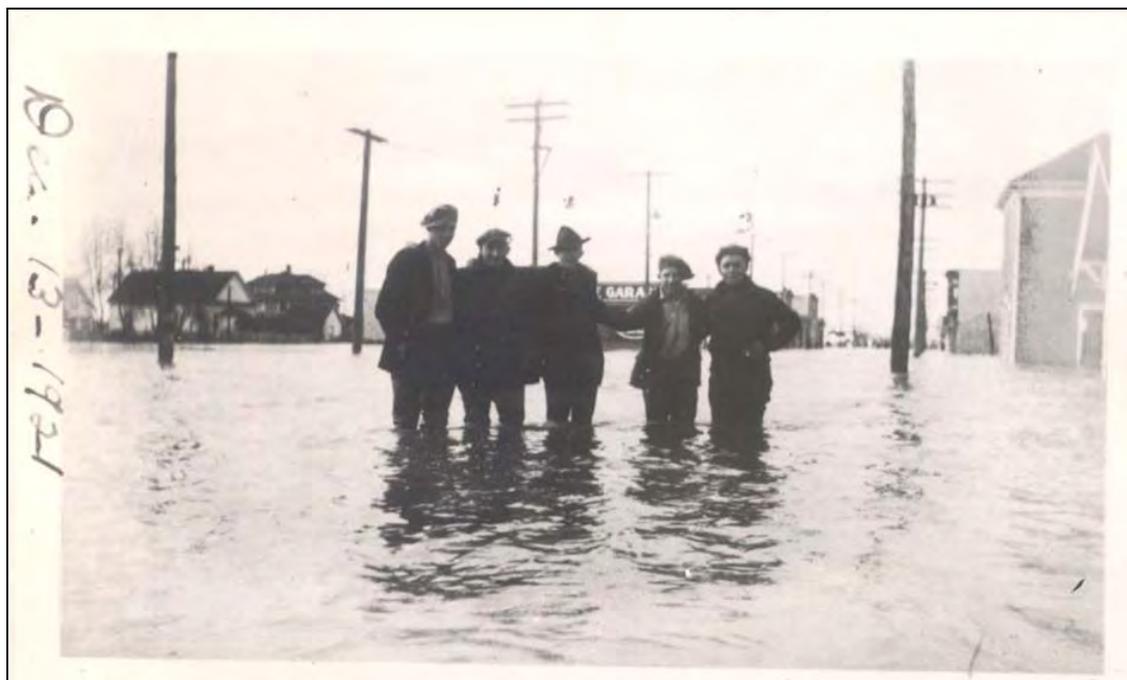
The U.S. Army Corps of Engineers, Seattle District Draft Flood Insurance Study Hydraulics Summary (1 May 2008), cites the photograph below and states, “*Figure 27 is a picture of the corner of Fairhaven and Anacortes Streets after the December 1921 flood which had a discharge that is within 10% of the predicted 100-year flood (228,000 cfs versus 210,000 cfs at Concrete). Figure 28 is the same flood looking East down Fairhaven Street. The Concrete Herald reported on 12/17/21 that “The entire city of Burlington was flooded to a depth of from three to five feet” (Concrete Herald, 12/17/21) which looks consistent with the flooding seen in these two pictures. . . . It is for these reasons that 3.5 feet of depth in this area seems reasonable.*”

Photo 2. 1921 flood at Fairhaven and Anacortes Street (Figure 27 from Seattle District, Corps of Engineers Revised Flood Insurance Study – Hydraulics May 2008)

However, it can be seen from the photographs above that the depth of water at the time the photographs were taken appears closer to 1.5 feet.

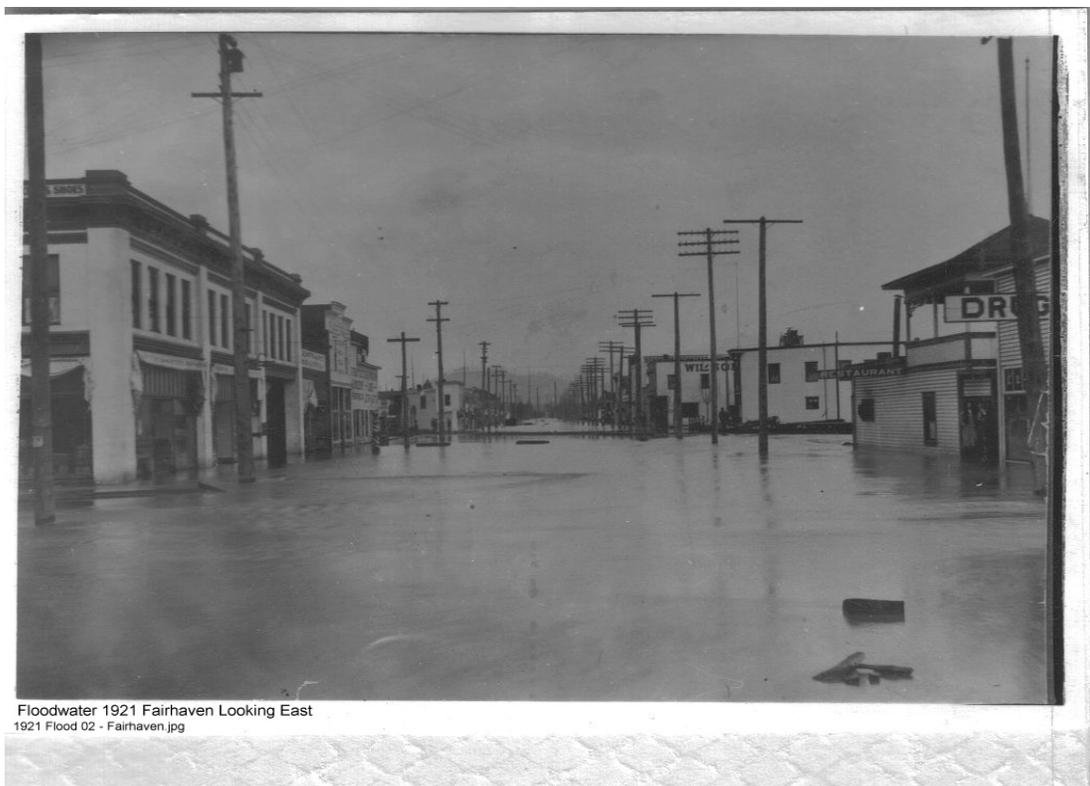
Photo 3. (Figure 28 from Seattle District, Corps of Engineers Revised Flood Insurance Study – Hydraulics May 2008)

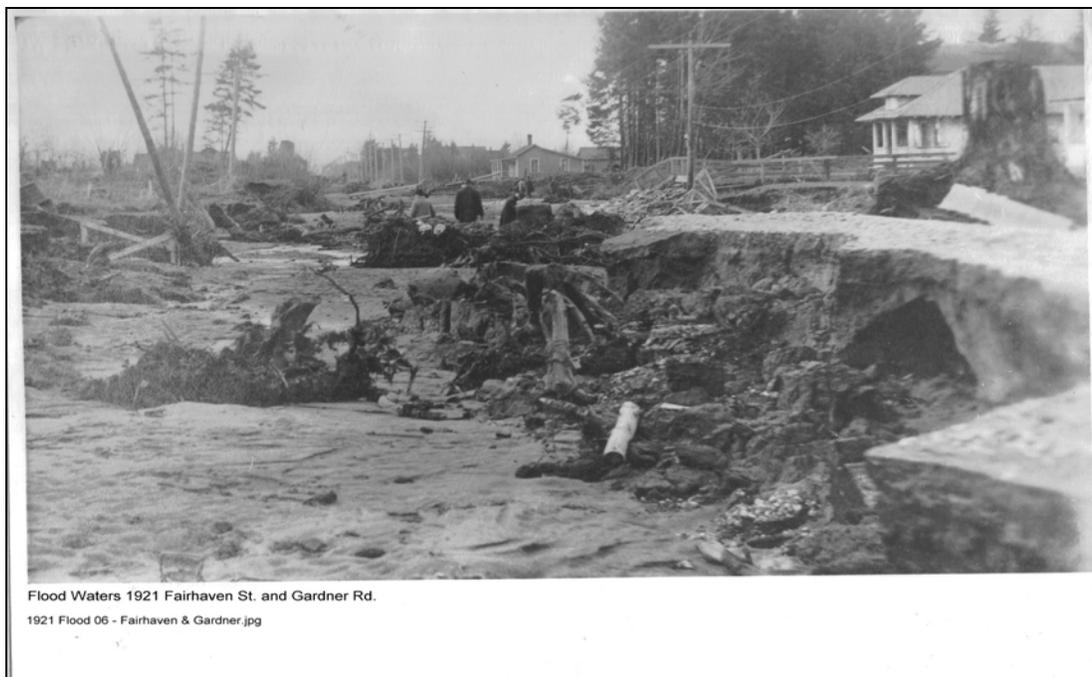
Photo 4.

The photograph below indicates it was taken at Fairhaven and Gardner, about $\frac{3}{4}$ mile east of the photographs above, and apparently looking east. While the damage is significant, it is consistent with a levee failure and flows of 10,000 cfs to 20,000 cfs. It is plausible water broke through the upstream levee, thereby causing this damage while a significant amount of water remained in the main channel, causing additional flooding further downstream. Without specific knowledge of the nature of the levee failures, it is very difficult to use this photograph to characterize the 1921 flood event (from Mr. Larry Kunzler's web page, www.skagitriverhistory.com, photo gallery).

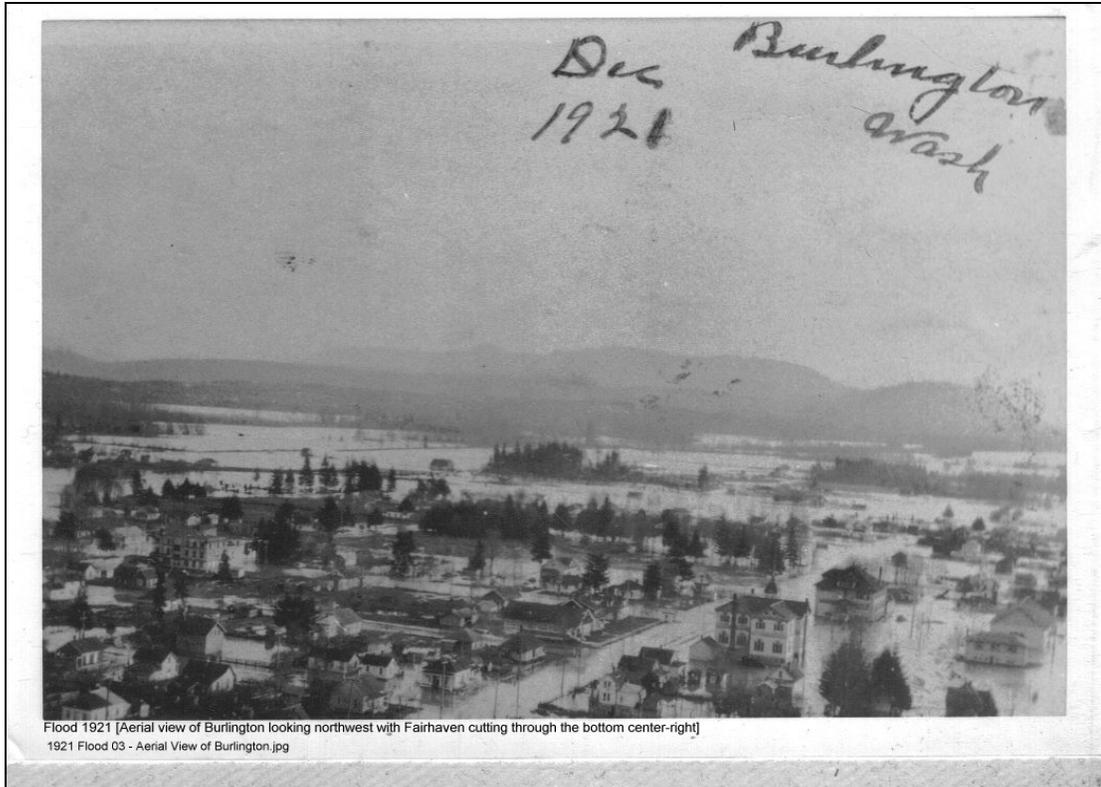
Photo 5 is an aerial of the eastern part of the city during the 1921 flood event. It is not known when this photograph was taken in relationship to the flood peak. It can be seen that although flooding was widespread, water depths appear shallow in most areas.

Photo 5. Flood 1921. Aerial view of Burlington looking northwest with Fairhaven cutting through the bottom center-right

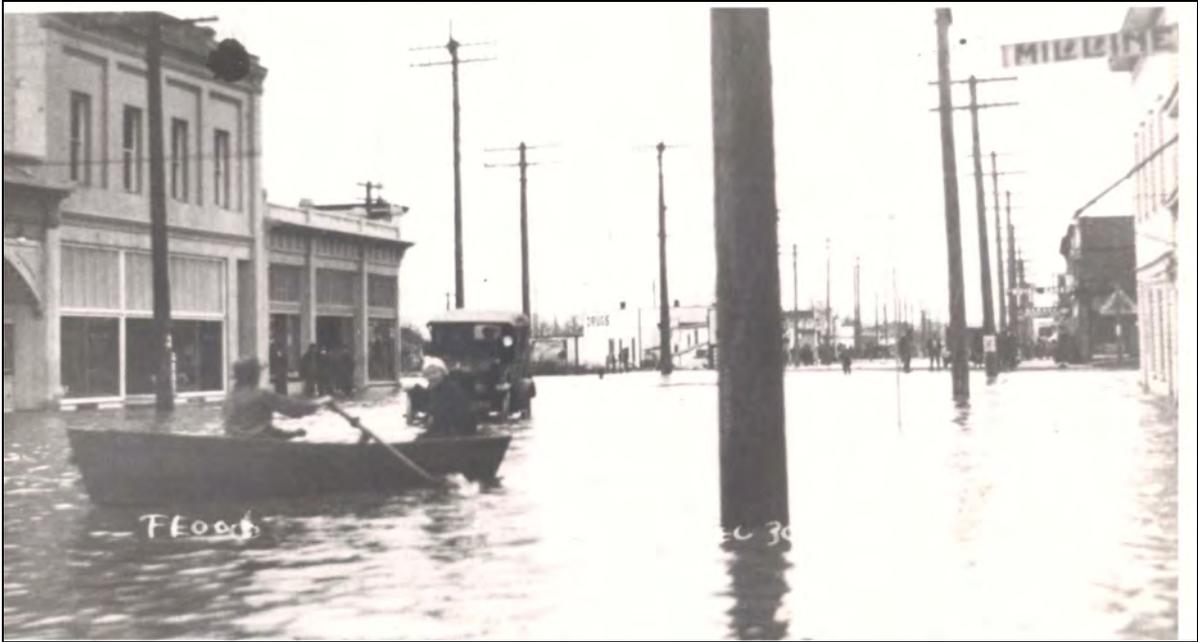
Photo 6.

The above photograph of the 1921 flood shows a building that still exists today (2-story structure, left part of photo) at 612 Fairhaven. Based on the information in the photograph, the City of Burlington undertook a forensic investigation of flooding in this building. We do not know when this building was constructed, although local estimates are some time around the turn of the last century.

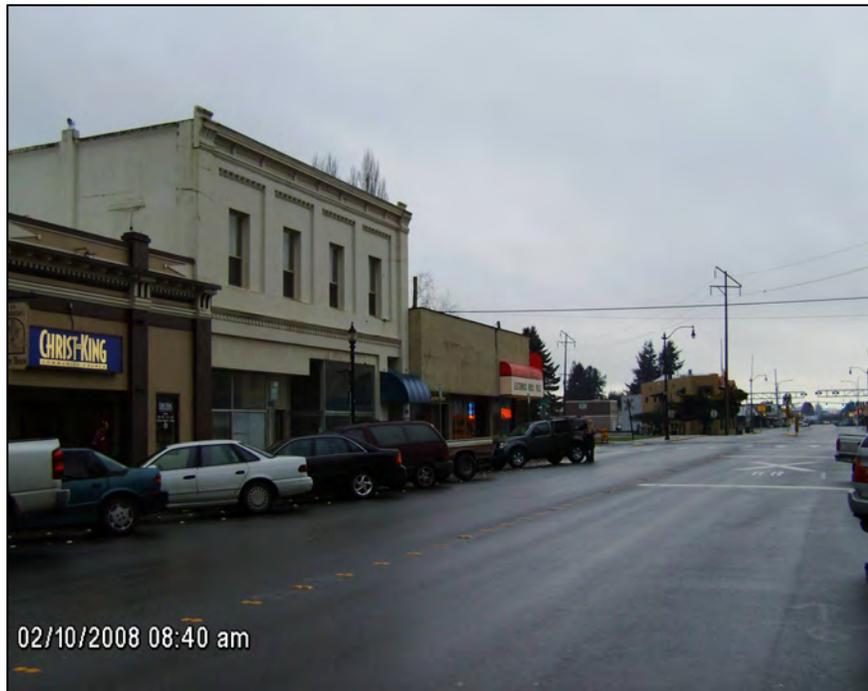
Photo 7. 612 Fairhaven today

The City undertook the investigation with the goal of trying to ascertain the highest flooding the old building had been subjected to. We found that all the lath/plaster had been removed and replaced with newer material about 10 inches up on the base of the wall. Additionally, we observed what we believed to be flood marks about 16 inches up the wall, possibly consistent with floating oil or debris on top of the water surface. Could this indicate the maximum flooding the building received was similar to what the photographs show? Probably. But the forensic evidence was not conclusive. Taken together, the old photographs and the forensic investigation in downtown Burlington indicate significant flooding in the town during the 1921 event. But was a Skagit River discharge of 228,000 cfs necessary to produce this amount of flooding? No.

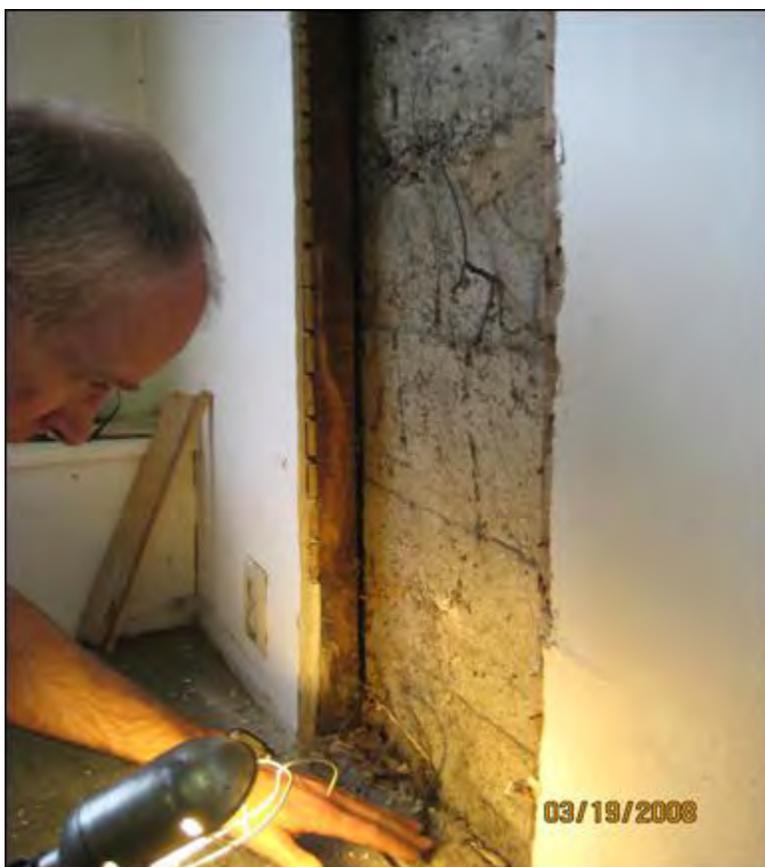
Photo 8. Removal of wall section for forensic investigation. Note bottom lath/plaster has been replaced. Was this due to flooding, or to install electric outlets? Or perhaps both?

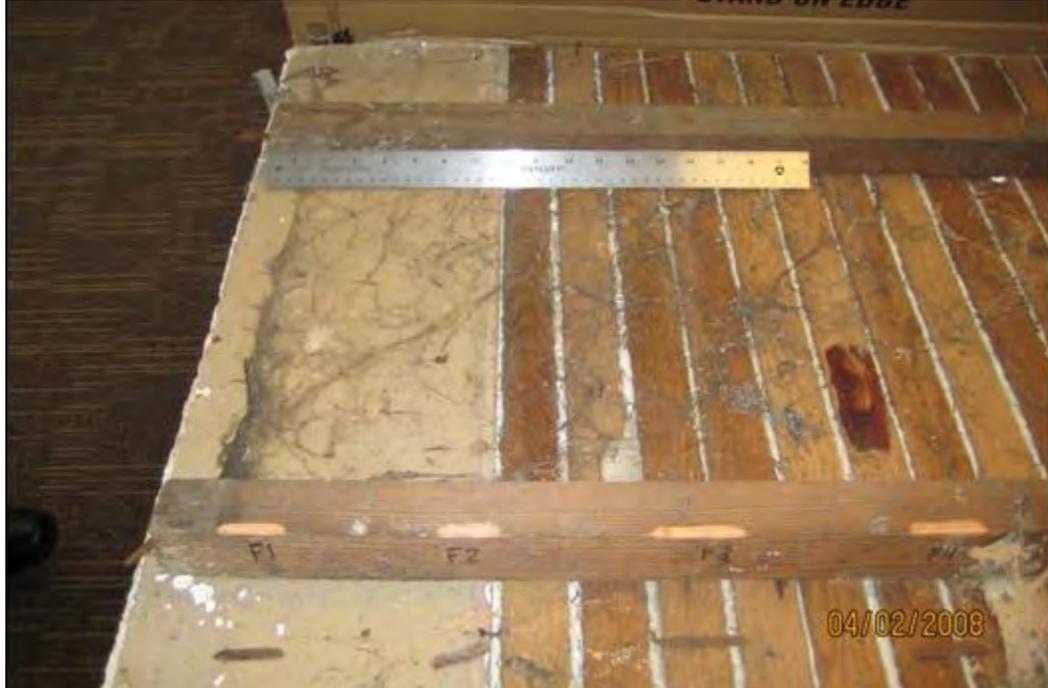
Photo 9. 612 Fairhaven, wall panel removed. Note apparent flood mark to the left of the F3" sample.

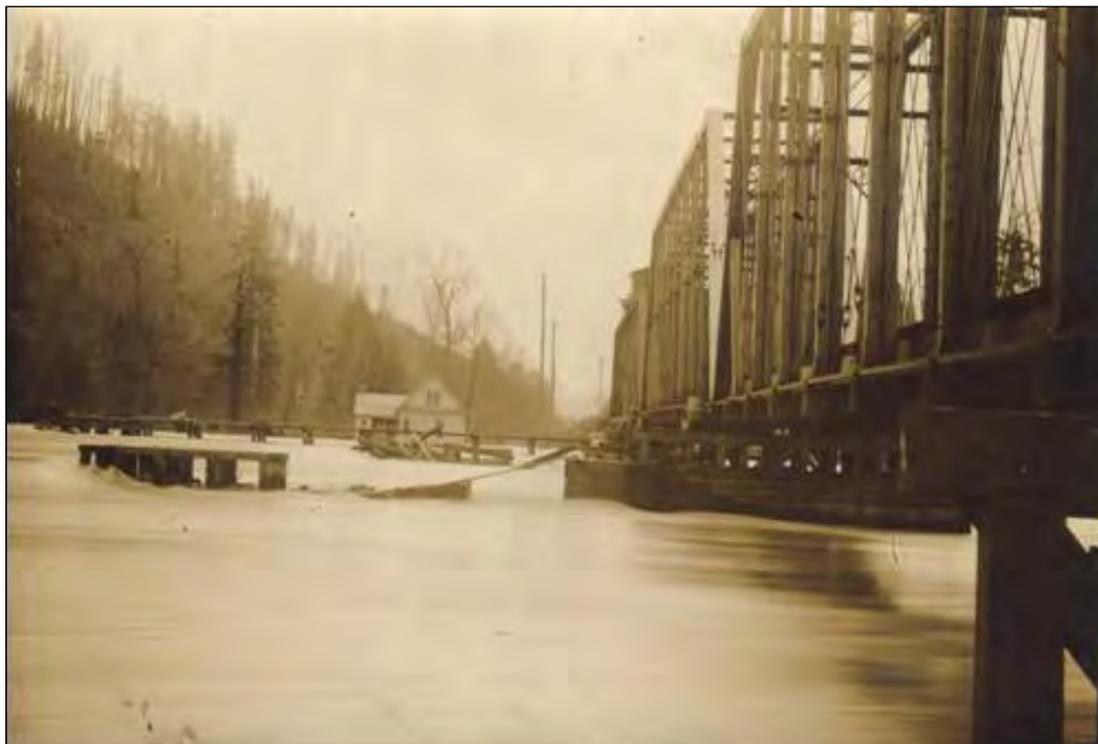
These articles clearly indicate the 1909 flood event was very serious. But was it a flood with a peak discharge of 245,000 cfs? The photograph below is believed to be of the 1909 flood event at Sedro-Woolley, at the current location of the old abandoned railroad bridge. Note that the bridge was later modified and put on concrete piers – this bridge in the photograph is still on wood pilings. Notice the old house on the south side of the bridge. That house still exists today, although it has been modified. Real property records indicate it was built in 1908.

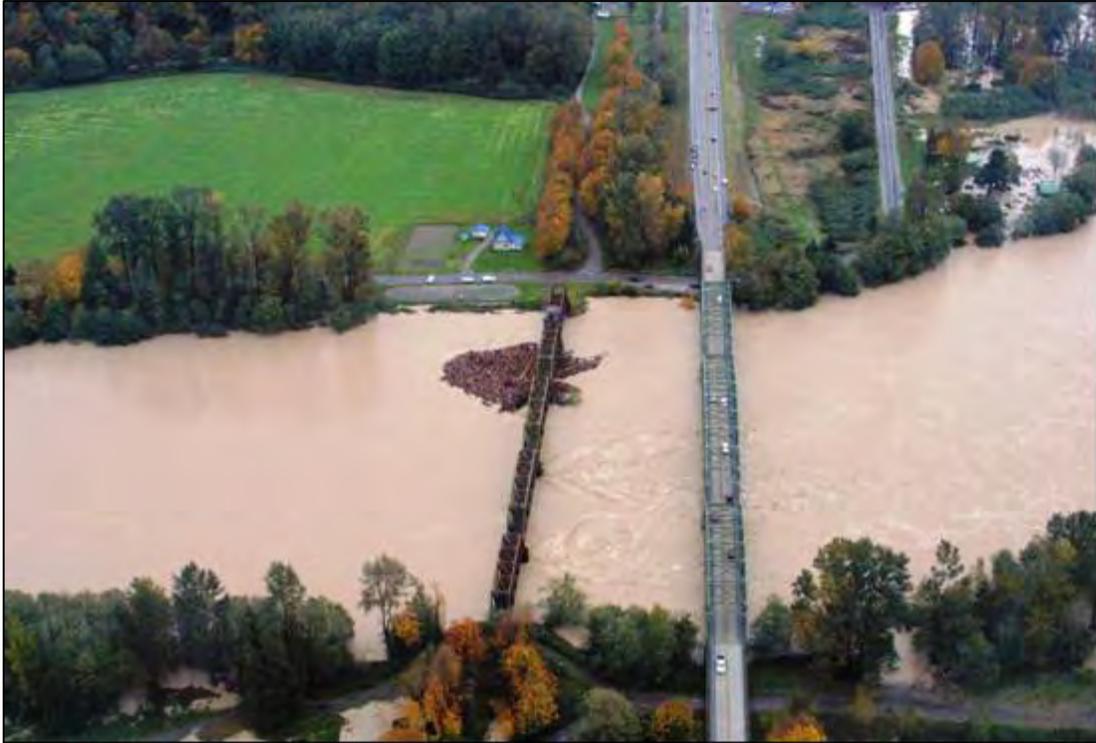
Photo 11.

Photo 10. Compare the photograph above, to this picture of the 2003 flood event, looking south (approximately 157,000 cfs here):

This water surface level is within about three feet of overtopping the South Skagit Highway, and then flooding the house.

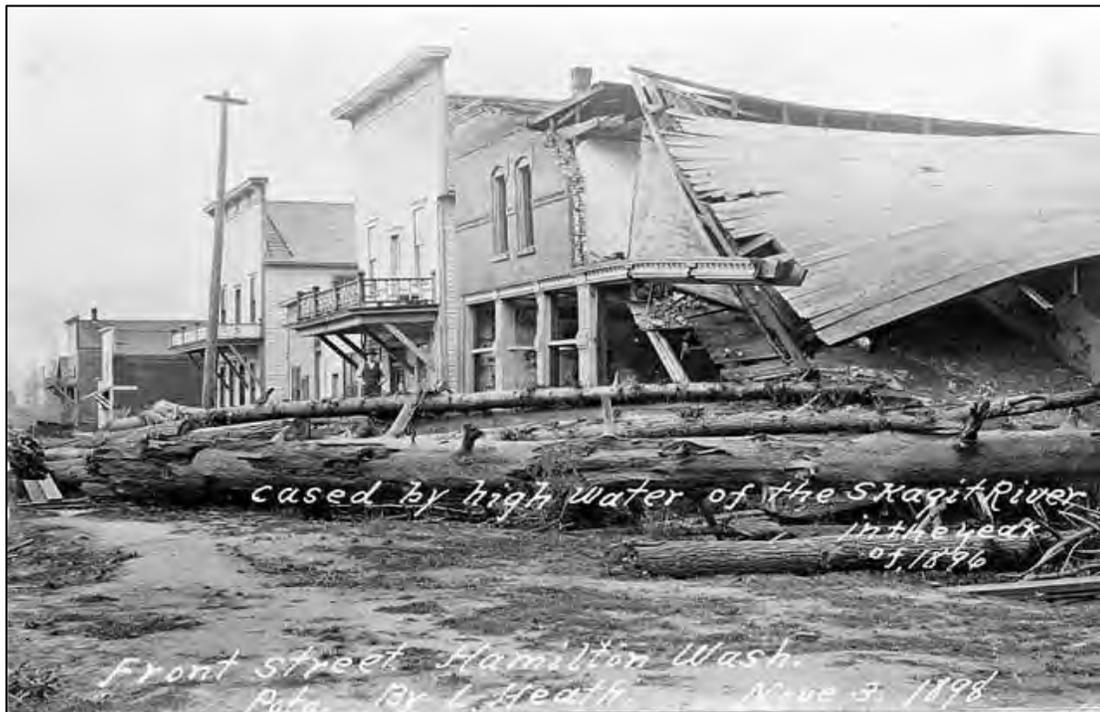
Photo 18.

This photographic evidence below from 1897 in Hamilton shows significant damage adjacent to the old “Water Street” of Hamilton. After this flood event, the town migrated to the north, further away from the main stem of the river. Would it have taken a flood discharge of 265,000 cfs to create this damage, or would a much smaller but still very significant flood event (in the neighborhood of 180,000 cfs) have done it?

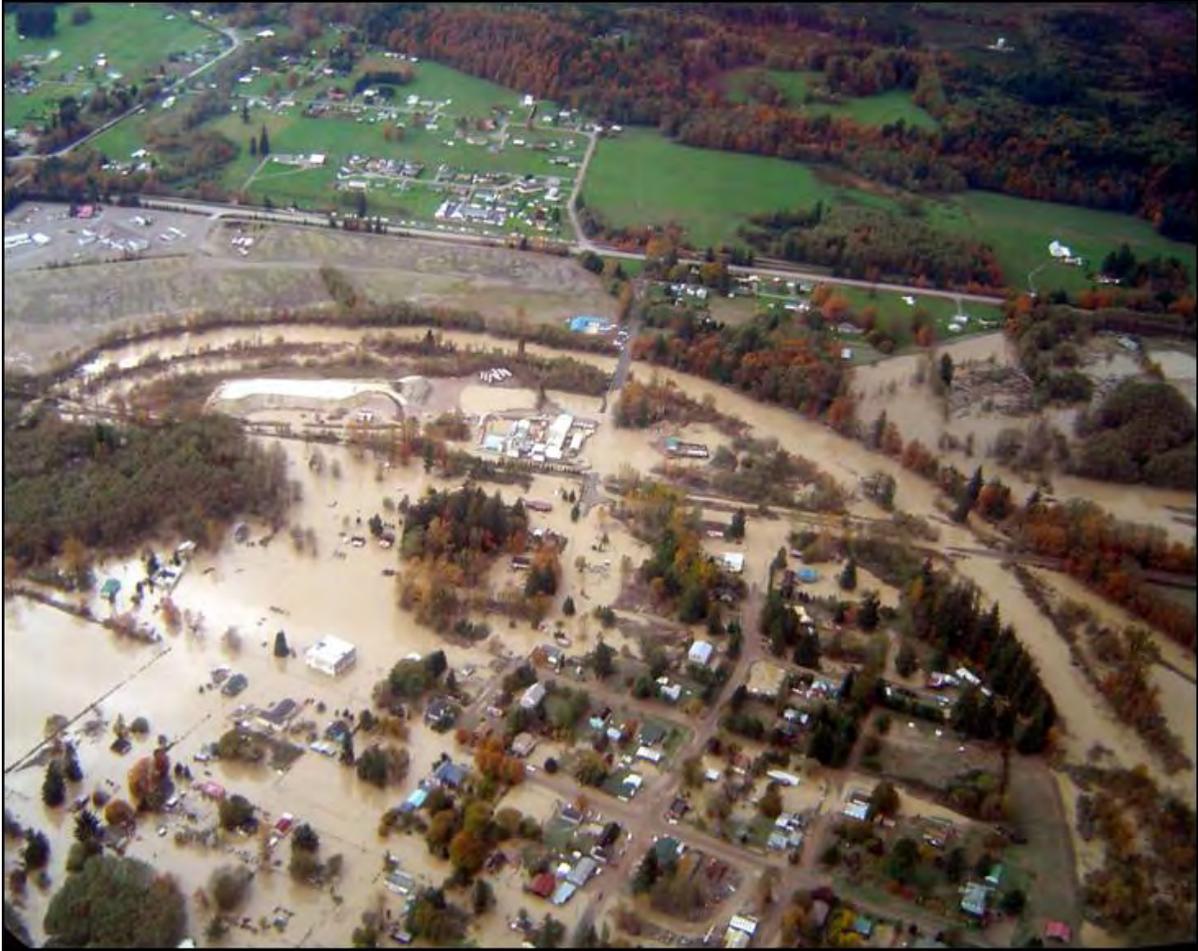
Photo 19.

As can be seen from this aerial photograph, there is a several-foot elevation drop in Hamilton from east to west:

When “nearly the whole of Hamilton was covered,” water would be between zero feet deep on the east end of town by the “Smith” house (ground elevation about 98 feet), to about 6 feet of depth on the west side of town (ground elevation about 92 feet). If a flood discharge of only 147,000 cfs put that amount of water in town, it would indicate the channel capacity in 1932 was much the same as it is today. Could the river capacity in this reach have decreased so substantially over the 11 years since the 1921 flood event, that a “small” flood with a peak discharge nearly 80,000 cfs less than 1921 have flooded the town to a level only a little lower than in 1921?

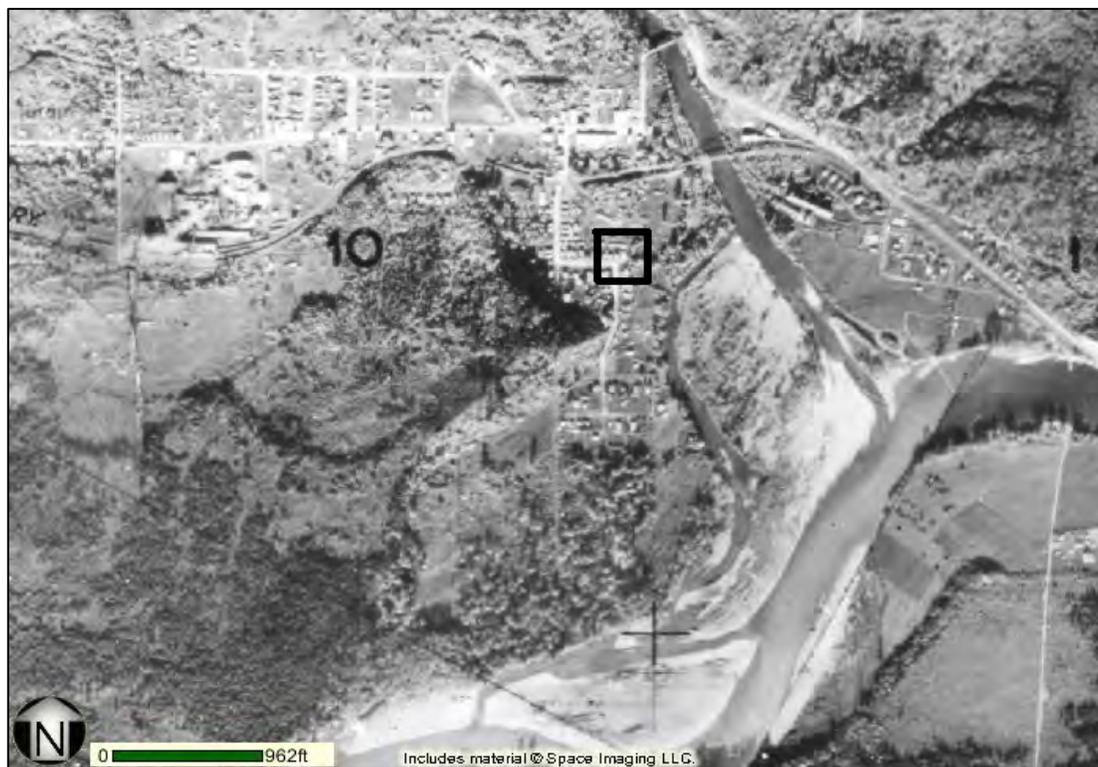
Photo 22. “Crofoot’s Addition, 1937 with location of L.E. Wolfe residence annotated.

The outcome of the forensic investigation in the Crowfoot’s Addition to Concrete, and the information provided from the hydraulic model extension between the Dalles gage and Concrete, is addressed in the main body of the report.
