SKAGIT RIVER

Rough Estimate of Flood Damages from  
Sedro Woolley to Mouth of Skagit  
River.

1951 FLOOD

Memo on Skagit Flood of February, 1932.

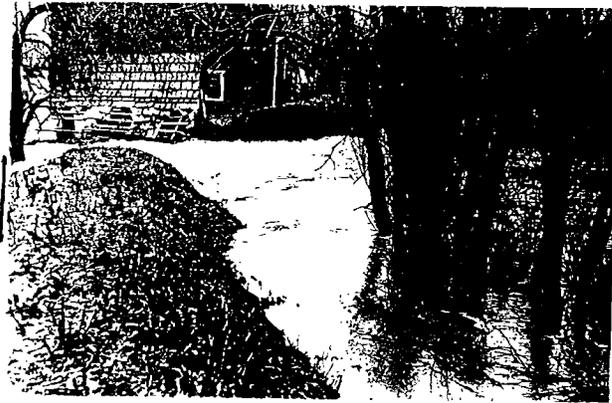
#432

*Feb 10, am. Break, Dist #13 about 1000 feet below N. Fork Bridge. This break enlarged and another one developed, completely destroying the barn shown and also an adjoining farm house and all other buildings.*

*Note: On 11 Feb a more serious break in Dist. #13 occurred on Peew Slough near its head. This break and the one above flooded the entire district causing much damage from scour, deposition of silt, and inundation.*

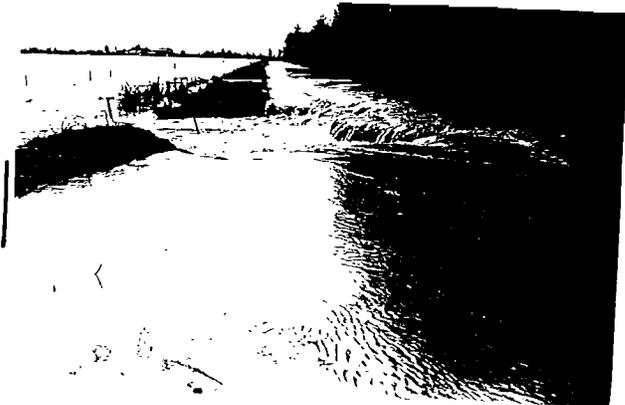
#431

*Feb 10, am Break, private dike on Freshwater Slough about 1 mile below S. Fork Bridge. County bridge leading to this island was later washed out.*

*Note: In Nov. 1949 flood this levee was overtopped but did not fail.*

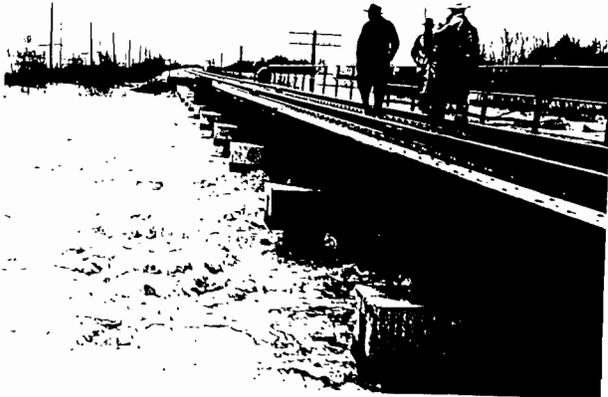
# 428

← *Milltown Break on 10 Feb 1951*

*Uncompleted Milltown levee repairs on 10 Feb 1951 shown below.*

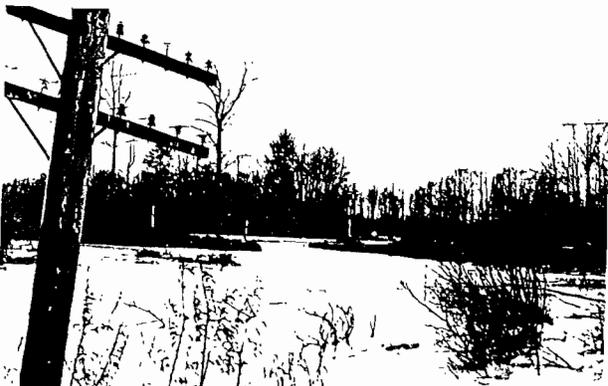
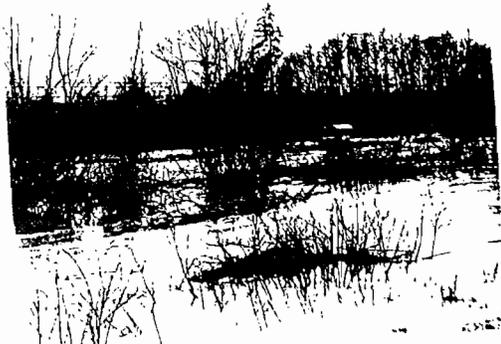
# 430

*Feb 11, am Break on South Fork  
just below Conway.*

*All pictures this sheet taken  
from G.H. Ry. grade, which was  
reached by wading in from  
Hwy. #99 before the water got  
too deep.*

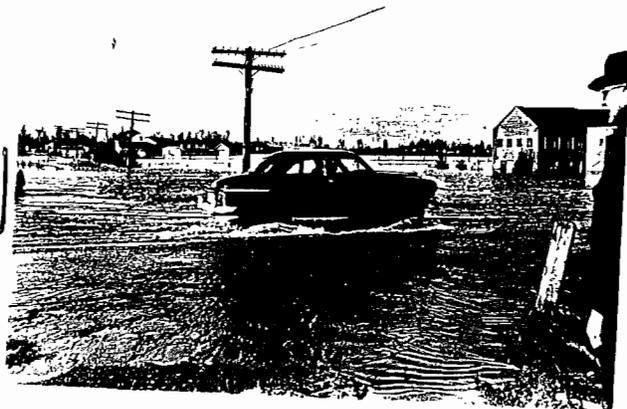
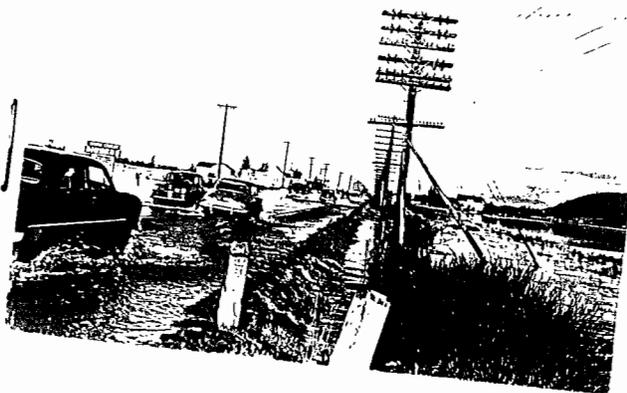
These two photos show Highway #99 just east of Conway on 11 Feb 1951 about noon. Traffic was heavy because it was Sunday.

Water was rising rapidly at this time from the Conway and Hilltown breaks. About an hour after these photos were taken the highway was closed to traffic and remained closed for more than a week.

View north toward Mt. Vernon. The water later got much deeper, but even at this time the pavement was difficult to follow in many places and the shoulders were getting badly eroded. Only luck prevented a serious traffic tie-up in the rising water.

The highway should have been closed much sooner.

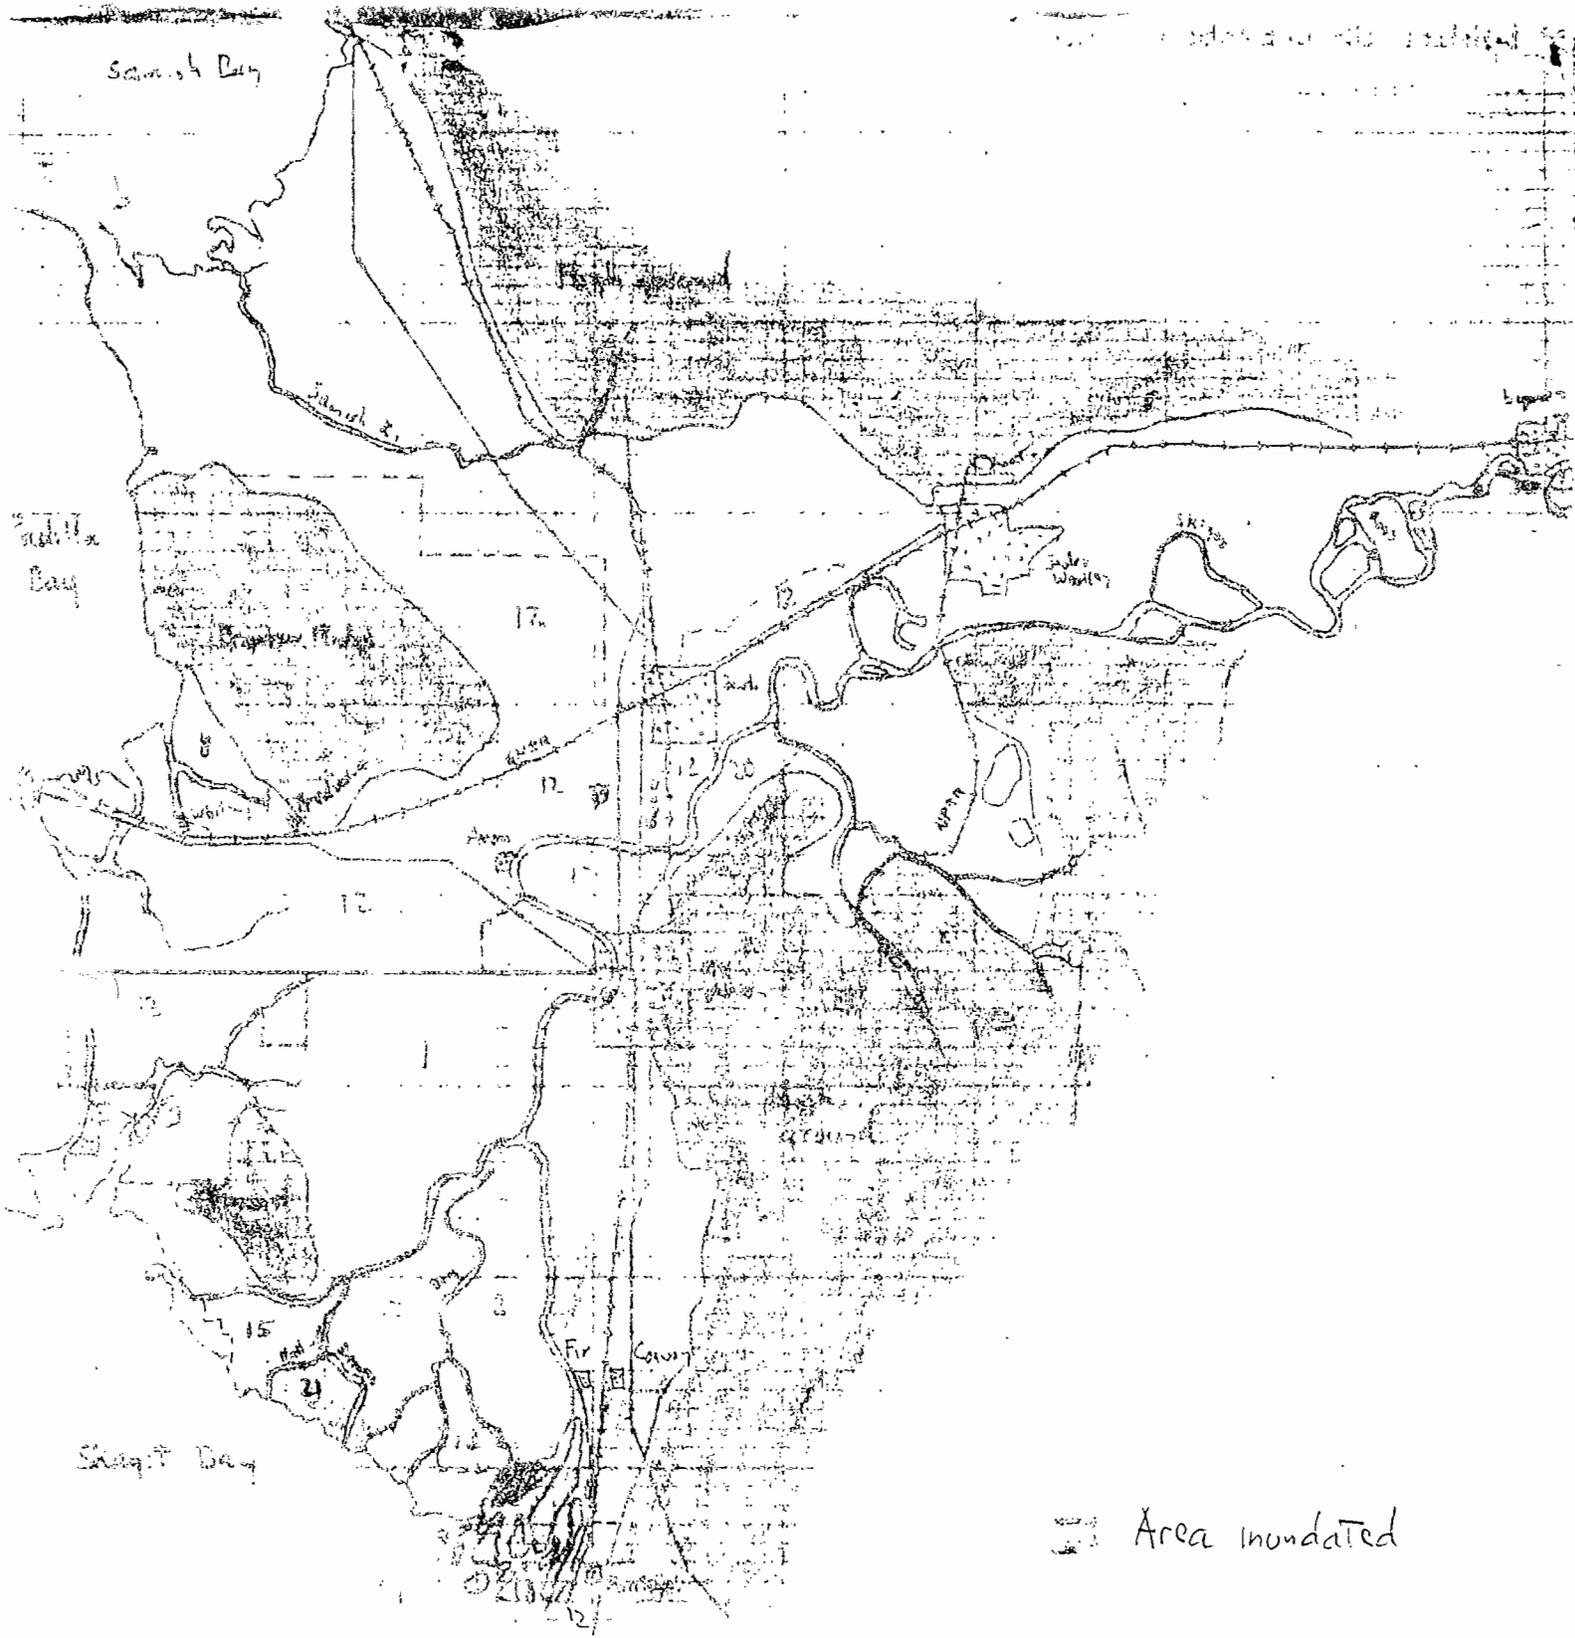
SKAGIT RIVER WASH  
 FLOOD PLAN  
 1949

Area inundated

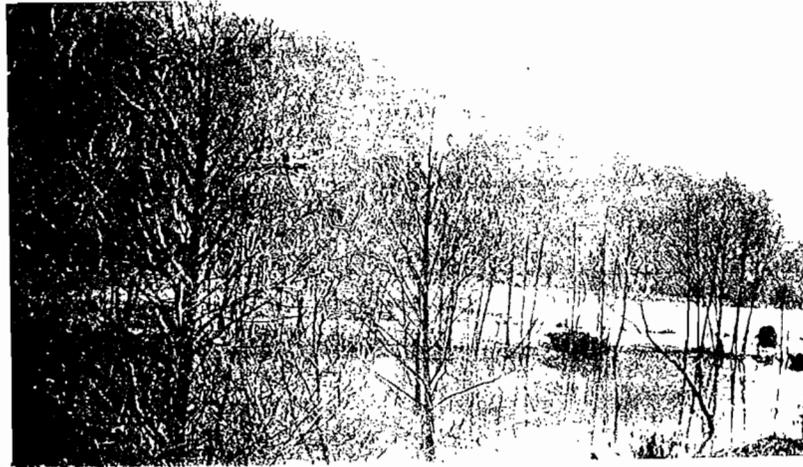
No. 1. Looking southwest from the right bank of the Skagit at mile 24. Our upper gage was located on the opposite bank in this immediate vicinity. The main channel is in the background, with overflowed bank of stream in the foreground. Picture taken 10:00 a.m., Feb. 29.

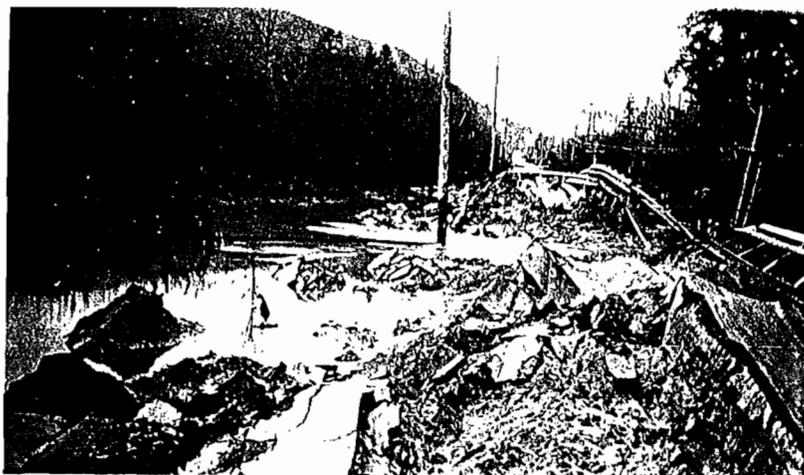
No. 2. Looking south along the Clear Lake road from near the city limits of Sedro Woolley. This fill was composed of sand with some clay and flattened out like molasses when it became saturated. The fill was not overtopped. Note some water still flowing through the break. Picture taken 10:00 a.m., Feb. 29.

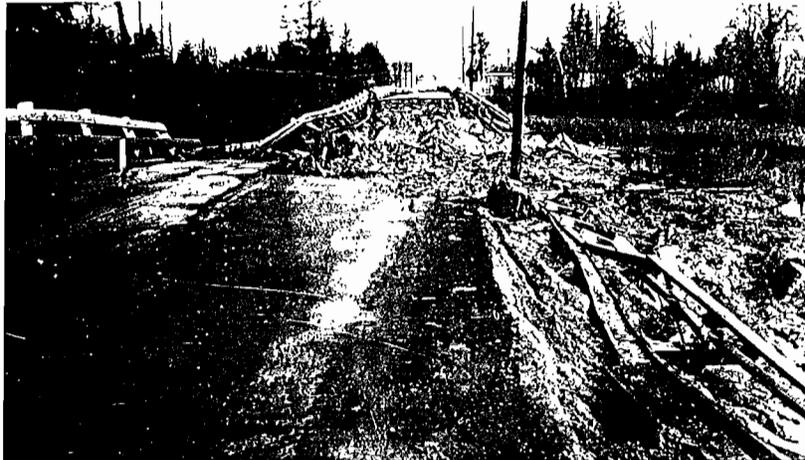
No. 3. Looking north along the Clear Lake road at same break shown in No. 2. Picture taken March 3d.

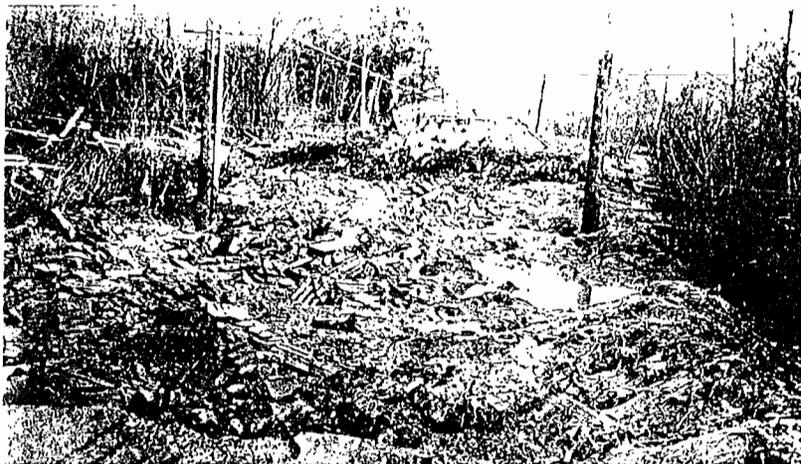
No. 4. Looking north along the Clear Lake road at break shown in Nos. 2 and 3. Picture taken March 2d.

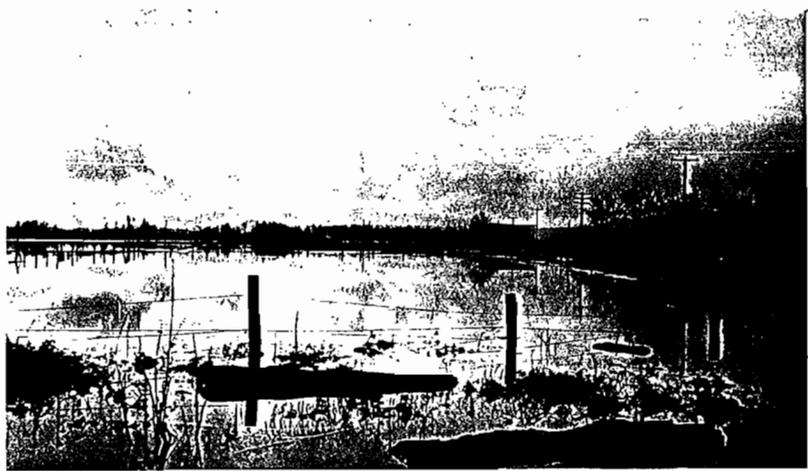
No. 5. Looking south from the Great Northern Railway near the north and south highway near the east side of section 27, T. 35 N., R. 4 E. This lake was formed immediately below Sterling Bend. Picture taken at 9:30 a.m., Feb. 28th.

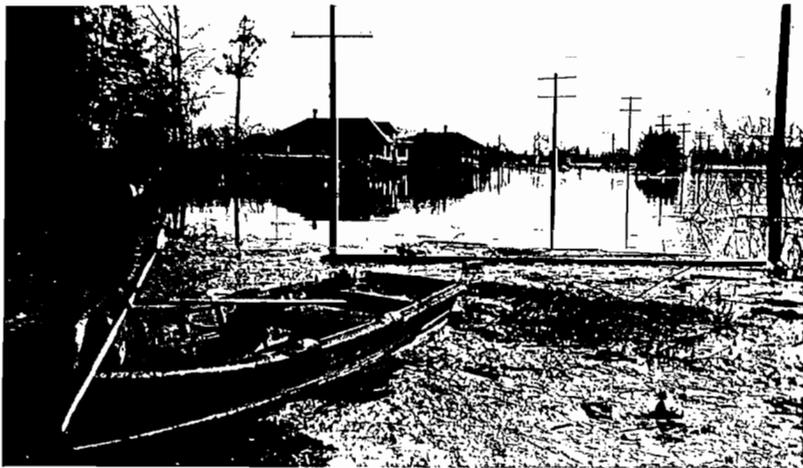
No. 6. Looking east along the road that runs out of Burlington to the east. Picture taken at 10:00 a.m., Feb. 28th from the top of the dike.

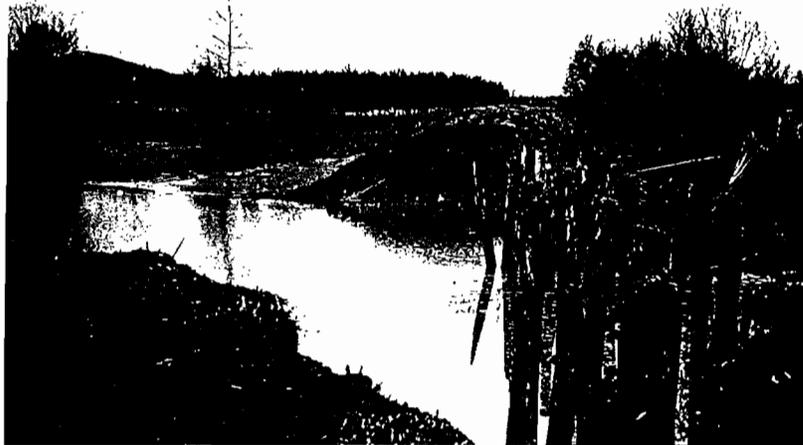
No. 7. Looking upstream (north) along the broken dike above the Great Northern Railway bridge. (mile 16.2). Note the old pile trestle that was used to repair the dike after the 1921 flood. The main river channel is on the right. Picture taken 2:00 p.m., March 1st.

The third break occurred on the right bank of the main Skagit at mile 16.2 a half mile above the Great Northern Railway bridge about noon of the 28th. It also started from a boil. About 150 feet of dike was eroded. The released water overtopped the Great Northern Railway grade and washed out the fill in two places for lengths of 130 and 360 feet, respectively. Part of the water flowed over the Pacific Highway to a depth of about 3 feet, and part went under the trestle bridge near the S.E. corner of Sec.6, T. 34 N., R. 4 E. It spread out over the farm land and finally found its way to the Sound, largely to the north of Avon, via Fredonia and Whitney. No extensive damage was sustained, outside of the erosion of the Great Northern grade. See photos Nos. 7, 16, and 17.

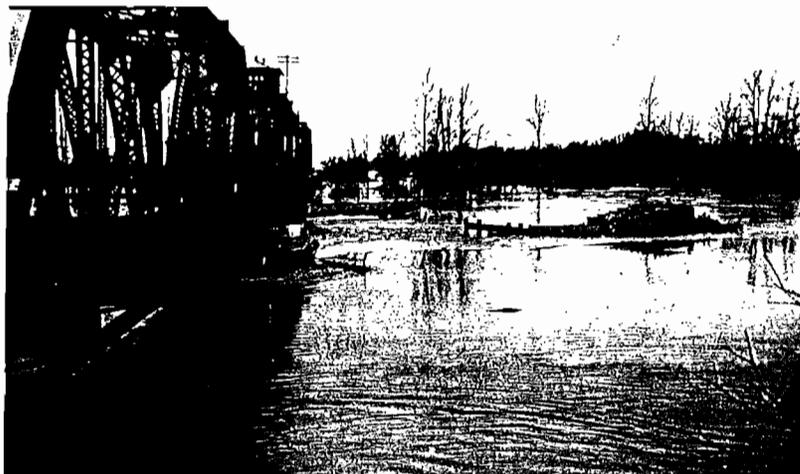
No. 8. Looking north along the upstream side of the Great Northern Railway bridge (mile 15.5) at the crest of the flood (10:30 a.m., Feb. 28).

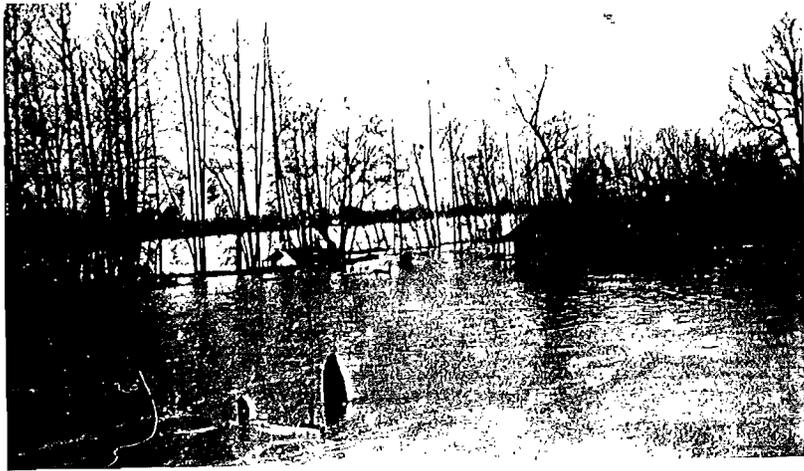
No. 9. Looking downstream to the southwest, from the Great Northern Railway bridge, 10:30 a.m., Feb. 28th. The main river channel is in the background. The buildings are located on the channel side of the dike. (Invisible on the right.)

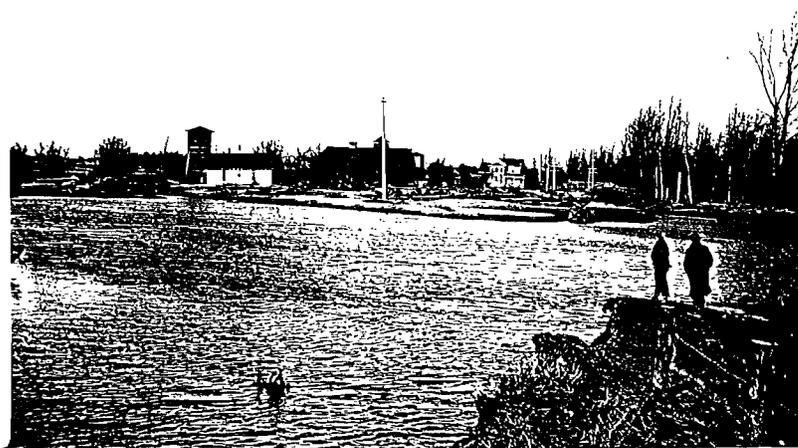
No. 10. Looking upstream along the dike at the break on the right bank of the South Fork a mile north of Conway, taken about 2:00 p.m., March 2d. The river channel to the right is not visible. The lake in the foreground is formed by the water after passing through the broken dike. Note the numerous large snags stranded in the door-yard. The white house in the left background was knocked off its foundation.

The first and probably the most serious break occurred Saturday evening, Feb. 27 on the right bank of the South Fork a mile above Fir <sup>Failure</sup> ~~Failure~~ occurred by a boil. About 500 feet of dike was washed away. About five acres of good tillable land was badly eroded and strewn with snags. One residence was knocked off its foundation. About three sections of farm land were inundated. See photos Nos. 10, 11, and 12.

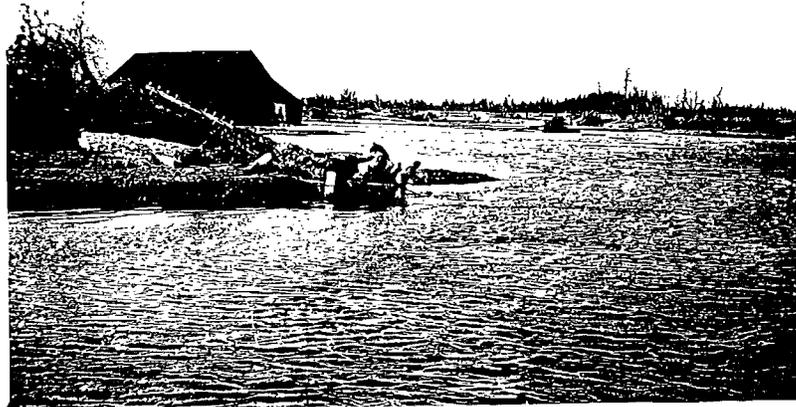
No. 11. This picture was taken from approximately the same point as No. 10, looking more to the west. An orchard is shown in the background, part of which was washed away. The snag in the left foreground is located in what was the front yard of a large farm house. The house was not damaged.

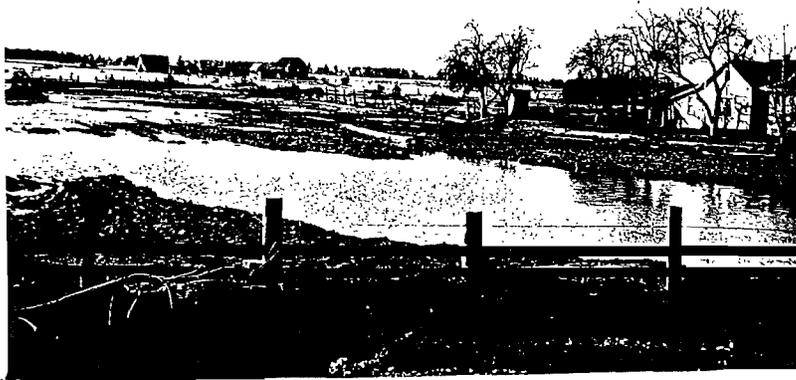
No. 12. Looking west from the dike. The farm house mentioned in No. 11 is shown in part on the extreme right. Note the flooded land in the background. This flooded area extended over to Deer Slough and covered about three sections.

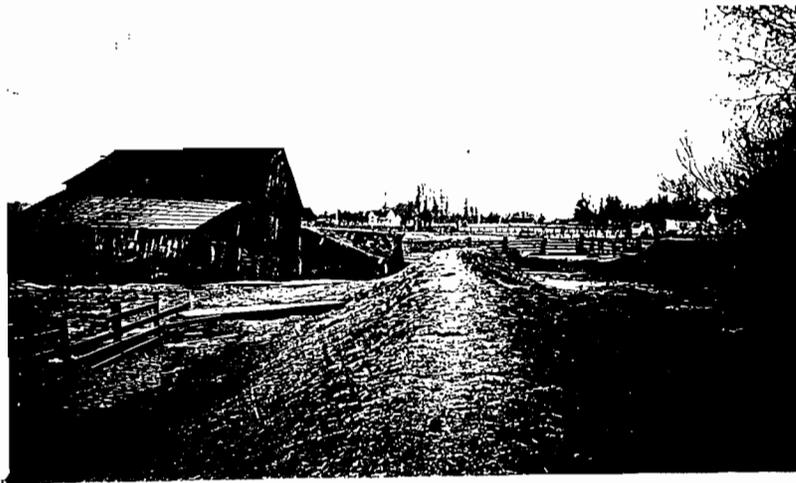
No. 13. Looking north along the broken dike on the right (west) side of Deer Slough on the morning of March 3d. On the left is the barn that was undermined and badly racked.

The second break occurred Sunday morning about 5:00 a.m. on the right bank of Deer Slough, locally known as Dry Slough, about 2 miles below its confluence with the North Fork. Approximately 90 feet of dike was eroded, starting with a boil. The break occurred directly in front of a large, rather cheaply built barn, and undermined it. It was badly racked, and will have to be torn down. The ranchers intend to build a new dike out around the site of the barn, which will add about an acre to the slough channel. See photos Nos. 13, 14, and 15. At least two sections of good farm land were flooded.

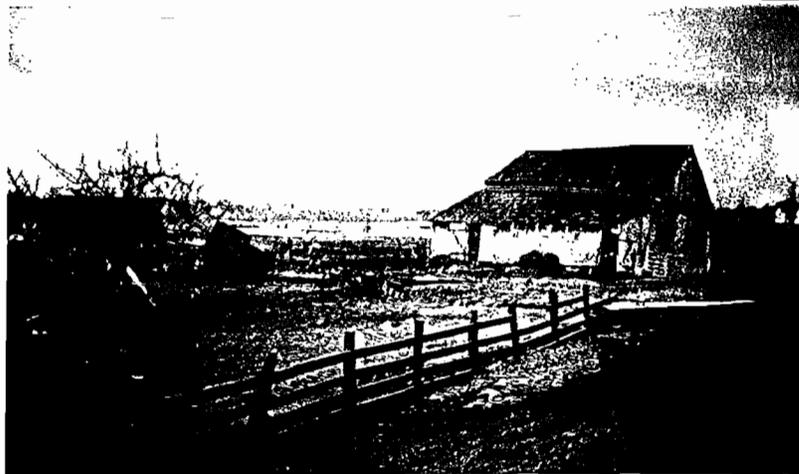
No. 14. Another view of the barn showing the flooded farm land in the background.

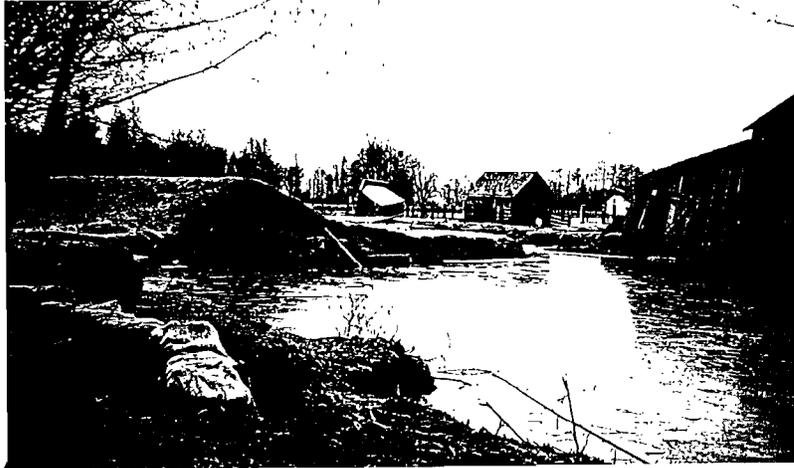
No. 15. Looking southwest from the dike at the downstream end of the break on Deer Slough.

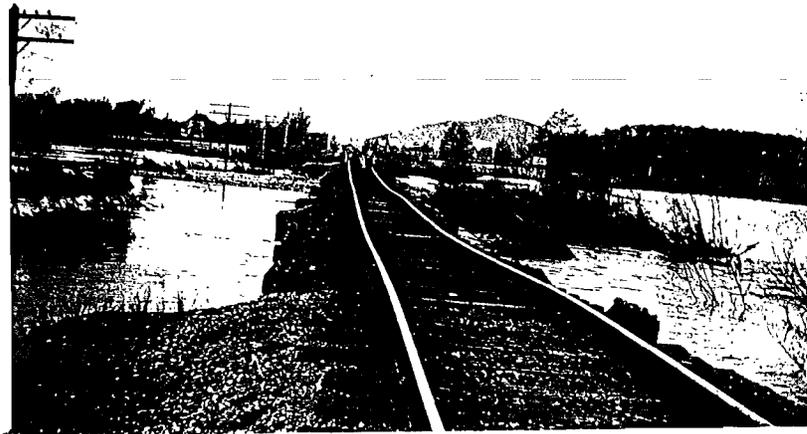
No. 16. Looking north along the Great Northern Railway washout, near Burlington. Track undermined for 360 feet at this location. A break occurred here during the 1921 flood. Note that the old trestle used in repairing the roadbed after the 1921 flood is still in place and was used to shore up the track after the present flood. Picture taken at 2:00 p.m., Feb. 29th.

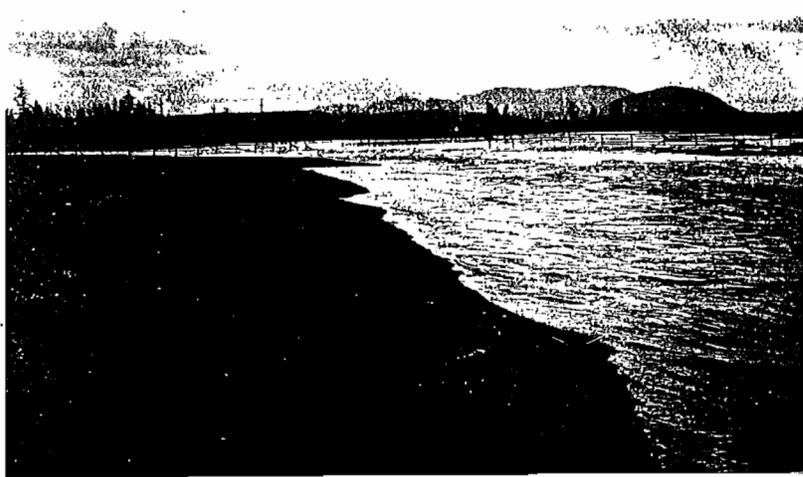
No. 17. Looking southeast from the Pacific Highway, showing the water that has passed through the break in the dike near Burlington. This flow passed under the trestle at the Highway. Picture taken about 2:00 p.m., Feb. 29th.
