17 August 2007

Re: City of Hamilton
Historic Flood Investigation
WJE No. 2006.5898

Subject: Debris Studies

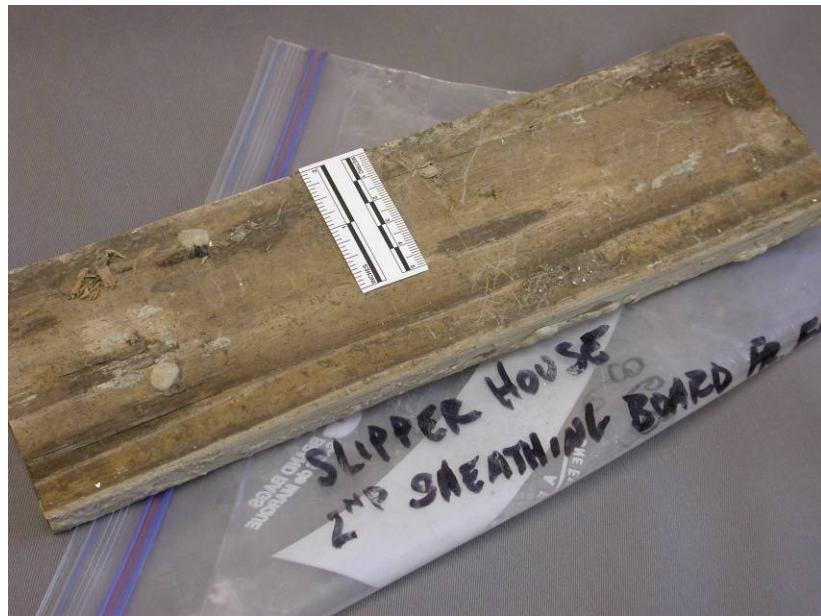
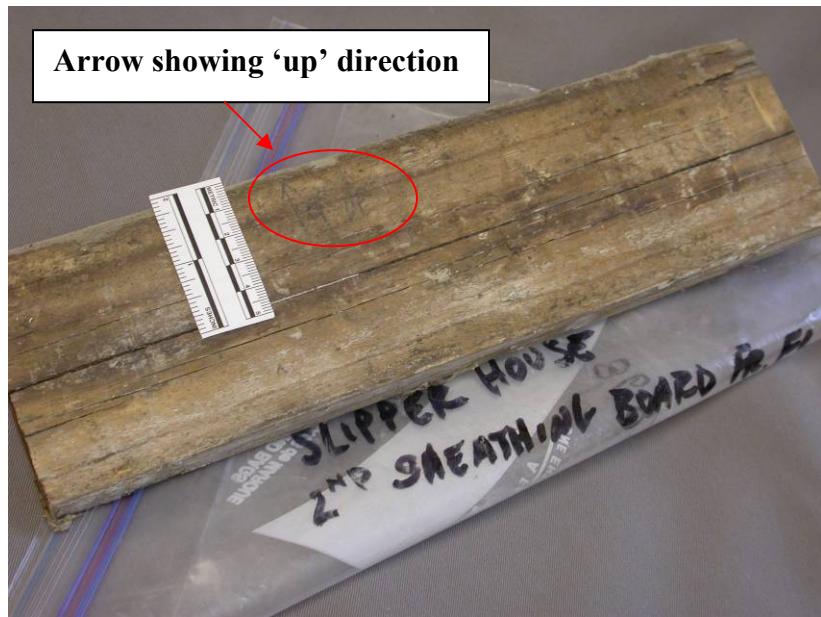
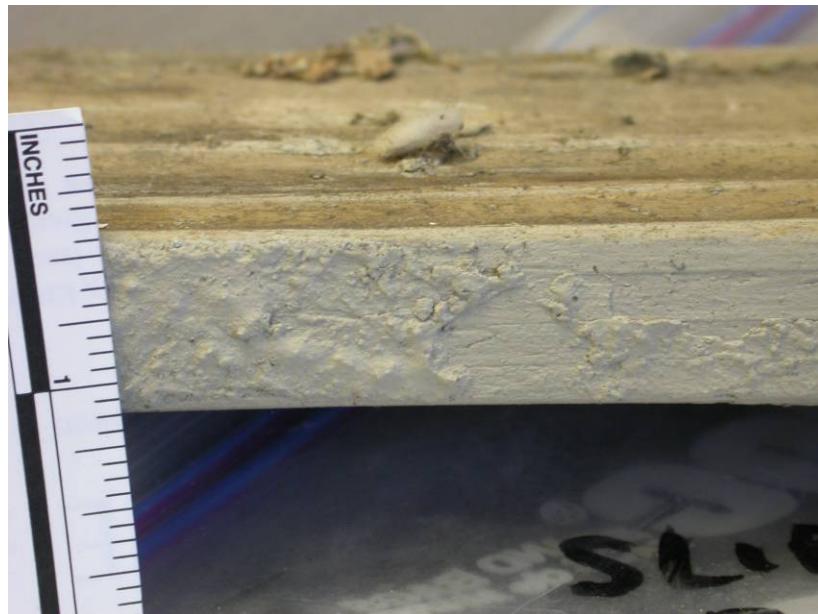
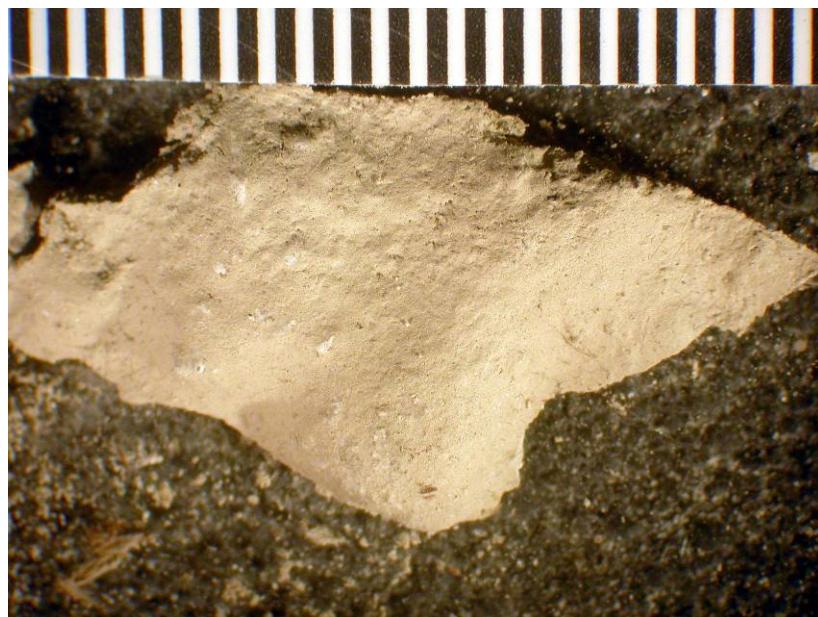
Sample 1 Slipper House: The sample is a saw-cut section of wood sheathing, approximately 12 inches long, 3.2 inches high, and about 0.6 inches thick. One side of the sample is marked with an arrow and a notation 9 inches up. Insect webs are observed on the unlabeled side. Gray, buff, and beige deposits are observed on both sides and on the top and bottom surfaces. Deposits are also observed in the longitudinal cracks (Figures 1 and 2). The heaviest deposits are observed on the top surface, where nearly the entire surface is covered with beige, fine-grained material (Figure 3). Mounds up to 0.1 inch thick occur in several spots. The smooth surfaces of the clumps suggests that the deposits have been influenced by water; either deposited or molded by water later. The deposits are firmly ‘cemented’ to the wood. Microscopical examination reveals that the deposits contain a variety of siliceous mineral grains and carbonated paste that contains frequent portland cement relics. Small fine-grained nodules, possibly carbonated lime, are also observed in the carbonated paste. The sand grains include quartz, feldspar, mica, hornblende, volcanic rocks, chert, hematite, opaque oxides, and epidote.

Figure 1. Slipper House Sheathing Board back surface.

Figure 2. Front surface of Slipper House sheathing sample.

Figure 3. Closer view of deposits on top surface of sheathing.

Figure 4. Close view of deposits removed for study. Millimeter scale.

The deposits collected from the Slipper House are composed of carbonated portland cement and lime paste containing siliceous sand grains, and appear to be mortar residue. The sand was presumably locally derived, as would be typical at the time of construction of this house. The main constituents of the sand are quartz, feldspar, mica, hornblende, volcanic rocks, chert, hematite, opaque oxides, and epidote and these could possibly be constituents of the local soil. These rocks and minerals are the same constituents found in the majority of the debris samples. The volcanic rock fragments are particularly distinctive as these include brown volcanic glass containing acicular crystals, and colorless volcanic glass containing stretched air bubbles. The volcanic rock fragments are particularly abundant in the Smith House Samples 3 (Opening 3 Sill Plate), 7 (Exterior Opening Vertical Wall Surface), and 11 (Opening 3 Interior Wall).

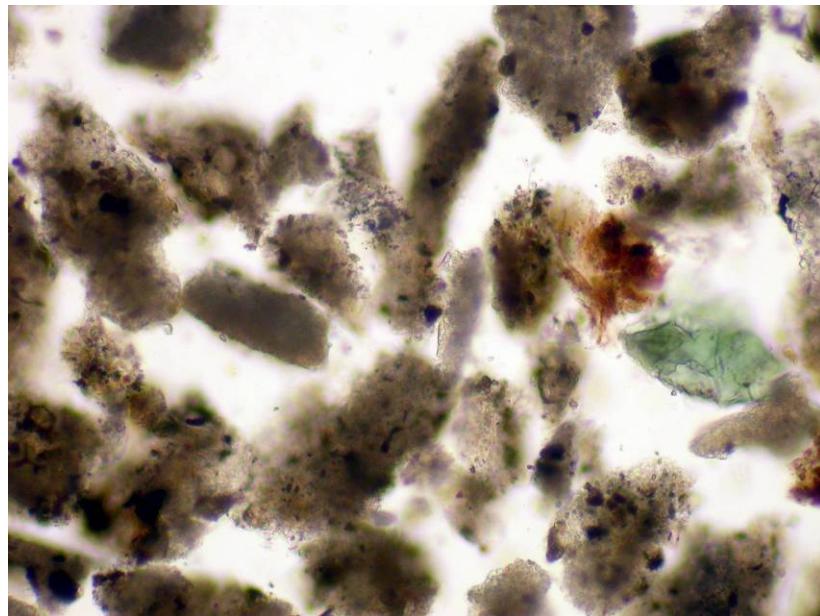
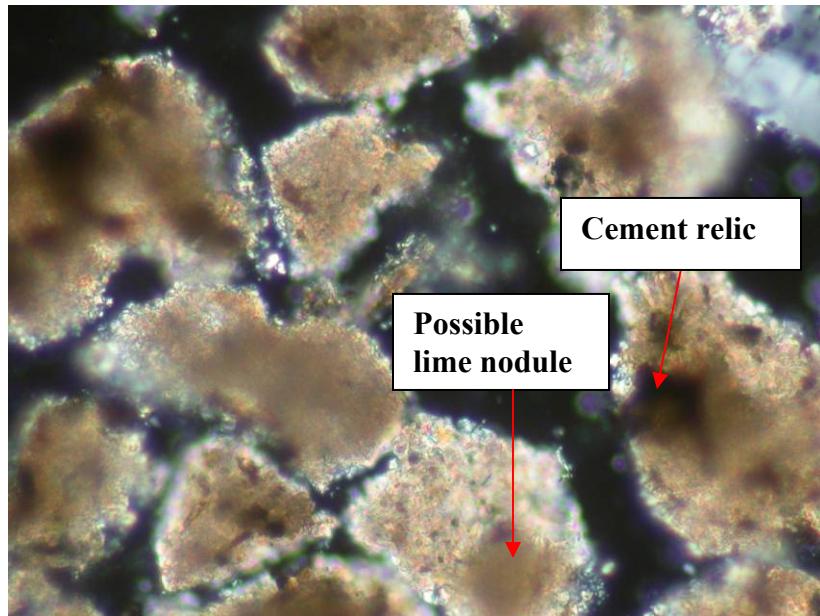
Figure 5. Fragments of carbonated cementitious paste and mineral grains. Plane-polarized light.

Figure 6. Magnified view of carbonated paste. Cross-polarized light.

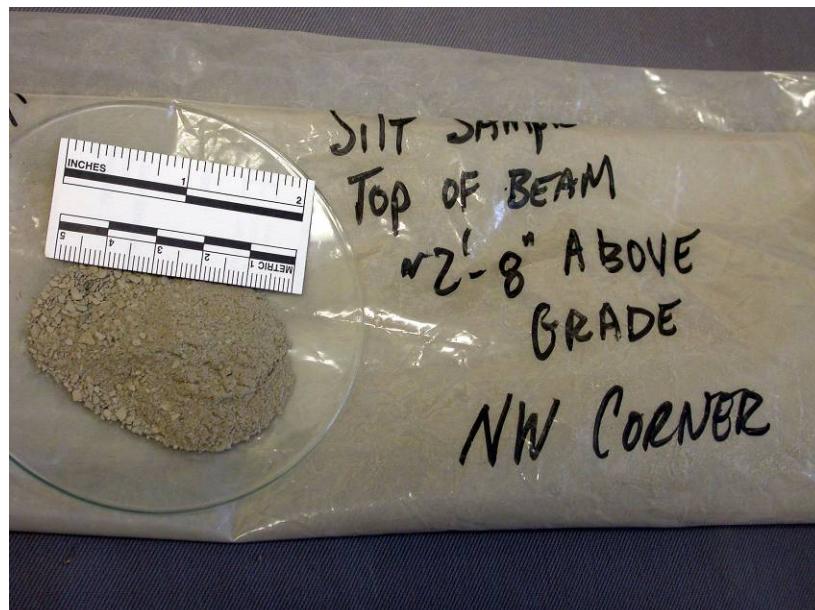
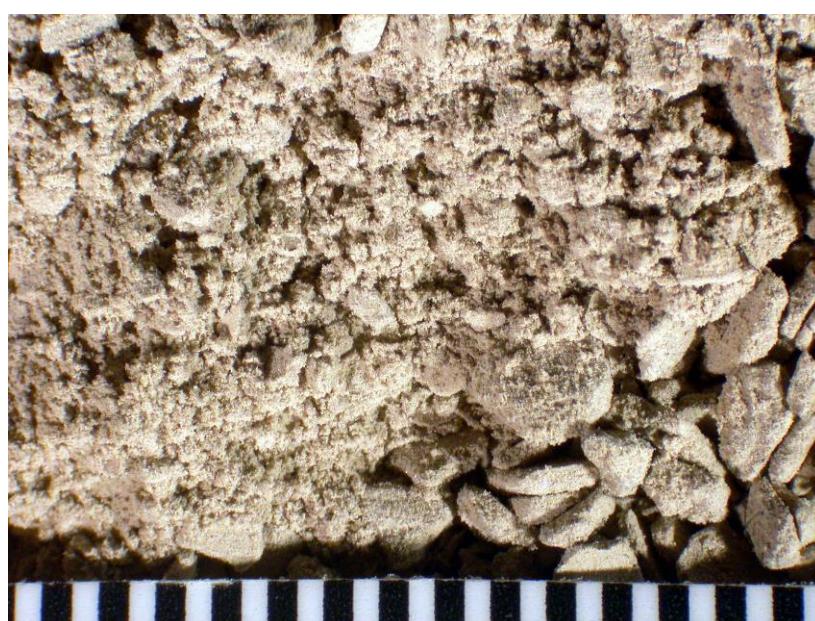
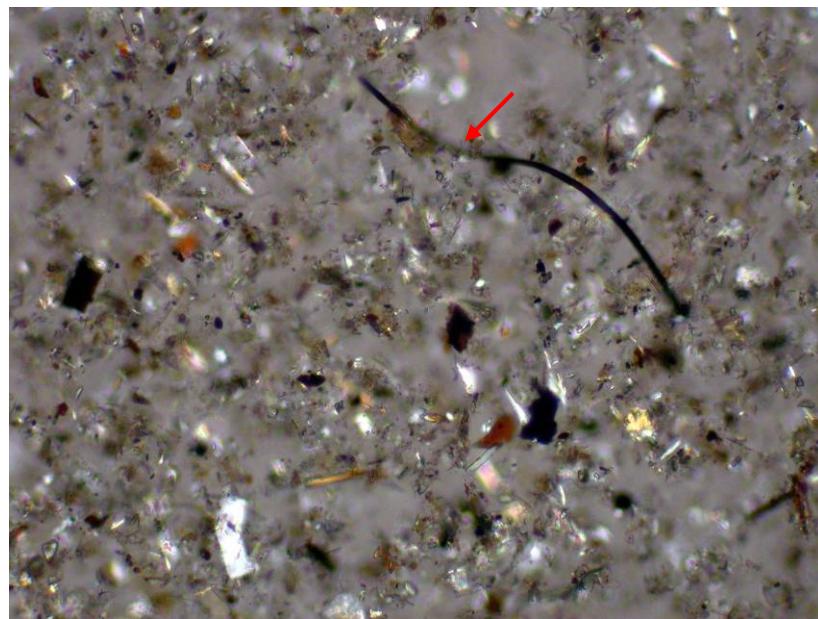
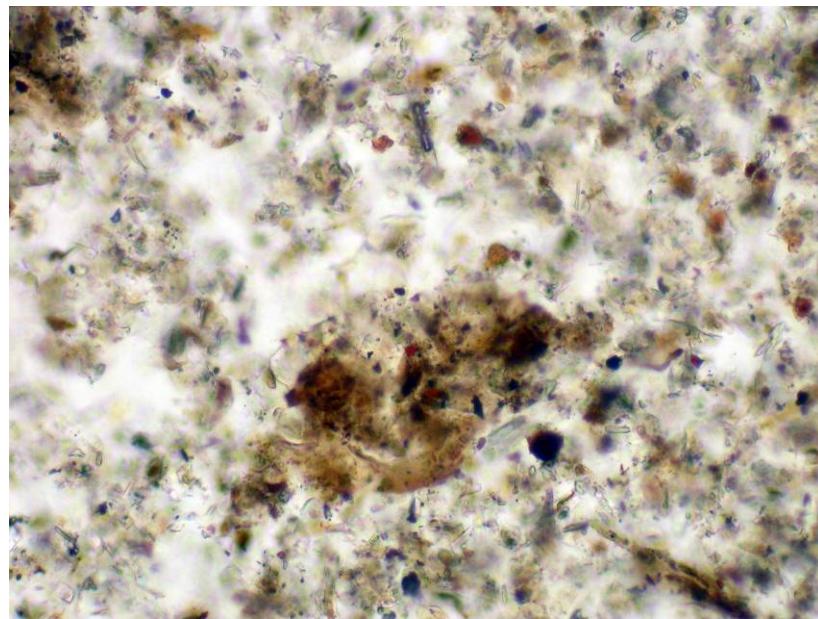
Sample 2 Smith House crawlspace, NW Corner. Silt Sample from Top of Beam (2 feet 8 inches above grade): The sample contains approximately 10 grams of beige, fine-grained, material that consists mostly of loose powder, and a smaller amount of slightly harder flakes up to about 0.05 inch across. The sample mainly consists of clay or clay-like minerals (platy habit and less than 30 micrometers long), reddish lumps of soil, mineral grains up to 50 micrometers in diameter, and small amounts of rootlets, wood fiber, and hair.

Figure 7. NW Corner Silt Sample from top of beam.

Figure 8. Closer view of silt sample.

Figure 9. Cross-polarized light view of fine-grained silt showing mineral fragments (bright), soil (reddish brown), and hair or rootlet (arrow). Upper filter slightly uncrossed.

Figure 10. Plane-polarized light view of fine-grained silt particles. Reddish brown particles are soil. Platy mineral grains are less than 30 micrometers long.

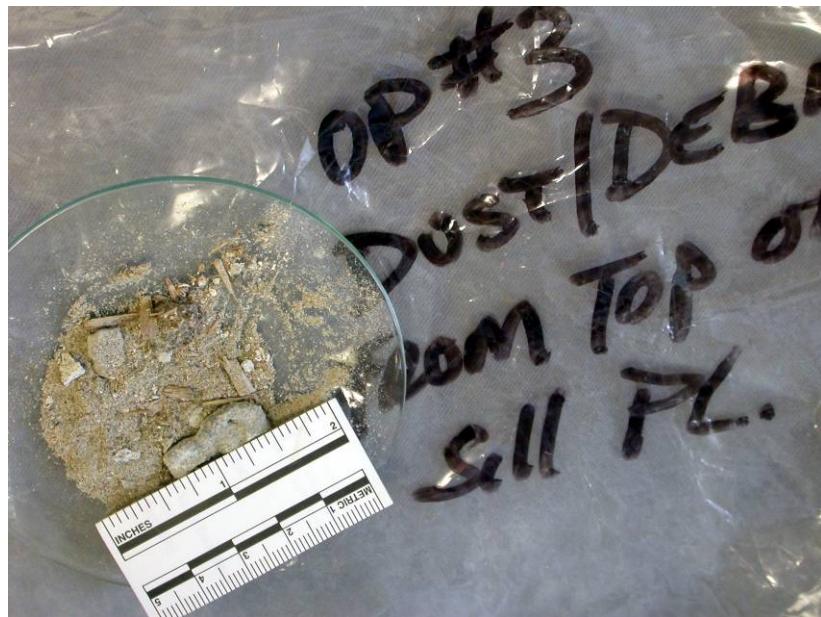
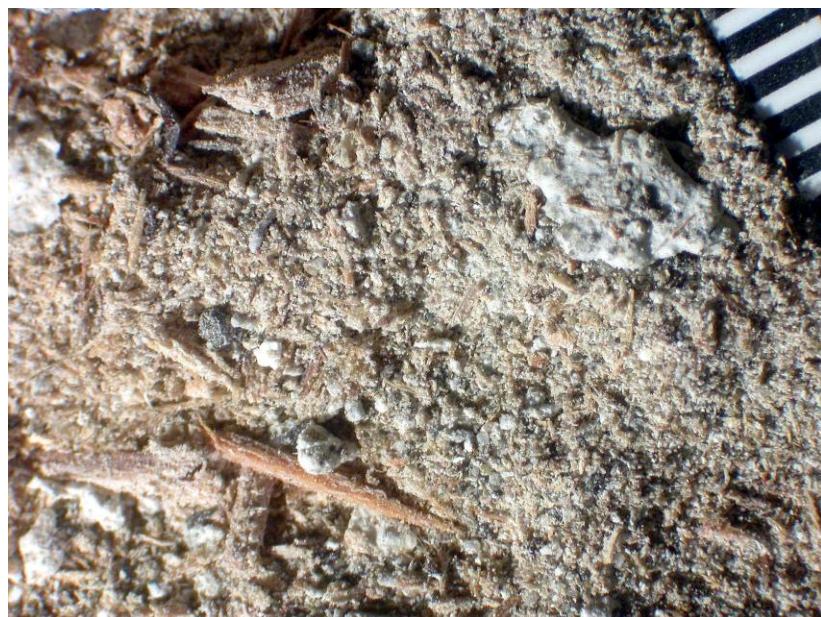
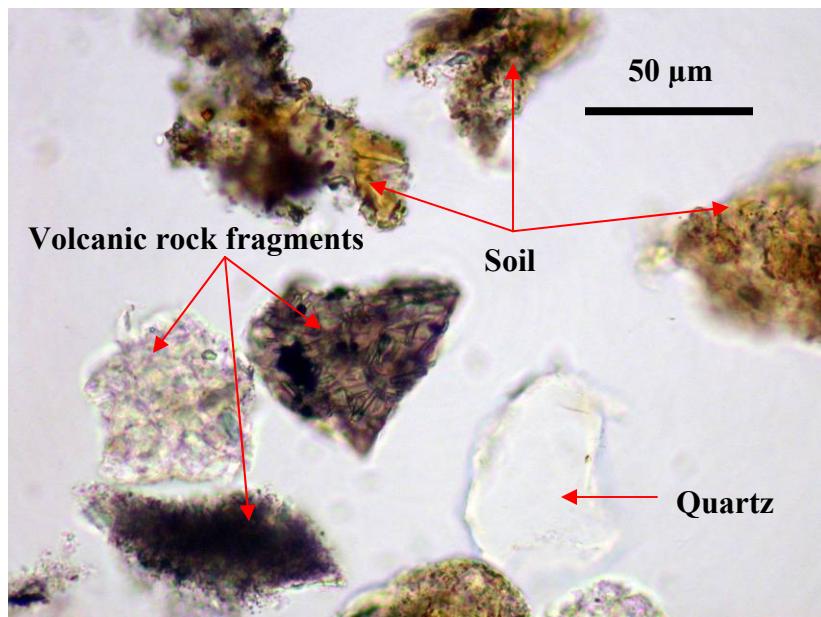
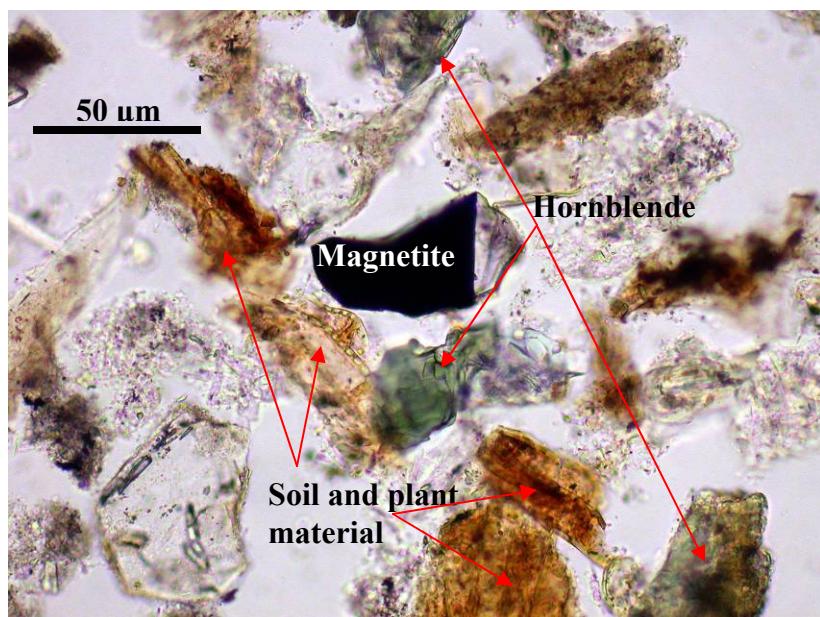
Sample 3 Smith House Opening No.3. Dust / Debris from Top of Sill Plate: The sample contains approximately 6 grams of beige, fine-grained, powdery material, gray mortar fragments up to 0.8 inch long, brown wood splinters up to 0.5 inch long, and a dark brown clump of fibrous material approximately 0.4 inch across. The powdery loose material mainly consists of angular volcanic rock fragments (including basalt that contains brown glass and pumice that contain colorless glass) and angular mineral grains (including quartz, chert, feldspar, hornblende, biotite mica, pyroxene, hematite, and opaque grains. The material identified as chert is microcrystalline and may be felsite (intergrown quartz and feldspar matrix in a siliceous volcanic rock). The loose material contains abundant wood fibers, and small amounts of reddish soil particles.

Figure 11. Opening No. 3 Dust/Debris Sample.

Figure 12. Closer view of sample. Millimeter scale.

Figure 13. Representative particles in the sample. Plane-polarized light.

Figure 14. Representative particles in the sample. Unlabeled particles are quartz and feldspar. Plane-polarized light.

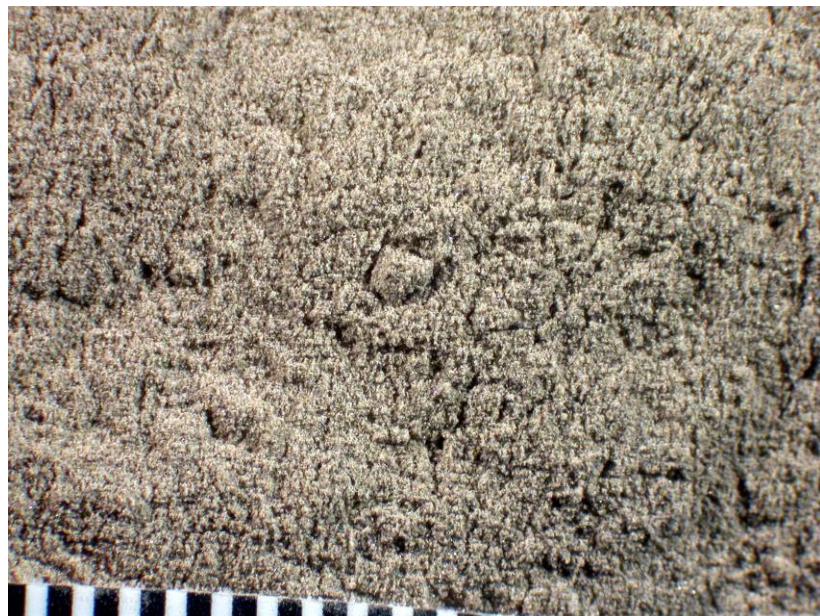
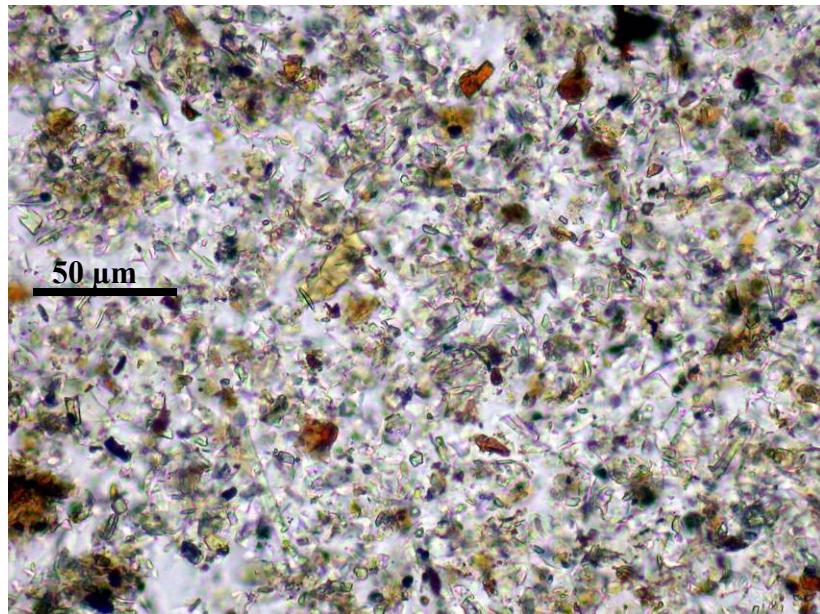
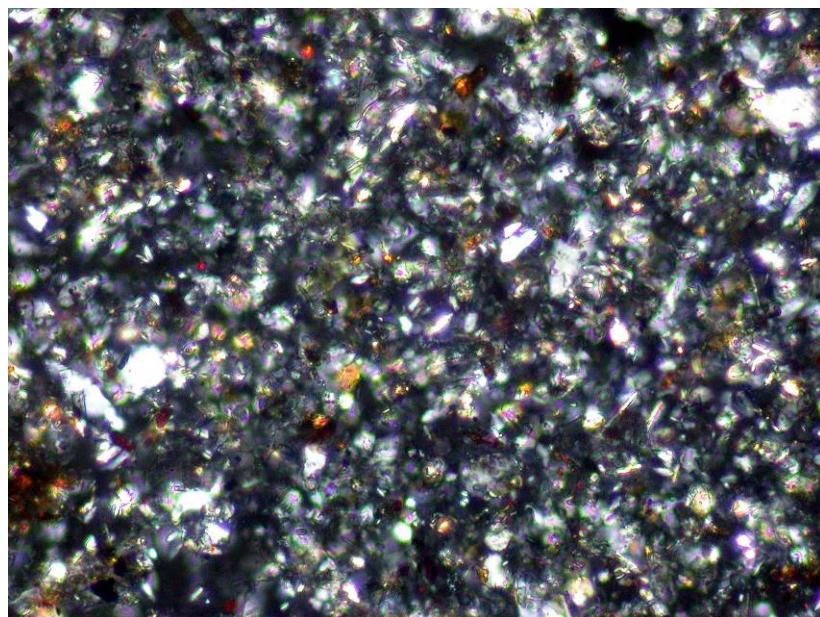
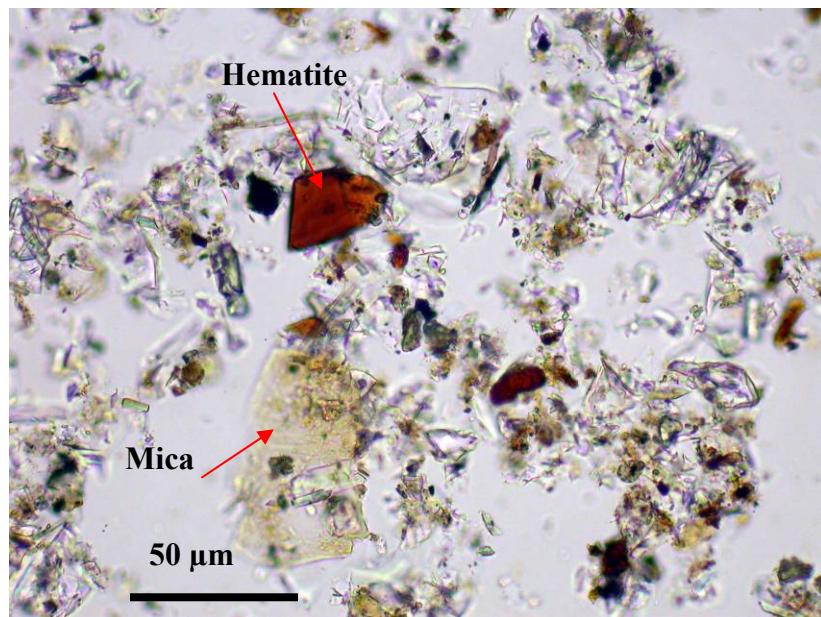
Sample 4 Smith House Crawl Space NE Corner: The sample contains approximately 36 grams of beige, exceptionally fine-grained, powdery material that consists mainly of angular mineral grains and rock fragments, and small amounts of reddish soil particles and plant material (stems and rootlets). The rock fragments and mineral grains include: basalt, natural glass, quartz, feldspar, pyroxene, hornblende, mica, hematite, apatite, and opaque grains. Mineral grains are more abundant than rock fragments.

*Figure 15. Close view of Crawl Space NE Corner Sample.
Millimeter scale.*

Figure 16. Representative particles shown in plane-polarized light.

Figure 17. Cross-polarized light view of the field shown above.
Bright particles are mostly quartz and feldspar. Reddish particles
are soil and hematite. Upper filter is slightly uncrossed.

Figure 18. Magnified view of representative particles. Quartz and feldspar are colorless and exhibit low relief.

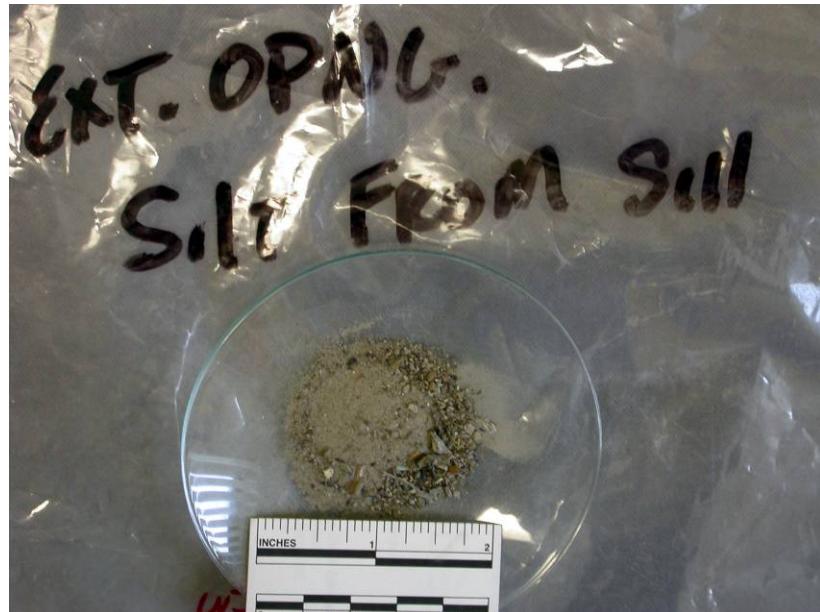
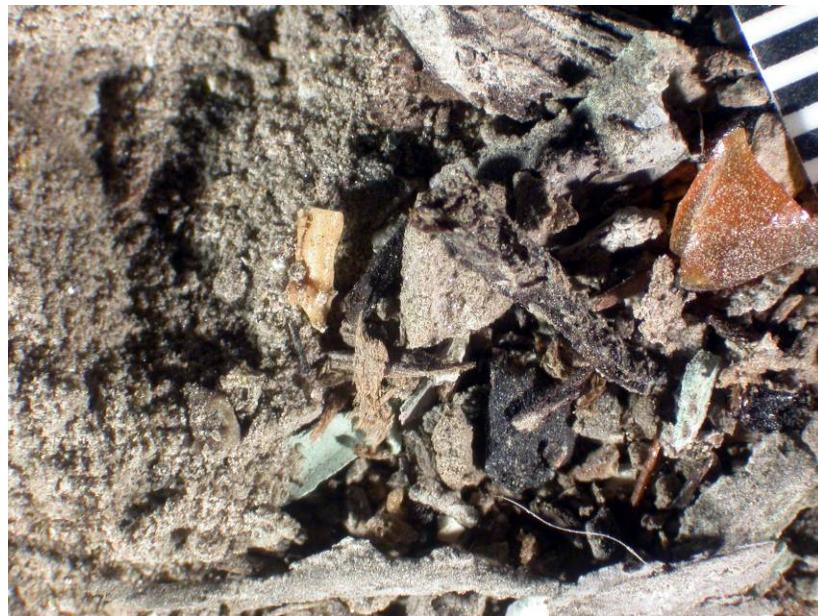
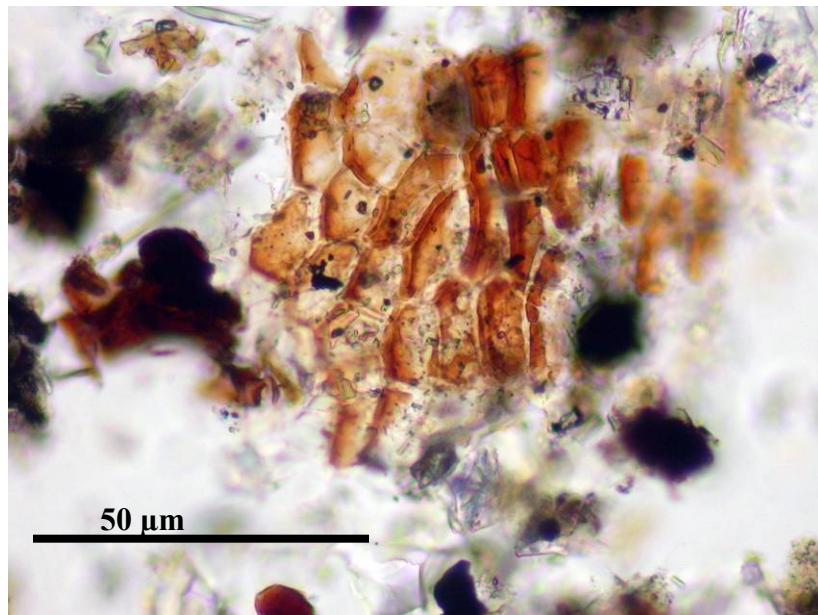
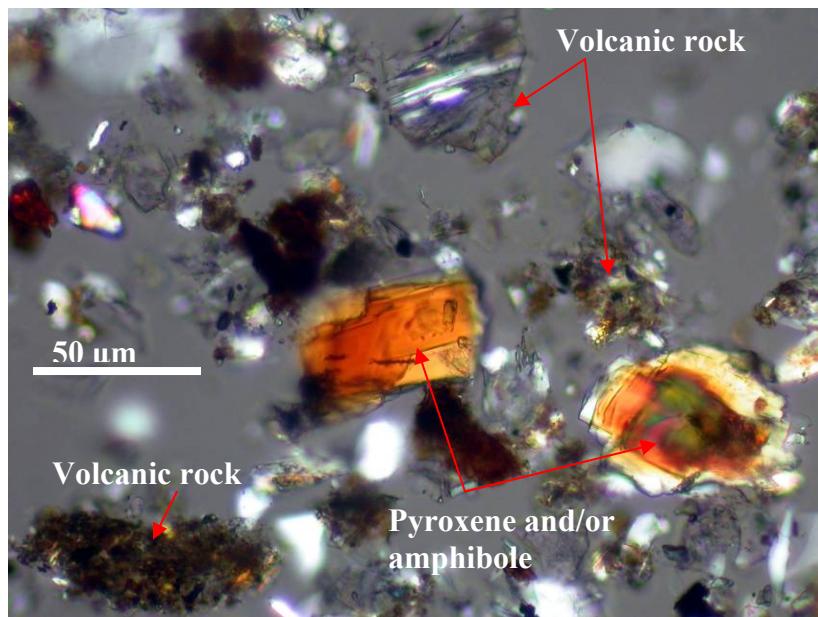
Sample 5 Smith House Exterior Opening, North Wall, Sill: The sample contains approximately 3 grams of beige powdery material, plant material (wood, stems, and rootlets), insect parts, paint flakes, and rodent droppings. The powdery material (less than 50 micrometers in diameter) mainly consists of angular fragments of volcanic rocks (basalt and volcanic glass) and angular mineral grains. Smaller amounts of soil and plant material are observed. The mineral grains include quartz, feldspar, pyroxene, hornblende, mica, hematite, apatite, and opaque grains (largely magnetite).

Figure 19. Exterior Opening Silt from Sill Sample.

Figure 20. Closer view of sample. Millimeter scale.

Figure 21. Cellular structure in plant material. Plane-polarized light.

Figure 22. Representative particles in the sample. Cross-polarized light with upper filter slightly uncrossed.

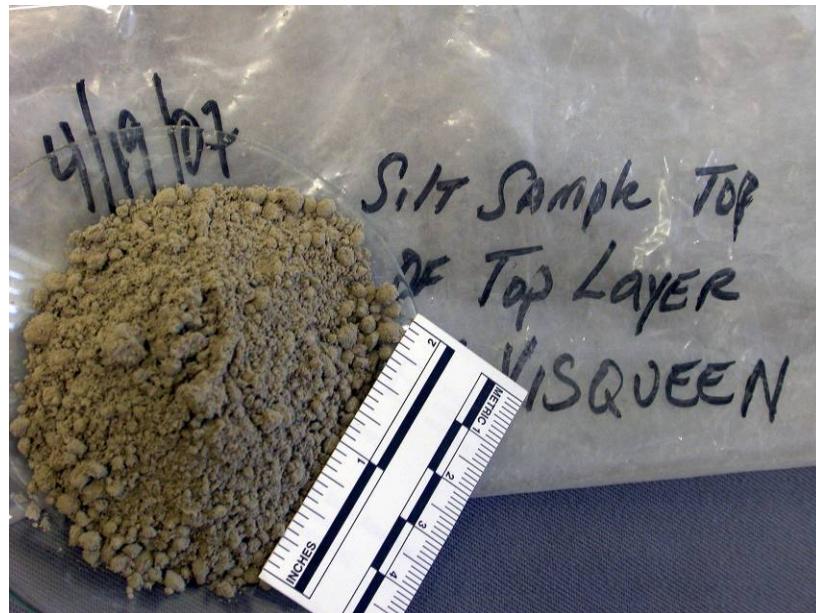
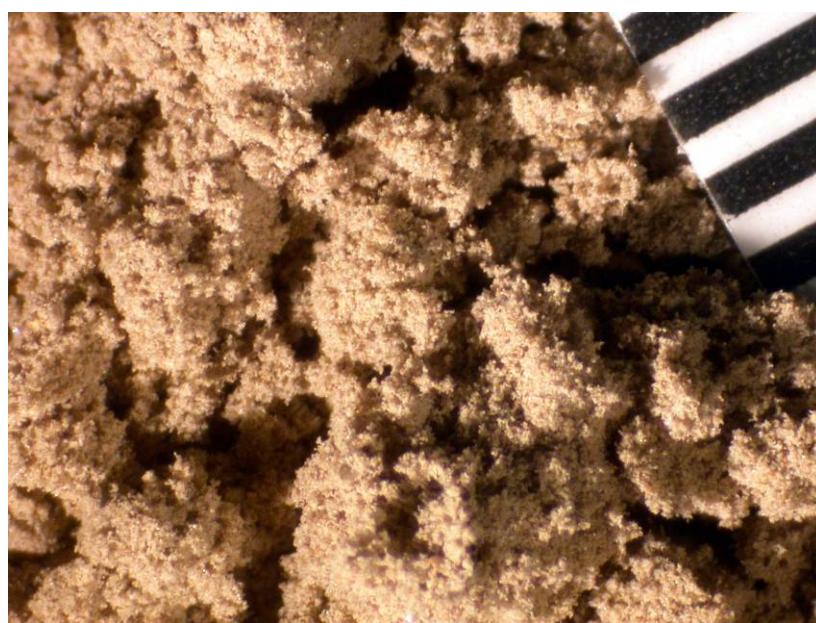
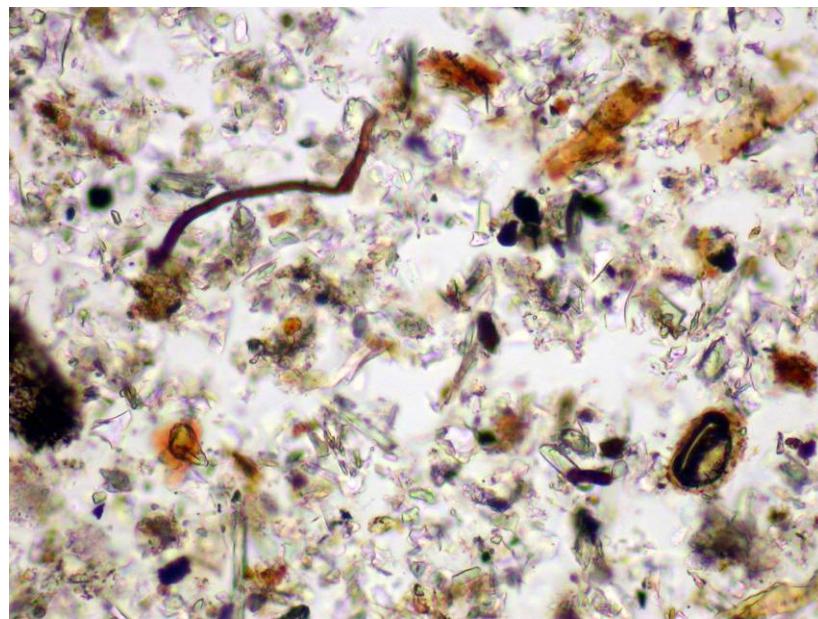
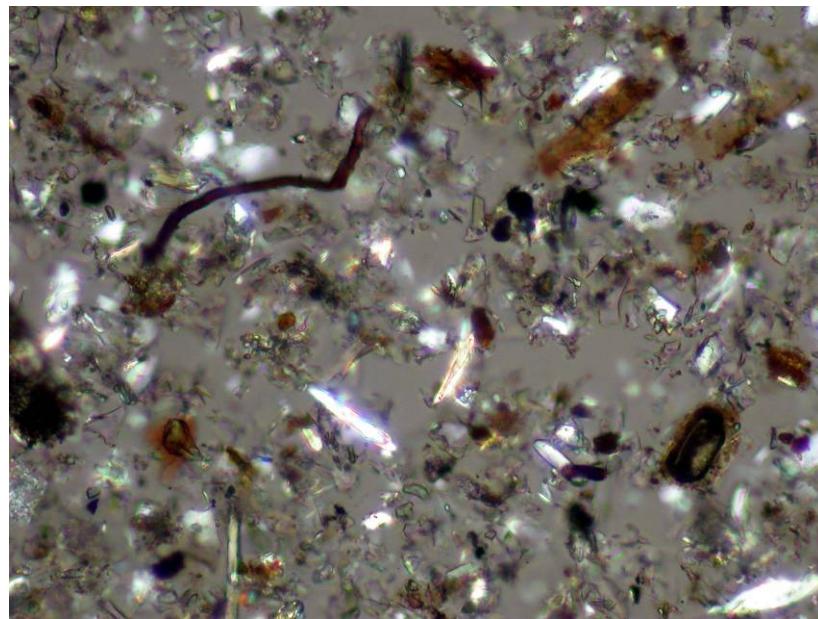
Sample 6 Smith House Crawlspace, Top Layer of Visqueen: The sample contains approximately 25 grams of beige powdery material that exhibits a slight tendency to form small clumps up to a few millimeters in diameter. The powdery material (less than 50 micrometers in diameter) mainly consists of angular fragments of quartz and feldspar, flakes of mica (biotite and chlorite), acicular minerals, fragments of opaque oxides and hornblendes, and smaller amounts of volcanic rocks (basalt and volcanic glass), reddish soil, and plant material (stems fragments and rootlets).

Figure 23. Sample from top of top layer of visqueen.

Figure 24. Closer view of sample. Millimeter scale.

Figure 25. Angular, almost colorless, fragments are mineral grains. Reddish material is mostly soil and plant material. Plane-polarized light.

Figure 26. Cross-polarized light view of field above showing mineral grains (bright) and soil and plant material (reddish brown). Upper filter slightly uncrossed.

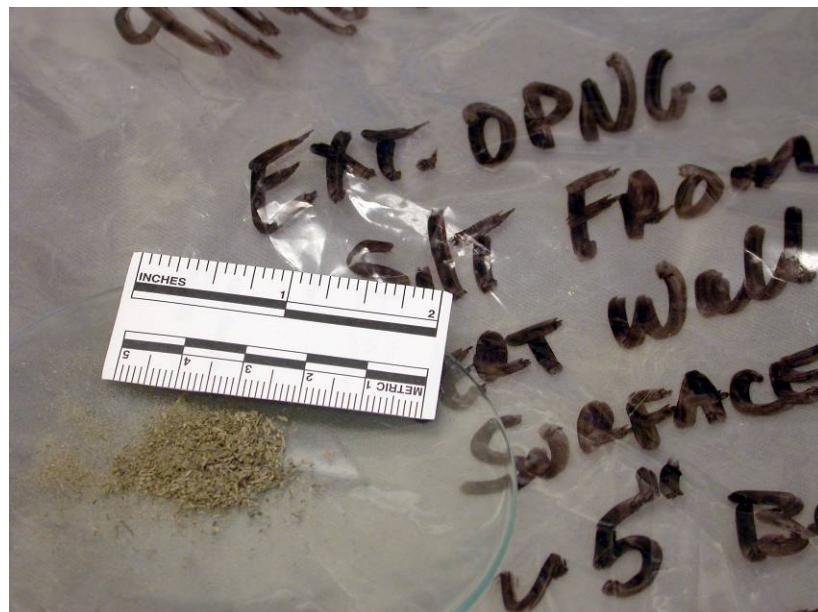
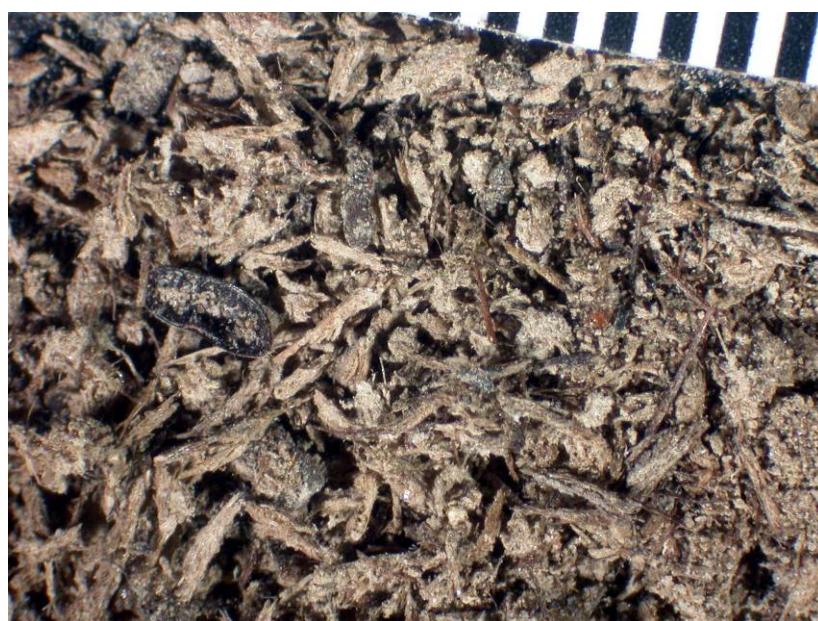
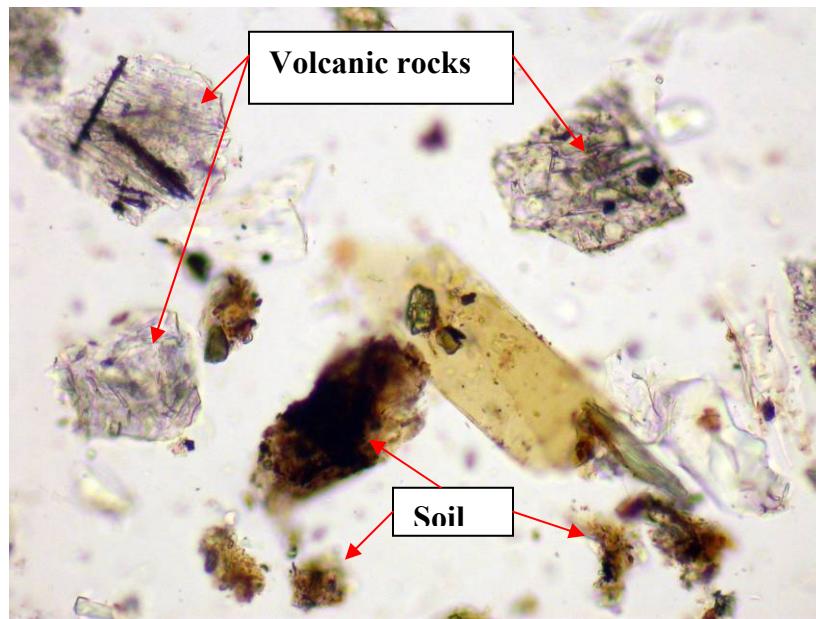
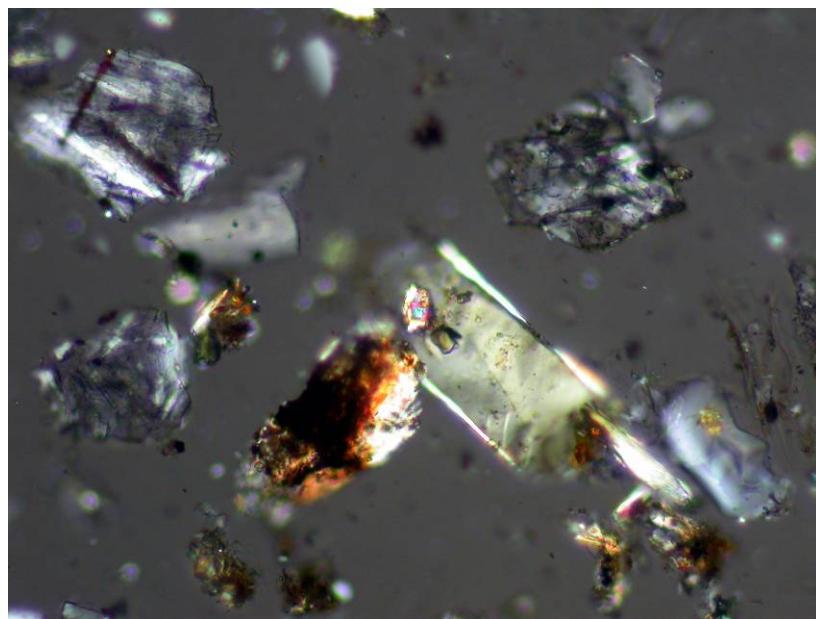
Sample 7 Smith House, Exterior Opening, North Wall, Vertical Wall Surface: The sample contains approximately 4 grams of wood fragments, insect parts, and beige powdery material. The sample was passed through a No. 200 sieve (75-micrometer openings) and the powdery material was collected and examined. This material consists of angular fragments of quartz and feldspar, flakes of mica (biotite and chlorite), acicular minerals, fragments of opaque oxides and hornblende, and smaller amounts of volcanic rocks (basalt and volcanic glass), reddish soil, and plant material (stems fragments and rootlets).

Figure 27. Silt sample from Exterior Opening Vertical Wall Surface.

Figure 28. Closer view of sample. Millimeter scale.

Figure 29. Rock fragments (labeled), and soil particles passing the No. 200 sieve. Plane-polarized light.

Figure 30. Cross-polarized light view of field above showing rock fragments and mineral grains (bright) and soil (reddish brown). Upper filter slightly uncrossed.

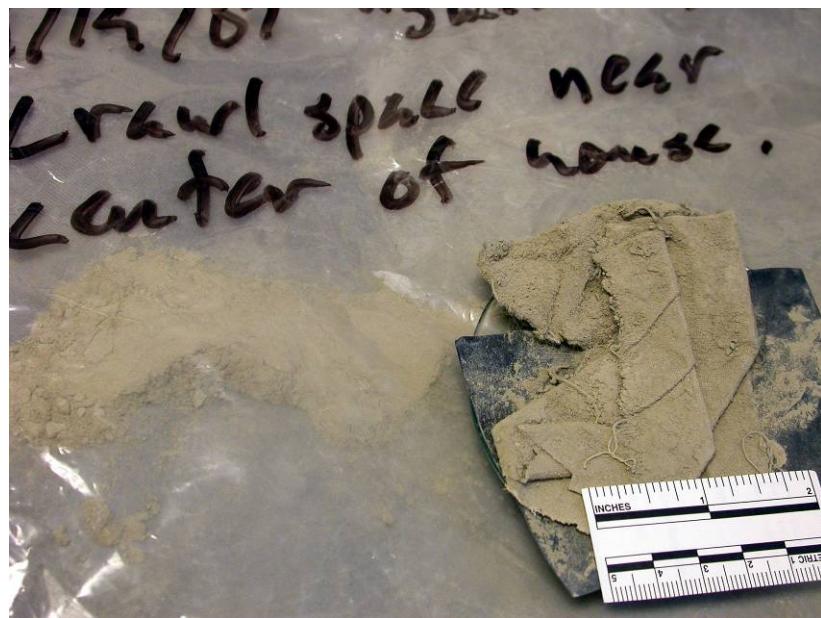
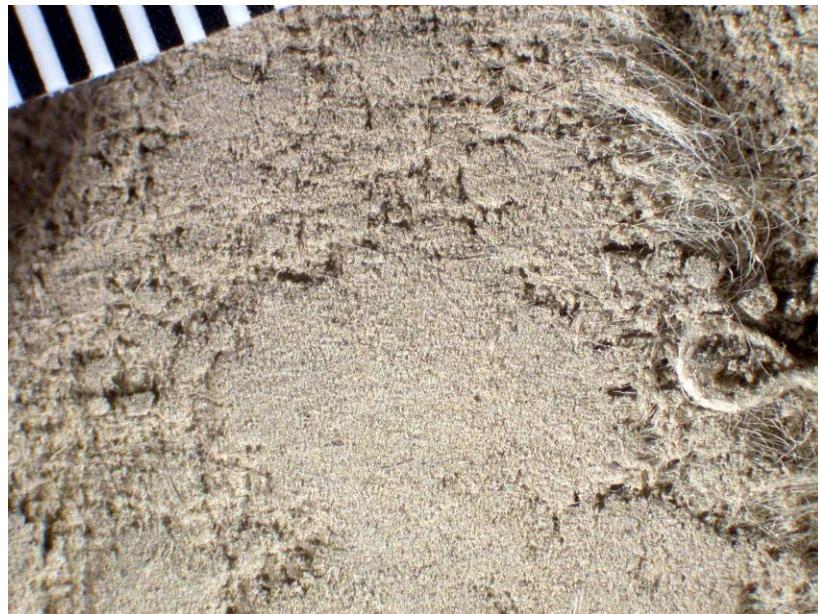
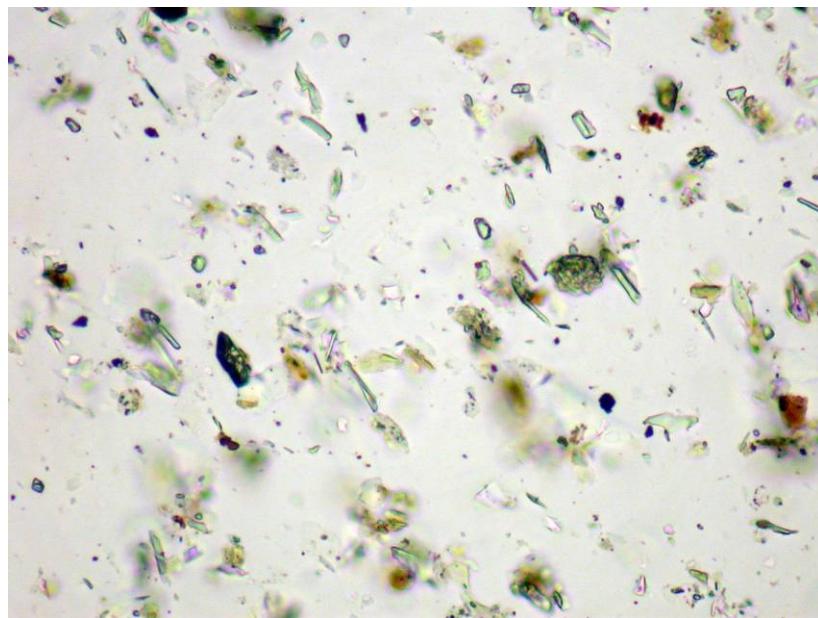
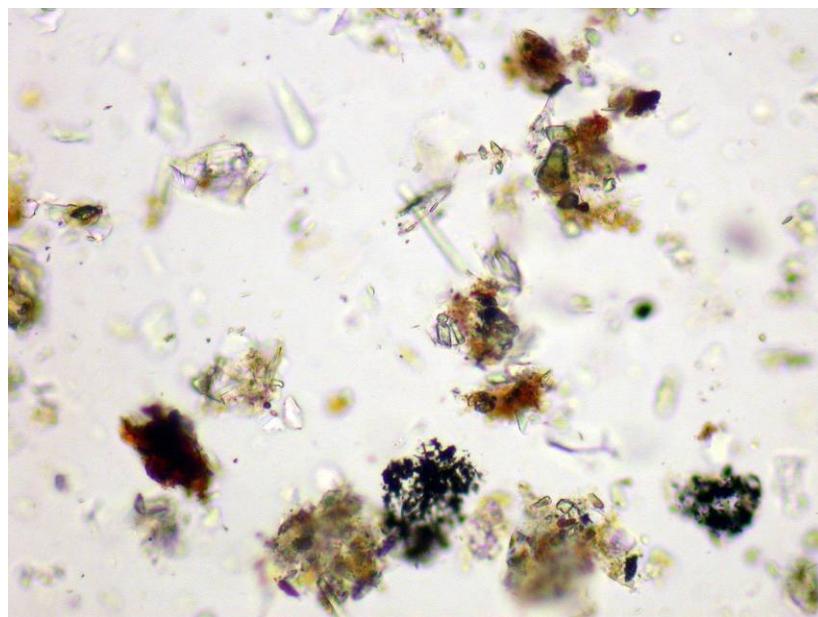
Sample 8 Smith House, Crawl Space Center: The sample consists of beige powder, a piece of fabric, and a piece of thin black plastic. The fabric and plastic are coated with beige powder. The total mass of the sample is approximately 17 grams. The loose powder and the powdery material collected from the fabric and plastic were examined as one sample. The powder consists of particles that are mostly less than 30 micrometers in diameter. The major constituents are platy clay or clay-like minerals, angular fragments of quartz and feldspar, flakes of mica (biotite and chlorite), acicular minerals, fragments of opaque oxides and hornblendes, and volcanic rock fragments, reddish soil, and plant material (rootlets).

Figure 31. Sample from Crawl Space Near Center of House.

Figure 32. Closer view of fine-grained deposits on fabric. Millimeter scale.

Figure 33. Platy and acicular minerals (aligned diagonally) less than 30 micrometers in the longest dimension. Plane-polarized light.

Figure 34. Larger rock and mineral fragments and soil particles (reddish brown). Plane-polarized light.

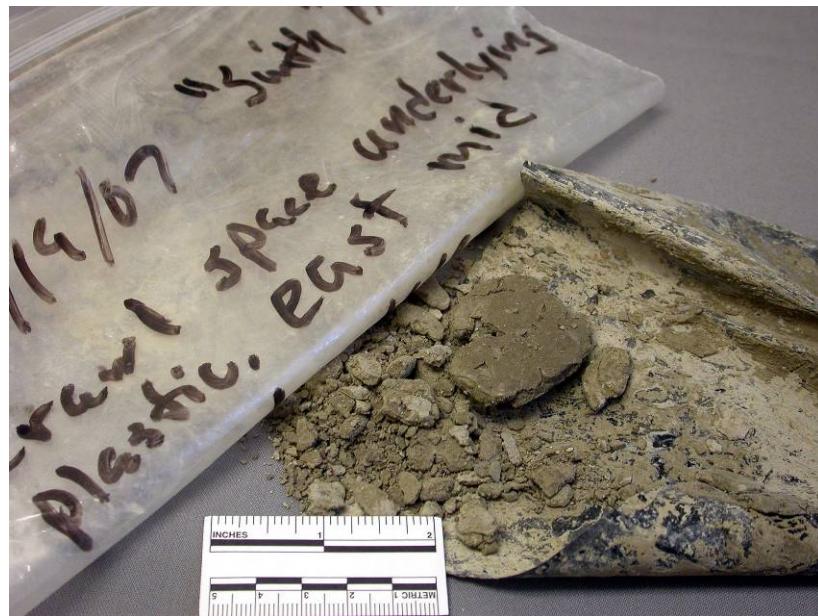
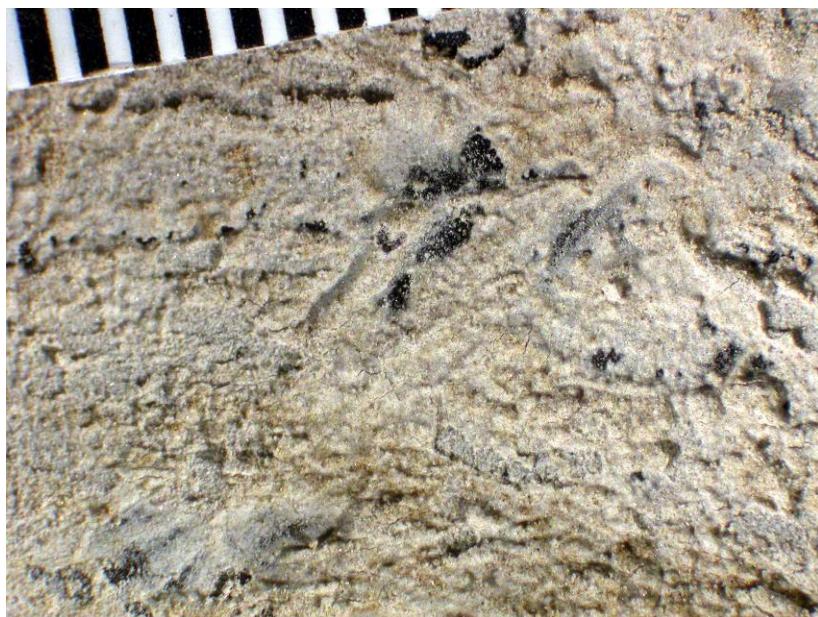
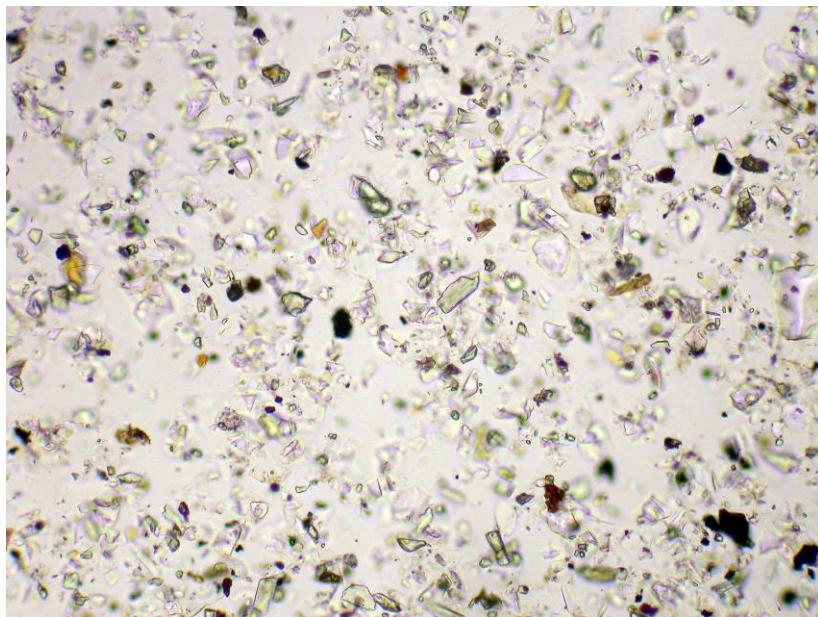
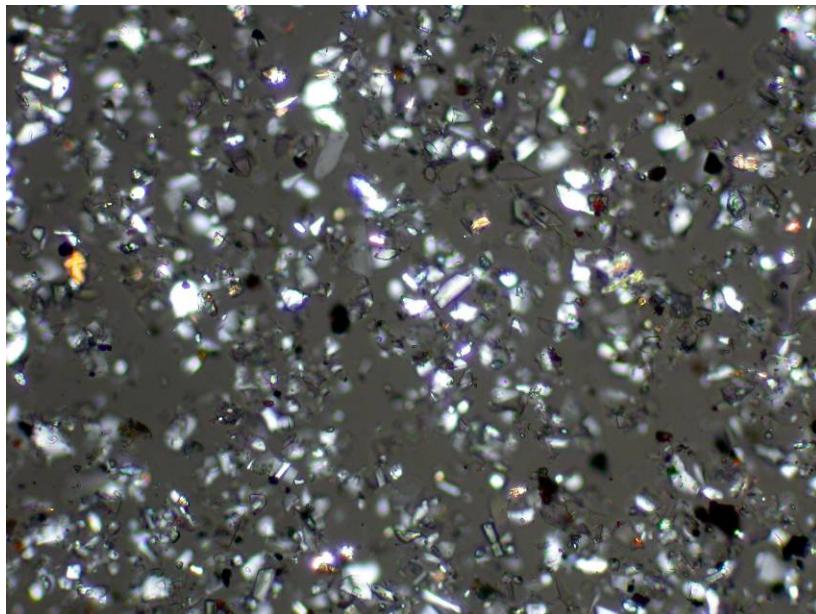
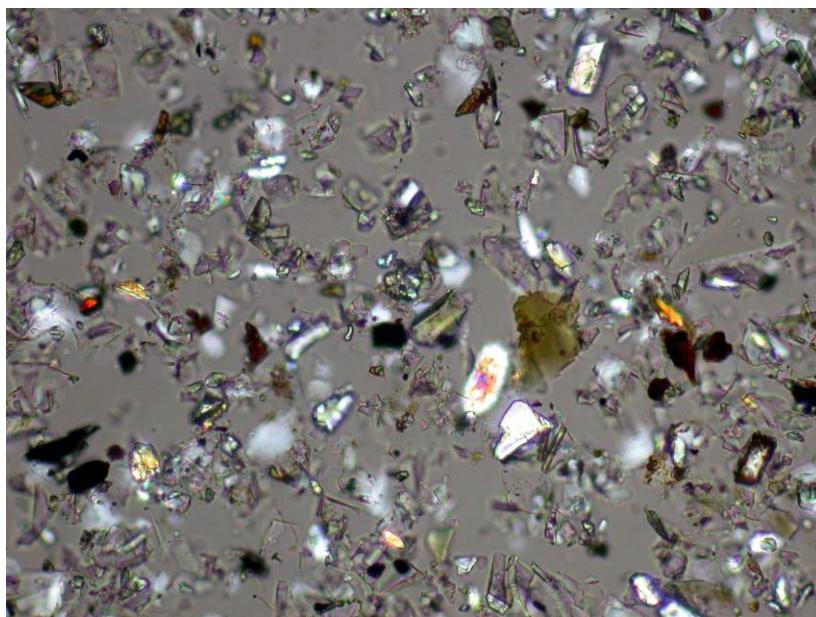
Sample 9 Smith House, Crawl Space Under Plastic, East: The sample was moist when received. The sample consists of black plastic and beige-brown lumps. The plastic is coated on both sides with beige to brown deposits. The total mass of the sample is approximately 55 grams. A sample of the deposits was collected from the surface of the plastic, dried, and then mounted in immersion oil. The deposits mainly consist of angular particles of quartz and feldspar. The particles are mostly less than 30 micrometers in diameter. Smaller amounts of mica, hornblendes, acicular minerals, fragments of opaque oxides, volcanic rock fragments, epidote, and pyroxene are observed. The sample also contains traces of reddish soil.

Figure 35. Sample from Crawl Space Under Plastic, East Mid Crawl Space.

Figure 36. Closer view of deposits on plastic. Millimeter scale.

Figure 37. Deposits on the plastic consist of small, angular fragments of minerals. The largest particles are 30 micrometers long. Plane-polarized light.

Figure 38. Cross-polarized light view of field shown above. The sample consists mainly of quartz and feldspars (shades of gray). Upper filter slightly uncrossed.

Figure 39. Magnified view showing quartz and feldspar (shades of gray), opaque grains (black), hematite (red), hornblende and pyroxene (yellow) and biotite mica (greenish brown). Cross-polarized light with upper filter slightly uncrossed.
