17 August 2007

Re: City of Hamilton
Historic Flood Investigation
WJE No. 2006.5898

Subject: Debris Studies

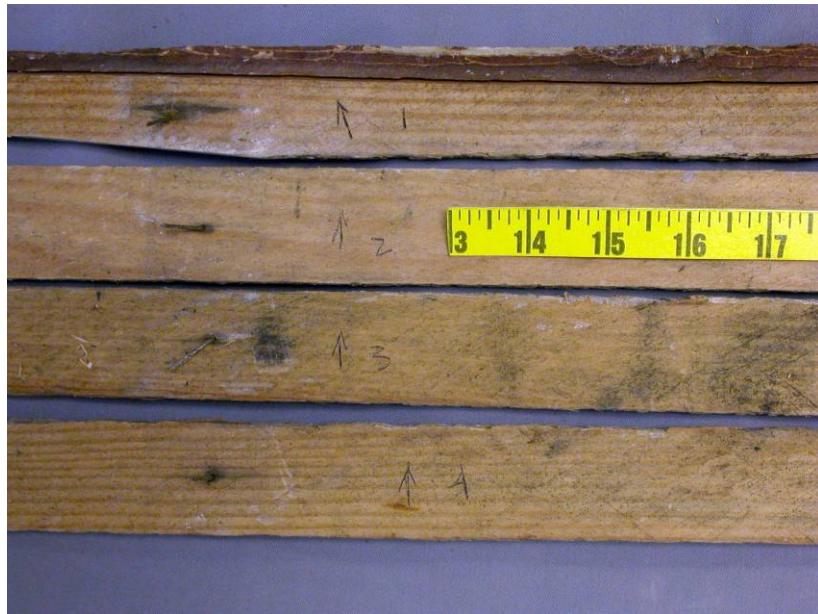
Sample 10 Smith House, Opening No. 2, Interior of East Exterior Wall: The sample consists of four, 22.5 inch long, sections of wood lath. One side of each slat (side with protruding nails) is marked with the number (position) of the lath and an arrow indicating the 'up' direction. Dark patches of fungal growth and several light-colored patches are observed on this side of the lath. Patches of deposits are more common on the opposite side of the lath (nail head side), and on the top surface of lath slats 2 and 3. Deposits were collected from these surfaces, and were found to consist of gypsum (plaster) and quartz sand grains.

Figure 40. Opening No. 2 East Exterior Wall, back surface.

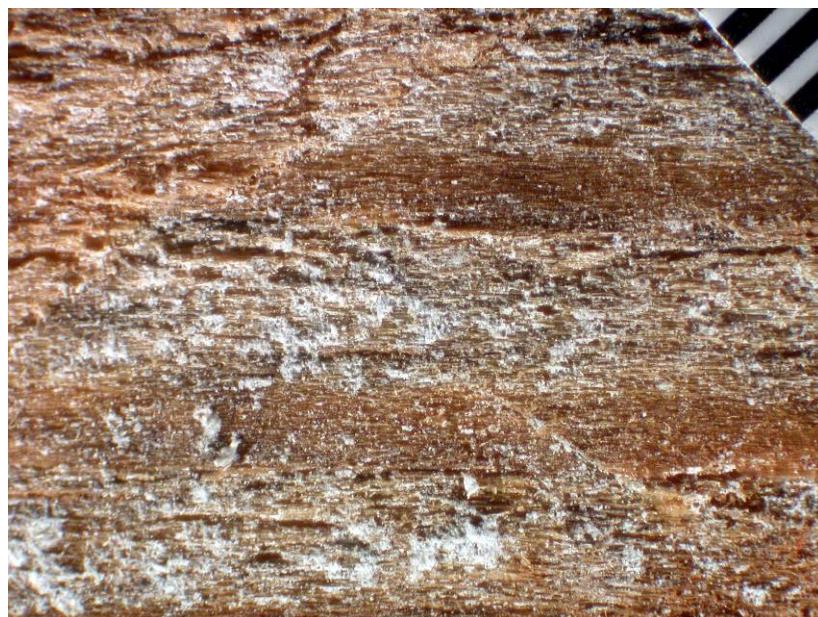
Figure 41. Opening No. 2, front surface of lath slats.

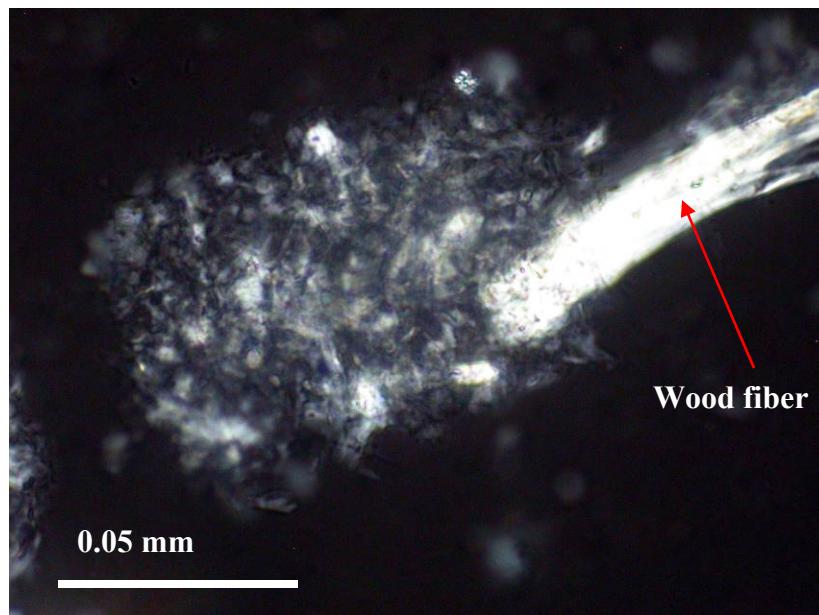
Figure 42. Closer view of deposits on lath. Millimeter scale.

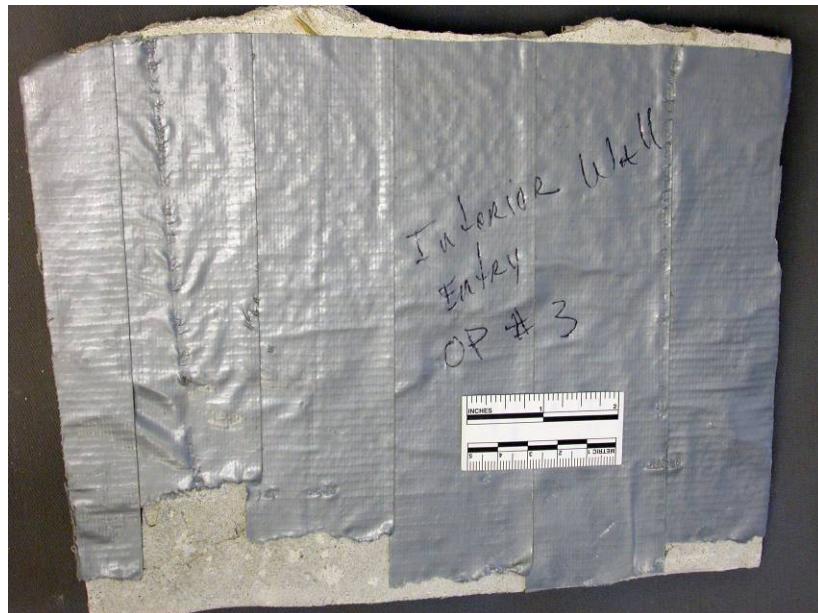
Sample 11 Smith House, Opening No. 3 Interior Wall: The sample is a saw-cut section of plaster, 9 inches wide, 7.5 inches high, and 0.25 to 0.45 inch thick. The front surface is nearly covered with tape. Four pieces of wood lath, 1.4 inches wide and 0.3 inch thick, are loosely attached to the back surface. Each slat is marked with a number (1 through 4) and an arrow indicating the ‘up’ direction. The back surface of the plaster is ‘dusty’ but is otherwise fairly clean. The back surfaces of the two upper pieces of lath are generally free of deposits, except for dust and adhered gypsum plaster. Patches of fine-grained deposits (debris) are observed on the back and top surfaces of the two bottom slats. The deposits, which were removed using tape, mainly consist of quartz, feldspar, volcanic rocks (including brown and colorless volcanic glass), hornblende, micas, epidote, and opaque grains. Small amounts of wood fibers were also collected with the deposits.

Figure 44. Front side of the samples from Opening No. 3 Interior Wall Entry.

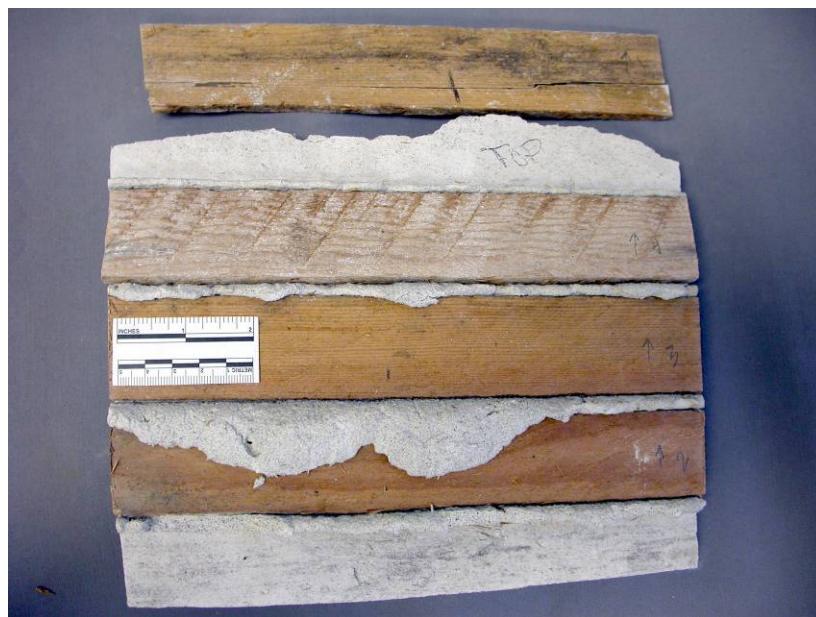
Figure 45. Back side of the sample. Lath No. 1 is above the sample.

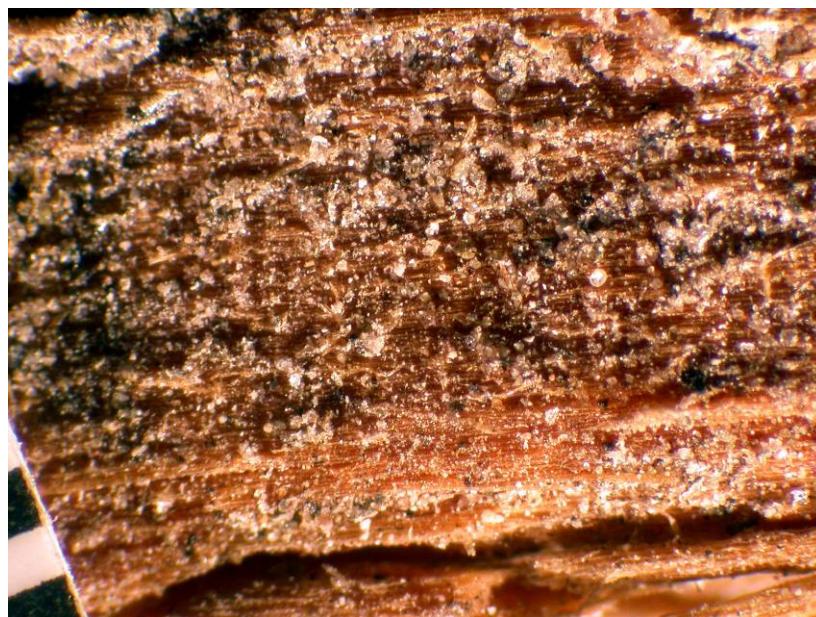
Figure 46. Fine-grained debris on the back surface of lath No. 2.
Millimeter scale.

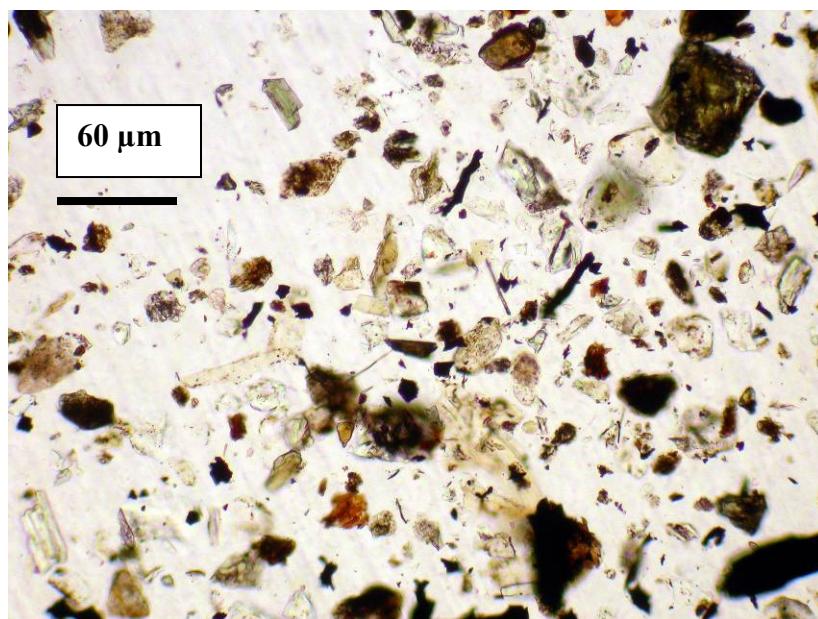
Figure 47. Plane-polarized light view of mineral debris collected from lath using tape.

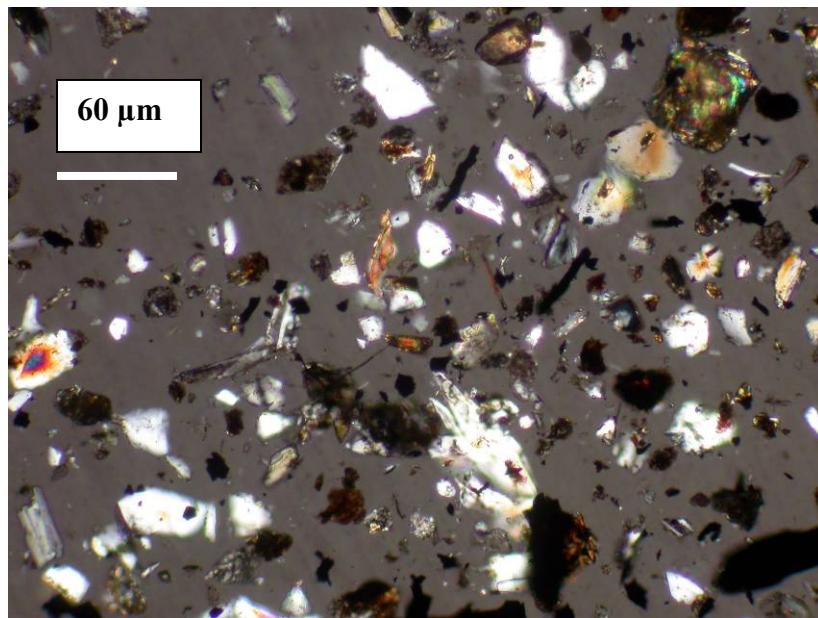
Figure 48. Cross-polarized light view of the field shown above. Most of the particles are quartz and feldspar. A multi-colored epidote grain is shown in the upper right. Upper filter is slightly uncrossed.
