Skagit River Revised Flood Insurance Study Levee Scenario Discussion

Ted Perkins, Hydraulic Engineer
US Army Corps of Engineers, Seattle District
8/9/2007

Skagit Levee Failure Scenarios

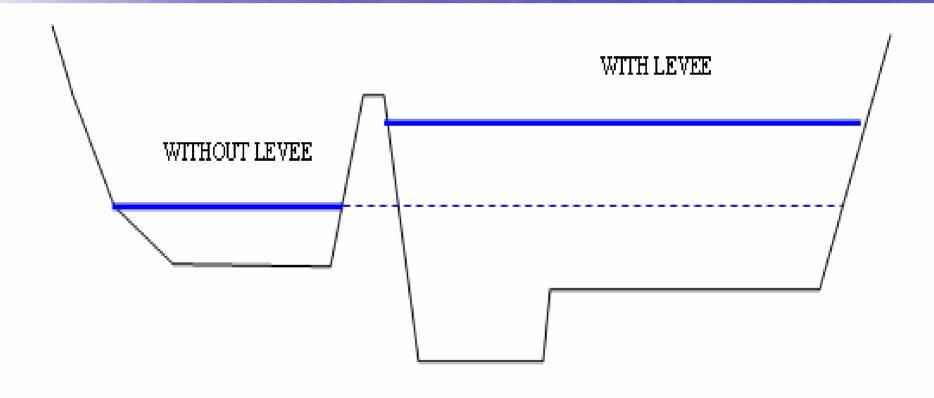
One Levee System

• If the subject levee does not meet the requirements stated in Section 65.10 of the NFIP regulations, as verified by the RPO, the Mapping Partner shall recompute the 1-percent-annual-chance flood elevations as if the levee did not exist.

SINGLE LEVEE

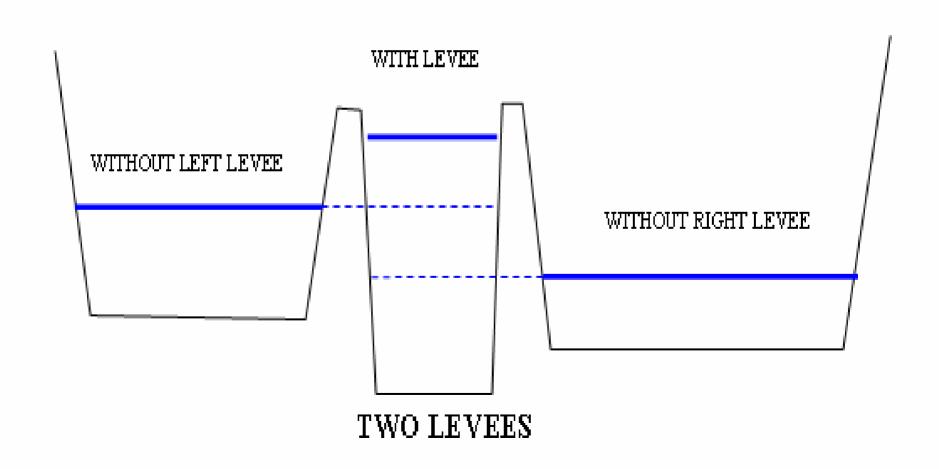
Levees on Both Sides of the River

The above procedures for the determination of BFEs and regulatory floodways also apply to the conditions where levees exist on both sides of the stream. In these cases, the evaluation shall include the possibility of simultaneous levee failure, failure of only the left side, and failure of only the right side, and shall consider simultaneous levee failure for both the BFE and regulatory floodway computations. The Mapping Partner shall contact the RPO for guidance on the evaluation of levee systems under these circumstances.

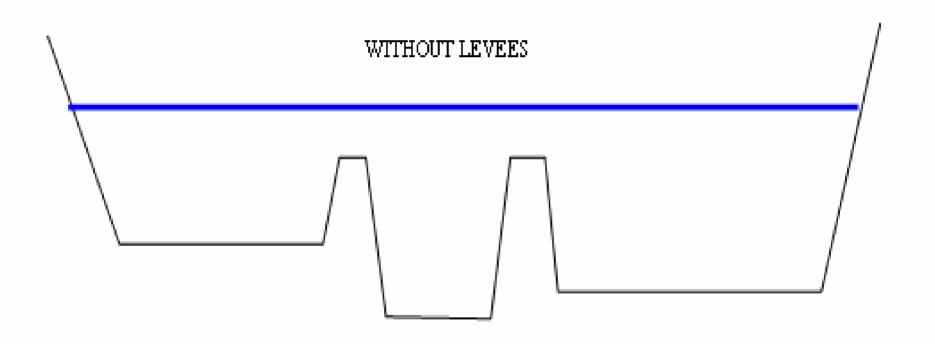
Levees Inundated

LEVEES INUNDATED

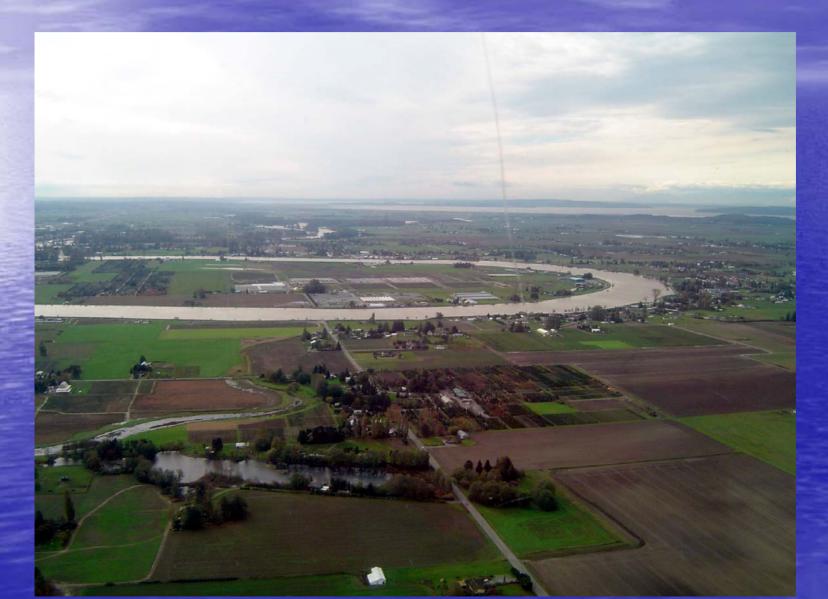
Surrounded by Levees

For levee systems where an area of land may be totally or partially surrounded by levees or where two or more flooding sources join that have levees on both sides of the stream, the Mapping Partner that is performing the analysis shall contact the RPO before proceeding with any analyses for levee failures. For these complex situations, the flood hazard in the area that would have been protected by the non-failed levee(s) must be based on selection of failure scenarios that yield the highest BFE or flood hazard.

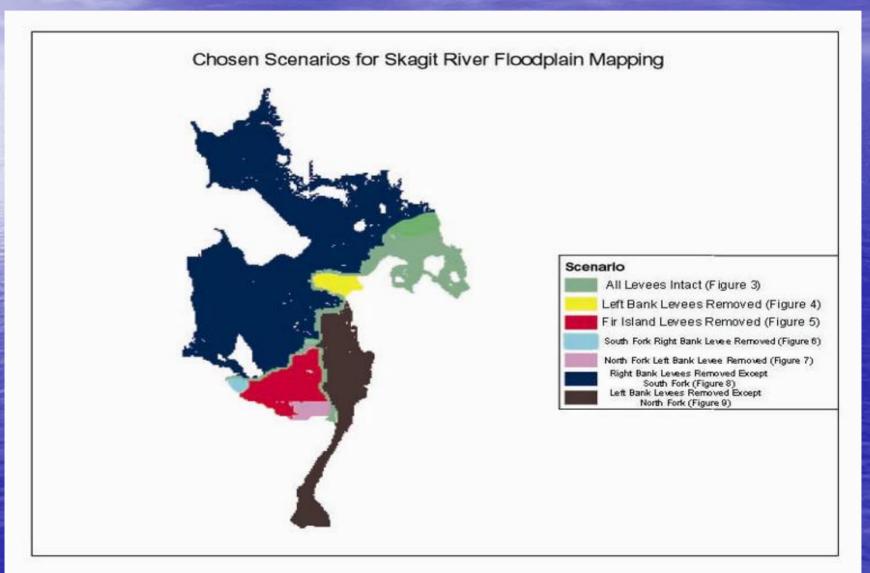
Right Bank Levees Removed Burlington to Samish and Padilla Bays Dark Blue Area

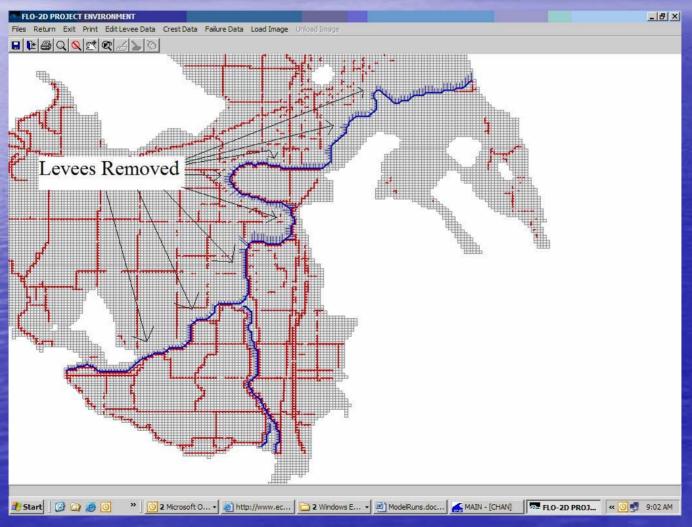
Right Bank Levees on Mainstem and North Fork Skagit River Removed While All Other Levees Remain Intact

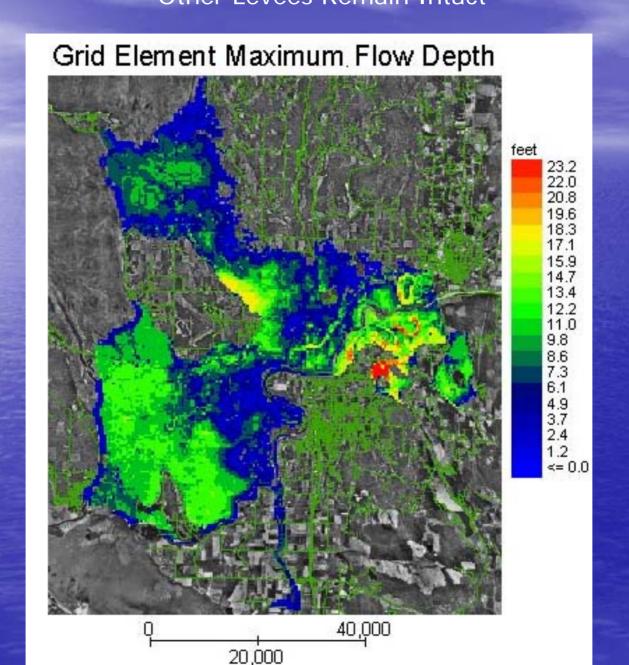
Right Bank Levees on Mainstem and North Fork Skagit River Removed While All Other Levees Remain Intact

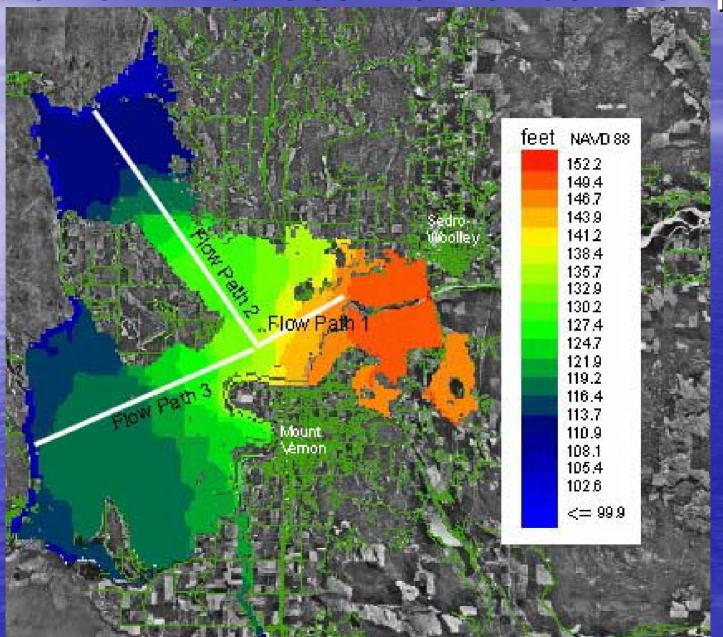
Right Bank Levees Removed Flowpaths

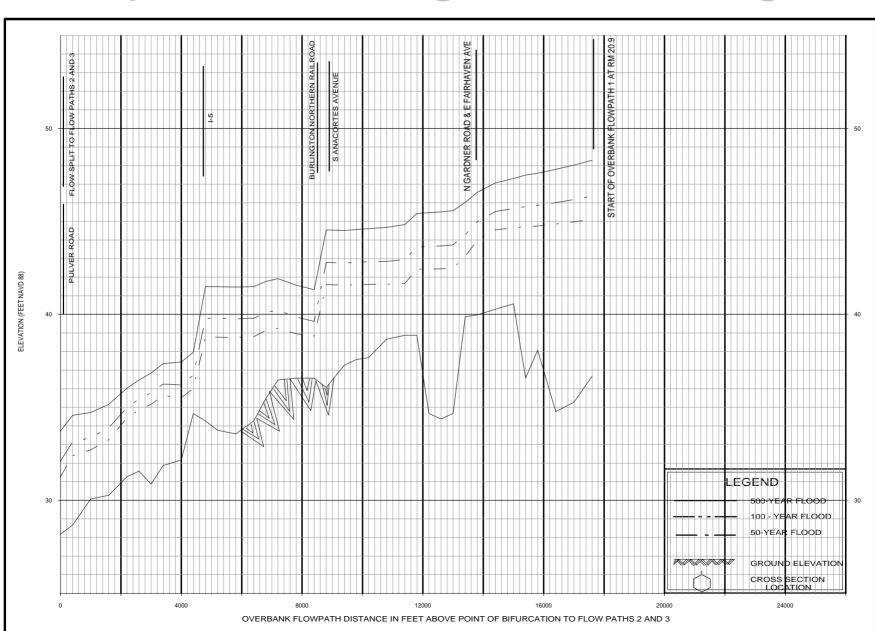
Flowpath 1 Burlington Area (Page 60)

SKAGIT RIVER DELTA, OVERBANK FLOW PATH

FLOOD PROFILES

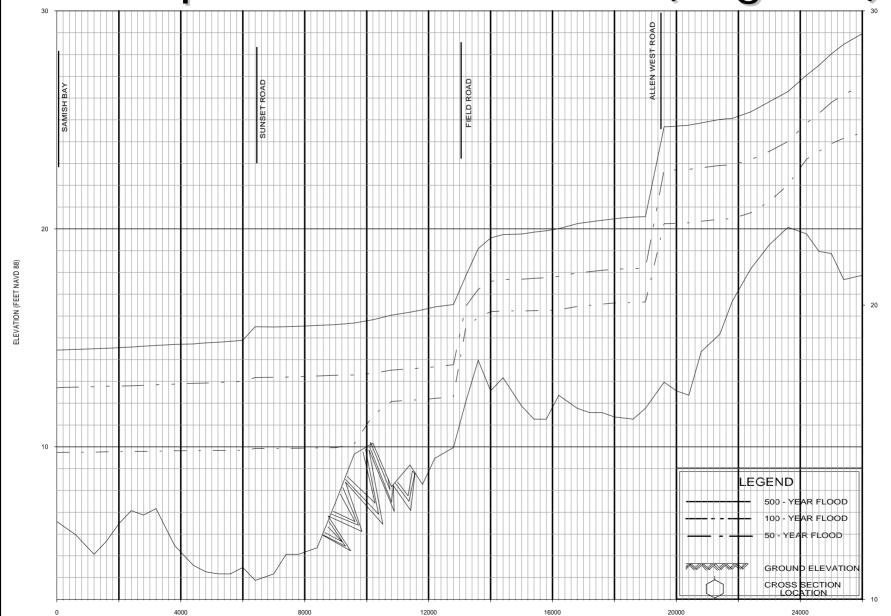
Flowpath 2 Samish Area (Page 61) ROAD

STREAM DISTANCE IN FEET FROM SAMISH BAY

SKAGIT RIVER DELTA, OVERBANK FLOW PATH

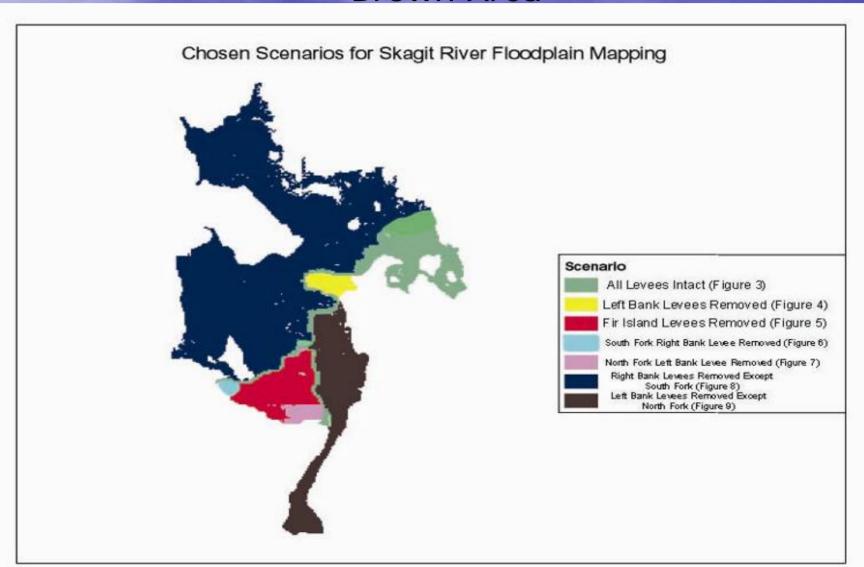
Left Bank Levees Removed Mount Vernon to Stanwood Brown Area

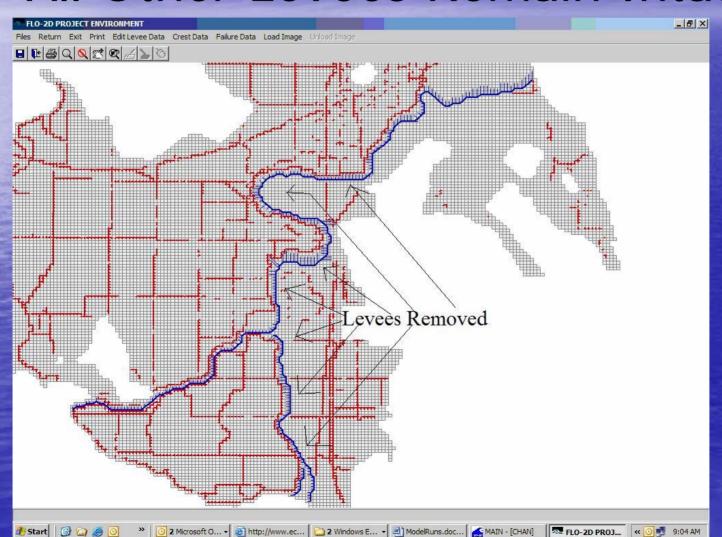
Left Bank Levees on Mainstem and South Fork Skagit River Removed While All Other Levees Remain Intact

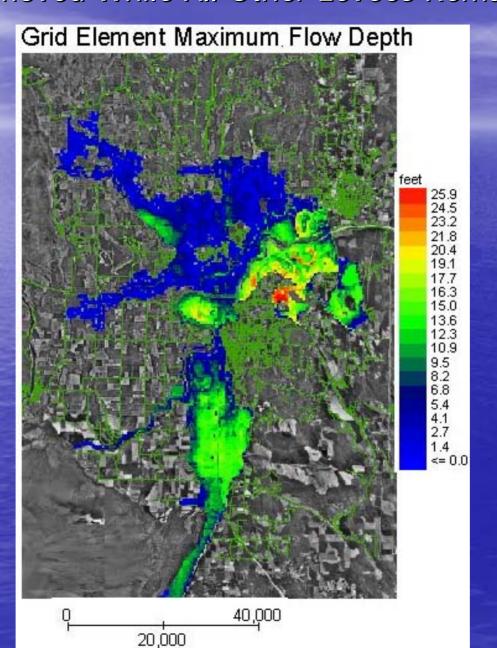
Left Bank Levees on Mainstem and South Fork Skagit River Removed While All Other Levees Remain Intact

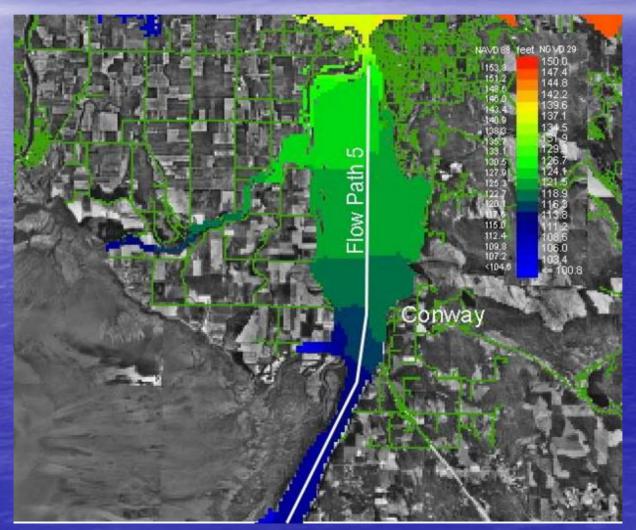
Left Bank Levees on Mainstem and South Fork Skagit River Removed While All Other Levees Remain Intact

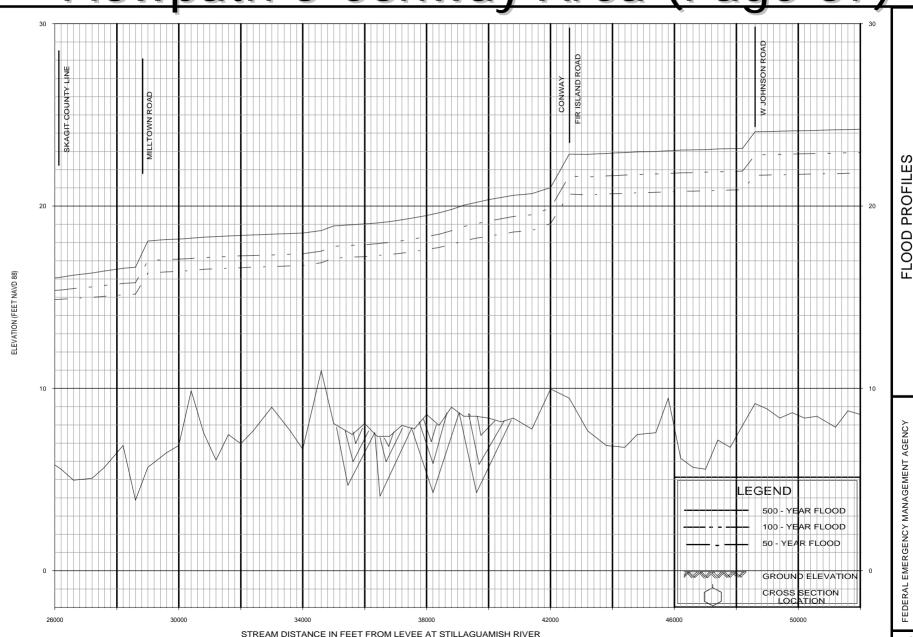
Flowpath 5 Conway Area (Page 67)

SKAGIT RIVER, OVERBANK FLOW PATH 5

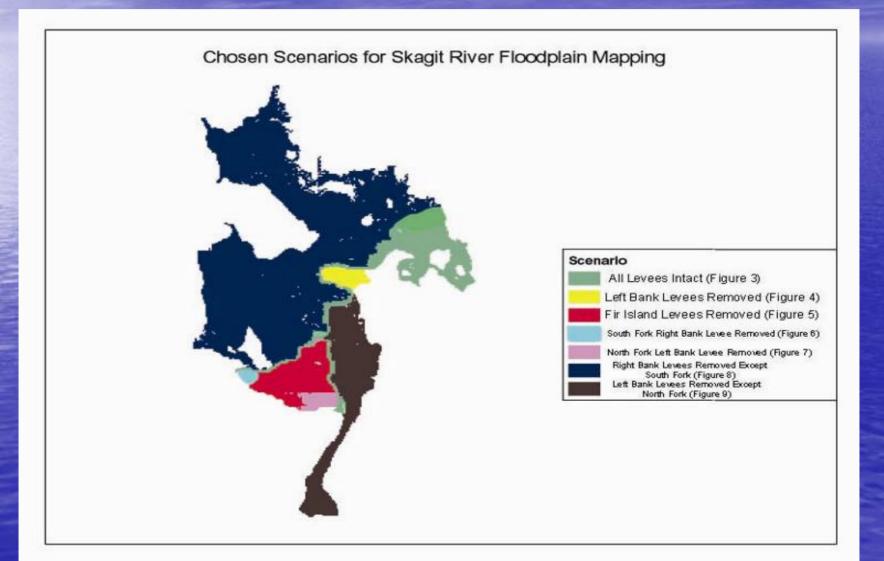
Fir Island Red, Pink and Light Blue Areas

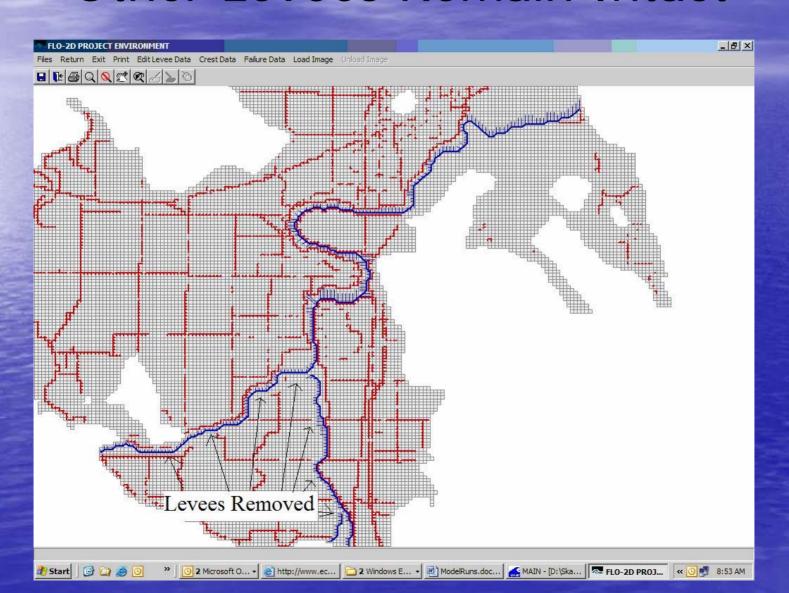
Fir Island Levees Removed While All Other Levees Remain Intact

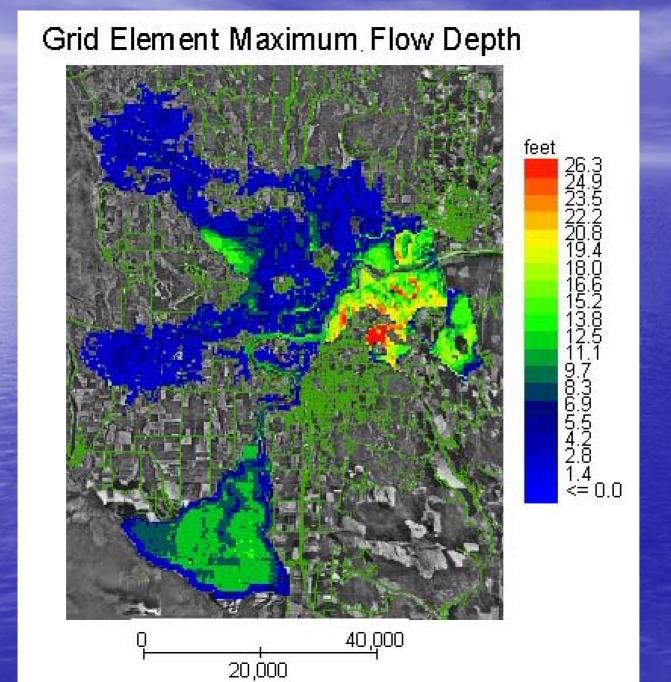
Fir Island Levees Removed While All Other Levees Remain Intact

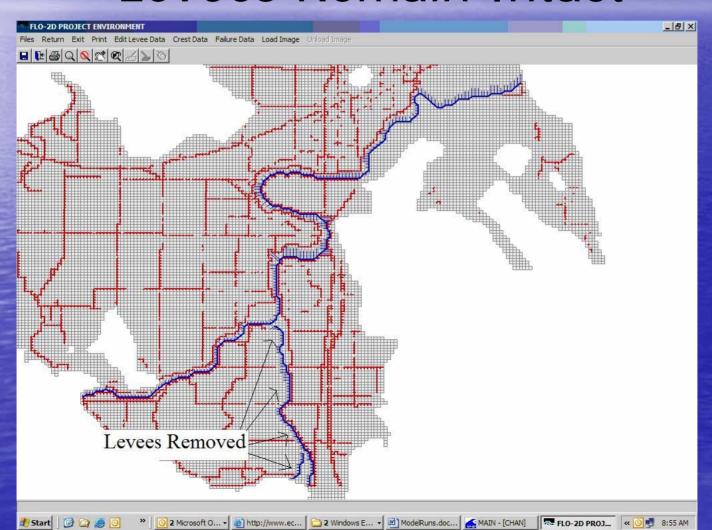
South Fork Skagit River Right Bank Levee Removed While All Other Levees Remain Intact

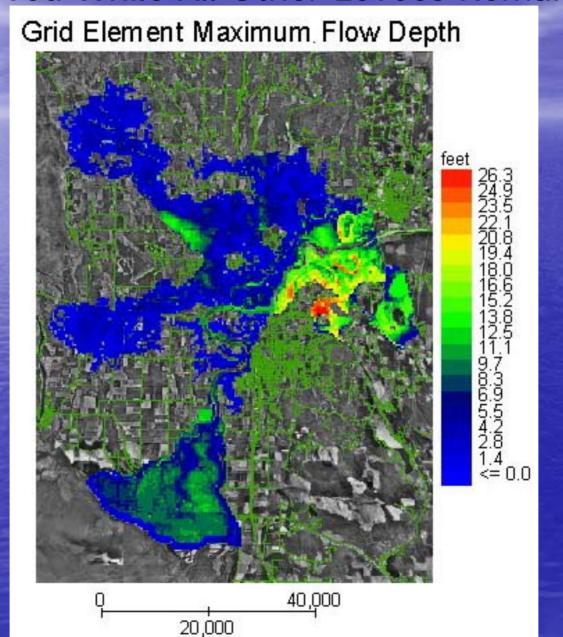
South Fork Skagit River Right Bank Levee Removed While All Other Levees Remain Intact

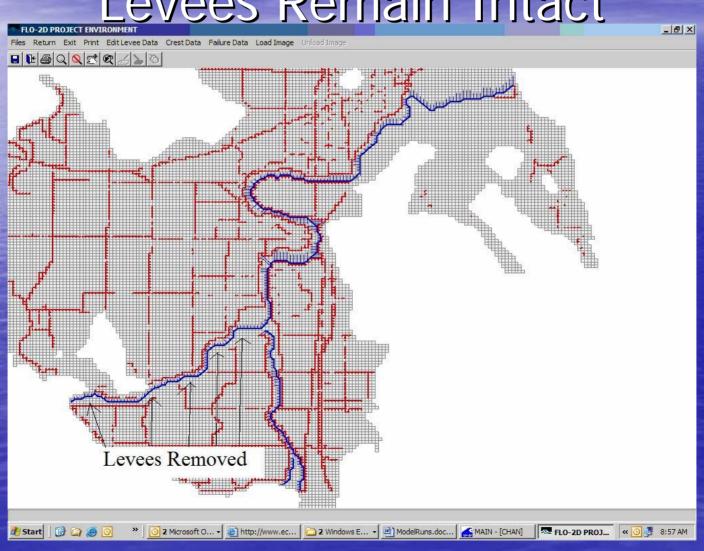
North Fork Skagit River Left Bank Levees Removed While All Other Levees Remain Intact

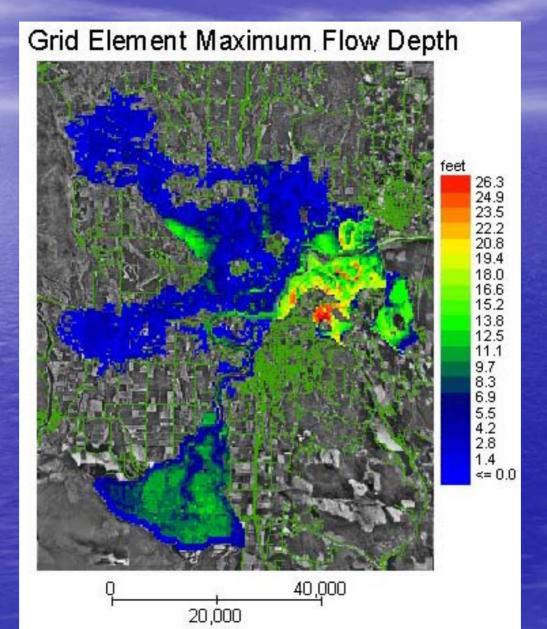
North Fork Skagit River Left Bank Levees Removed While

All Other Levees Remain Intact

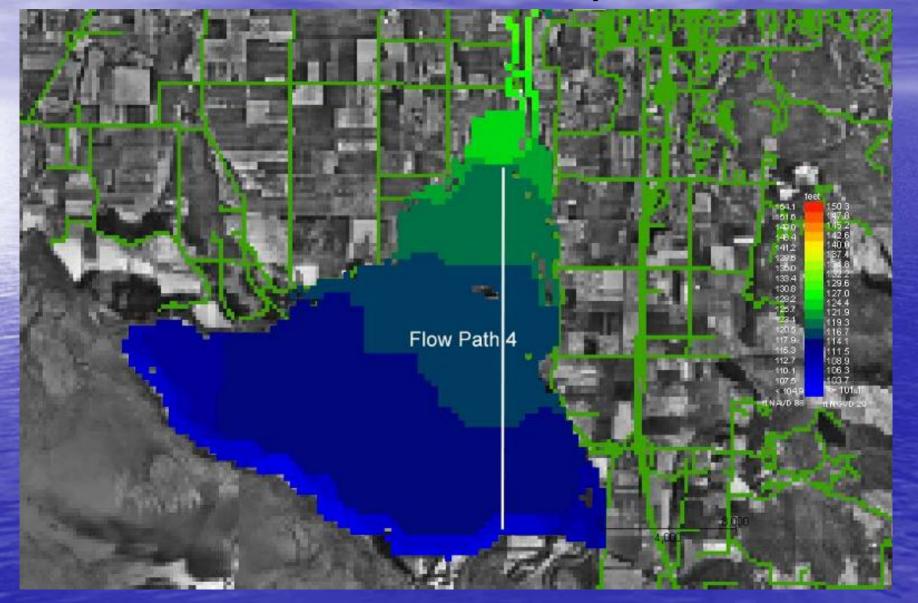
Fir Island Flowpath

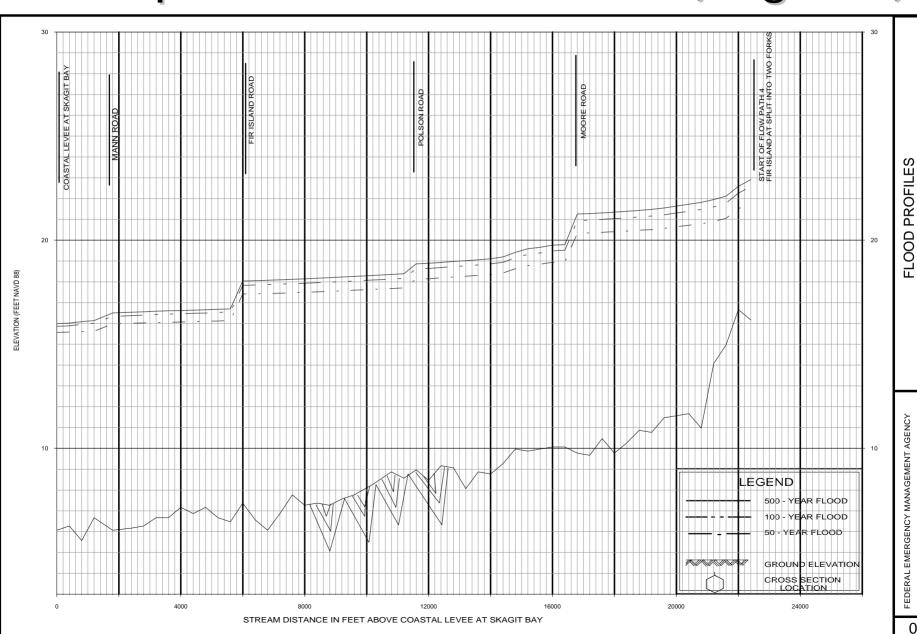
Flowpath 4 Fir Island Area (Page 65)

SKAGIT RIVER, OVERBANK FLOW PATH 4

SKAGIT COUNTY, WA

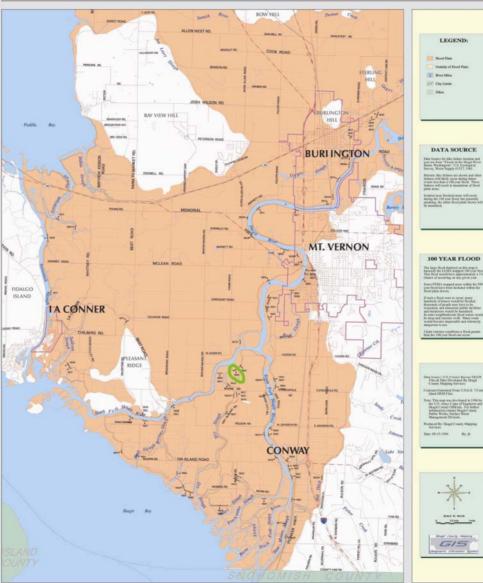
Fir Island 1990 Flood

Major Dike Failures Lower Skagit River Basin Washington

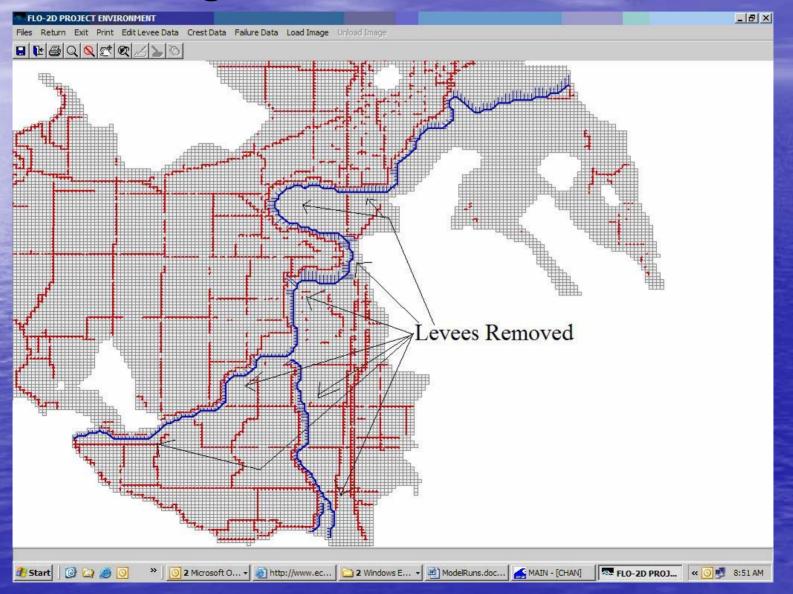
All Left Bank Levees Removed with Right Bank Levees Intact

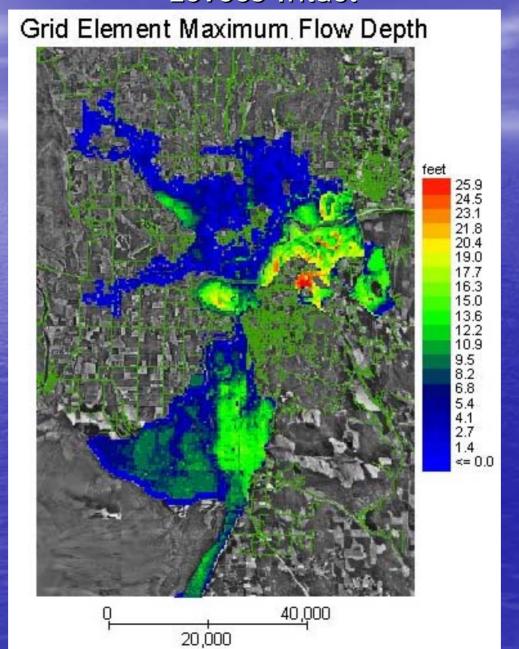
All Left Bank Levees Removed with Right Bank Levees Intact

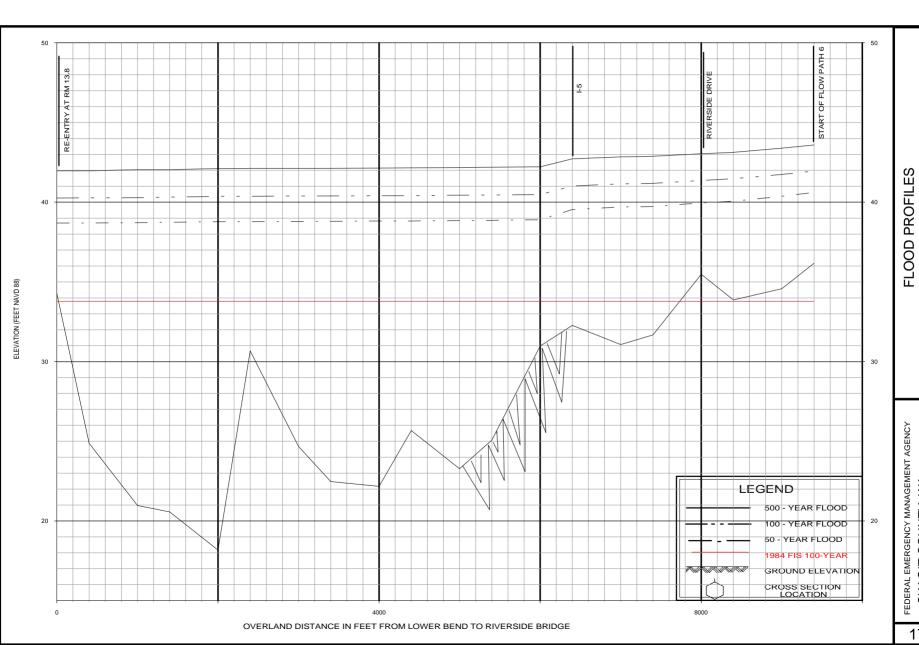
Flow Path 6 - Big Bend

SKAGIT RIVER, OVERBANK FLOW PATH

DERAL EMERGENCY MANAGEMENT AGEN
SKAGIT COUNTY, WA
(AND UNINCORPORATED AREAS)

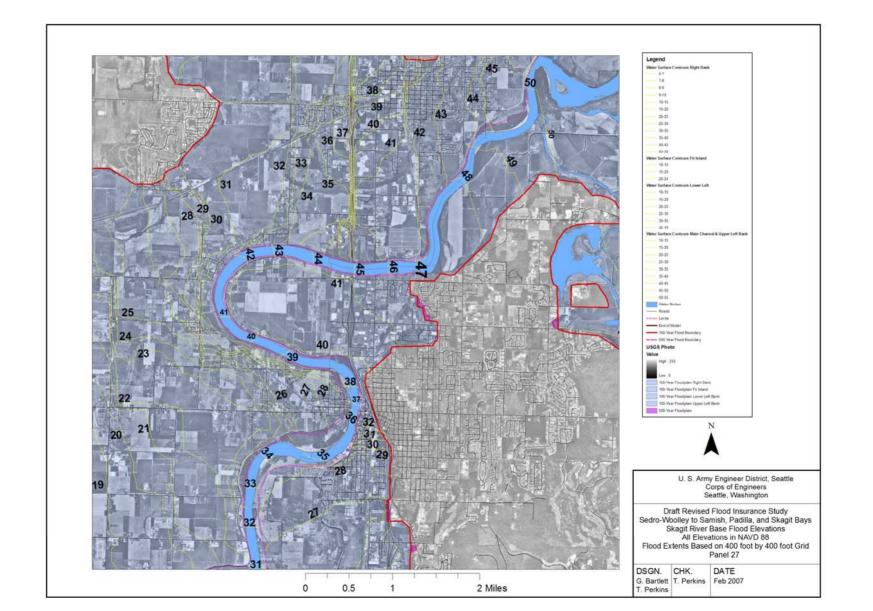
Base Flood Elevation Map

Concrete Flow = 220,000 cfs
