# 1921, Concrete Herald Newspaper

“About three o’clock in the afternoon it went over the banks in Crofoot addition and the residents of that part of town began to move out ... The waters also crept up around some of the dwellings in East Concrete, and some of the residents moved out for the night. **In Crofoot addition only three residences remained above the high water mark, the water being to a depth of an inch to 14 inches in the others.** No particular damage was done, except for small articles outside being washed away, and the job of cleaning out the mud left by the flood. ... **In East Concrete practically no damage was done.**” *Dec. 17, 1921 Concrete Herald “Skagit River Goes On Wild Rampage; Light Damage Here”*

# Ripple House #2, parcel #P70748

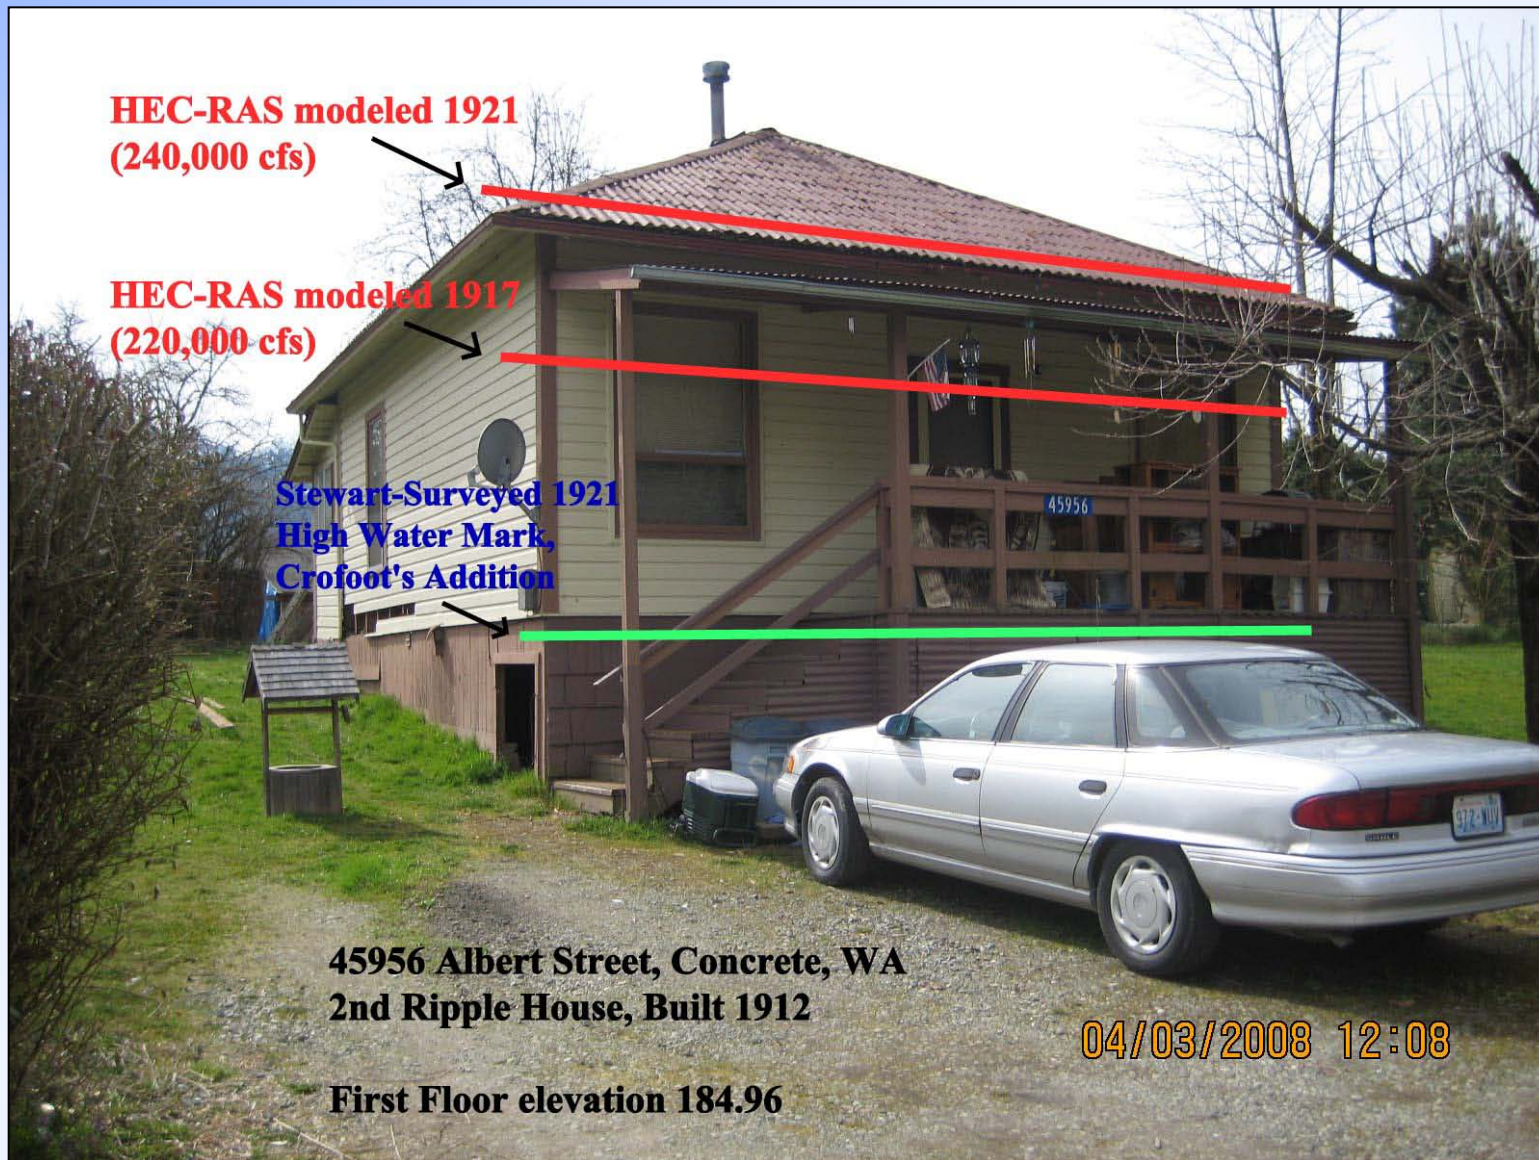
First Floor Elevation 184.96. Annotated photo showing exterior siding removed for inspection of interior wall cavity

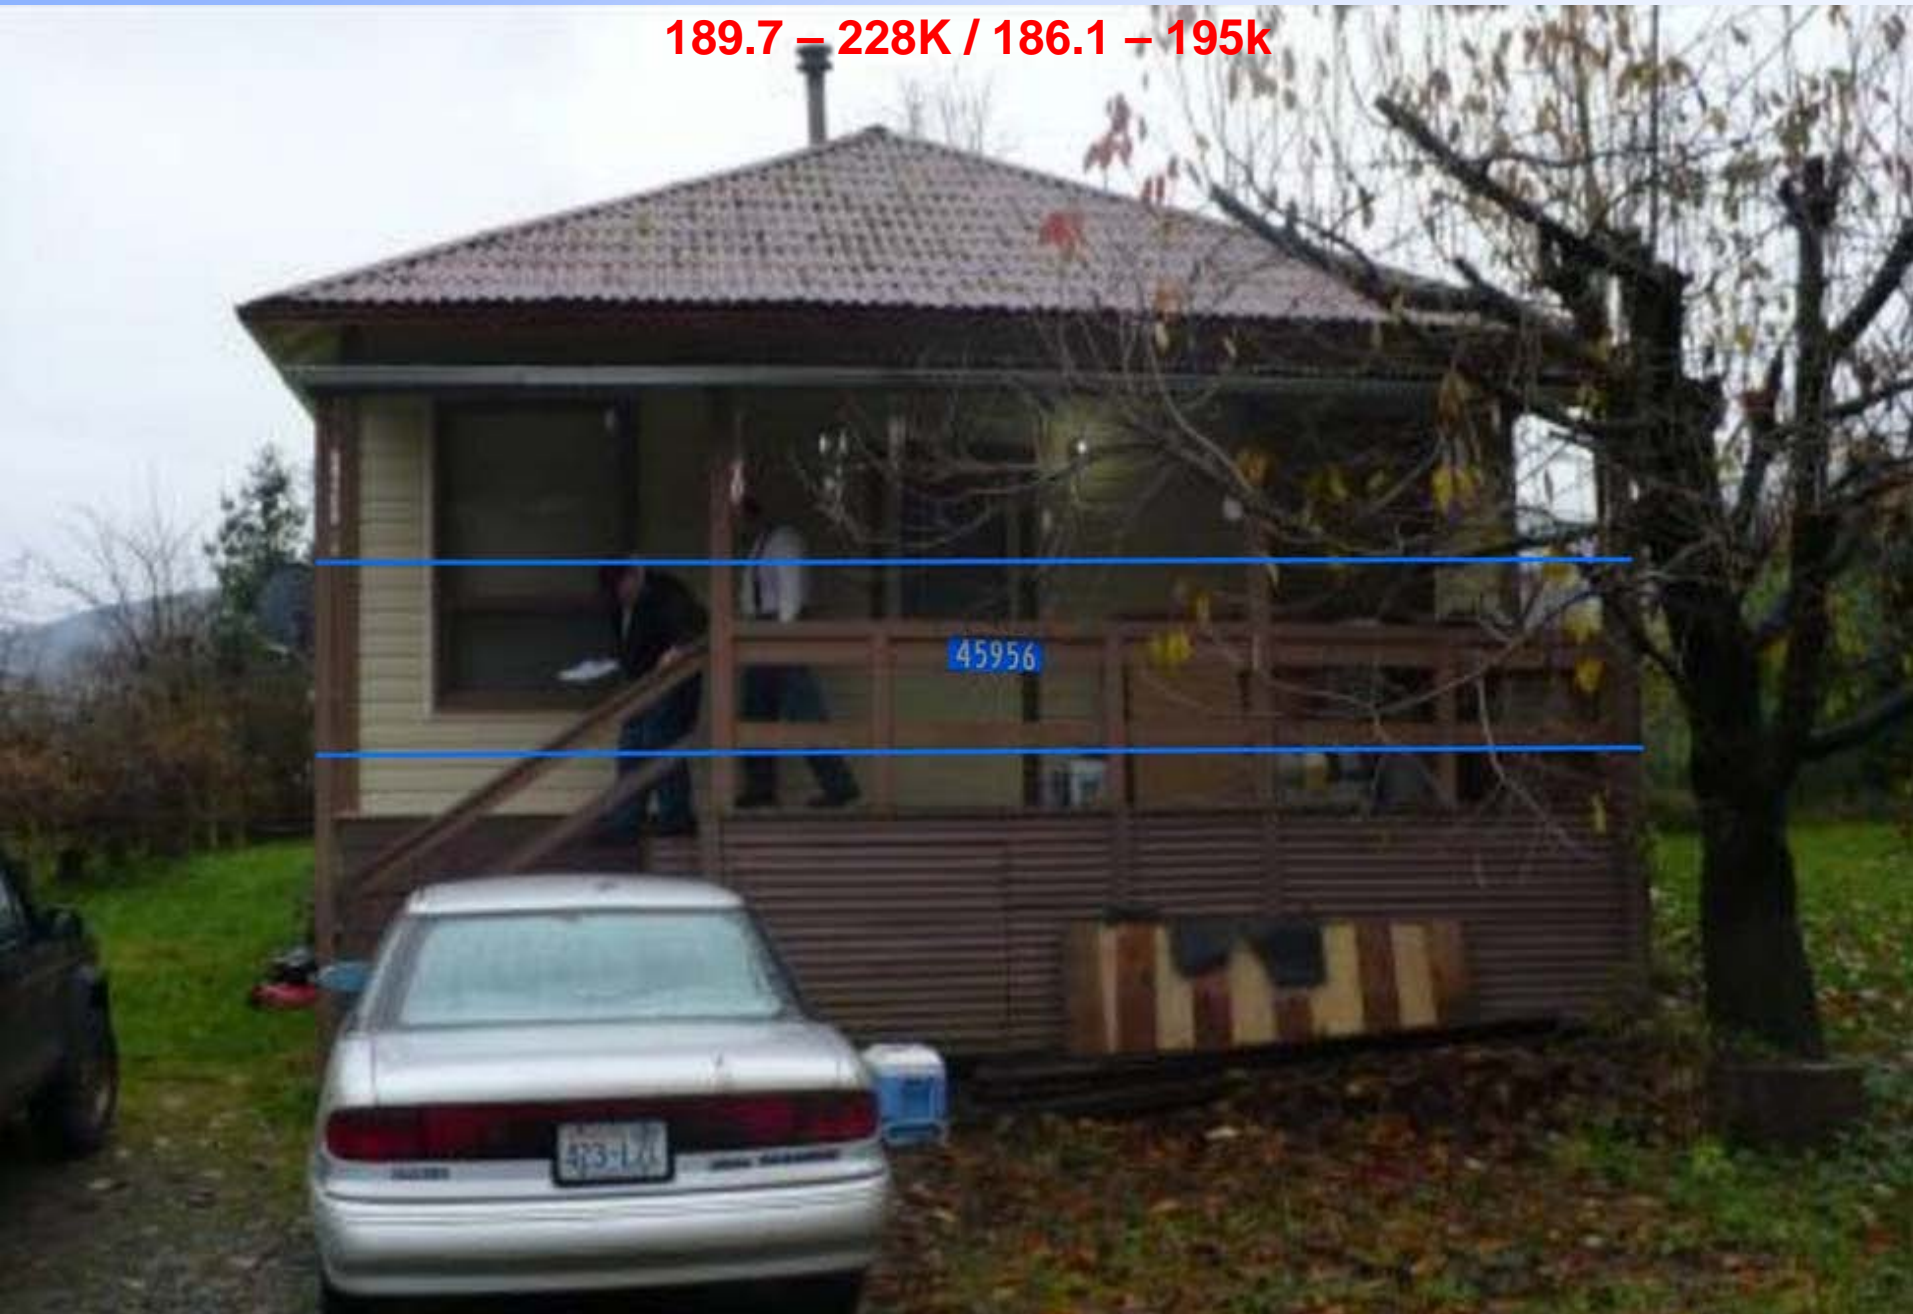
189.7 – 228K / 186.1 – 195k
