U.S. Army Corps of Engineers  
Seattle District

## SKAGIT RIVER BASIN, WASHINGTON REVISED FLOOD INSURANCE STUDY HYDRAULICS SUMMARY

## SKAGIT COUNTY, WA

1 MAY 2008

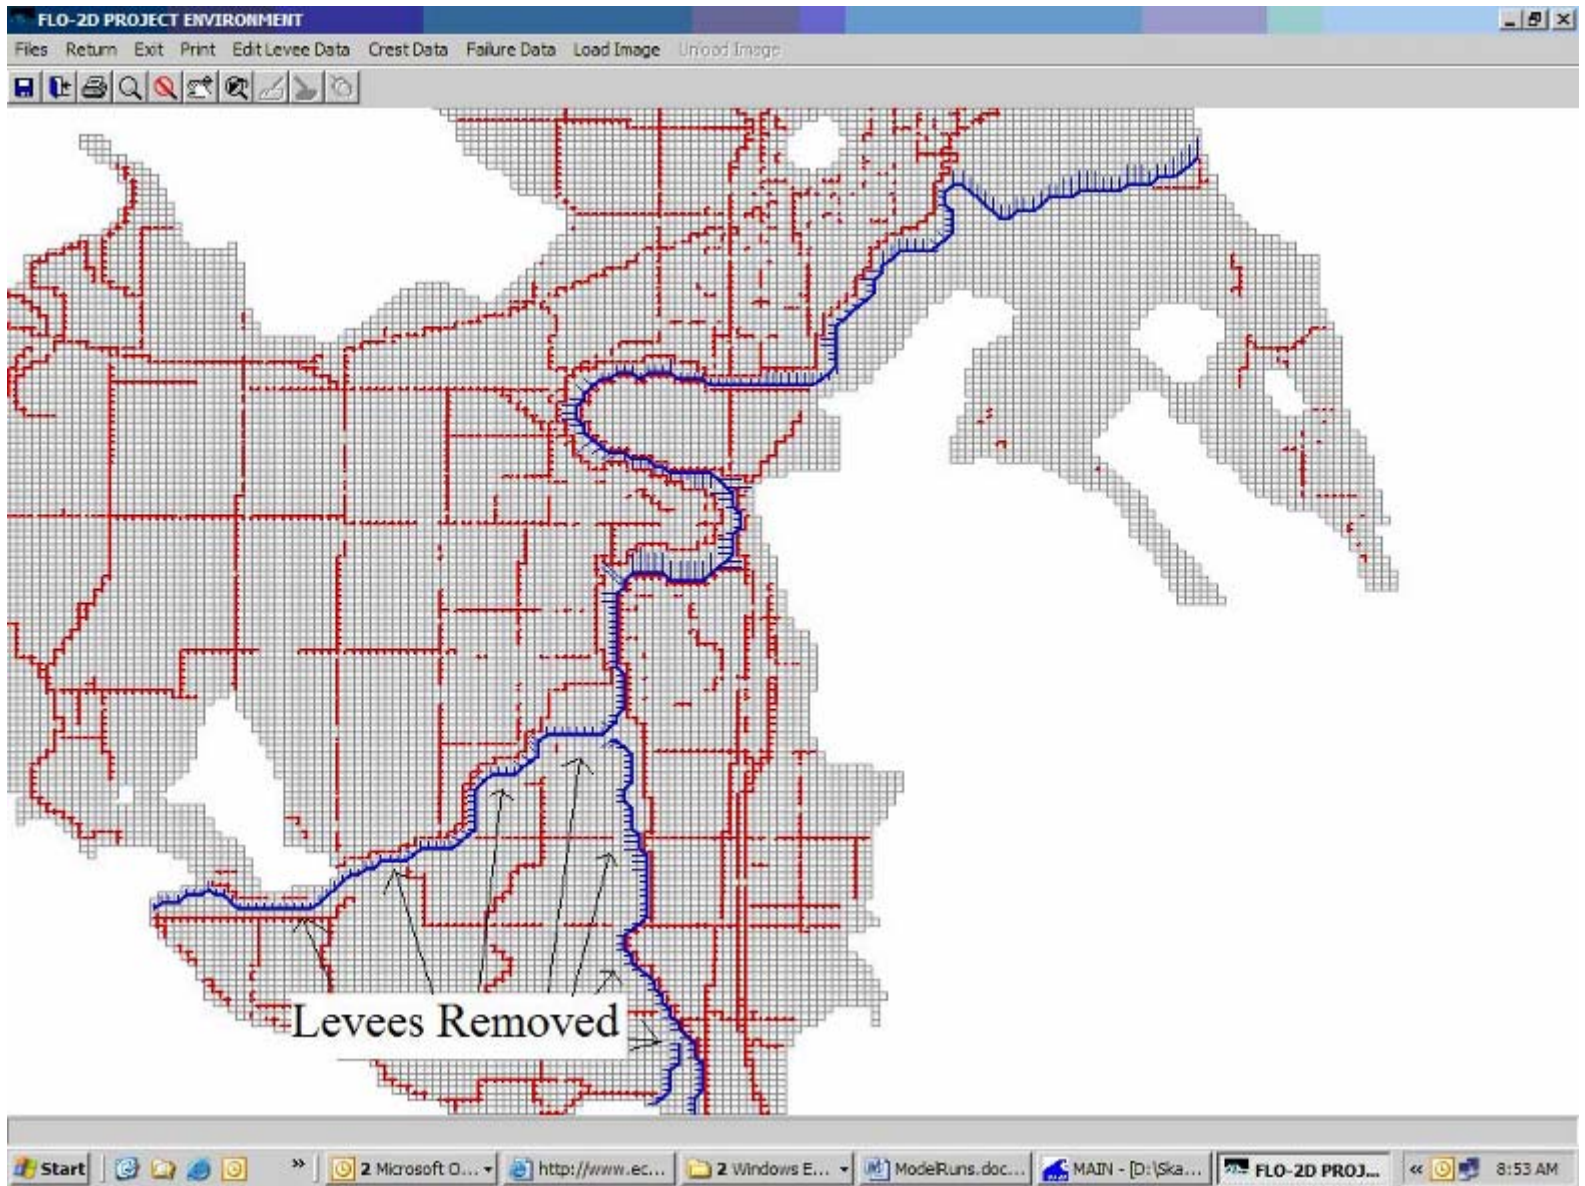
**Figure 6 - Fir Island Levees Removed While All Other Levees Remain Intact**

The lower Skagit River valley has levees that encompass all of these conditions. There are levees on both sides of the river from the Burlington Northern Railroad Bridge (River Mile 17.5) to the split at Fir Island into the North Fork and South Fork Skagit Rivers. The North and South Forks also have levees on both sides of the river. Fir Island is completely surrounded by two flooding sources (North Fork Skagit River and South Fork Skagit River). The Big Bend area that encompasses North Mount Vernon also is surrounded by levees on the left bank from the Burlington Northern Railroad Bridge (River Mile 17.5) to the Division Street Bridge (River Mile 12.95). After consulting with the Regional PO for FEMA, seven levee removal scenarios were deemed necessary to run to appropriately depict the base flood elevation. These scenarios are shown in Figures 4 through 10. Figure 11 details how the scenarios are used to define the different floodplain areas.

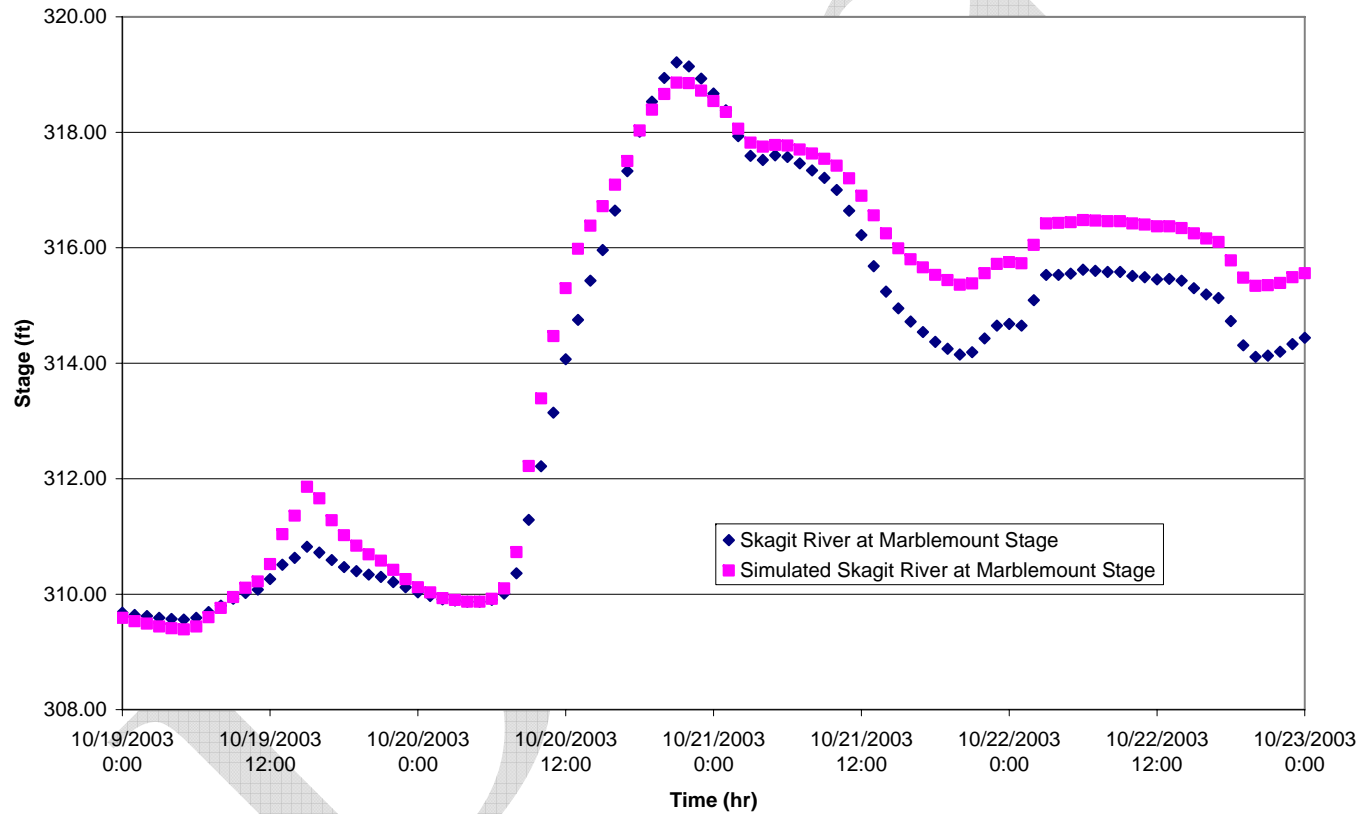
Figure 12 – Skagit River at Marblemount 2003 Stage – Modeled vs. Actual

Figures 12, 13, 14, 15 and 16 show the simulated and observed stage hydrographs for the 2003 event at the upstream locations for the Skagit River at Marblemount, the Sauk River near Sauk, Skagit River near Rockport, the Skagit River near Concrete and Skagit River near Sedro-Woolley gages, respectively. Figures 17, 18, and 19 show the rating curves from the USGS rating and from the model at these locations with the exception of Rockport and Sedro-Woolley, which are not rated. These figures show that the model does a fairly good job with the higher flows. The model has more trouble calibrating with the lower flows that could be caused by aggradation or degradation of the channel since 1975 and/or changing roughness in the channel in lower flows. The change in channel bottom from 1975 would have a lot larger impact on lower flows than higher flows. This study’s focus is on defining damages caused by floods so the errors in the lower flows have little impact on the results.

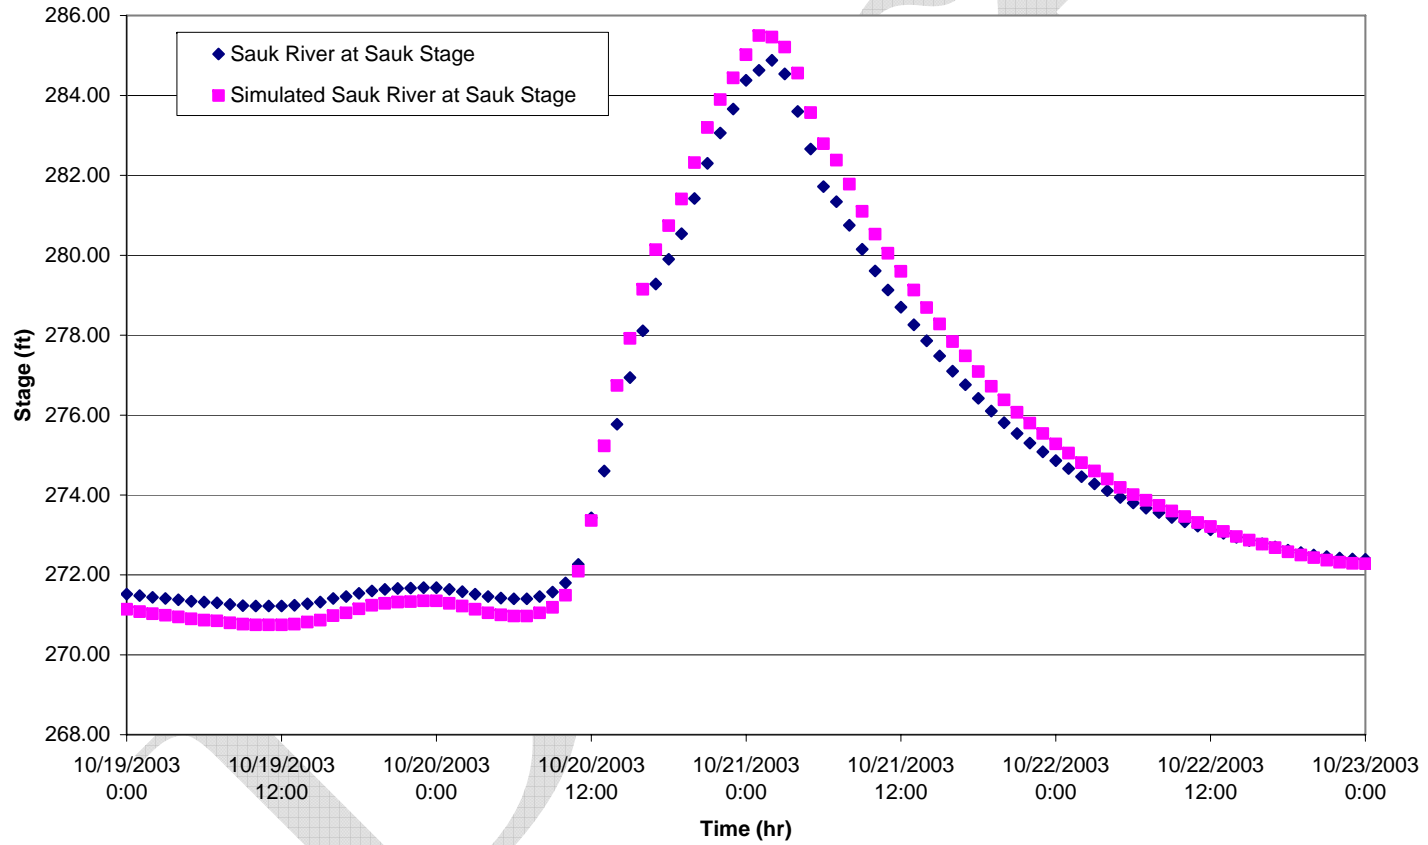
Figure 13 – Sauk River 2003 Stage – Modeled vs. Actual

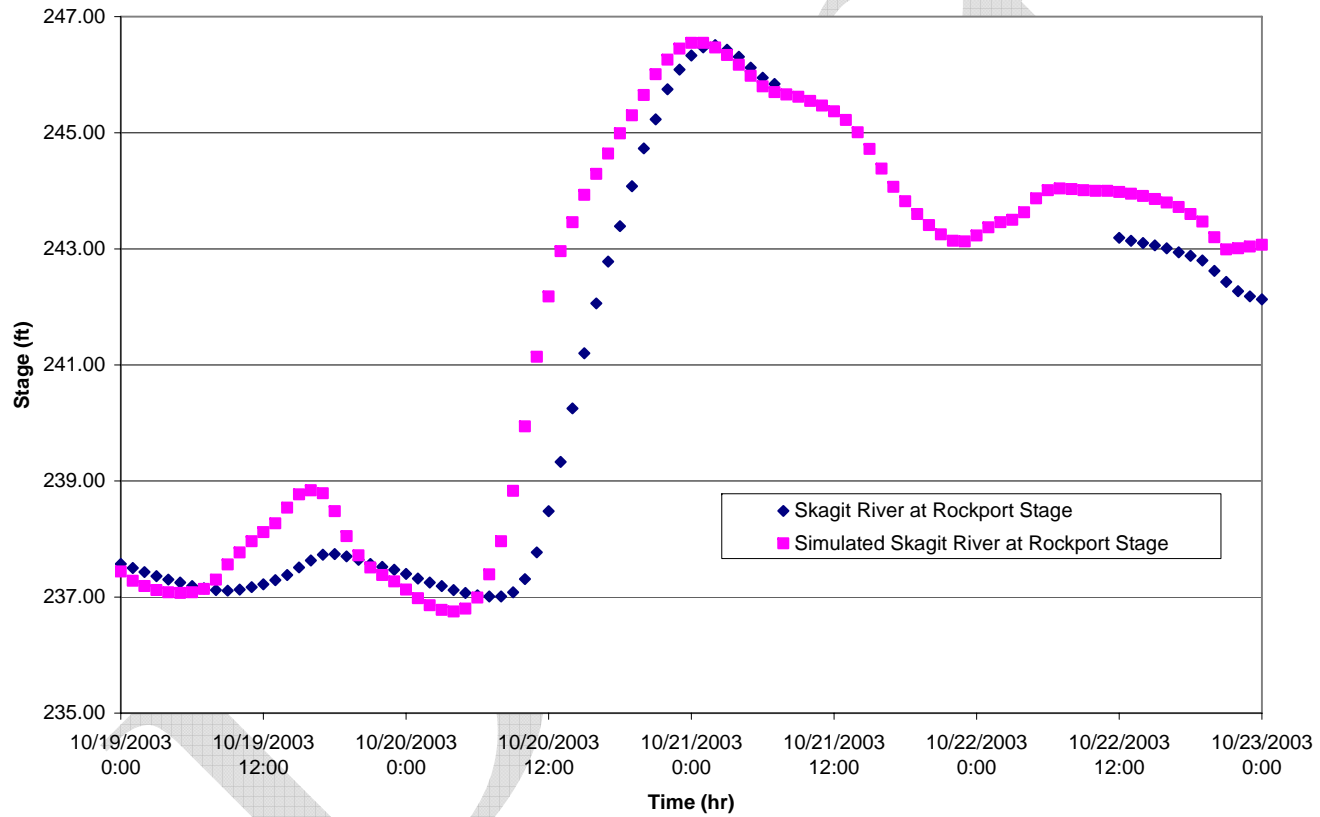
Figure 14 – Skagit River at Rockport 2003 Stage – Modeled vs. Actual

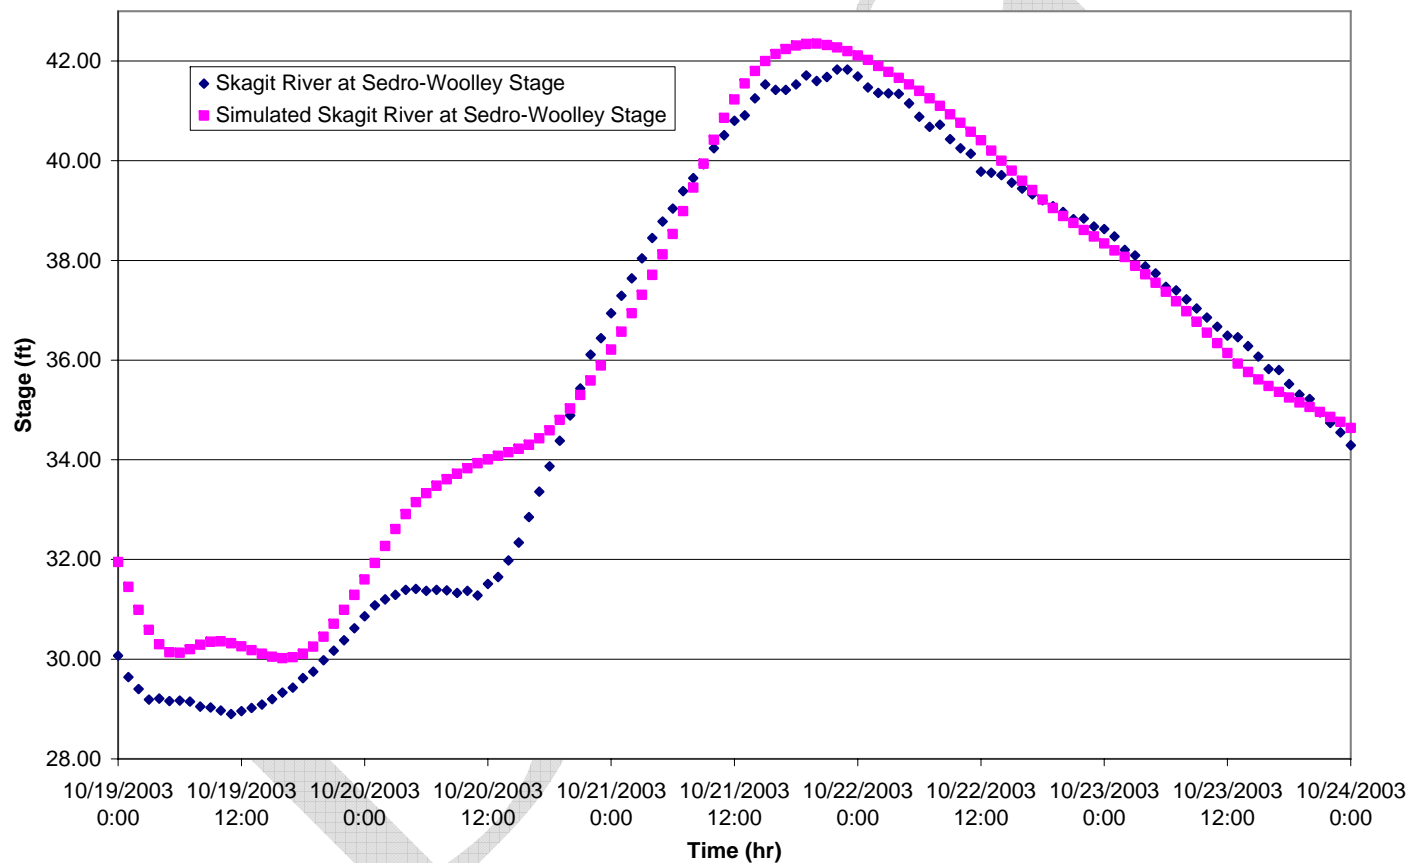
**Figure 16 – Skagit River near Sedro-Woolley 2003 Stage – Modeled vs. Actual**

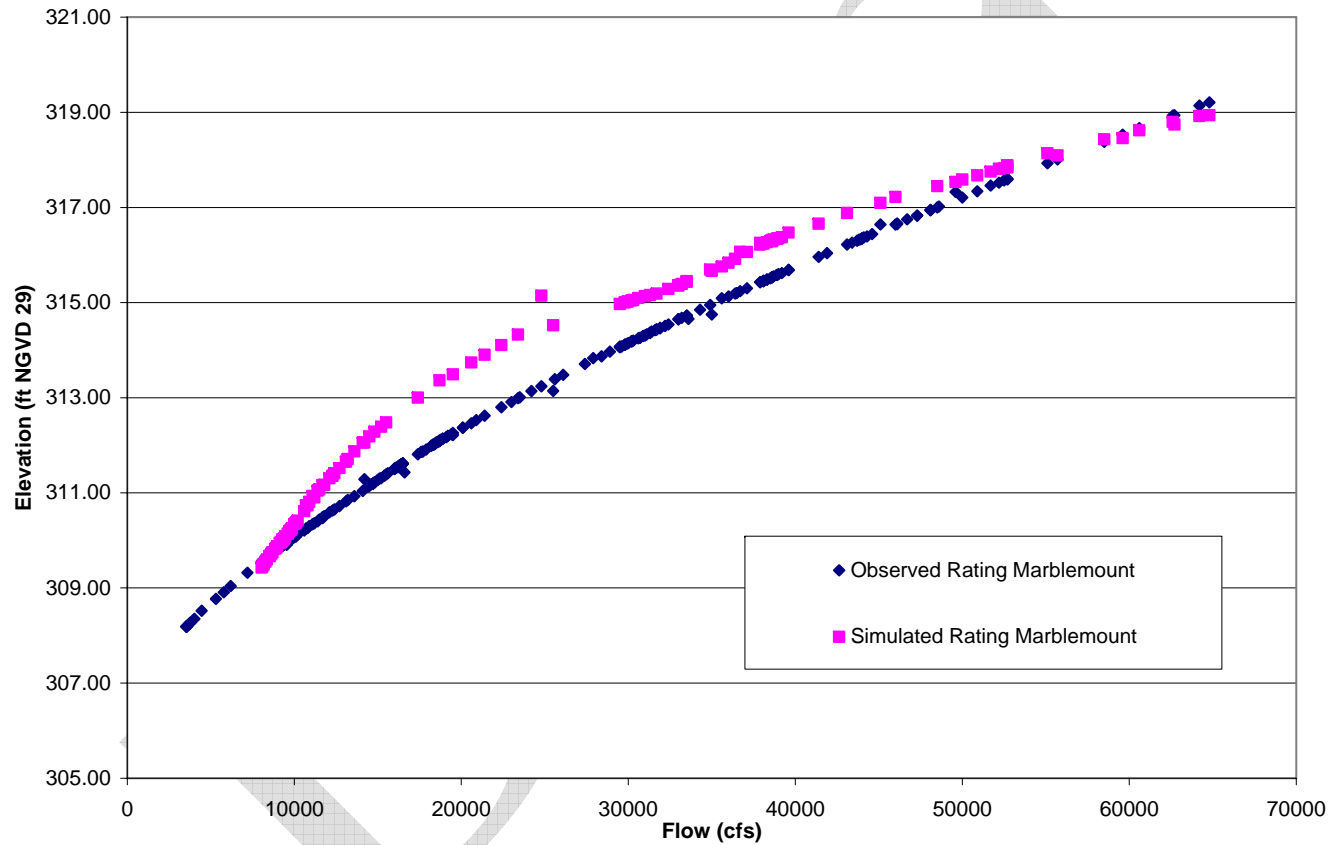
Figure 17 – Skagit River at Marblemount 2003 Rating Curve – Modeled vs. Actual

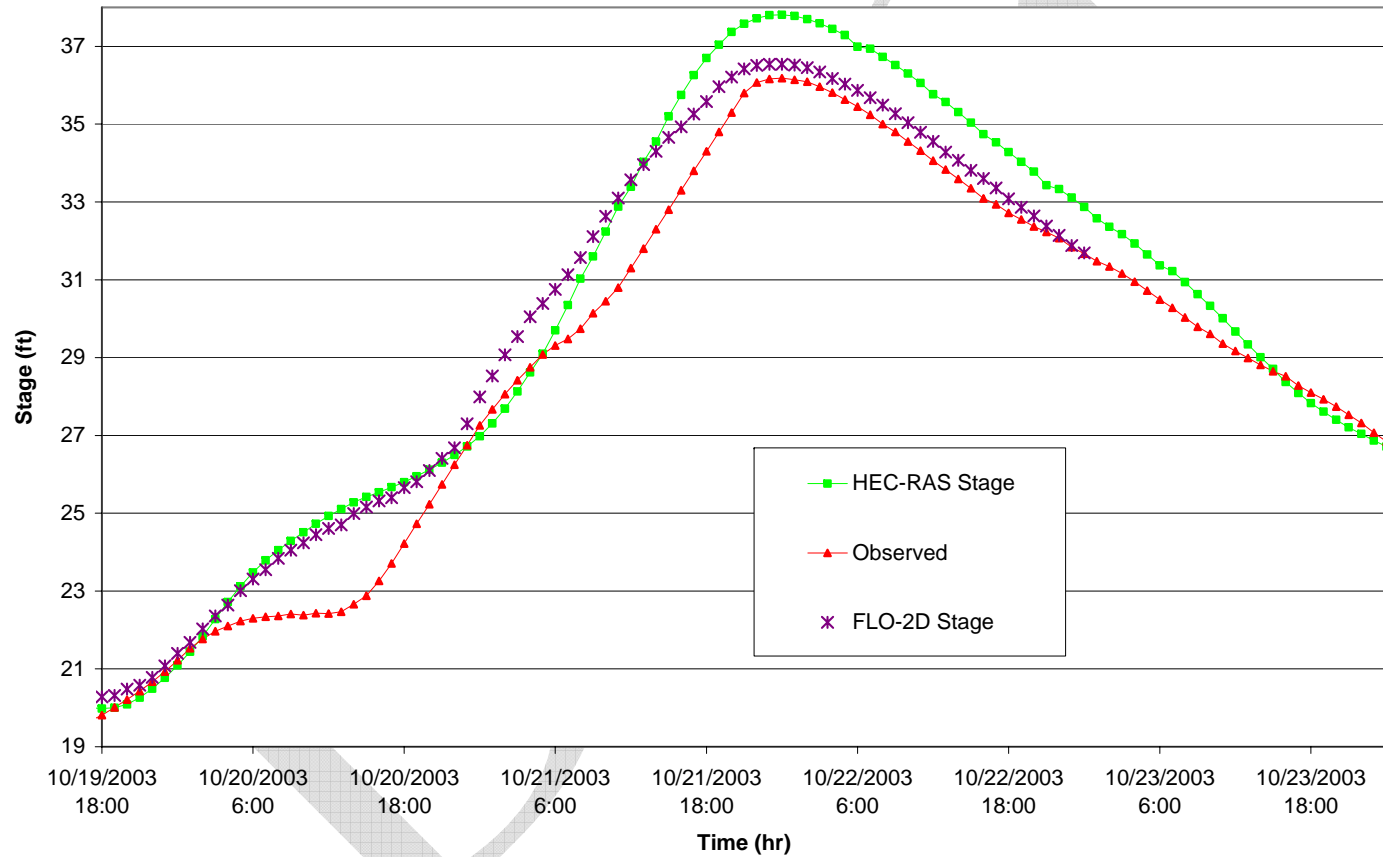
Figure 20 – October 2003 Mount Vernon Gage Stage Comparison between HEC-RAS, FLO-2D, and Observed

The hourly data combined with the peak stage data show that the model is working appropriately to match the observed stages for the 2003 flood event. The hourly data includes the HEC-RAS results from the Flood Damage Reduction Study to show that the slightly higher elevations observed in the model are likely due to uncertainty around the local inflows between Concrete and Mount Vernon and not how the hydraulic model is routing these flows. As a final check, the rating table developed for the Mount Vernon gage for computing flow from given stages as shown in Figure 21 confirms the model is matching the correct flows with the appropriate stages.

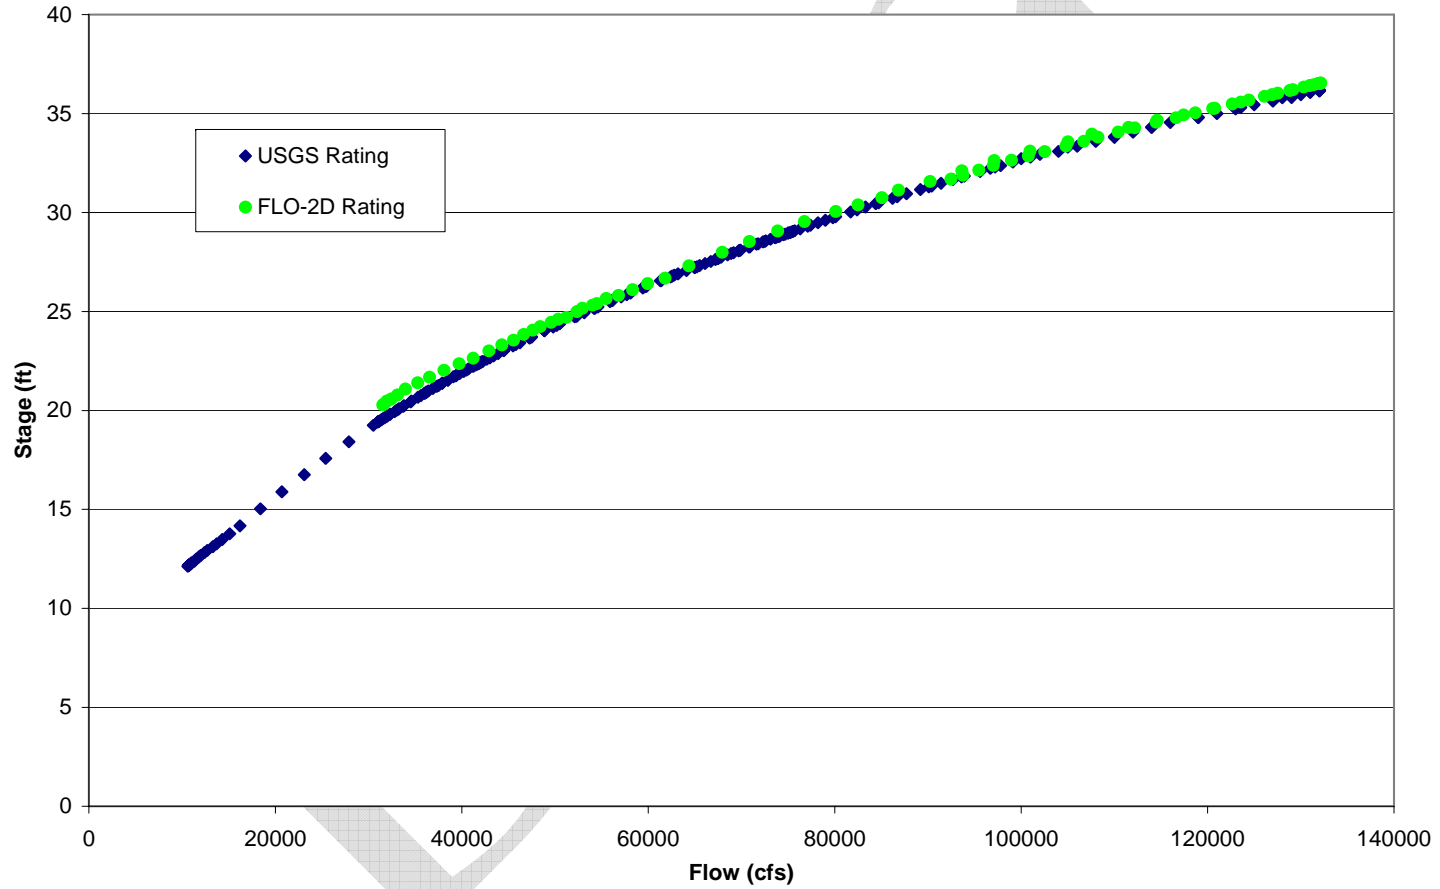
Figure 21 – Mount Vernon Rating Curve Comparison between USGS gage and FLO-2D

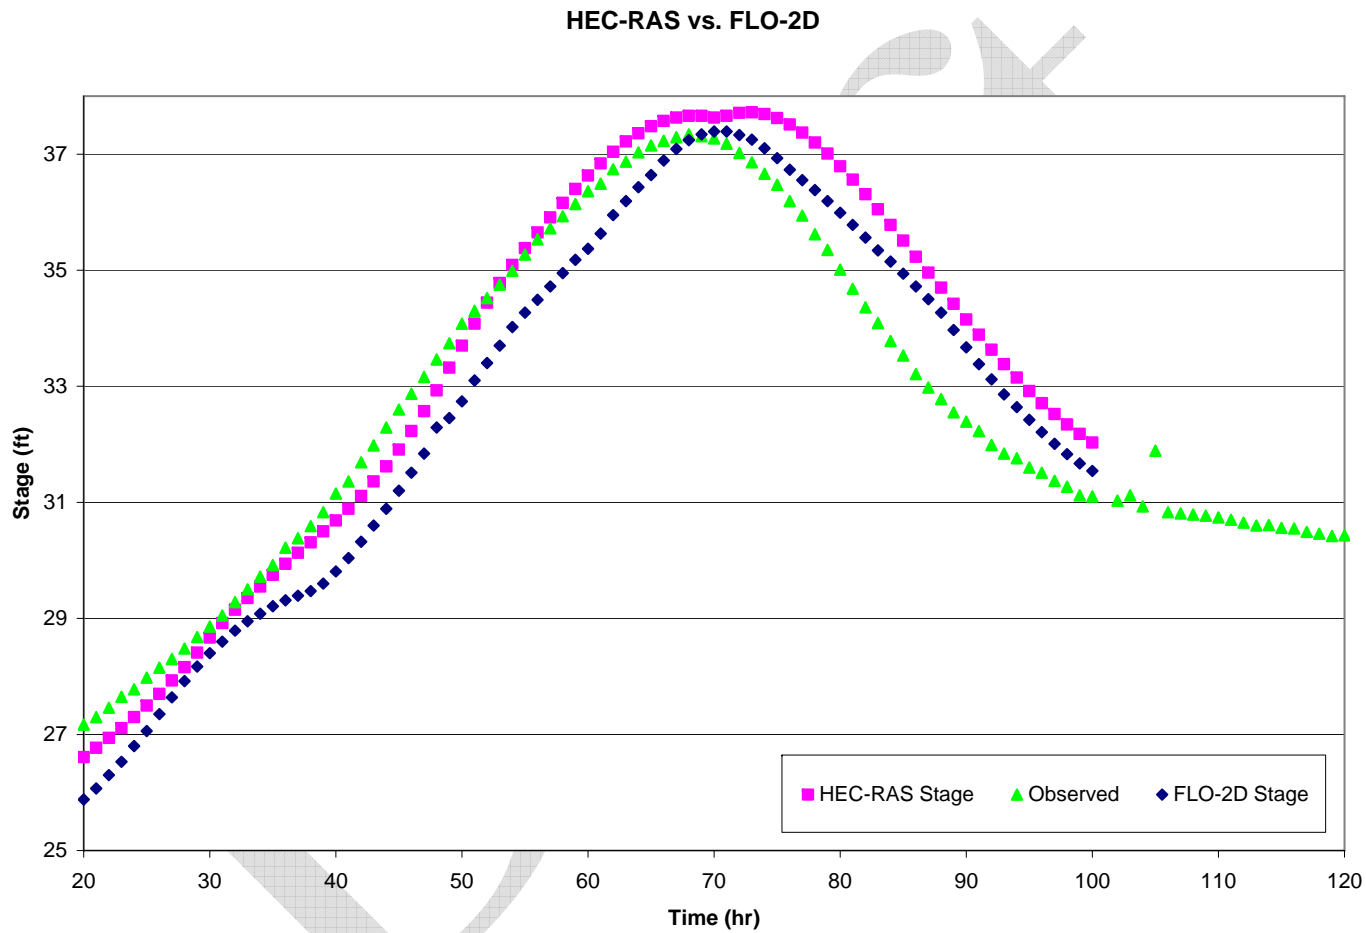
**Figure 22 – 1995 Skagit River near Mount Vernon Stage Comparison between USGS gage, HEC-RAS, and FLO-2D**

Table 6 shows the stage calibration to the 1995 event to the bridge debris condition. The high water marks that were taken are mostly at the outskirts of the floodplain and taken a few hours before the peak flow passed these locations. What is most important in this calibration is that the Burlington Northern Railroad Bridge is metering out the appropriate flow through the leveed in corridor downstream. This is best shown by a comparison to the flow seen at the Mount Vernon gage as is shown in Figure 22.

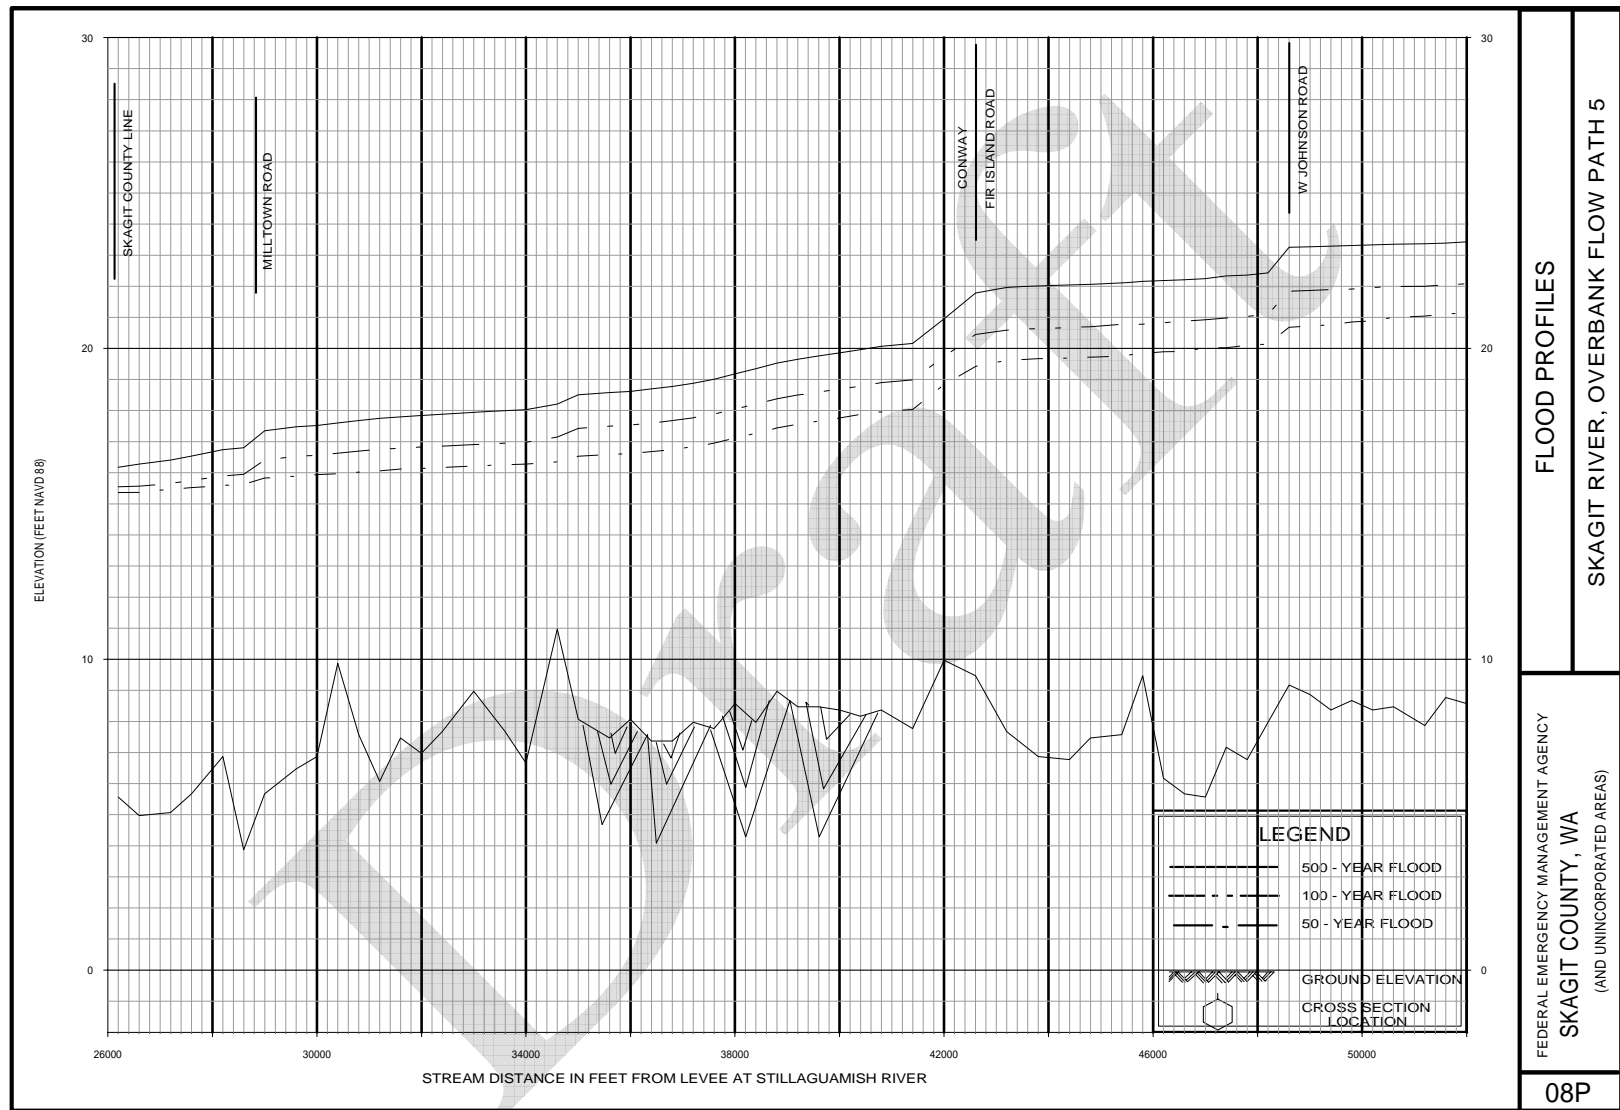
08P

FLOOD PROFILES

SKAGIT RIVER, OVERBANK FLOW PATH 5

Flood profile 07P through 09P depicts flow path 5, which represents the floodplain from West Mount Vernon down to Stanwood. It shows a 100-year depth at the town of Conway of 10 feet. On February 11, 1951, the Skagit River near Mount Vernon gage reached 144,000 cfs, which is roughly a 25-year flood event. The levee system in this reach failed and the flooding in this area can be seen in Figure 31. The Mount Vernon Argus dated 2/15/51 states that “Conway residents declared the 1951 flood was two feet, ten inches below the 1921 inundation in their community.” This would make the 1921 flood similar in depth to the 100-year modeled flood estimate.
