Preliminary Historical Investigation of East Concrete and Crofoot Addition Flood Levels

11/17/2007

Prepared for Northwest Hydraulic Consultants (nhc) in cooperation with K&L Gates

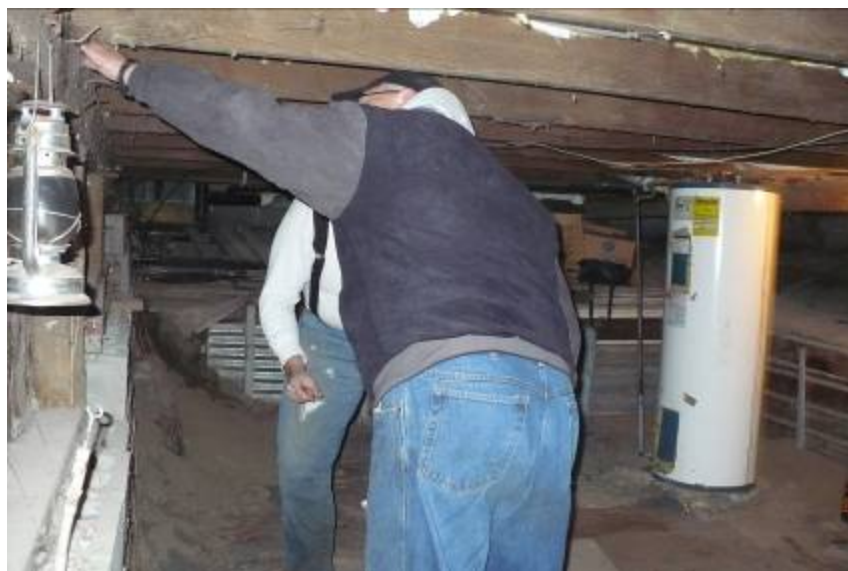
Crawl space under the house. Notice river silt on ledge to the left.

One of the main problems with using this house might be that at some point in time the exhaust duct pipe for the clothes dryer had come undone (or was not hooked up at all) as you can find lint dust on the upper rafters and the pipe installation appeared to be brand new. Further investigation as to the duct pipe installation is warranted upon a future visit with the Shope's. At this visit, no apparent watermarks were observed on the upper rafters. Mr. Shope did say that the flood waters in 2003 did make it up to the base of the stop sign post at the end of the road, intersection South Dillard Avenue and Albert Street.

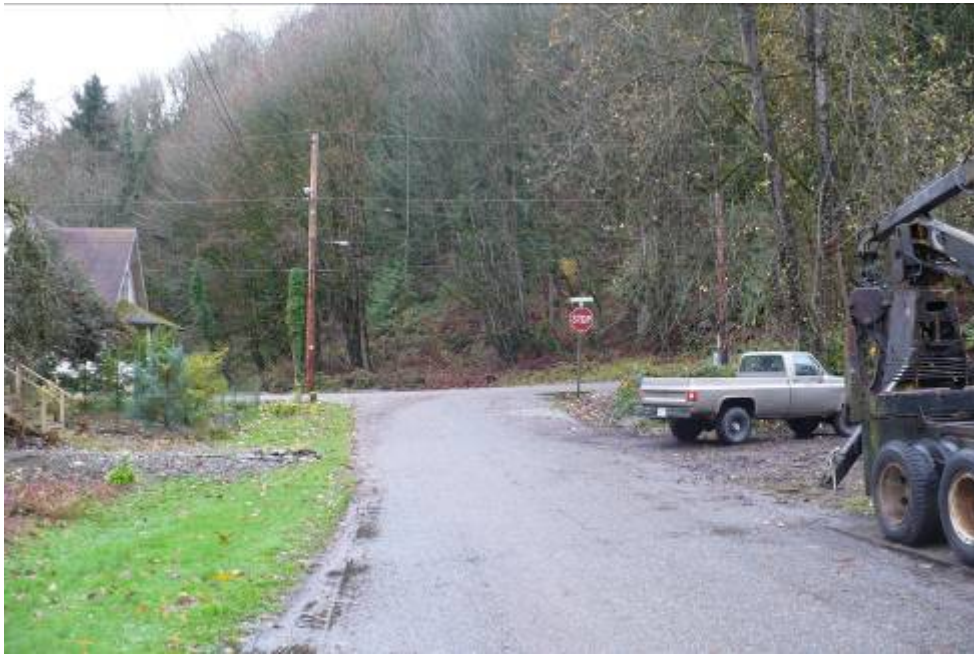
Floodwaters in 2003 made it to base of Stop Sign post.

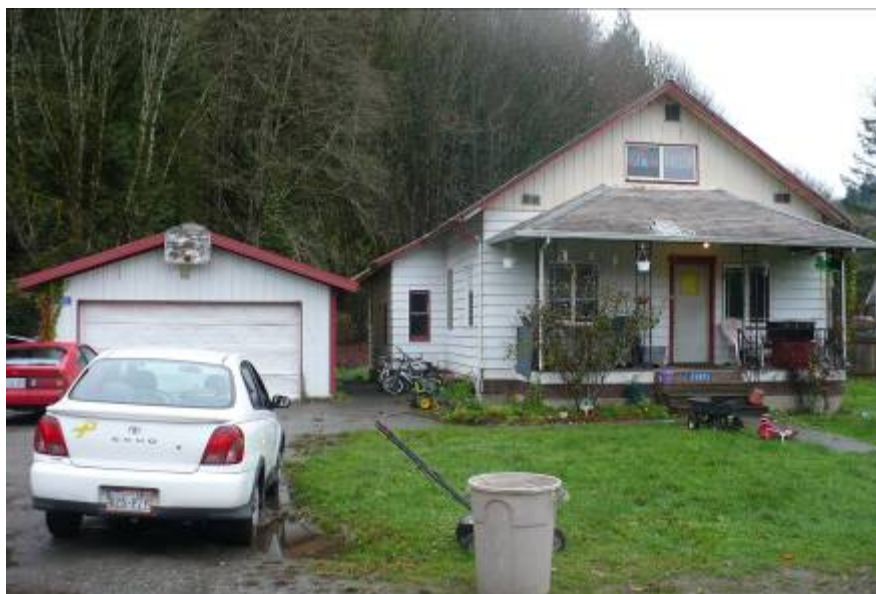
45893 Benjamin Street – Assessor Records show construction 1912.

Occupants are renters who recently moved in and know nothing about local flood history.

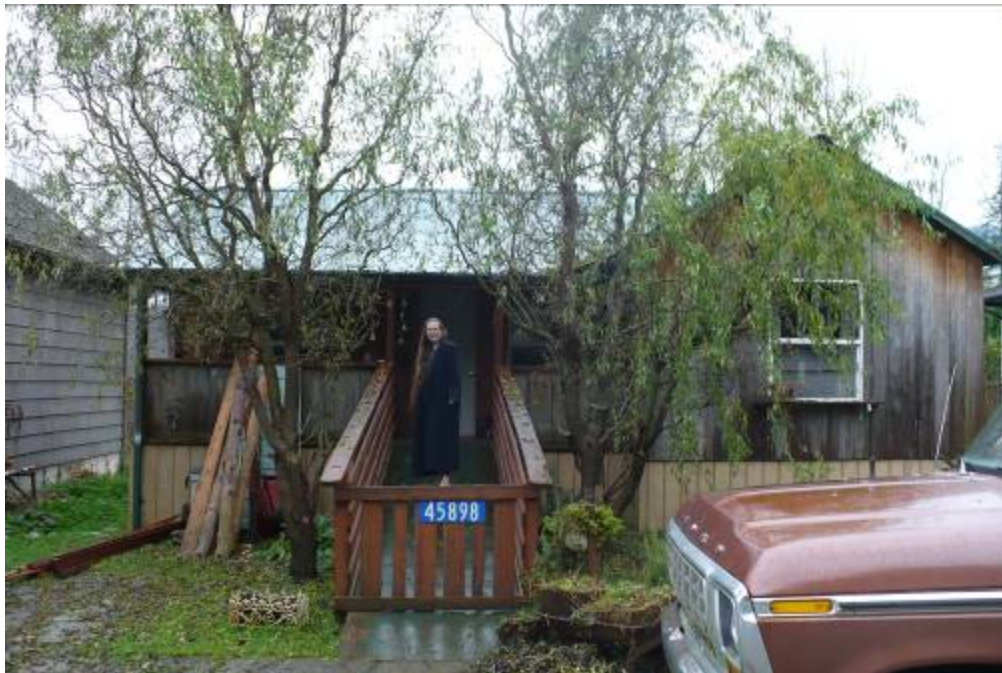
45898 Benjamin Street – Assessor Records Built 1912

Mrs. Rogge stated that in 2003 she had 4 feet of water in her backyard and under her house. We did not inspect the area under her house or the backyard as she was leaving for an appointment and did not have time to talk. However, she is more than willing to let us come back later and conduct whatever kind of inspection we need to do. To the best of her “limited knowledge,” the house has never had water in it before. There has been no evidence of any river silt in her walls or floors. In my opinion, this would be a great house to use as a test house because we have a very cooperative homeowner, the floodwaters in 2003 were 4 feet deep AND the fact that the house was built in 1912 just 3 years after the 1909 flood event. Why would anyone build a house just 4.5 to 5 feet off the ground when according to Stewart this area would have had at least 10 more feet of water on it in 1909, just three years before this house was built? (2003 event 166,000 cfs vs 1909 event 260,000 cfs).

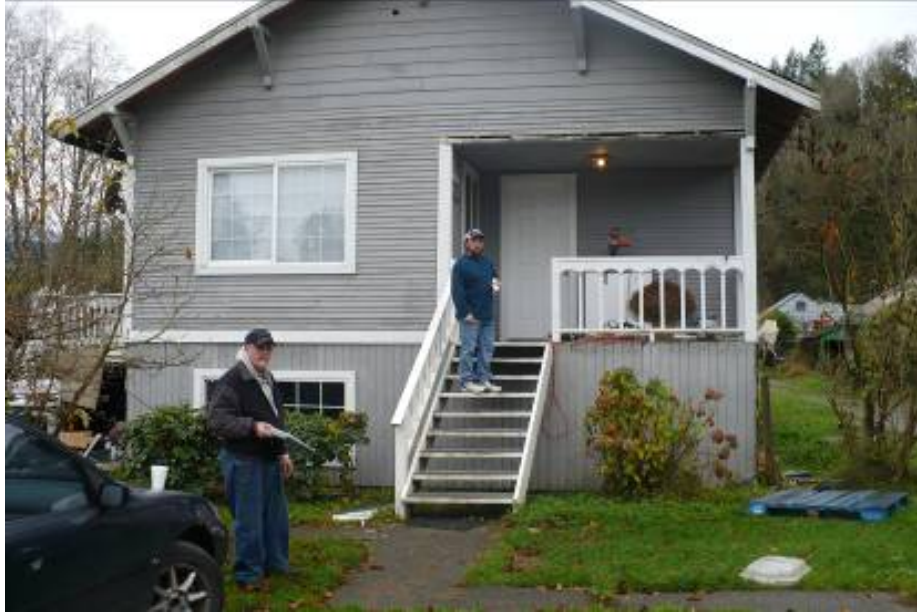
7752 S. Dillard Avenue – Tax Assessor Records Built 1915

Allen Jenkins, owner, stated that the floodwaters in 2003 came up to the step he is standing on above. He was also here in the 1995-flood event, which according to his words, “*was not nearly as serious as the 2003 event.*” He recently remodeled the basement and did not see any flood marks or silt above the 2003 event. Would have interviewed him longer but he was on his way to visit his son in Harborview who had been involved in a serious work related accident.

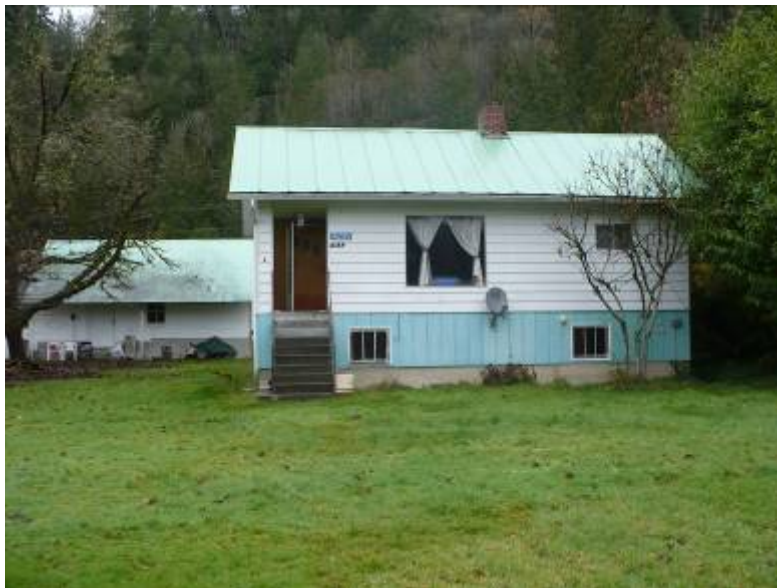
46335 Forest Place

We only conducted two interviews of homeowners in East Concrete. The first and perhaps most important was with Lori Gehret, the current owner of 46335 Forest Place. According to the Assessor records, the house was constructed in 1912. She only purchased the house 2 years ago and knows nothing about the local history of the house. However, Annie Bussiere, local resident/historian/former editor Concrete Herald who took over from Chuck Dwelley, owner of Annie's Pizza, told us that the house was originally owned by the Stokes family.

Mildred Stokes-Gardinier was raised in this house. Mildred and her husband, Dick Gardinier, were both raised in East Concrete in the early days and later married and took over ownership of the house. Unfortunately, both of the Gardinier's have passed. However, Annie Bussiere told us that the Gardiniers told her that they once had floodwater up to the floor of their house. Since the house was built in 1912, the only flood that could have done that would have been the 1921 flood of which Chuck Dwelley wrote: **"In East Concrete practically no damage was done."**

Now clearly, if it were up to the floor, it would have filled the basement. This raises an interesting question. Why would anyone, just three years after the 1909 flood, put in a basement with windows in it? Lori Gehret did tell us that her neighbors next door did say that the area flooded in 2003 not from the Skagit or Baker Rivers but from "intense run-off from the hill behind her." Several of the homes in East Concrete are raised up off the ground, suggesting that the old timers knew the area flooded from the Skagit and Baker Rivers. We interviewed Mrs. Gehret's neighbor, Sharon Stewart.

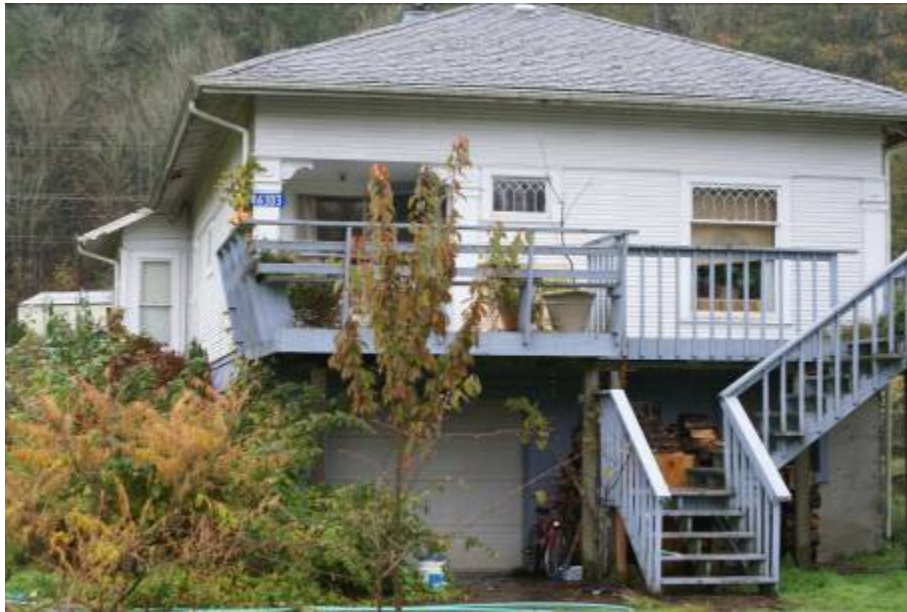
46303 Forest Place – Constructed 1912

Sharon Stewart just moved into the above residence in 2003. She confirmed that during that flood event they had about 4 feet of water in this location, however it was not from the Baker or Skagit Rivers. There is some kind of a "sump pump" structure just down the street and during that "storm event" the sump pump failed and the water backed up "into this hole in the ground". The water in this area was from the "intense run-off from the hill behind" the homes. Other than
